## **VISUAL BUILDING AND PEST INSPECTION REPORT**

Complies with Australian Standard 4349.1 & 4349.3

31 Canea Crescent, Allambie Heights

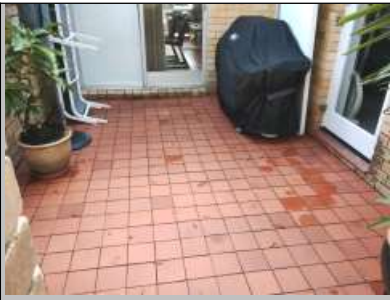
Front elevation.

Constructed from concrete or masonry. The condition of the structure is generally acceptable.

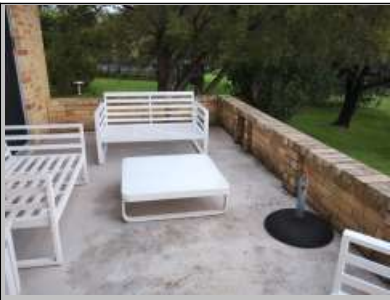
Rear elevation.

Constructed from concrete or masonry. The condition of the structure is generally acceptable.

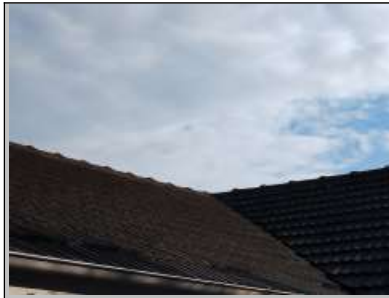
The roof is of pitched construction.

The overall condition of the roof coverings is fair.

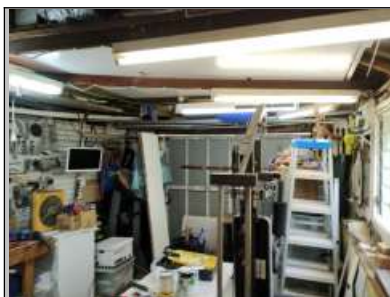
Garage.

The structure is generally in fair condition.

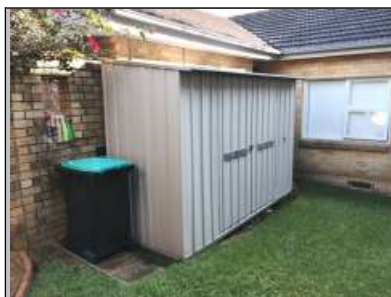
Metal garden shed.

The structure is generally in fair condition.

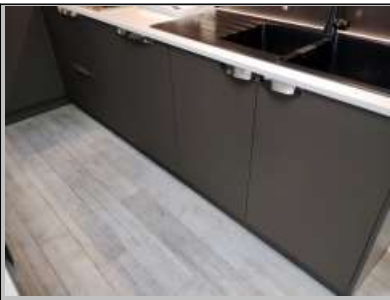
The condition of the fixtures is generally good.

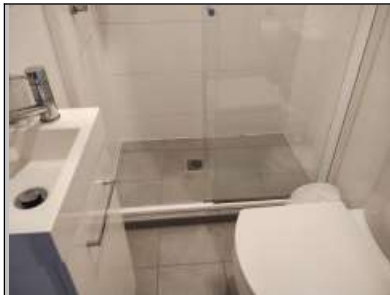
Adjacent to hall.

The shower recess was tested and there was no visible water penetration to surrounding areas. IMPORTANT NOTE: This test may not reveal water leaks until the shower is put into constant use and surrounding areas monitored over a period of time.

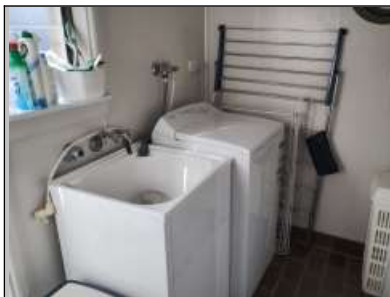
Located in the garage.

The tub and taps appear serviceable. Drain appears serviceable.

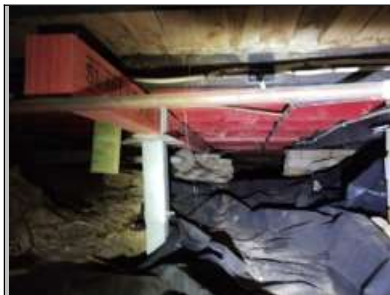
Crawl space was limited due to the method of construction resulting in a limited visual inspection from a distance being carried out. Inspection was restricted in or below the following locations and or areas: front Dining room. Entry/Foyer.

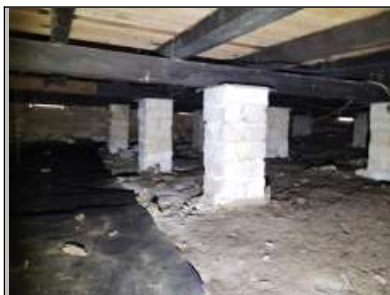
The building is constructed on a combination of strip footings and piers. The footings appear to be generally sound.

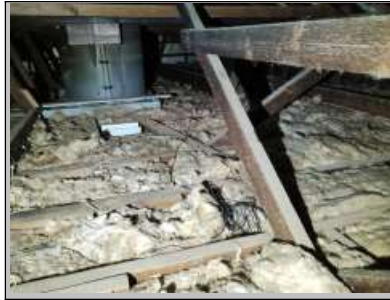
Insulation is present in the roof cavity. This restricted inspection to some roofing timbers. Removal of insulation is not within the scope of a standard visual inspection report, however as in accordance with "industry best standard" the inspector will lift insulation in 3 areas in roof void.

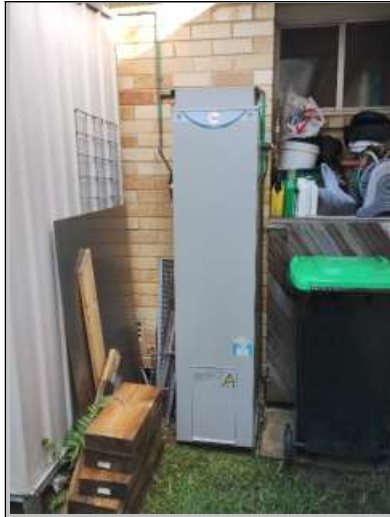
Gas hot water system: Mains pressure: Located externally: The hot water system appears to be in working condition. No specific tests other than running the hot water tap were carried out. No determination has been made as to the suitability or adequacy of the hot water system in relation to capacity or otherwise.

The unit was manufactured in 2018.

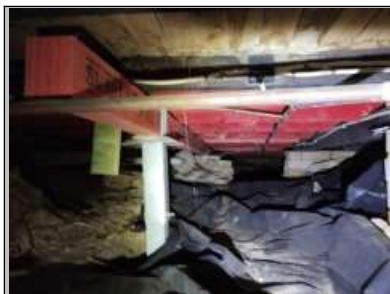
Crawl space was limited due to the method of construction resulting in a limited visual inspection from a distance being carried out. Inspection was restricted in or below the following locations and or areas: front Dining room. Entry/Foyer.

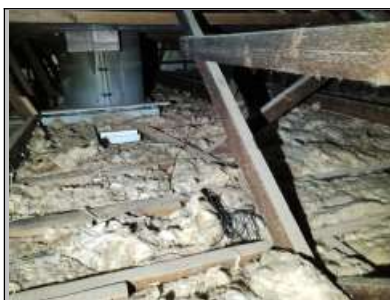
Insulation is present in the roof cavity. This restricted inspection to some roofing timbers. Removal of insulation is not within the scope of a standard visual inspection report, however as in accordance with "industry best standard" the inspector will lift insulation in 3 areas in roof void.
