## **VISUAL BUILDING AND PEST INSPECTION REPORT**

Complies with Australian Standard 4349.1 & 4349.3

108 John Oxley Drive, Frenchs Forest

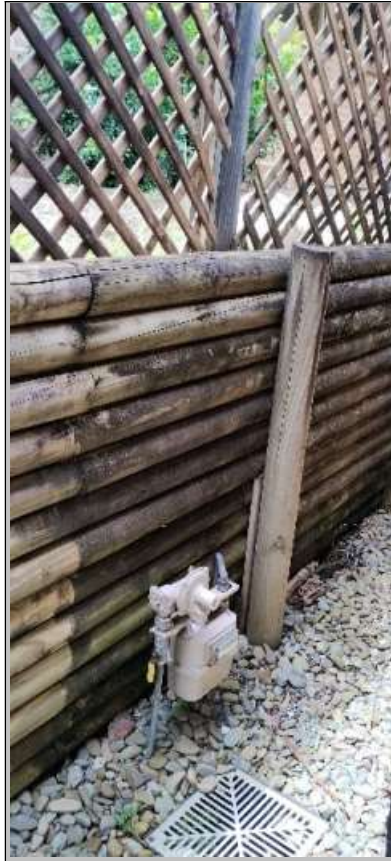
Eastern elevation.

The timber retaining walls show deterioration and should be monitored for additional movement.

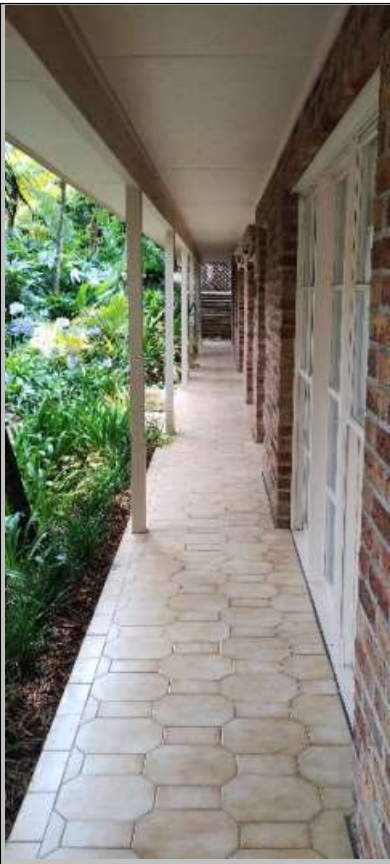
Front elevation.

Constructed from concrete or masonry. The condition of the structure is generally acceptable.

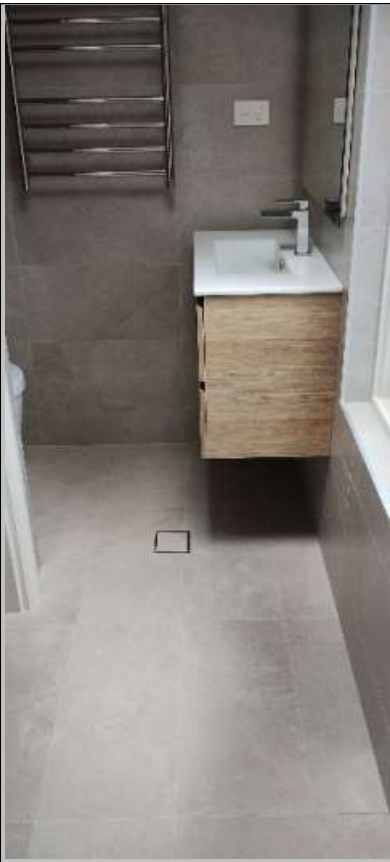
Rear.

The shower recess was tested and there was no visible water penetration to surrounding areas. IMPORTANT NOTE: This test may not reveal water leaks until the shower is put into constant use and surrounding areas monitored over a period of time.

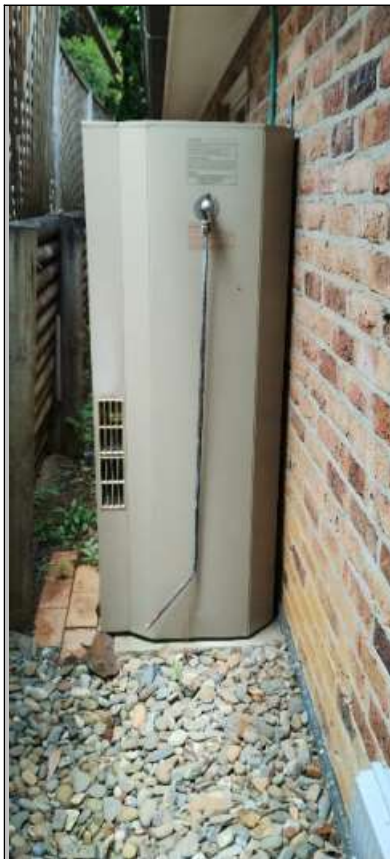
Gas hot water system: Mains pressure: Located externally: The hot water system appears to be in working condition. No specific tests other than running the hot water tap were carried out. No determination has been made as to the suitability or adequacy of the hot water system in relation to capacity or otherwise.
