## **VISUAL BUILDING & PEST INSPECTION REPORT**

Complies with Australian Standard 4349.1 & 4349.6

### **Vendor Report**

**61 Trent Bridge Road Belrose**

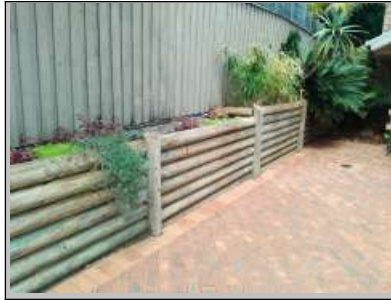
The timber retaining walls appear in acceptable condition.

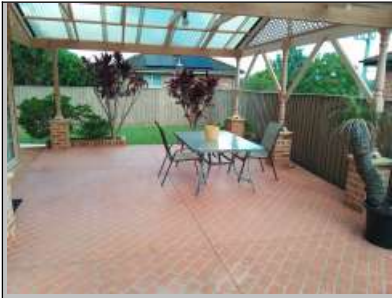
| Construction & Condition: | Constructed from concrete or masonry. The condition of the structure is generally acceptable. |

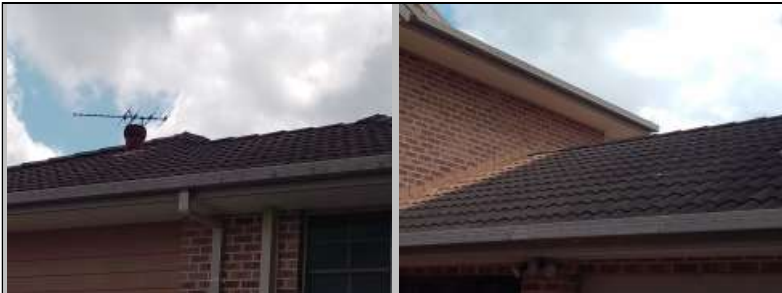
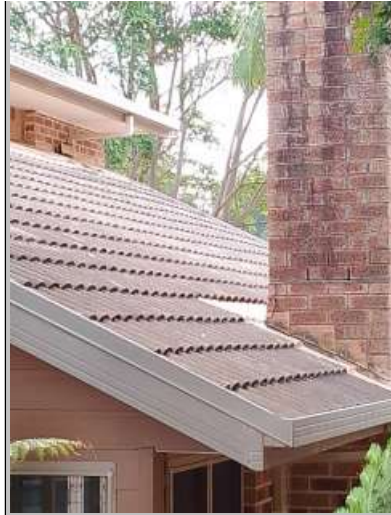
No access was possible to part of the external roof area due to the roof not being accessible from a 3.6 meter ladder.

The overall condition of the roof coverings is fair.

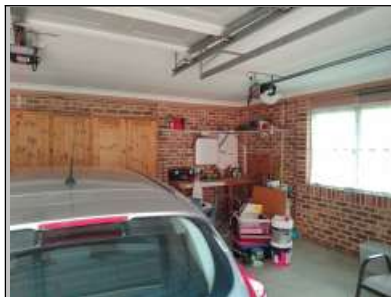
The structure is generally in good condition.

The condition of the ceilings is generally fair. Sagging was noted to the ceiling lining. This may be the result of lack of adhesion to joists and re fixing is advised.

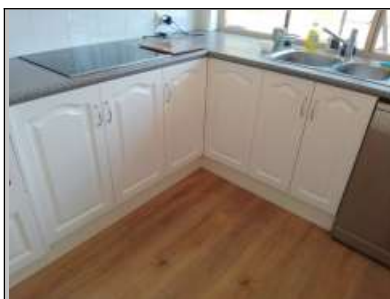
The condition of the fixtures is generally good.

The condition of the tiles is generally good.

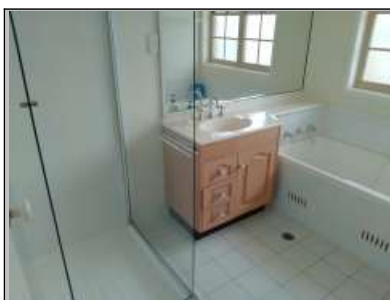
Level one.

The shower recess was tested and there was no visible water penetration to surrounding areas. IMPORTANT NOTE: This test may not reveal water leaks until the shower is put into constant use and surrounding areas monitored over a period of time.

The condition of the tiles is generally fair.

The toilet appears to be in working order. Toilet area is restrictive and the door swings inwards. In case of an emergency the door cannot be readily removed from the outside. Recommend liftoff hinges be installed to the door to comply with current Standards.

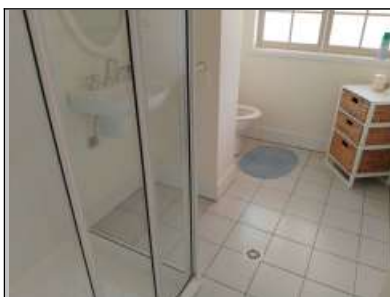
Ground floor.

The shower recess was tested and there was no visible water penetration to surrounding areas. IMPORTANT NOTE: This test may not reveal water leaks until the shower is put into constant use and surrounding areas monitored over a period of time.

The condition of the tiles is generally fair.

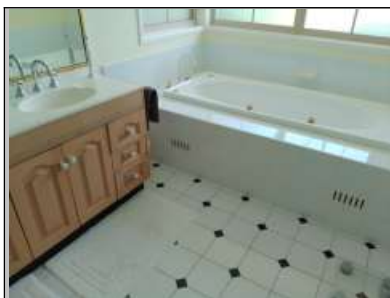
Level one. Rear.

The shower recess was tested and there was no visible water penetration to surrounding areas. IMPORTANT NOTE: This test may not reveal water leaks until the shower is put into constant use and surrounding areas monitored over a period of time. A spa bath is present however, due to the requirement to fill the unit above jet level for testing the spa was not tested for adequacy or reliability. Defects may be present and not detected.

The condition of the tiles is generally fair.

The toilet appears to be in working order. Toilet area is restrictive and the door swings inwards. In case of an emergency the door cannot be readily removed from the outside. Recommend liftoff hinges be installed to the door to comply with current Standards.

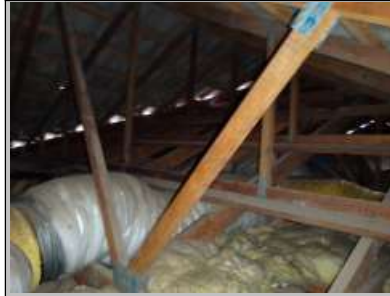
Body access into the roof void was restricted and access was not gained to any areas beyond the roof access hole.

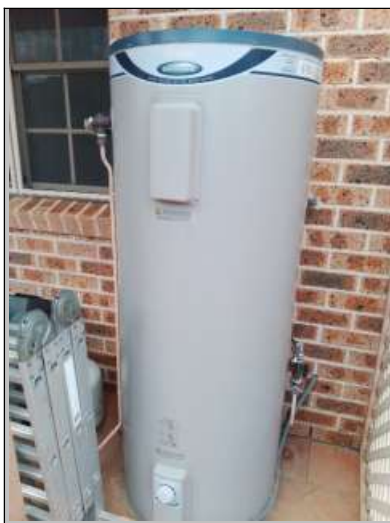
Mains electric hot water system: Mains pressure: Located externally: The hot water system appears to be in working condition. No specific tests other than running the hot water tap were carried out. No determination has been made as to the suitability or adequacy of the hot water system in relation to capacity or otherwise.

The unit was manufactured in 2014.

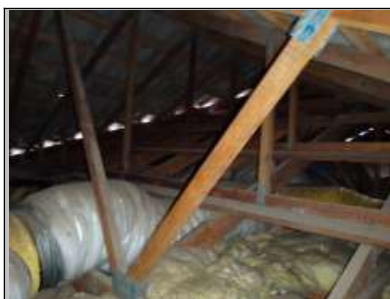
Body access into the roof void was restricted and access was not gained to any areas beyond the roof access hole.
