Affordable Inspections

7 Margaret Street Merewether

27th January 2021

Building Report

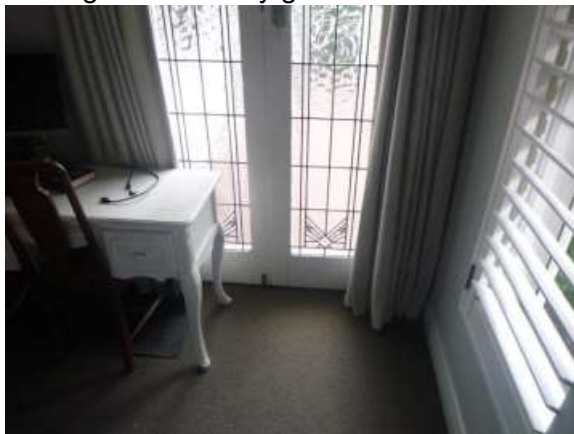
Doors Condition:	The condition of the doors is generally good. In the interests of safety, shatterproof film or safety glass should be installed to large glass panes within 600mm of the floor and 300mm of a doorway.
Location/area	Through out. Safety glass is recommended to door in main bedroom .

The following action is recommended:	A licensed builder should be called to make a further evaluation and repairs or rectification as needed. A glazier should be called to make a further evaluation and repairs or rectification as needed.
---	--

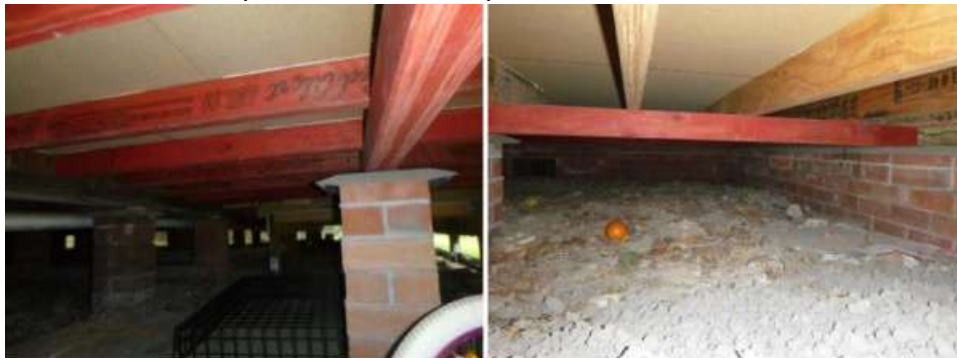
Description: The underfloor ventilation appeared to be limited. This may provide conditions that could encourage decay of timber components. Upgrading of the ventilation is recommended. If necessary, contact a Licensed Builder for advise and rectification.

The following action is recommended: A licensed builder should be called to make a further evaluation and repairs or rectification as needed.

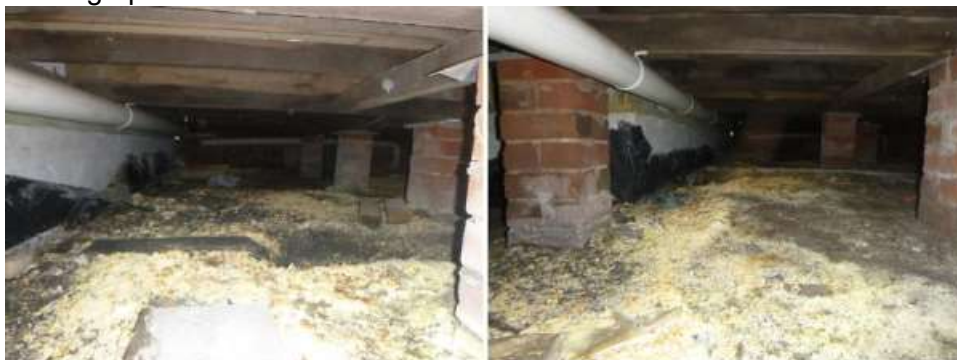
Details: No all areas have ant caps fitted. The purpose of antcapping is to prevent concealed termite entry by forcing the termites build mud tunnels around the visible sections of the antcapping enabling detection during a pest inspection. Antcapping will not prevent the entry of termites to a structure however, correctly fitted ant caps will assist in early detection. If it is not possible or practicable to fit antcapping, this area should be regularly inspected by a Licensed Pest Inspector. The underfloor soil is damp. This may be due to a drainage problem or some other factor.

The following action is recommended: A licensed builder should be called to make a further evaluation and repairs or rectification as needed.

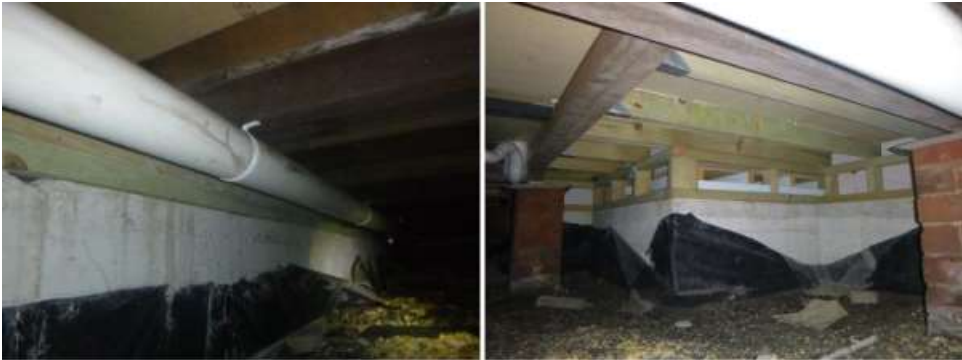
Various areas of the subfloor:

Description We note not all areas has ant capping installed. The purpose of ant capping is to reduce the risk of concealed termite attack. Ant capping should be repaired or installed where possible, if not possible, some form of termite management be that a chemical management system or a baiting system be installed..
