Timber Pest Inspection Report

Inspection Date: Fri, 06 Sep 2019

Property Address: 2 Lynette Place, Belrose NSW, Australia

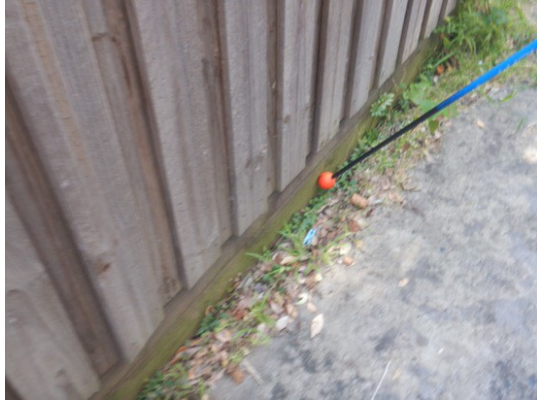
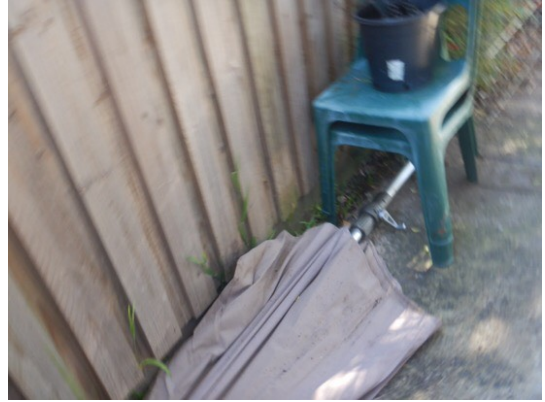
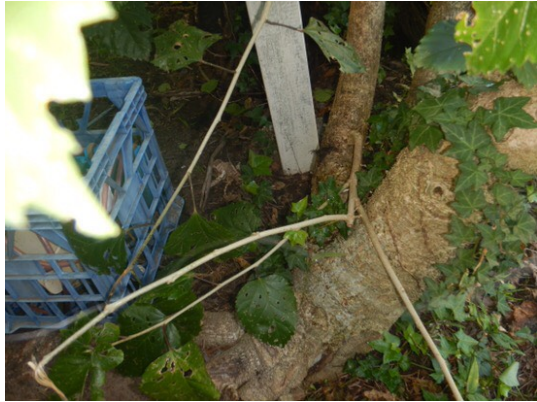
Building:	Main Building
Location:	All External Areas
Finding:	In ground contact
Information:	Any timbers in direct ground contact provide opportunity for concealed termite entry and are likely to be subject to premature rot and decay as the soil retains moisture or damp conditions against the timbers.

Remove untreated timber that is in direct contact with external grounds. Consider replacement with more durable materials i.e. treated timber or non timber elements. Frequent pest inspections are advised to readily identify any termite activity in these areas.

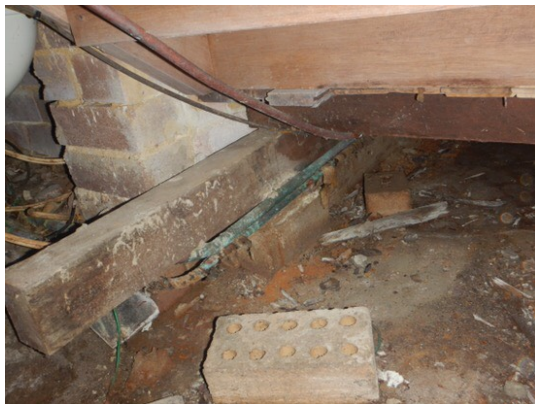
Building: Main Building

Location: Subfloor

Finding: Subfloor - Debris

Information: An array of debris was found in the subfloor area at the time of inspection. Debris in this area restricts subfloor ventilation and creates potential for concealed pest entry. Stored timbers and other materials may also make the area susceptible to termite activity and wood rot.

A clear and empty subfloor will be better ventilated and easier to maintain in a dry condition. The removal of any timber debris is vital in minimising the risk of termite or wood borer activity.

Debris in the subfloor should be removed as soon as possible. Depending on the location and amount of debris and stored items, the homeowner may elect to undertake this task. Alternatively there are a large number of rubbish removal subcontractors that could undertake these works.

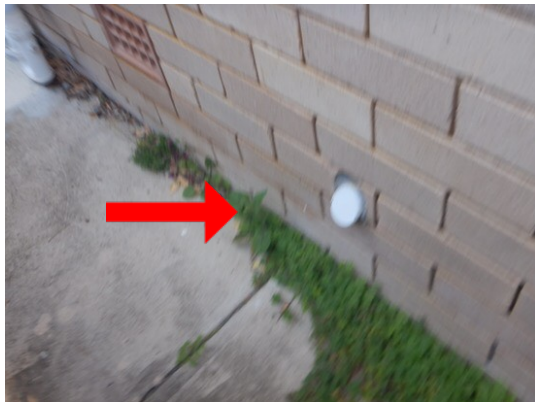
Building: Main Building

Location: All External Areas

Finding: Slab Edge - Exposure

Information: An inspection zone of at least 75mm in relation to the exposed slab edge, between the bottom brick and the perimeter pavement, is required. This inspection zone should be maintained in order to force termites into the open where they can be detected more readily during regular inspections. The slab edge should not be concealed by anything that may prevent inspection of the area, including render, landscaping, soil, turf, paving, concrete cladding or other structures.

If the slab edge is not properly exposed there is a high risk of termite attack. Sometimes, in order to determine the type of slab, a suitably qualified person such as an architect or builder may be required to consult the construction plans.

Where the slab edge cannot be properly inspected, it is highly recommended that termite or timber pest inspections be carried out every 6-12 months to aid protection of the property against infestation.

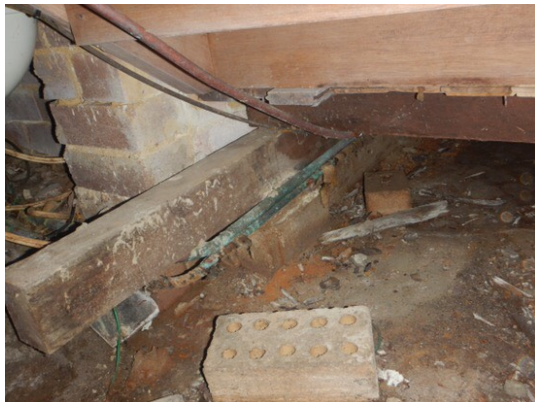
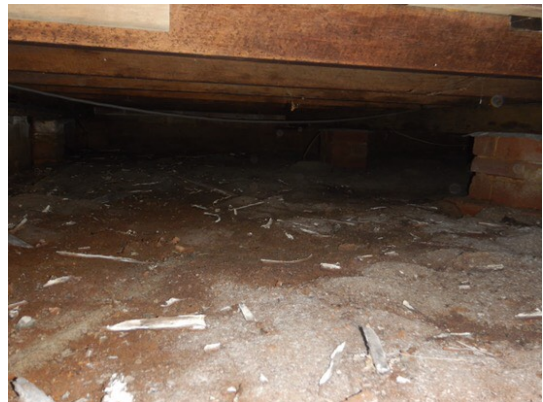
Building:	Main Building
Location:	Subfloor
Finding:	Excessive moisture - identified
Information:	Excessive moisture can attract termites and produce conditions that promote fungal growth and wood decay.

Excessive moisture is generally caused by deteriorated inadequate or missing roof drainage leaking plumbing pipes or fixtures poorly plumbed HWS overflows or condenser units and poor site drainage.

If mould growth has been found there may be environmental biological or health issues involved. In these cases an appropriately qualified inspector should also be contacted.

Prior to any remedial works being performed a qualified plumber should be appointed to further inspect the property and to identify the cause of the excessive moisture. Works to remove affected building elements may then be necessary and should be performed by an appropriate tradesperson.

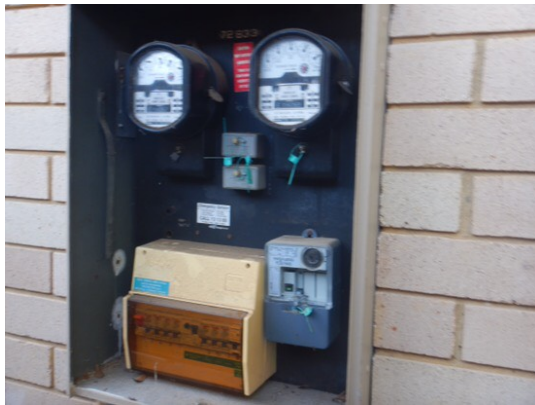
Building: Main Building

Location: All Areas

Finding: Termite Management System - no evidence of installation

Information: The application of a post-construction chemical termite barrier is highly recommended for all properties, particularly if live termite activity has been found on the site previously. Such barriers are highly effective in preventing termite attack on any timber building elements throughout the property.

A durable notice should be placed in the switchboard unit to indicate current termite barriers. At the time of inspection, it appeared as though no termite management system has been installed, with no evidence to suggest preventative works taking place.

The client may consider gaining further advice from a pest controller as to the costs and procedures involved with this application. It is recommended that obtaining such advice be a short-term priority.
