# Inspection Report

## Certified Building Inspection Services

**37 Trebbiano Dr, Cessnock, NSW, 2325**

Report/Agreement #            0606251202083420  
 Inspection Date:                06 Jun 2025  
 Inspection Time:                12:02 pm

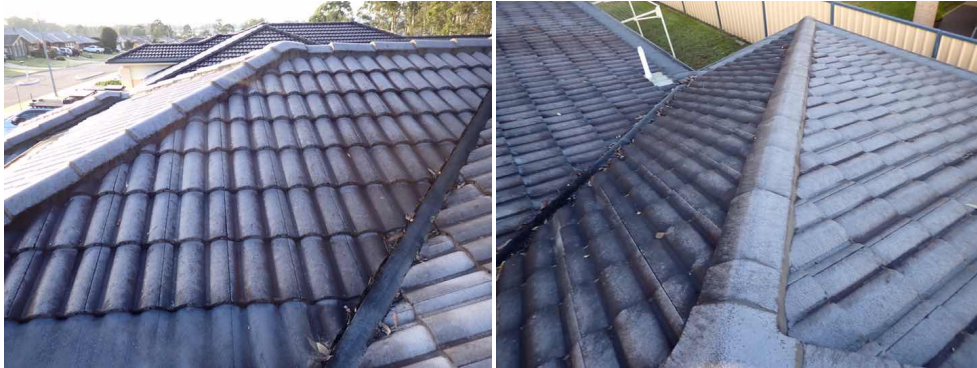
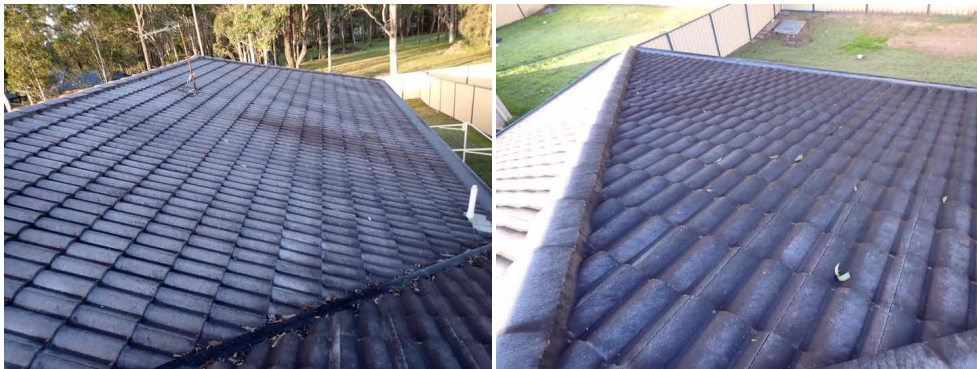
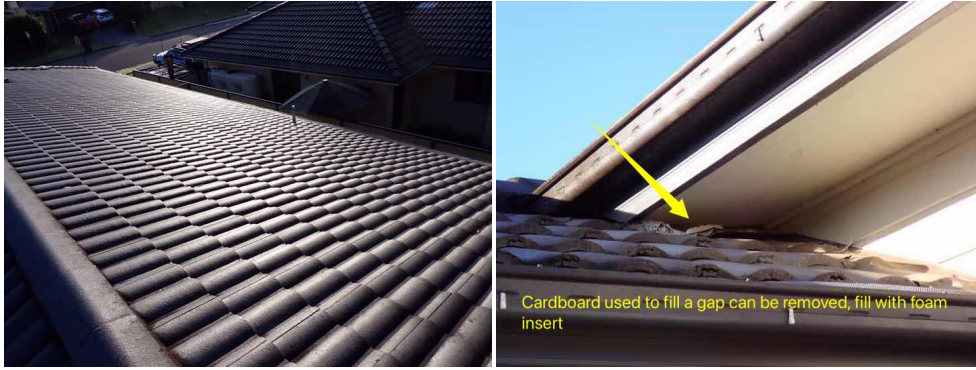
Of the visible areas, the general condition of the roof is in serviceable condition for the age.

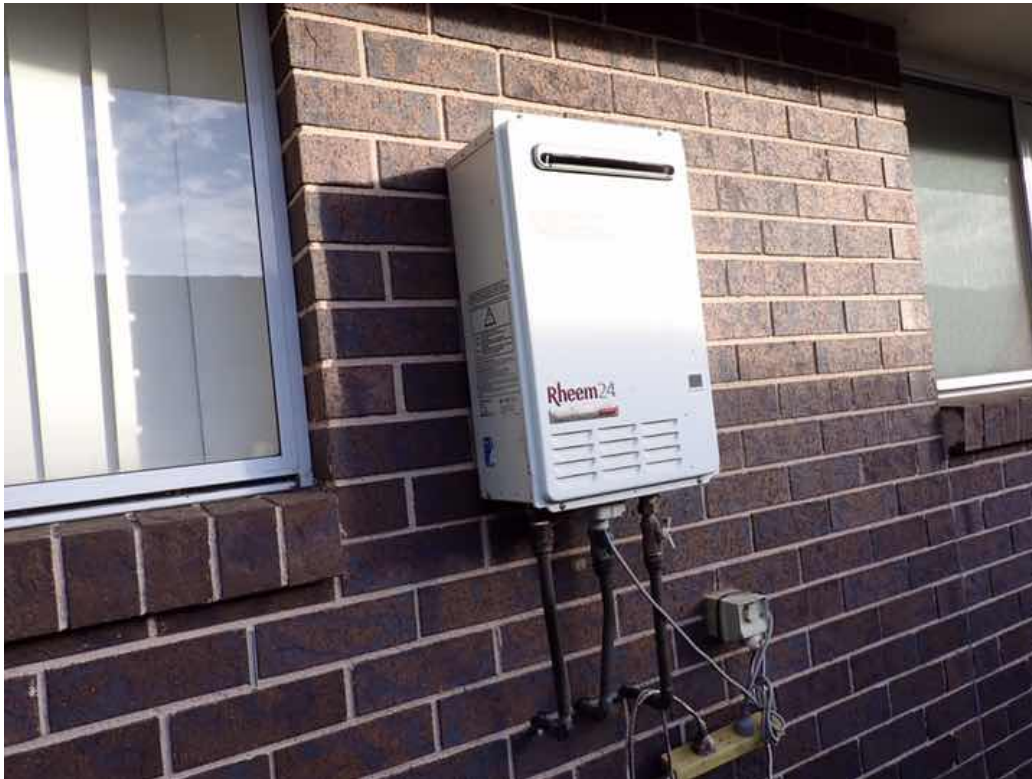
The hot water unit is a gas instantaneous system.

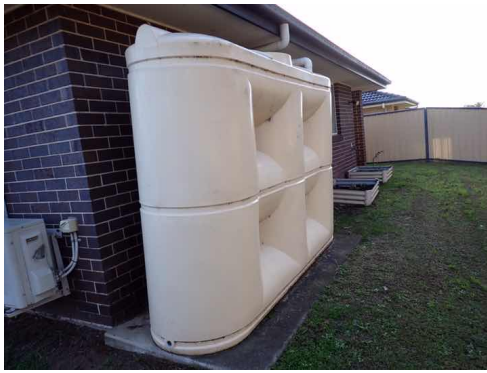
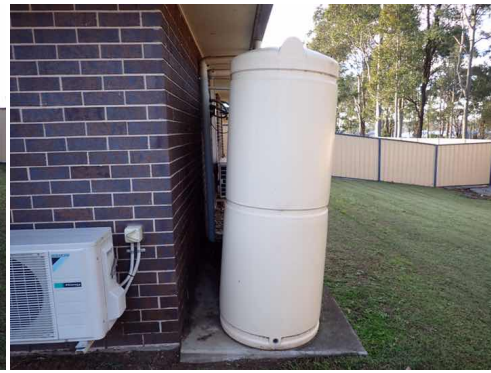
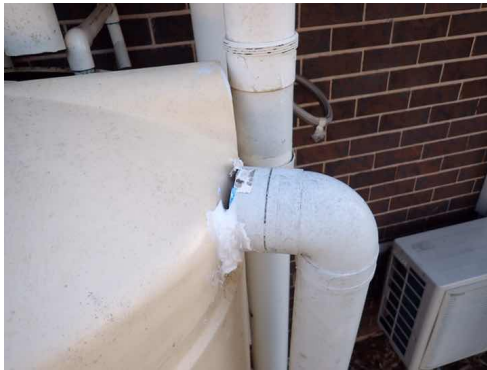
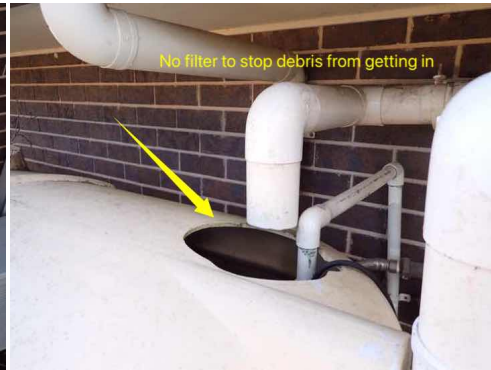
#### Water Tank Condition

Water tank is leaning causing pipework to not line up correctly, pipe work is now positioned incorrectly and top filter missing to stop debris from getting in tank - Recommendations: Assessment conducted by a licensed plumber advised.

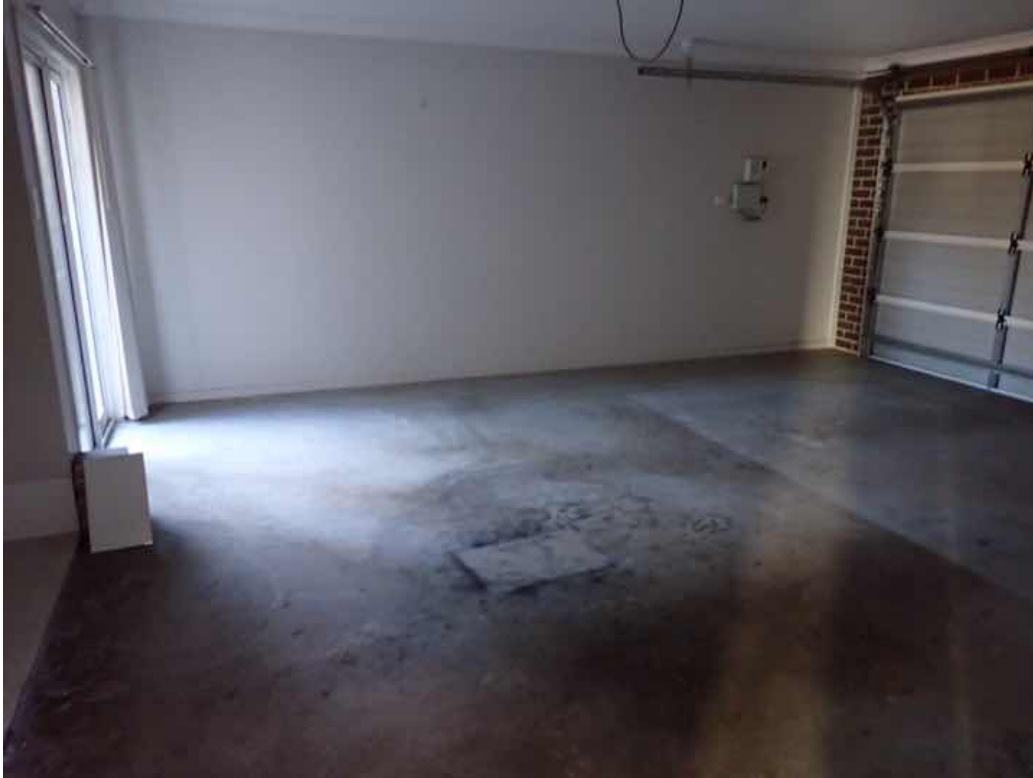
Of accessible and visible areas, the garaging is considered to be in a serviceable condition.

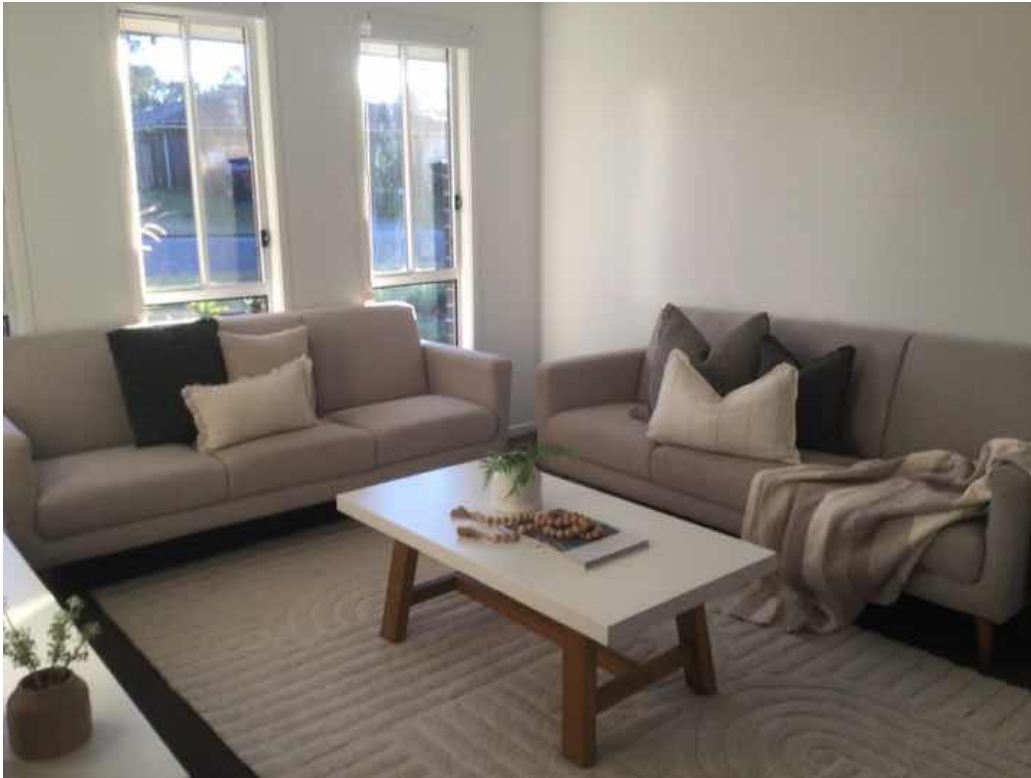
The lounge room is in serviceable condition with no notable structural defects sighted.

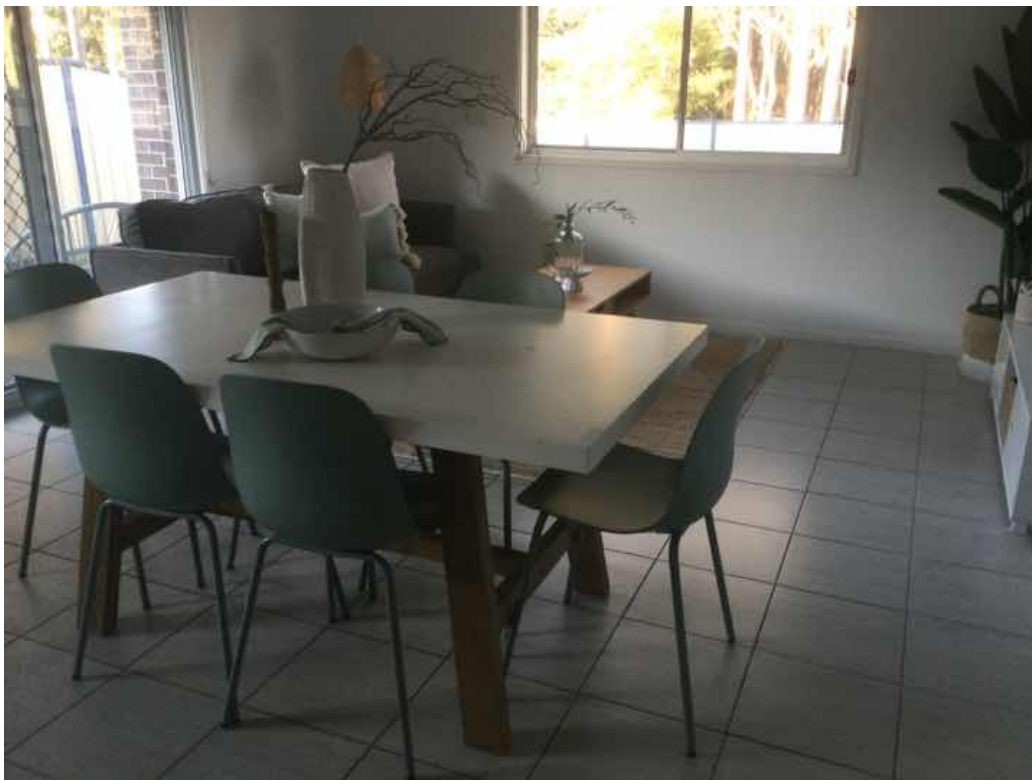
## Family Room

The family room is in serviceable condition with no notable structural defects sighted.

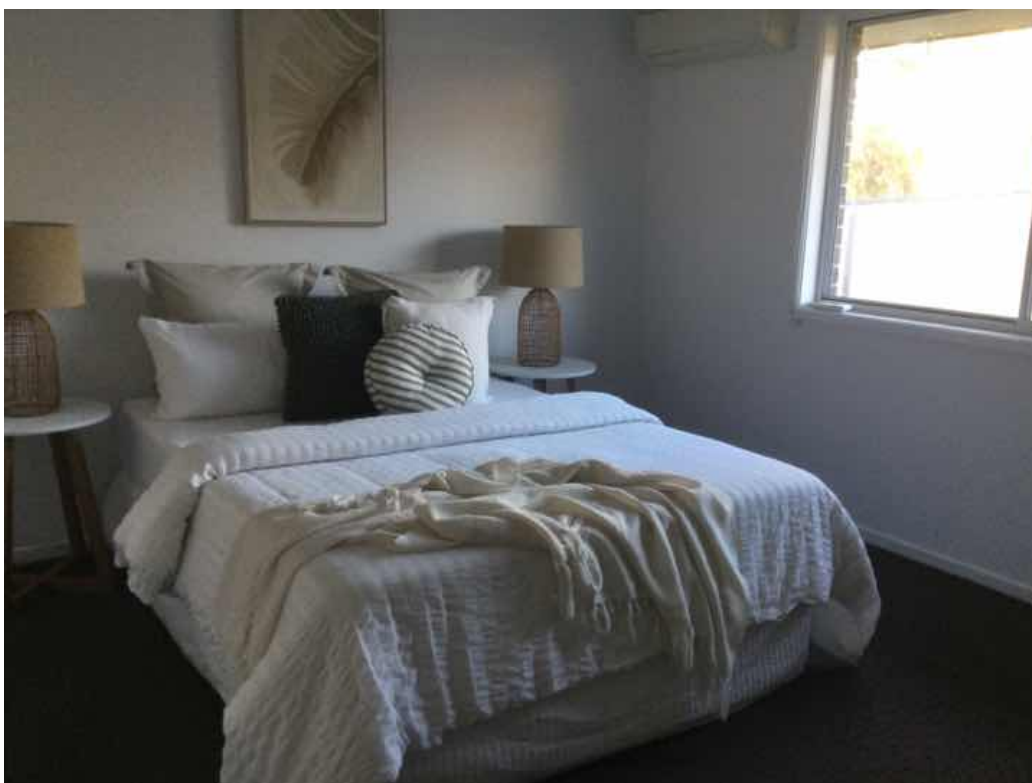
## **Bedroom 1**

This bedroom is in serviceable condition with no notable structural defects sighted.

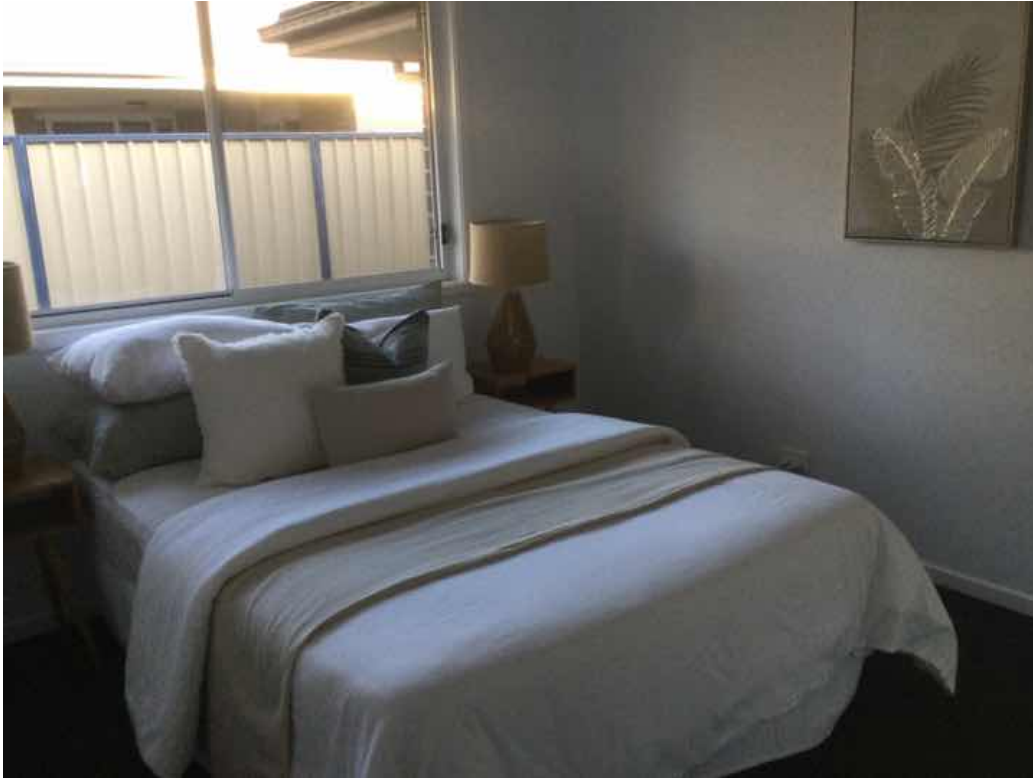
## **Bedroom 2**

This bedroom is in serviceable condition with no notable structural defects sighted.

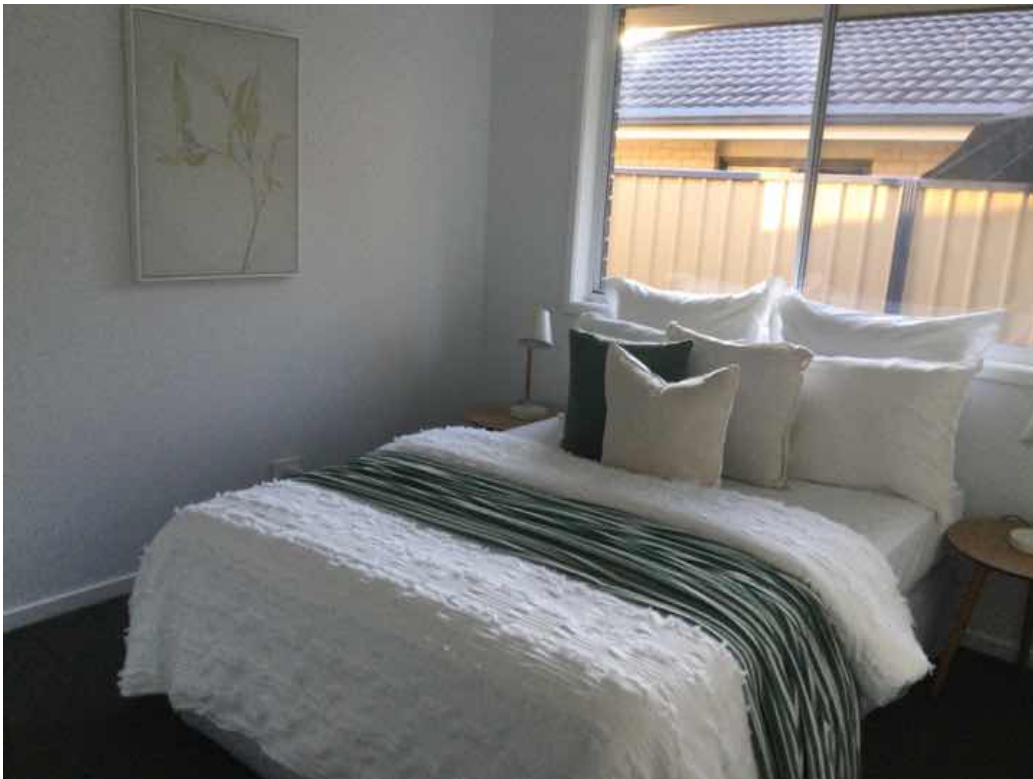
## **Bedroom 3**

This bedroom is in serviceable condition with no notable structural defects sighted.

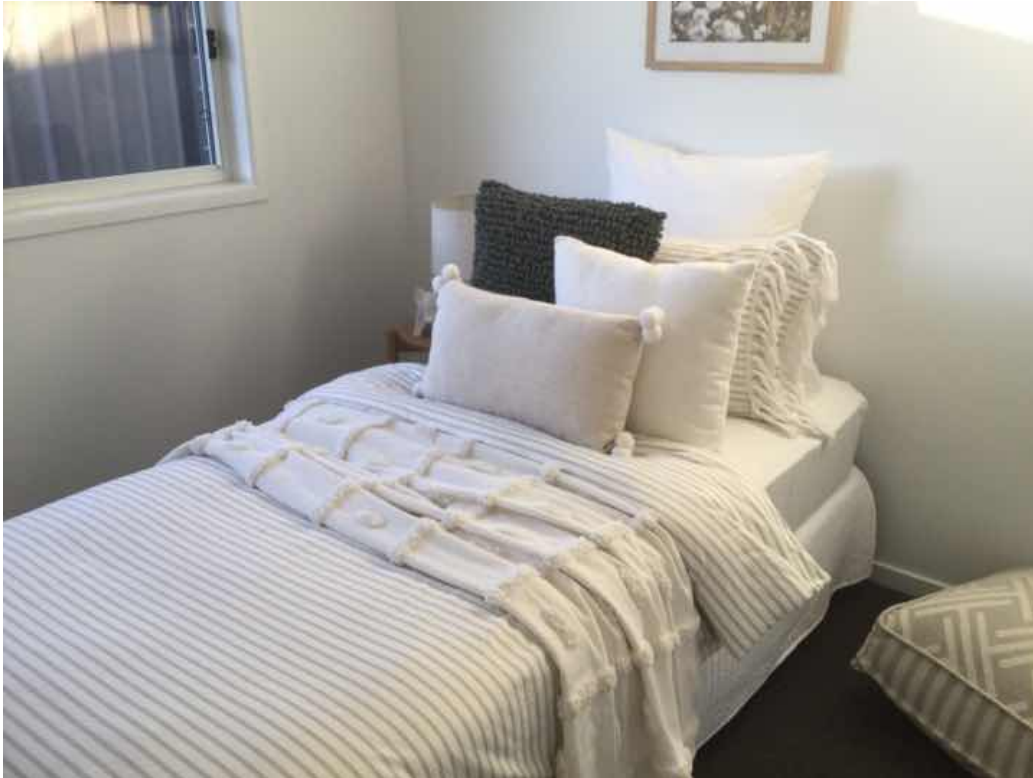
## **Bedroom 4**

This bedroom is in serviceable condition with no notable structural defects sighted.

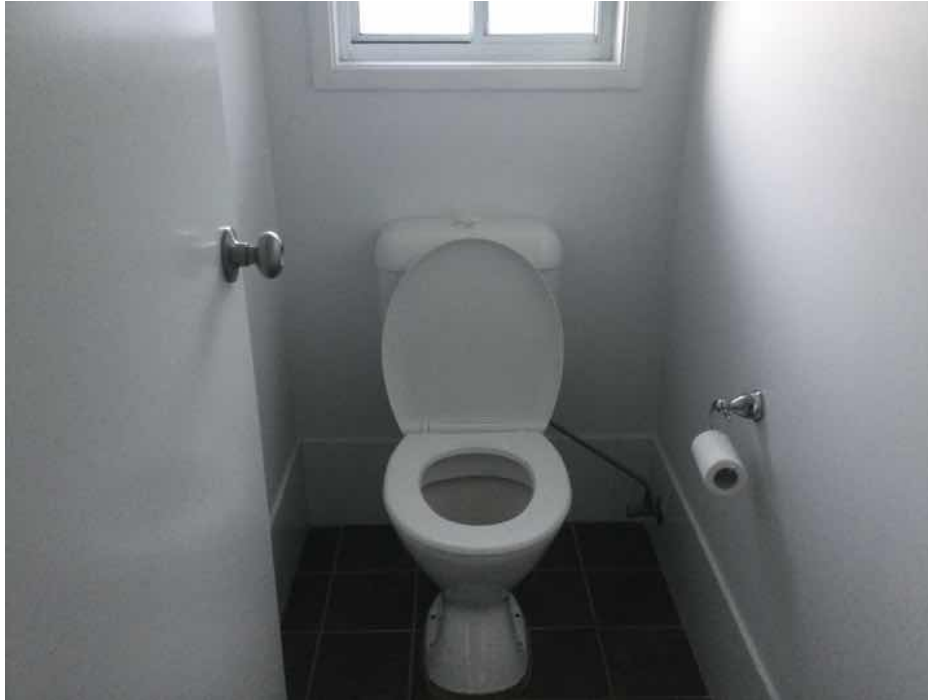
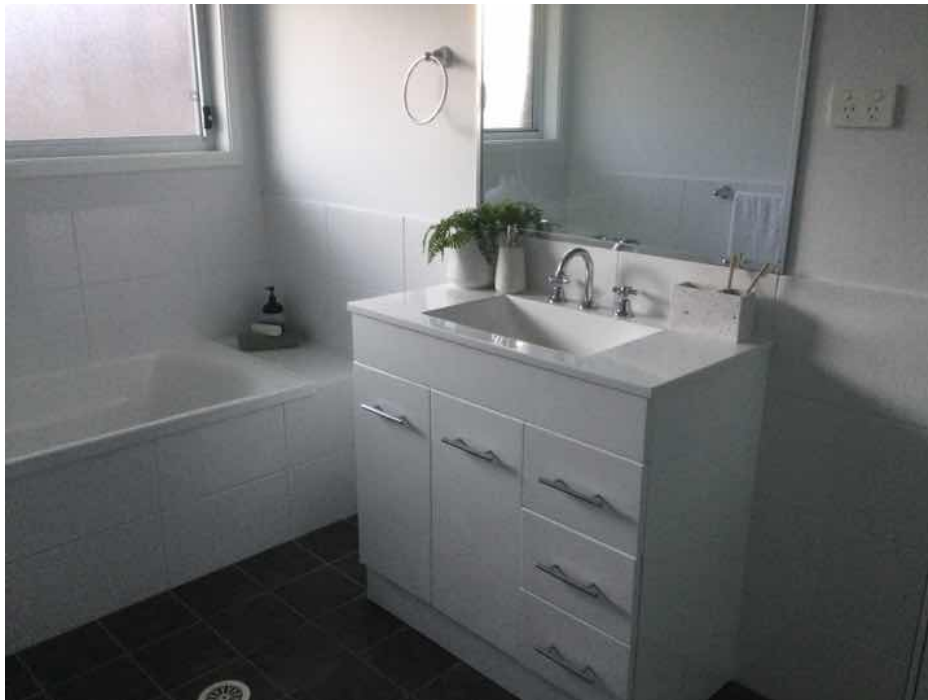
Of the visible areas, the general condition of this bathroom is serviceable or in reasonable condition for age of dwelling.

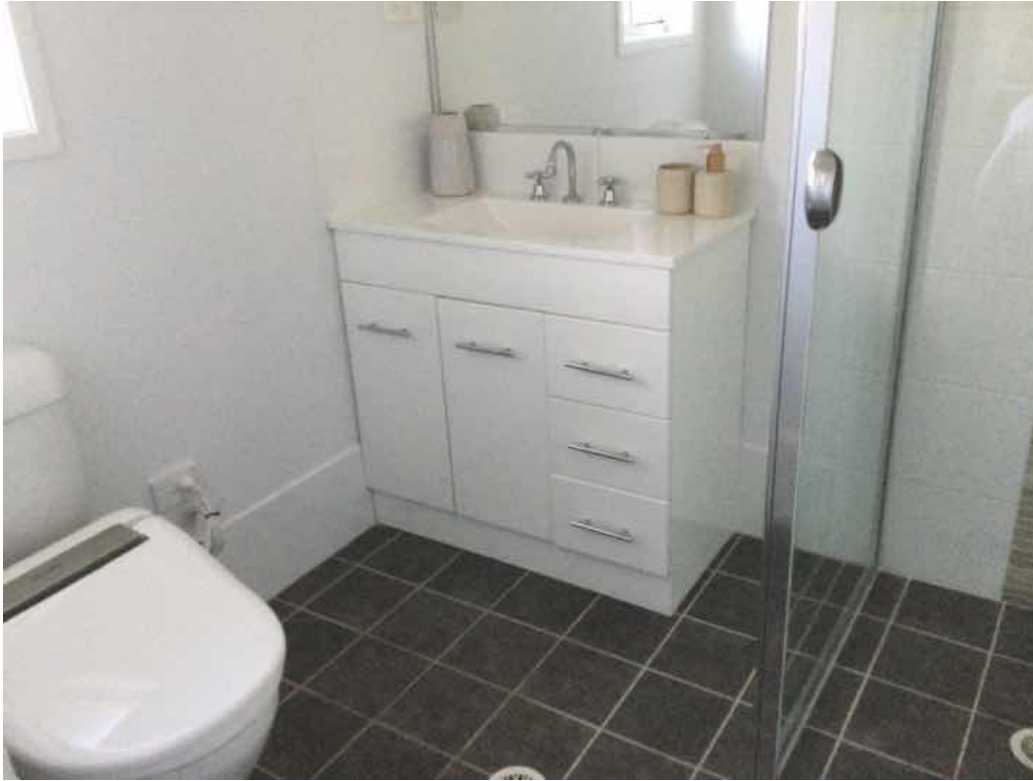
## **Bathroom 2**

Of the visible areas, the general condition of this bathroom is serviceable or in reasonable condition for age of dwelling.

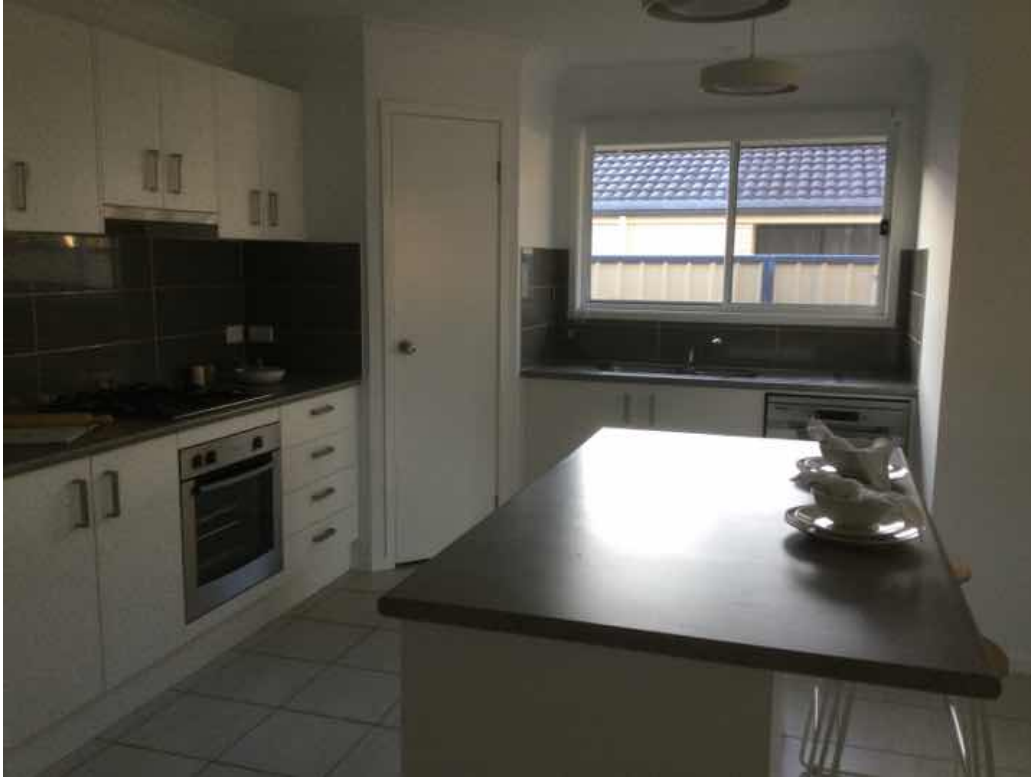
Of the visible areas, the general condition is serviceable or in reasonable condition for age of dwelling.

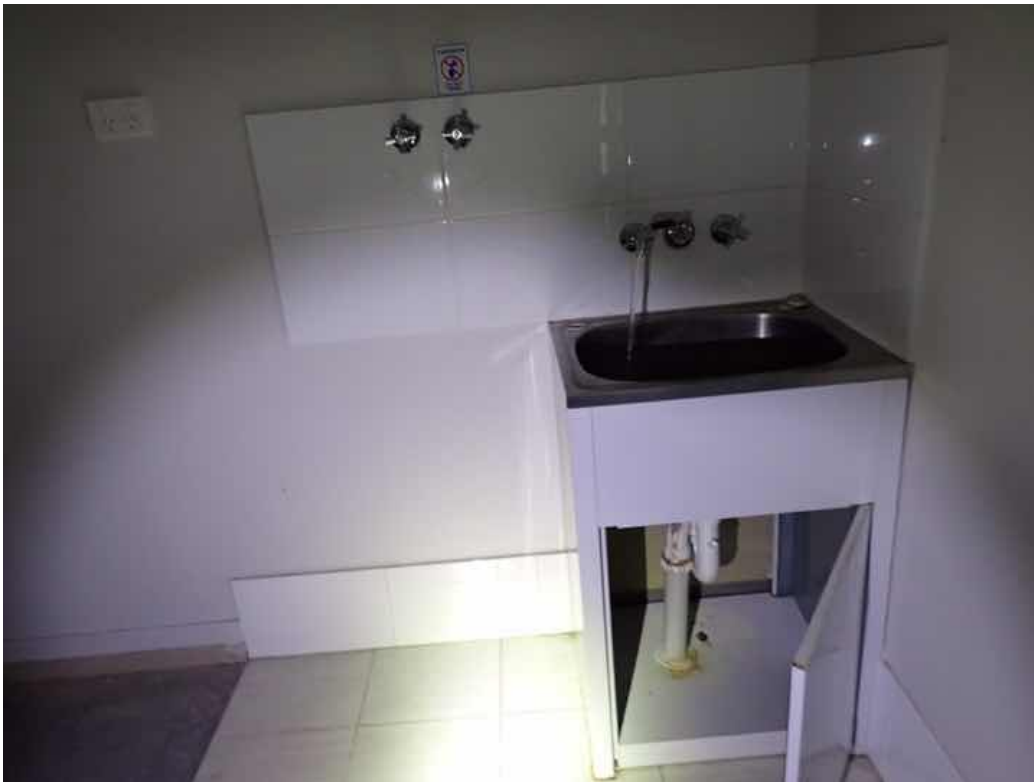
Of the visible areas, the general condition of the laundry is serviceable.

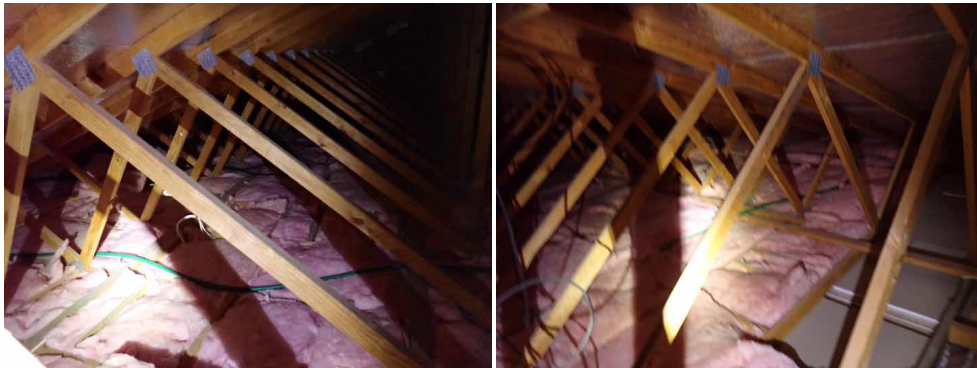
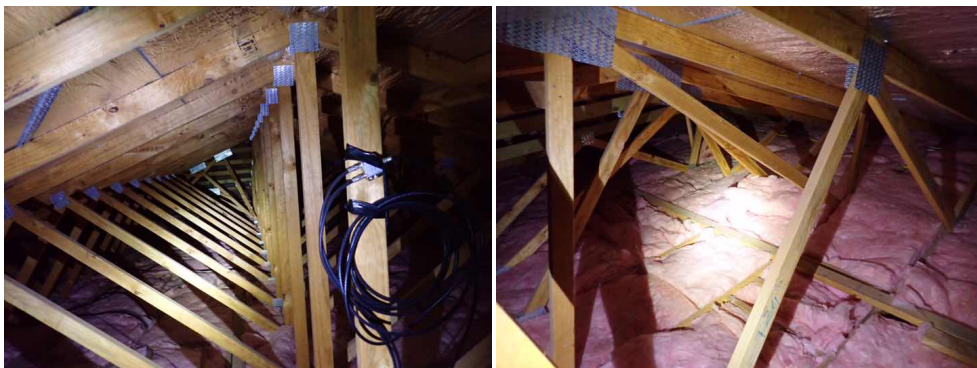
Visible sections of the roof void is in a serviceable condition for age of this dwelling.

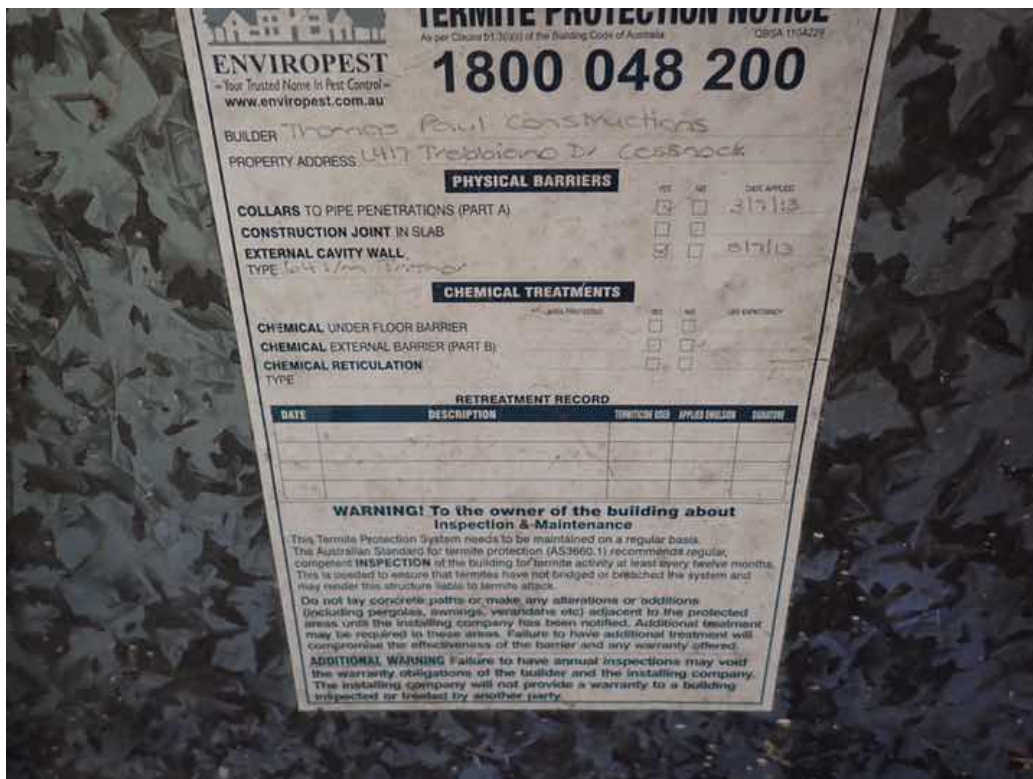
Yes, a durable notice was found during the inspection.

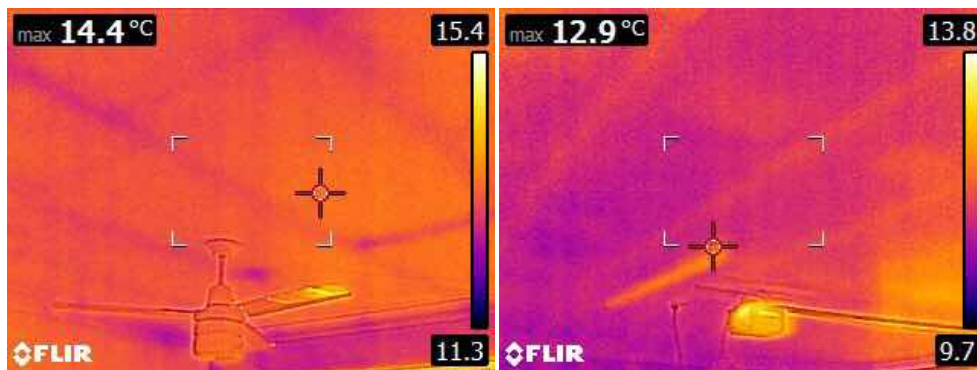
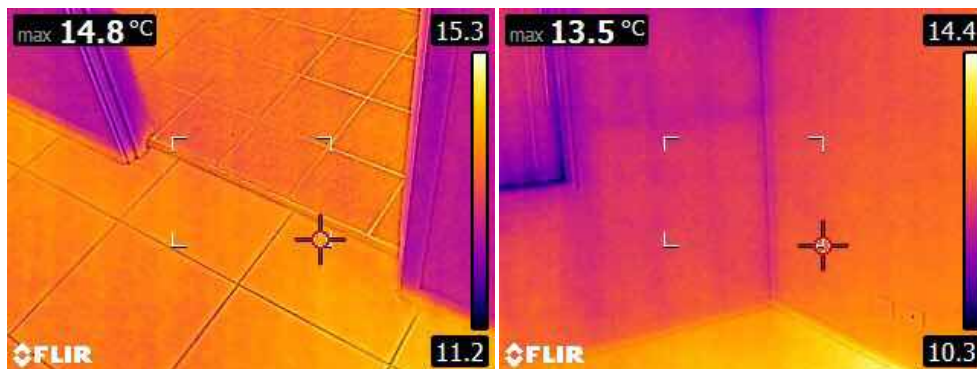
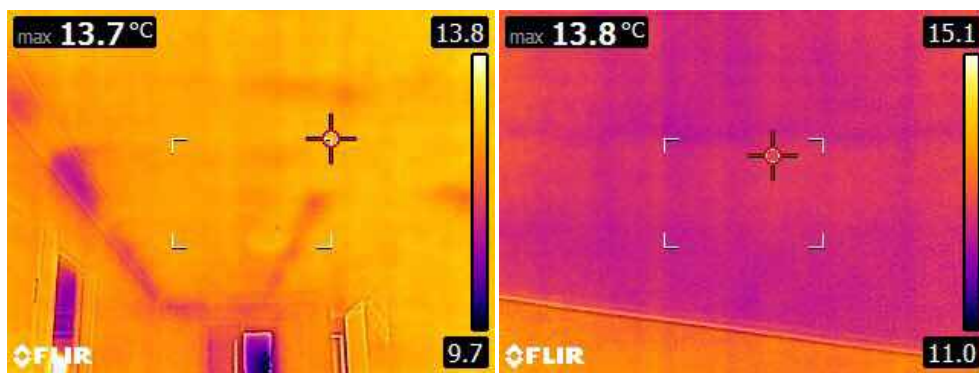
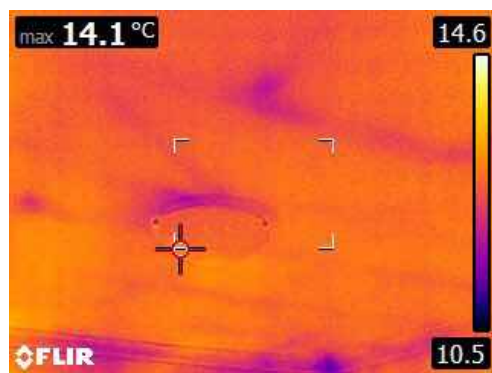
No thermal anomalies were detected during this inspection, however various factors must be taken into effect which may hamper or impede the reading obtainable by the imager. These factors include obstructions, ambient temperature, wall material and thickness etc. If any surface is restricted visually or otherwise, a proper thermal reading is not possible and is not within the scope of this inspection. Any findings or otherwise is reported on at the time of the inspection only.
