## Timber Pest Inspection Report

Inspection Date: Thu, 10 Nov 2022

Property Address: 28 Myra St, Frenchs Forest NSW 2086,  
Australia

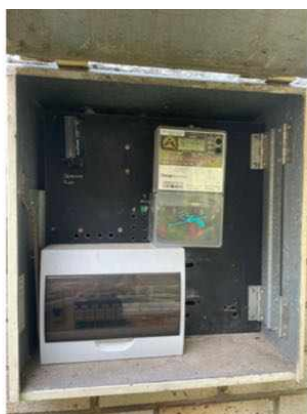
#### Termite and Timber Pest 1.01

| Location: | Yard - Side |
| Finding: | Termite durable notice not present |

A durable notice has been placed in the switchboard unit to indicate current termite barriers. At the time of inspection, it appeared as though there is only a physical termite management system has been installed.

The client may consider gaining further advice from a pest controller as to the costs and procedures involved with this application. It is recommended that obtaining such advice be a short-term priority.

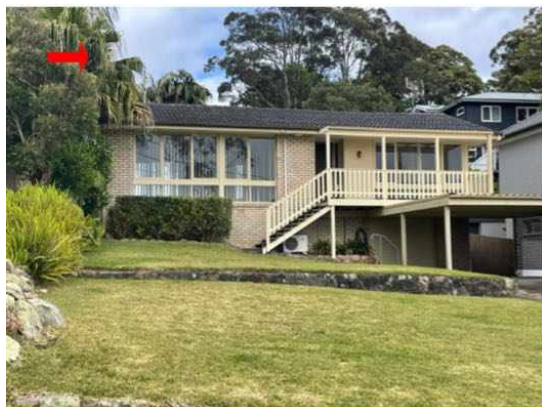
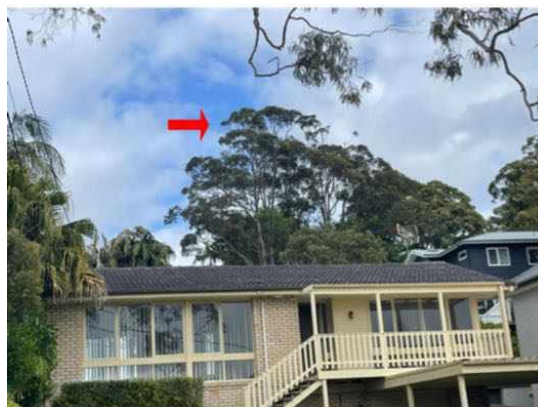
#### Termite and Timber Pest 1.02

| Location: | All Areas |
| Finding: | Trees - Overhanging and filling gutters |
| Information: | Overhanging trees often result in excessive amounts of leaf debris accumulating in gutters. |

Gutters are a critical part of the building's management of storm water and rain. It is therefore important that they be kept clear to prevent secondary damage to associated building elements, including exterior and interior walls, ceiling linings and any adjoining building elements. Where gutters are blocked, pooling of rainwater is likely to occur, fast-tracking rust and corrosion of the roof plumbing elements.

It is highly advised that all overhanging tree branches be removed as soon as possible to prevent any further damage. Repair and/or replacement of sections of damaged guttering may also be required where the extent of the damage necessitates.

Such works should be performed by the homeowner; however, appointment of a landscape contractor or an arborist may be required. Consultation with a licensed roof plumber is required where guttering has been damaged.

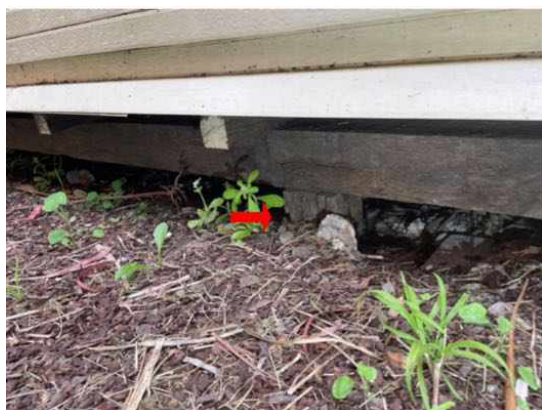
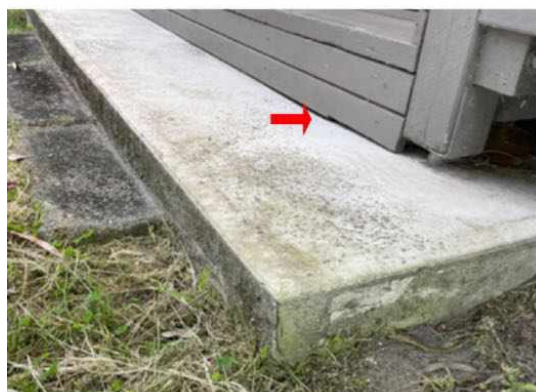
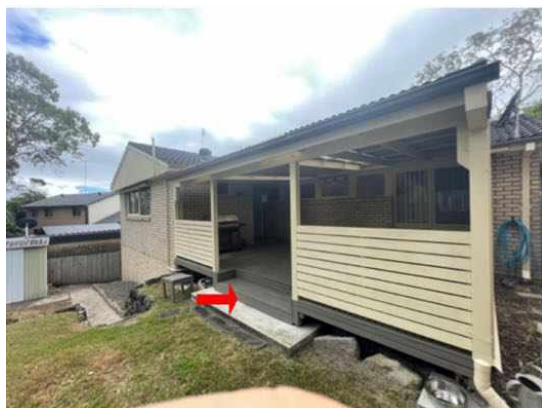
### Termite and Timber Pest 1.03

| Location: | All Areas |
| Finding: | Building materials in direct ground contact - conducive to termites |
| Information: | Where timber elements are in direct contact with the ground and consequently moisture or dampness they become conducive to termite activity. |

When met with excessive moisture timber begins to decay and develop wood rot. Any timbers that are in direct contact with external grounds especially if left untreated or non- durable also provide ingress for subterranean termites into that particular element.

The removal of any such materials that may be conducive to termite activity should be removed as soon as possible to minimise the risk of termite attack.

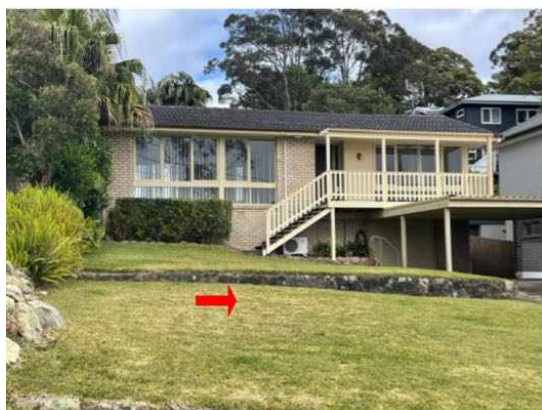
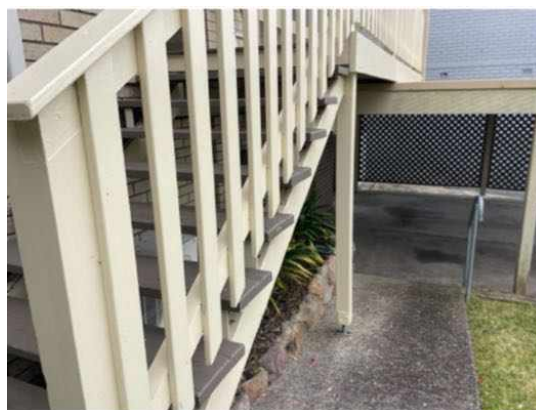
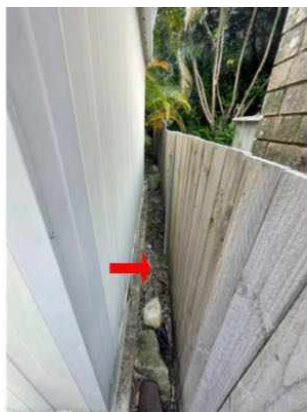
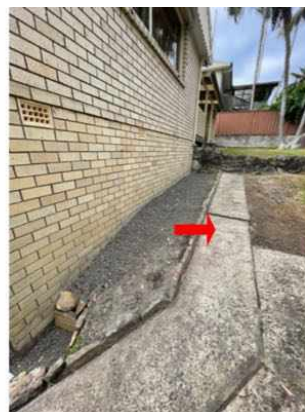
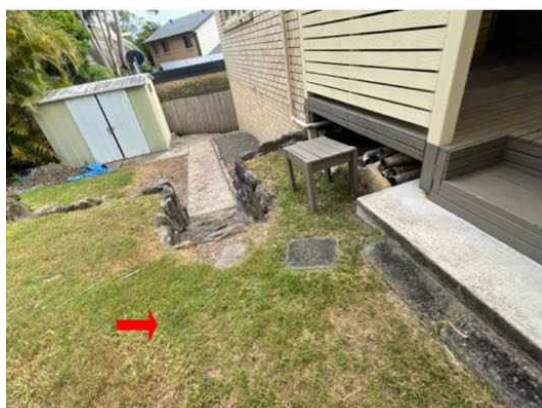
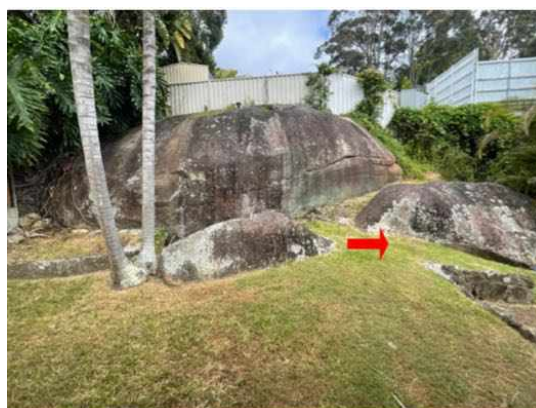
## Termite and Timber Pest 1.04

| Location: | All External Areas |
| Finding: | Evidence of excessive moisture was present at the time of inspection |
| Information: | Excessive moisture can attract termites and produce conditions that promote termite attack fungal growth and wood decay. |

Excessive moisture is generally caused by deteriorated inadequate or missing roof drainage leaking plumbing pipes or fixtures poorly plumbed HWS overflows or condenser units and poor site drainage.

It is highly recommended that all plumbing and drainage fixtures and fittings be maintained regularly in order to prevent excessive moisture being present in the external / internal property.

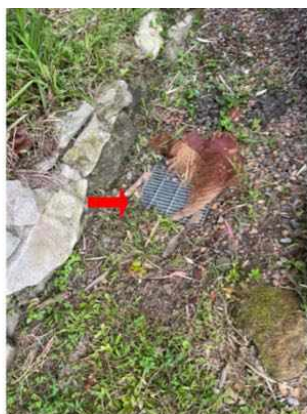
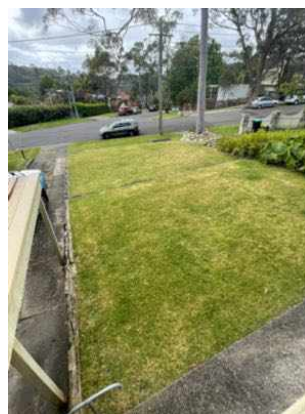
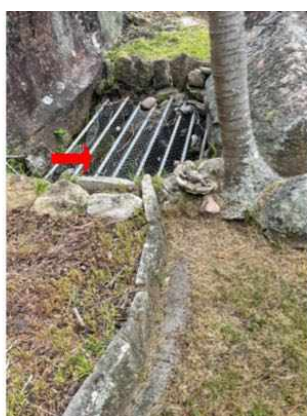
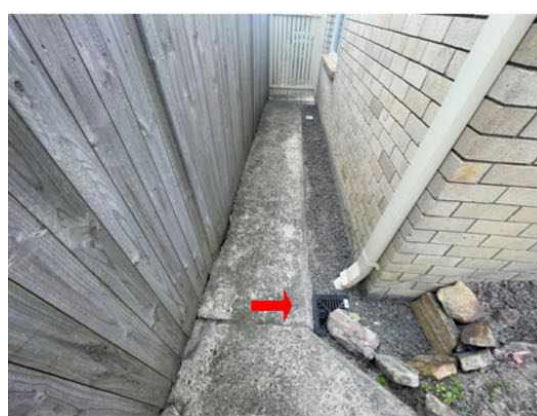
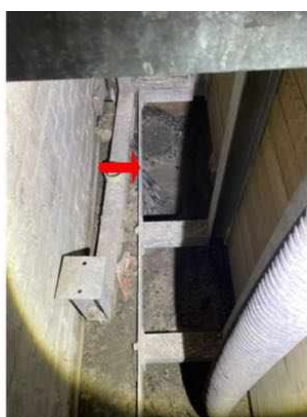
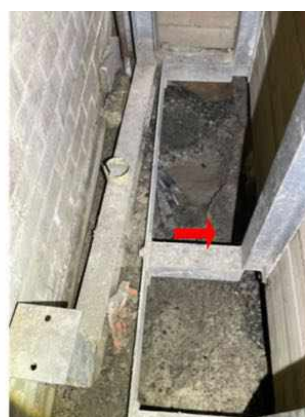
### Termite and Timber Pest 1.05

| Location: | All External Areas |
| Finding: | Site drainage - suspected Inadequate |
| Information: | The site drainage in this area was found to be suspected inadequate at the time of inspection, creating potential for subsequent water damage to associated building elements. |

It is important that water does not lie against the base of walls; surrounding paths and ground levels should be sloped to drain water away from walls. Downpipes should not discharge stormwater onto lower walls or plinths. Stormwater should be carried away by large, regularly cleaned drains. Ground levels may need to be lowered to expose a

Where site drainage is inadequate, installation of an Agricultural (Aggie) Drain may be required. A qualified plumber should be appointed to further inspect the property and perform any remedial works as necessary. Water damage and secondary defects are likely to occur if left unmanaged.

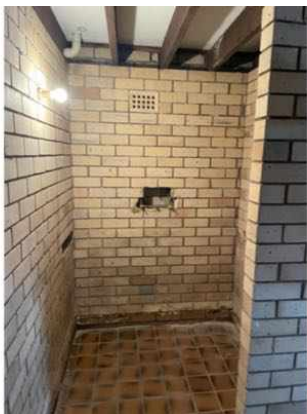
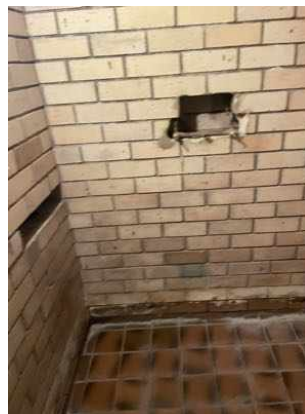
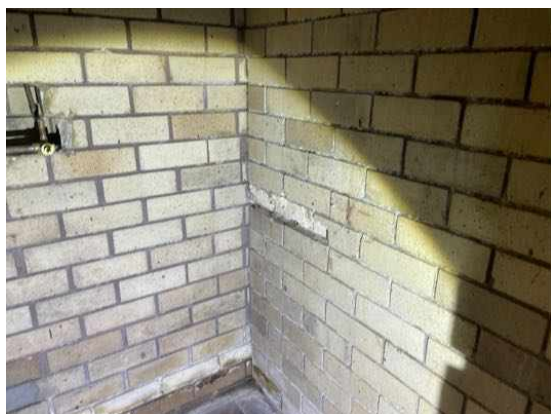
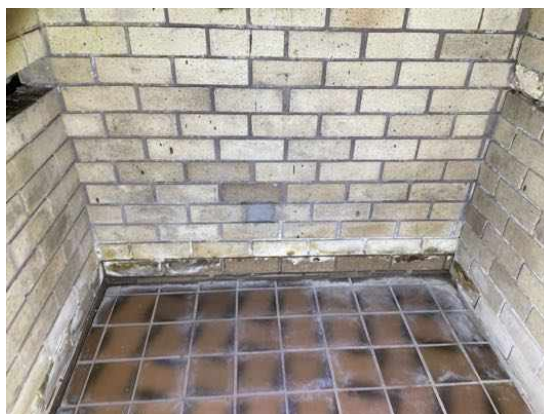
### Termite and Timber Pest 1.06

| Location: | All Areas > Ground Level |
| Finding: | Evidence of excessive moisture was present at the time of inspection |

Information: Excessive moisture can attract termites and produce conditions that promote termite attack fungal growth and wood decay.

Excessive moisture is generally caused by deteriorated inadequate or missing roof drainage leaking plumbing pipes or fixtures poorly plumbed HWS overflows or condenser units and poor site drainage.

It is highly recommended that all plumbing and drainage fixtures and fittings be maintained regularly in order to prevent excessive moisture being present in the external / internal property.

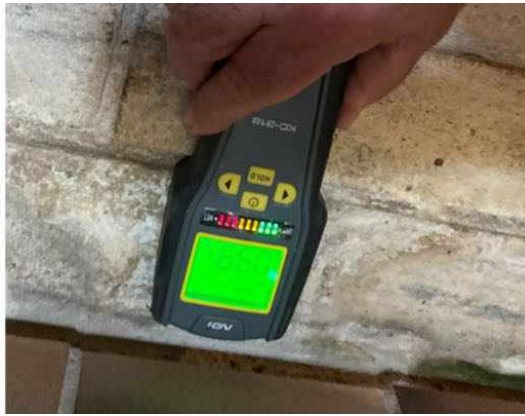
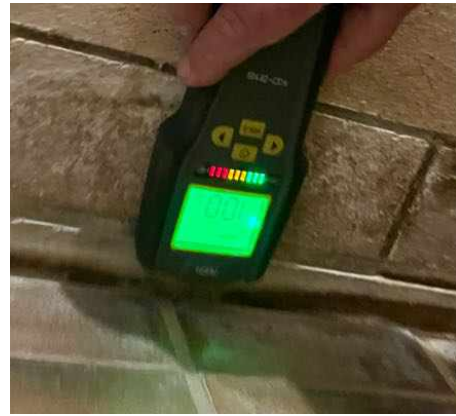
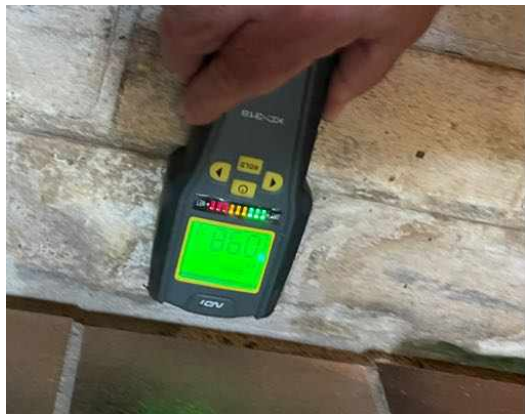
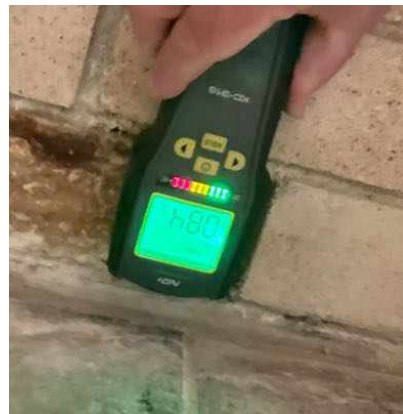
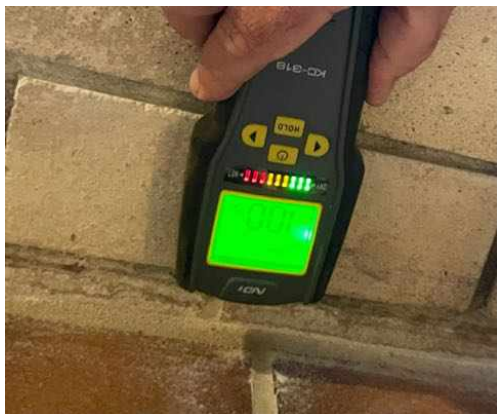
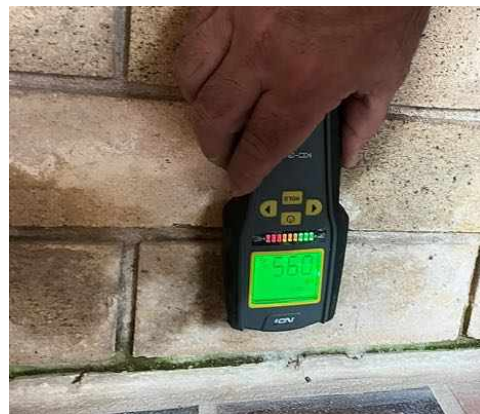
### Termite and Timber Pest 1.07

Building: Building 1  
 Location: All Areas > Ground Level  
 Finding: Moisture meter readings - high  
 Information: The moisture meter result for the areas inspected.

The moisture reading of 0-15% is quite normal and gives no cause for concern. However, moisture readings in excess of 15% indicate the need for further inspection.

Levels between 25-30% indicate that there may be water ingress, meaning that remedial work could be required.

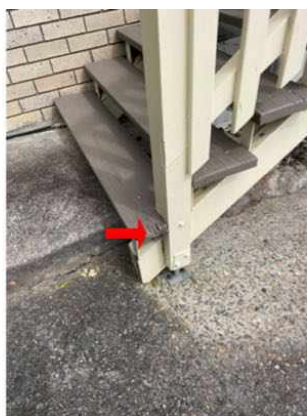
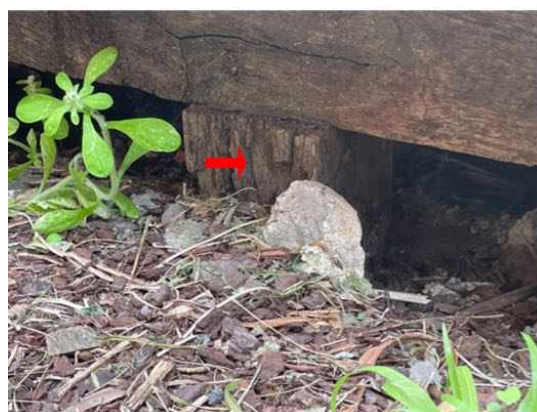
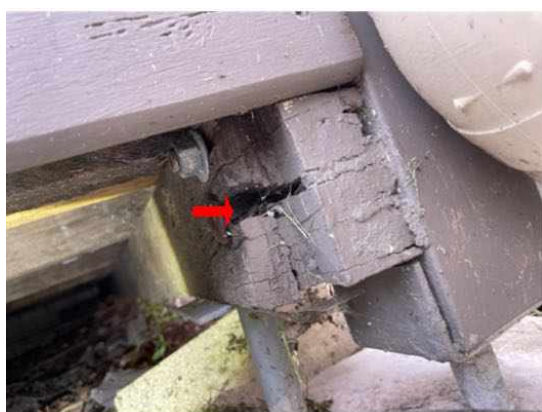
### **Termite and Timber Pest 7.01**

Location: All Areas

Finding: Wood rot

Information: This building element shows evidence of wood rot. Wood rot, also known as Fungal Decay, occurs when timbers and other cellulose building materials are exposed to damp conditions on an ongoing basis. This could be the result of exposure to weathering over a prolonged period of time, or the attraction of excessive moisture from other abutting building materials. Contributing factors also include poor air ventilation in the area.

Early intervention and regular maintenance, particularly of exterior timbers, will prolong the useful life of these building elements. Prior to any works being performed, the cause of the moisture that has created the visible wood rot should be identified and addressed in a suitable manner. Replacement of affected timbers may then be a necessary step in protecting surrounding building elements from such deterioration.

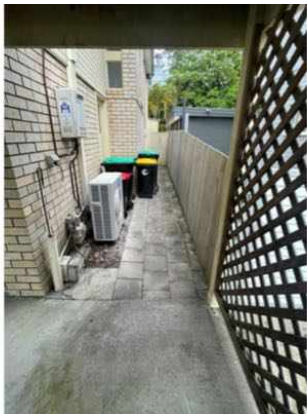
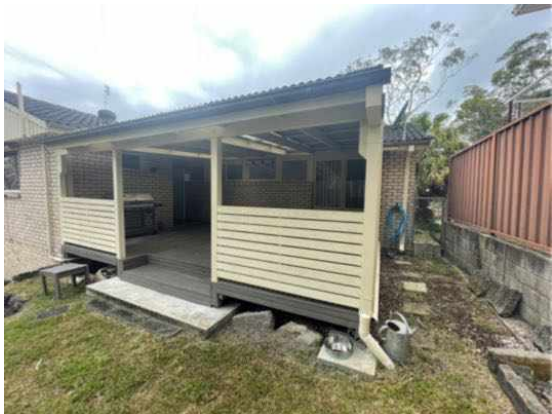
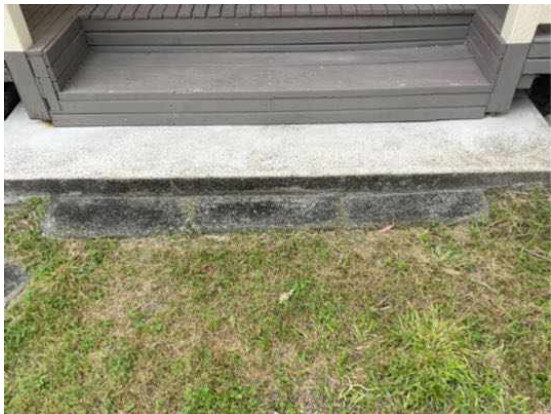
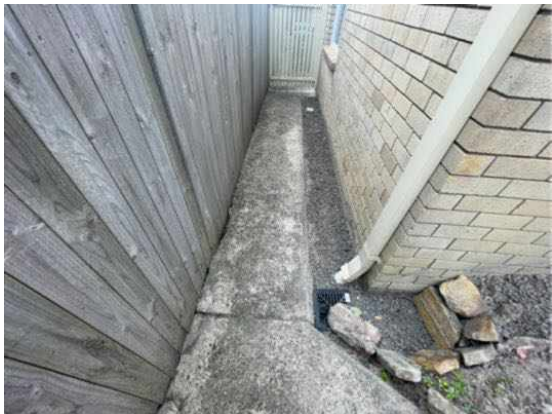
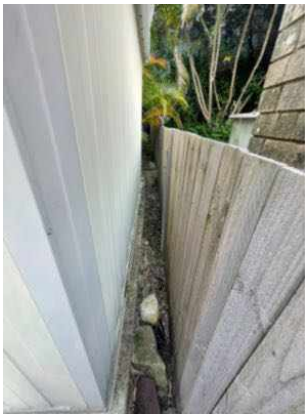
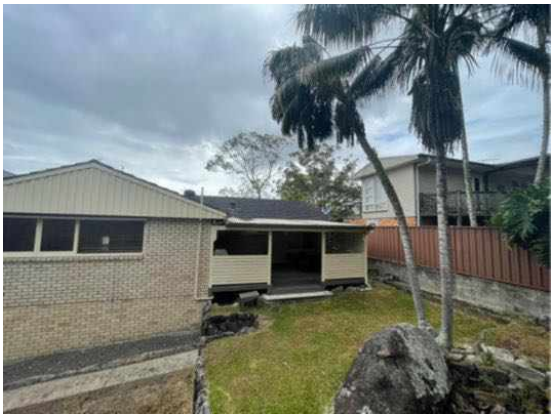
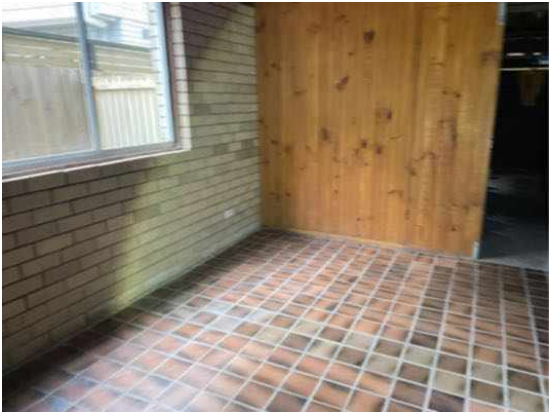
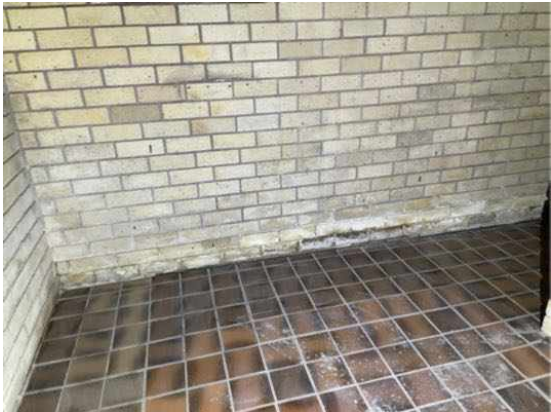
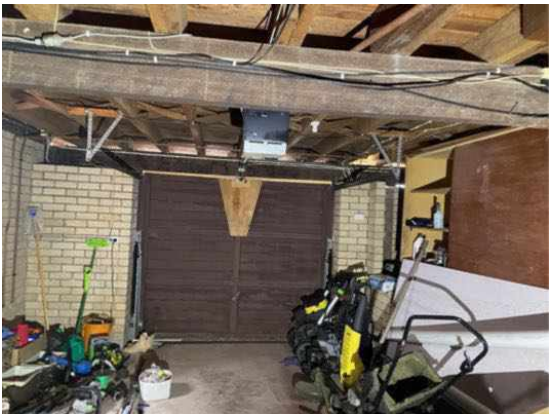
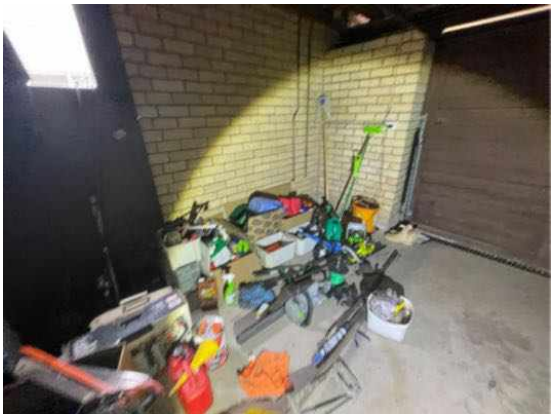
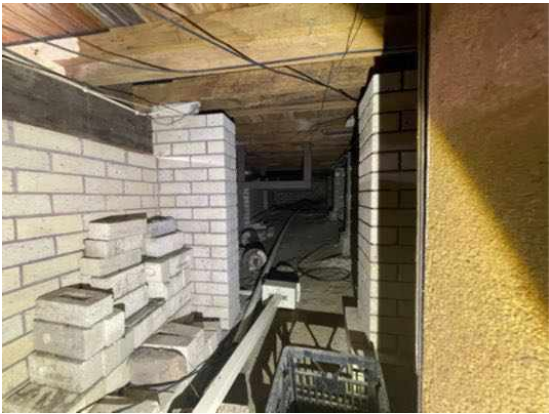
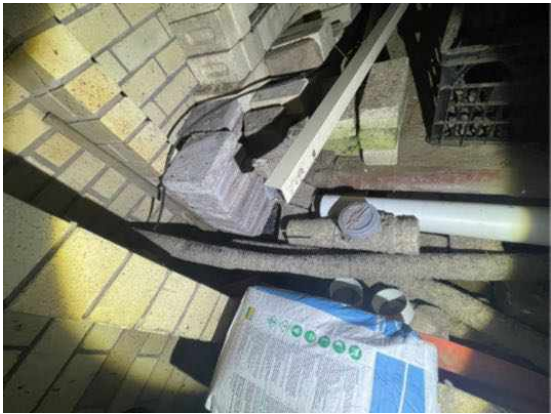
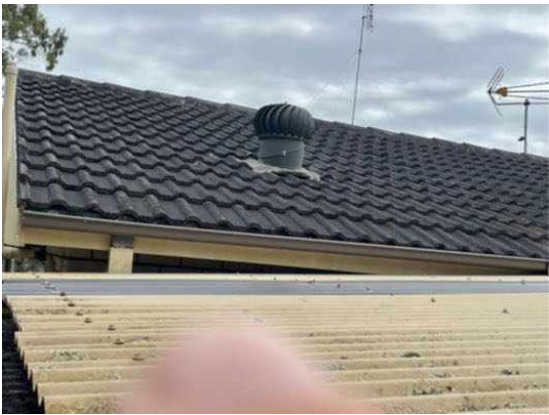
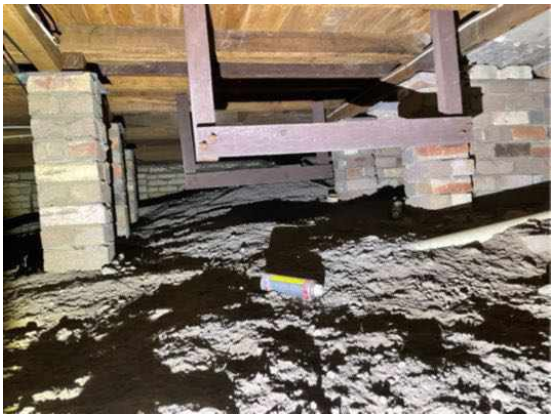
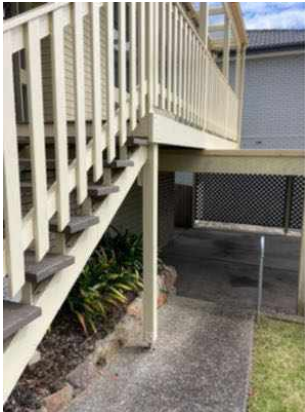
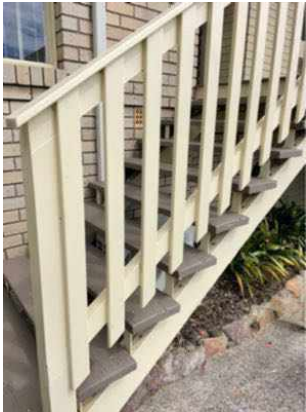
Noted Item

Building: Building 1  
Location: All Areas  
Finding: Additional Photos - Obstructions and Limitations  
Information: These photographs are an indication of the obstructions and limitations which impeded full inspection of the property at the time of inspection. These obstructions can hide an array of defects and should be removed to allow full inspection to be carried out.
