# Building and Timber Pest Inspection Report VR

Inspection Date: Tue, 5 Nov 2024

Property Address: 2 Kenford Cct, Stanhope Gardens NSW  
2768, Australia

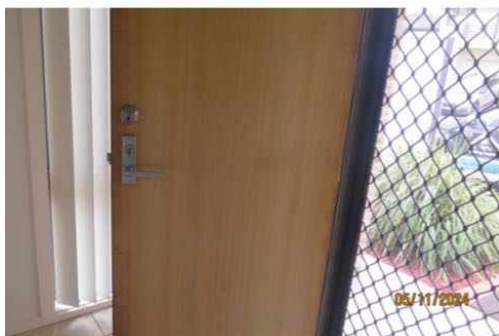
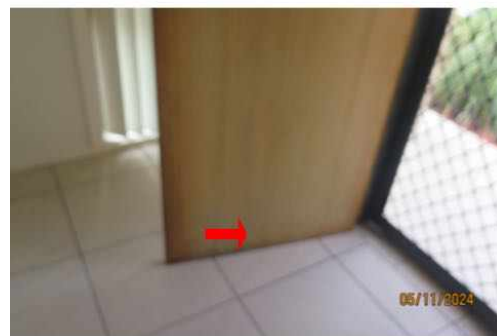
#### Finding 3.01

Building: Main Building  
Location: Entry  
Finding: Painted surface - Bubbling  
Information: Sections of paint in this area was found to have bubbled and deteriorated. Paint bubbling is generally an indication of excessive moisture in the area, that is currently hidden by the painted surface.

The presence of excessive moisture can have major implications on associated building elements if left unattended. While only seemingly minor at this stage, the damage cannot be determined due to the paint obstructing any further inspection of the damage.

It is highly advised that the affected paint be cleaned to allow a further, more invasive inspection by a licensed plumber. Failure to act on this defect may necessitate major works in the future.

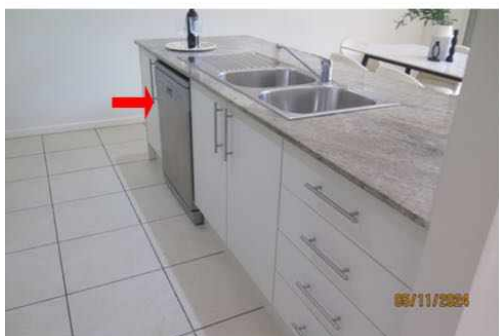
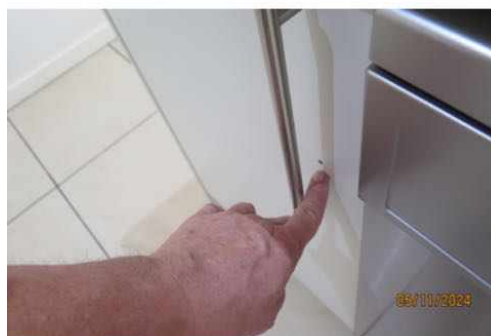
#### Finding 3.02

Building: Main Building  
Location: Kitchen

Finding: Building element - Damaged  
 Information: Breakage occurs generally when the building materials have either aged and decayed, or as a result of damage (accidental or deliberate).

Repair and/or replacement of broken elements is advised to ensure that additional secondary defects do not arise as a consequence. Such works are necessary, as all building elements play a key role in the operation and function of the overall structure and its performance.

A relevant tradesperson should be appointed to repair or replace the affected building element prior to any subsequent damage being caused.

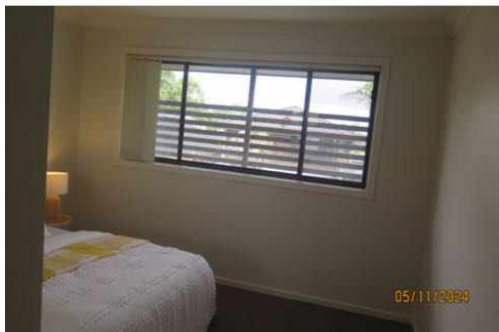
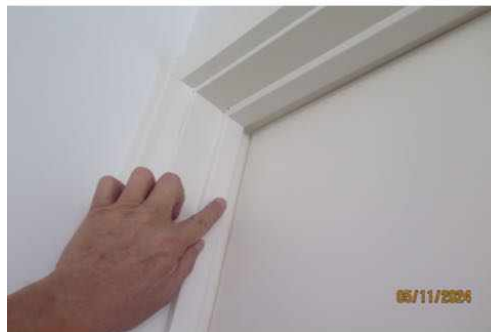
### Finding 3.03

Building: Main Building  
 Location: Bedroom  
 Finding: Doors - Binding/Jamming  
 Information: Binding and/or jamming of several doors throughout the property were evident during standard operation. This defect inhibits the functionality of affected doors as well as creating potential for secondary defects to associated building elements, such as damage to the floor covering.

A door that binds to flooring or to the associated door frame may have several causes, ranging from minor defects, such as poor installation of the door or deteriorated hinges, through to major structural issues, such as damage to subfloor structures.

Where door binding/jamming appears to indicate major structural issues, a registered builder specialising in re-stumping should be appointed to provide an estimate on the cost of rectification.

For minor causes, a qualified carpenter or general handyman should be appointed to perform minor rectification works at client discretion.

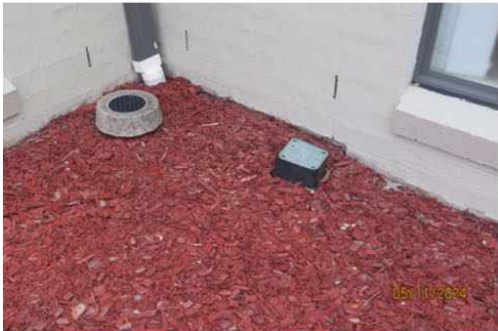
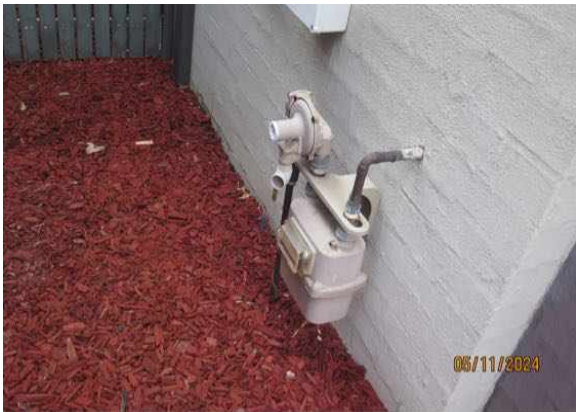
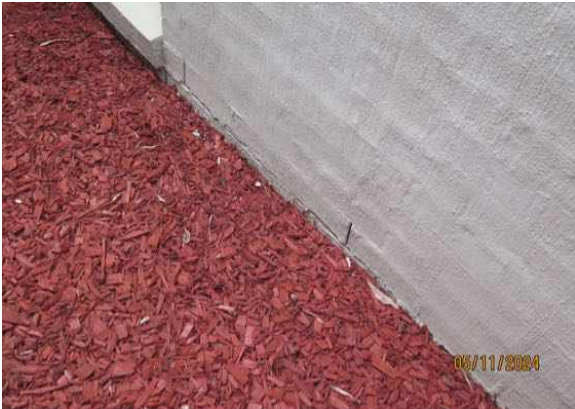
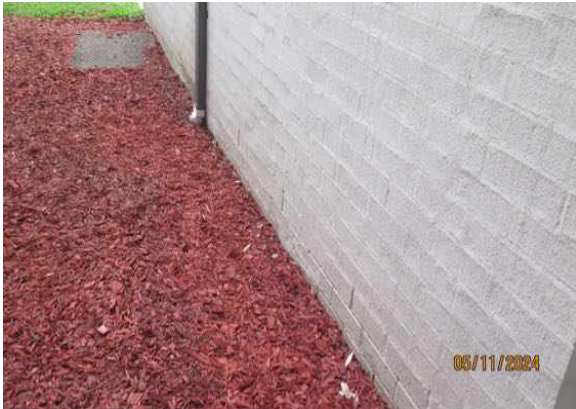
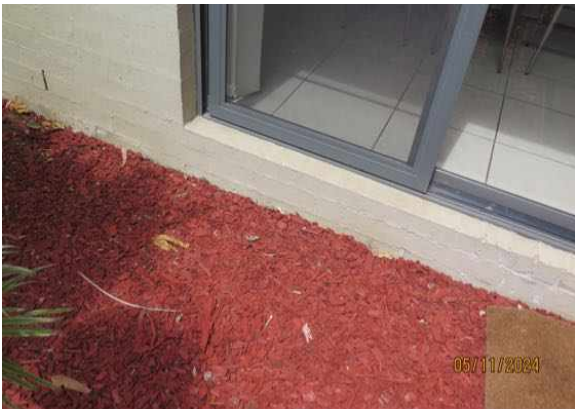
### Finding 6.01

Building:	Main Building
Location:	All Areas
Finding:	Slab Edge - Exposure
Information:	An inspection zone of at least 75mm in relation to the exposed slab edge, between the bottom brick and the perimeter pavement, is required. This inspection zone should be maintained in order to force termites into the open where they can be detected more readily during regular inspections. The slab edge should not be concealed by anything that may prevent inspection of the area, including render, landscaping, soil, turf, paving, concrete cladding or other structures.

If the slab edge is not properly exposed there is a high risk of termite attack. Sometimes, in order to determine the type of slab, a suitably qualified person such as an architect or builder may be required to consult the construction plans.

Where the slab edge cannot be properly inspected, it is highly recommended that termite or timber pest inspections be carried out every 6-12 months to aid protection of the property against infestation.

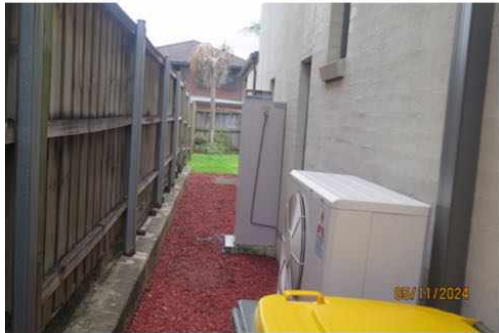
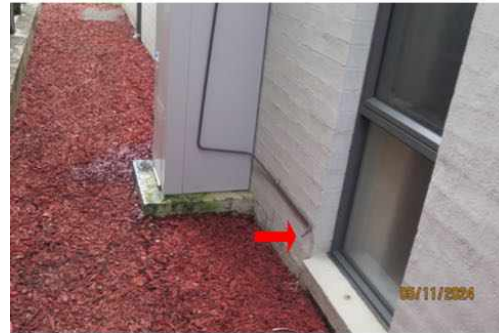
**Finding 6.02**

Building: Main Building  
 Location: Yard - Side  
 Finding: Plumbing - Point of connection non-compliant  
 Information: At the time of inspection it was noted that connections between above ground pipe work and below ground sewer/storm water systems were incomplete.

At the point of connection, the connection should be sealed against vermin and debris entering the sewer / storm water system. The sealing method depends upon the age and type of the pipe work being connected.

Additionally, where sewer pipes are concerned, gases can escape from unsealed

connections which can pose a serious health risk.

Engagement of a certified plumber is strongly recommended to ensure all connection points are sealed in accordance with the plumbing construction guidelines.
