BUILDING & TIMBER PEST INSPECTION REPORT

In accordance with AS 4349.1 & 4349.3

10950
Report Number

22 Inala Place, North Narrabeen NSW 2101
Inspection Address

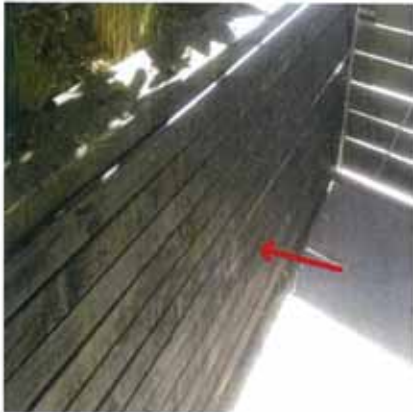
Visual inspection to top level retaining wall was limited due to attached timber screen.

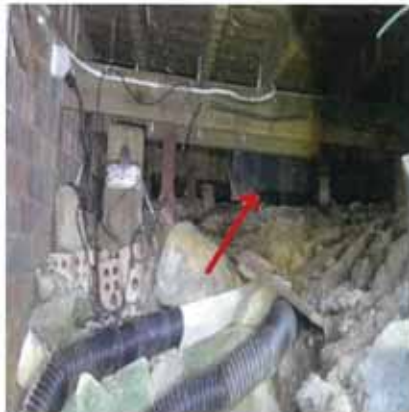
Visual inspection to spa deck subfloor area was limited due to low clearances.

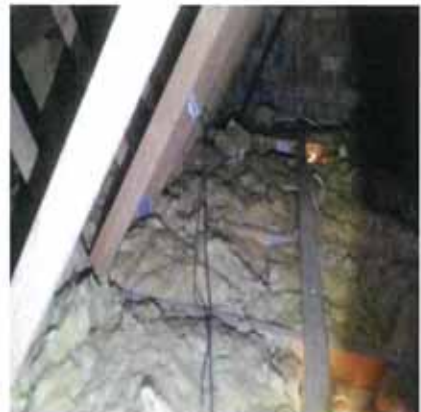
Limited visual inspection to some sections of the roof void due to insulation batts.

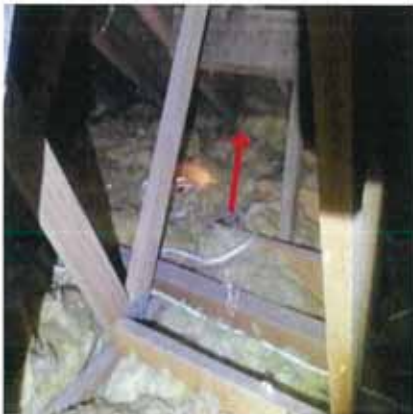
Low access to some sections of the roof void.

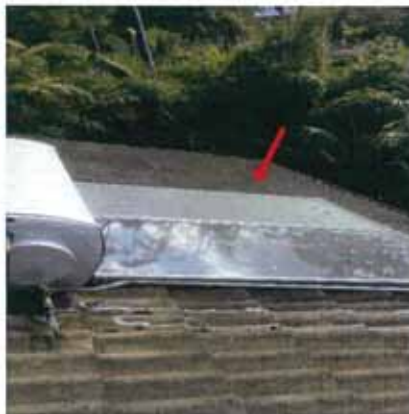
Visual inspection limited to a section of the roof surface due to solar hot water system.

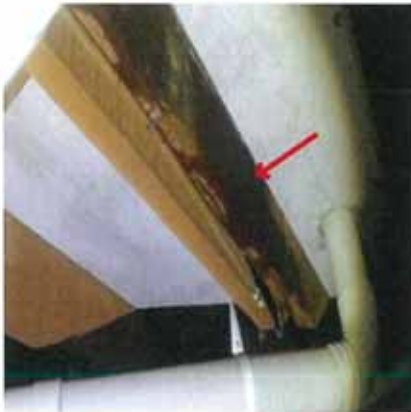
Leak detected below the ensuite shower area. Further investigation into the cause of the leak is required and repairs carried out.

Leaking was detected below the ensuite shower recess area. Further investigation into the cause of the leak is required. Termites are attracted to moisture.

* Silicone redone in Shower stall 22/08/21.

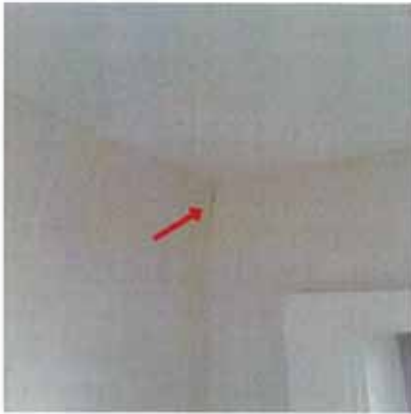
Cracked grout to wall junctions of top-level toilet area. A flexible sealant is recommended where differential movement takes place.

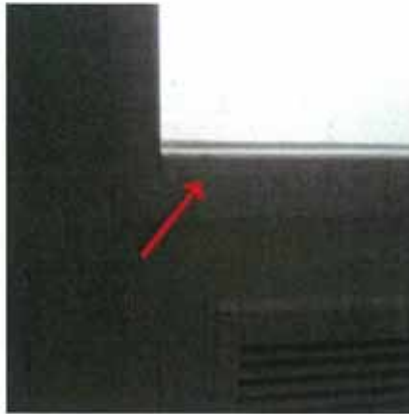
Moisture staining to walk in robe skylight surrounds. Probable cause is condensation dripping from the underside of the dome.

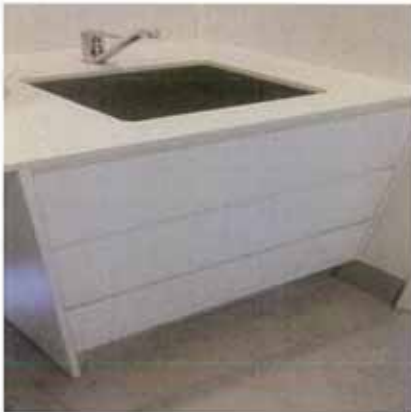
Maintenance required to laundry drawer sliders to ensure smooth operation.

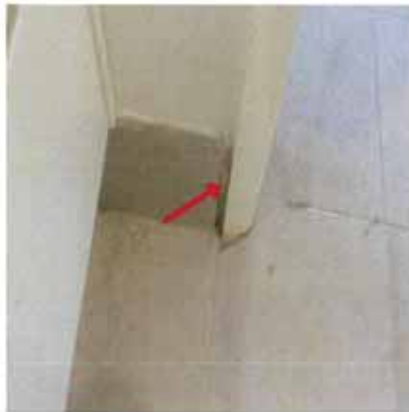
Skirting tile missing from either side of laundry door architraves. Installation of tiles would improve appearances.

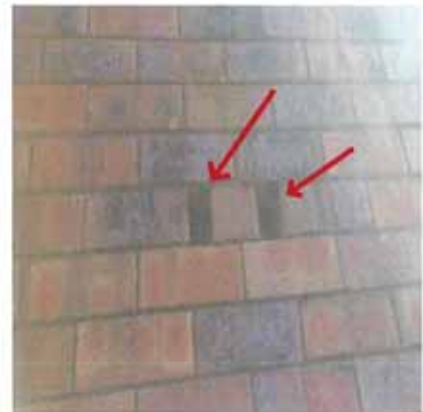
Recommend installing wire/ gauze to brick vents adjacent kitchen external access door to help prevent pests entering.

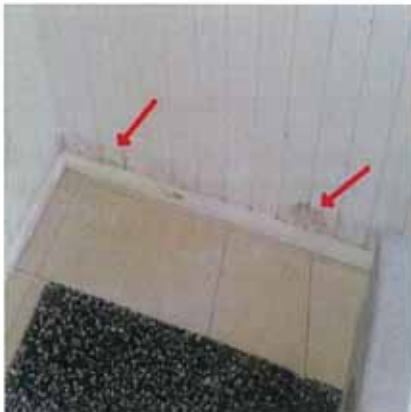
Mildew to sitting room wall linings. Please note a lounge was very recently removed from this area. Cleaning of mildew and monitoring for any reappearance is recommended. If mildew does reappear further investigation into the cause will be required.

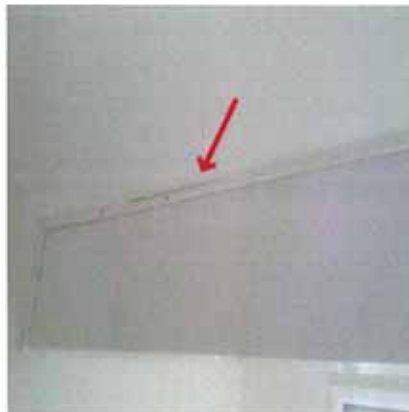
Moisture staining to kitchen ceiling beam. Suggests previous leaks. Recommend monitoring for any further changes/staining, if so, further investigation into the cause of the leaking may be required. This area is below a box gutter.

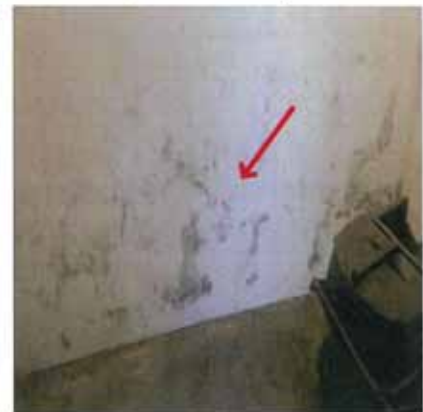
Moisture staining detected to the rear of the garage and storeroom area, indicates moisture penetrating masonry wall from subfloor area.

* Now cleaned.

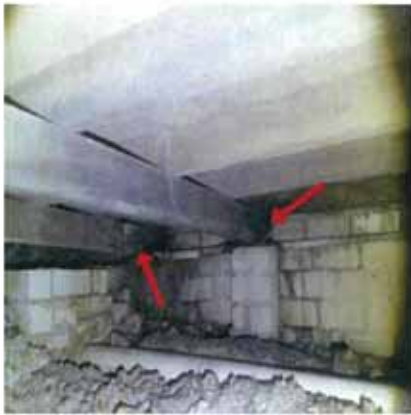
Moisture detected to western side; floor bearer ends. Further investigation into the cause of the moisture is required.

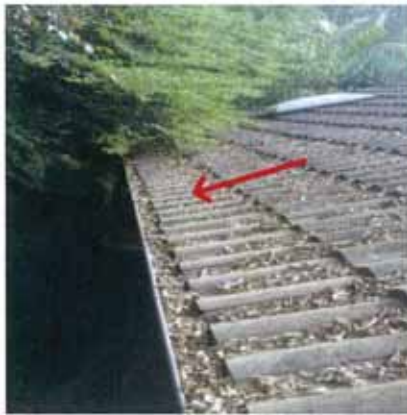
Roof gutter clean out is required. Roof gutters will need to be kept clear and open at all times to function correctly.

** gutters have been cleaned.*

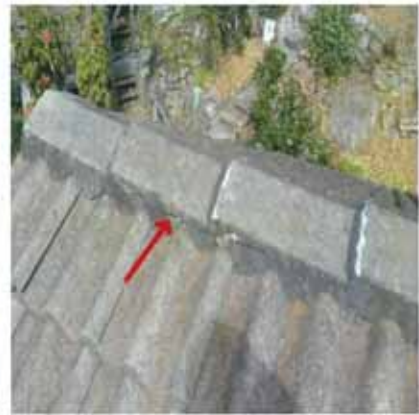
Cracking was detected to mortar in parts of capping tiles, re-pointing affected areas is recommended. Recommend seeking further advice from a licensed and practicing roof tiler.

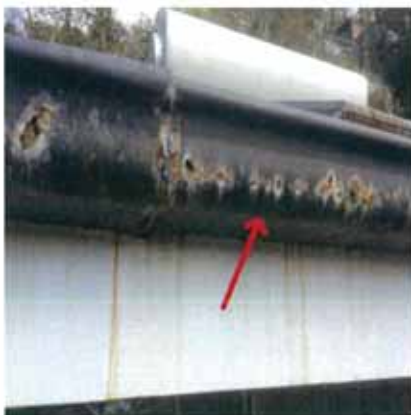
Rust holes detected to top level north facing roof gutters. Replacement of affected section recommended. Recommend seeking further advice from a licensed and practicing plumber or metal roofing contractor.

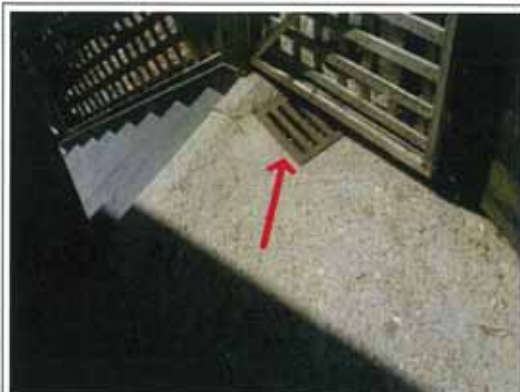
Surface drainage that is installed around the property will need to be kept clear and open at all times to function correctly.

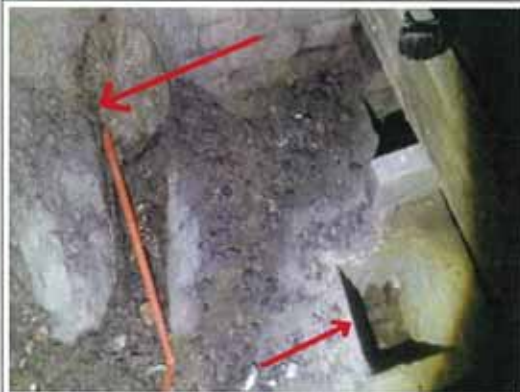
Evidence of moisture entering the western side subfloor area. Drainage that is installed to move subfloor moisture will need to be kept clear and open at all times to function correctly.

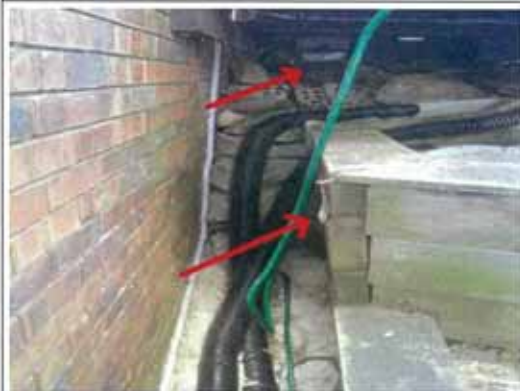
Timber retaining wall below spa area deck is leaning outwards. Attention to adequate foundation or drainage at the time of construction may not have been considered and a visual inspection cannot assess these issues. Regular monitoring of this movement is recommended and if changes occur, further investigation into the cause may be necessary.

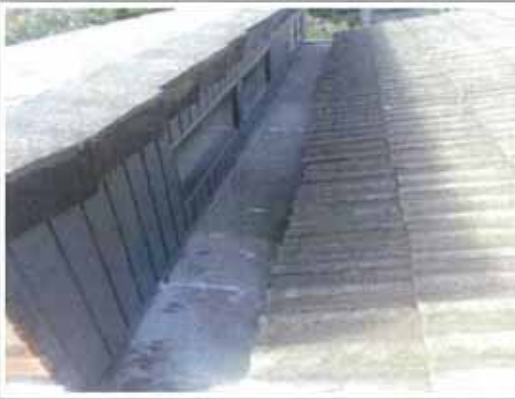
This property is fitted with box gutters. These gutters are fitted on the inside of the external walls. No calculations have been made as to whether the size of box guttering or outlets are adequate to move roof water in all situations. Box gutters must be cleaned and checked for rust and the deterioration of silicon sealant regularly. Recommend regular inspections by a licensed roof plumber.

Maintained 22/08/21 - Silicone added +
cleaned.
