# Building and Timber Pest Inspection Report

Inspection Date: Sun, 19 May 2024

Property Address: 2 Glasshouse Rd, Beaumont Hills NSW  
2155, Australia

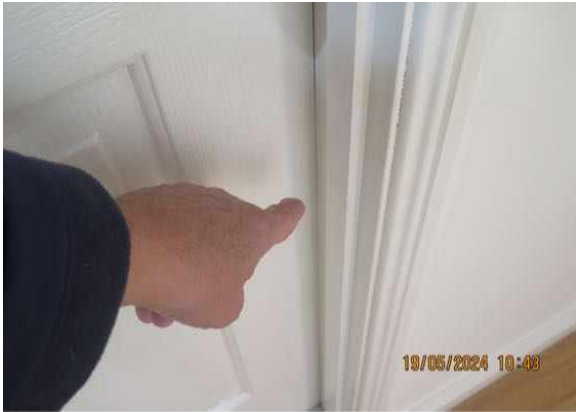
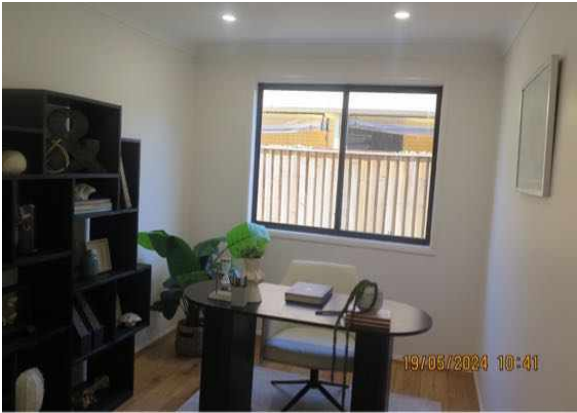
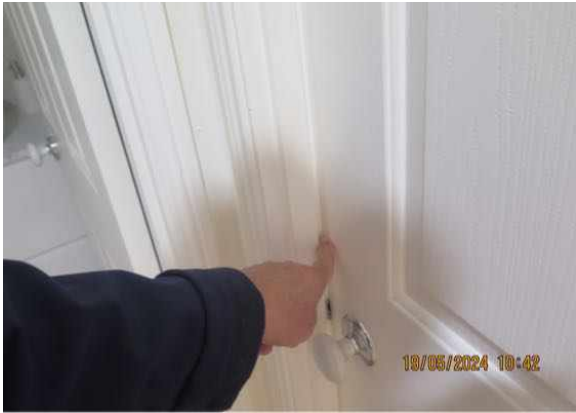
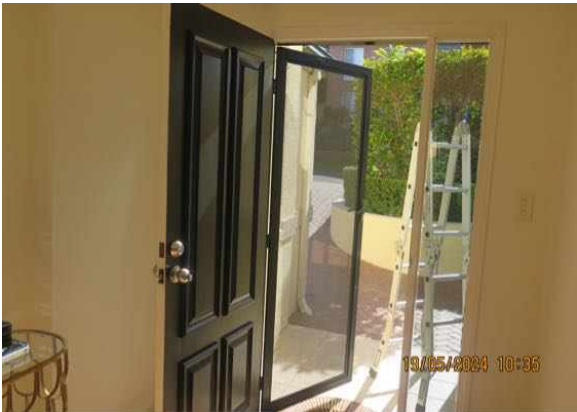
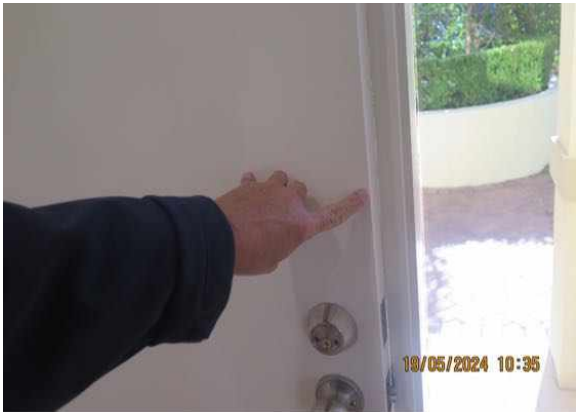
#### Finding 3.02

Building: Main Building  
 Location: All Areas  
 Finding: Door - Binding/jamming  
 Information: Binding and/or jamming of this door is evident during standard operation. This defect inhibits the functionality of the affected door as well as creating potential for secondary defects to associated building elements, such as damage to the floor covering.

A door that binds to flooring or to the associated door frame may have several causes, ranging from minor defects, such as poor installation of the door or deteriorated hinges, through to major structural issues, such as damage to subfloor structures.

Where door binding/jamming appears to indicate major structural issues, a registered builder specialising in re-stumping should be appointed to provide an estimate on the cost of rectification.

For minor causes, a qualified carpenter or general handyperson should be appointed to perform minor rectification works at client discretion.

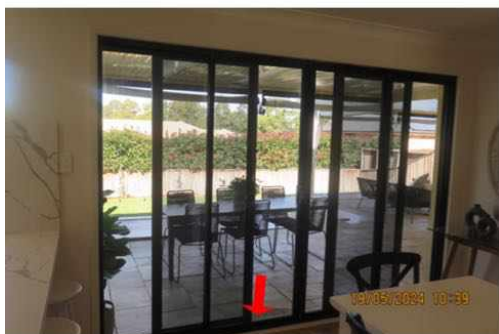
### Finding 3.03

Building:	Main Building
Location:	Dining Room
Finding:	Door - Stiff to slide
Information:	The door in this area was jammed and difficult to slide along the associated tracks at the time of the inspection. Restricted function of the affected door may pose as a potential safety hazard if required for emergency egress from the building.

Generally, factors such as general age of the building element and a lack of maintenance are the usual causes for this type of defect.

Replacement of door hardware or tracks may be required, as well as minor repairs and cleaning. A registered builder or general handy person will be required to repair the affected doors.

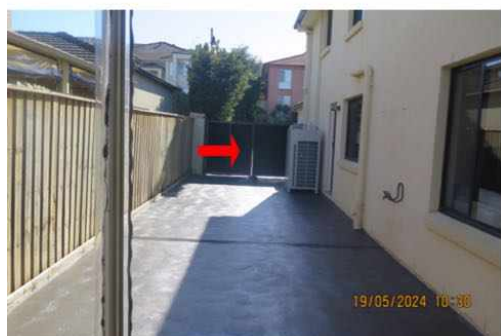
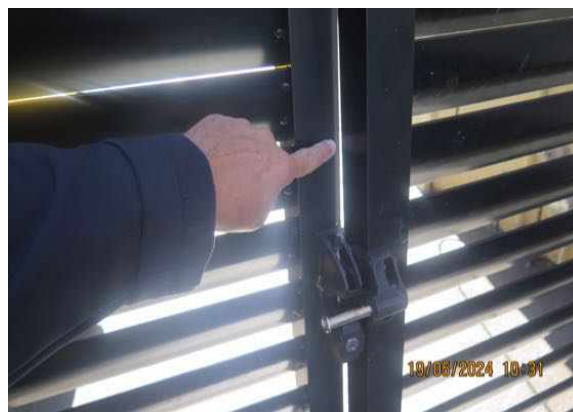
### Finding 3.04

Building:	Main Building
Location:	Yard - Side
Finding:	Door - Binding/jamming
Information:	Binding and/or jamming of this door is evident during standard operation. This defect inhibits the functionality of the affected door as well as creating potential for secondary defects to associated building elements, such as damage to the floor covering.

A door that binds to flooring or to the associated door frame may have several causes, ranging from minor defects, such as poor installation of the door or deteriorated hinges, through to major structural issues, such as damage to subfloor structures.

Where door binding/jamming appears to indicate major structural issues, a registered builder specialising in re-stumping should be appointed to provide an estimate on the cost of rectification.

For minor causes, a qualified carpenter or general handyperson should be appointed to perform minor rectification works at client discretion.
