Building and Timber Pest Inspection Report VR

Inspection Date: Wed, 19 Jun 2024

Property Address: 19 Galaxy St, Schofields NSW 2762,
Australia

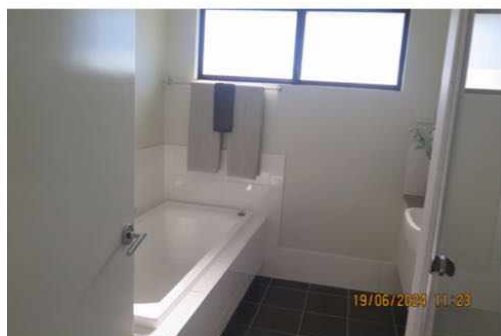
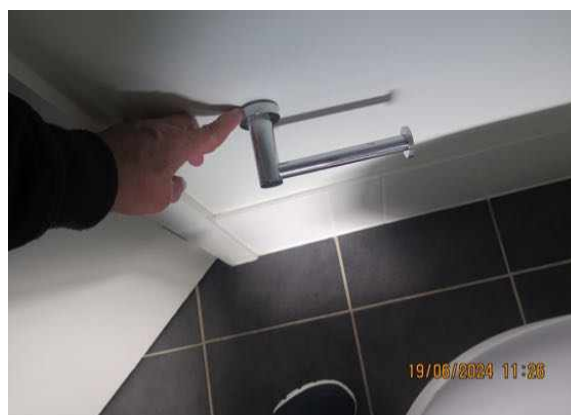
Finding 3.01

Building: Main Building
 Location: Bathroom
 Finding: Fitting or fixture - Loose
 Information: The fitting in this area is loose and requires adjustment to tighten.

If left unmanaged, the fitting may further deteriorate, causing potential for the development of other minor secondary defects.

A relevant tradesperson should be appointed to perform these rectification works at discretion of the client.

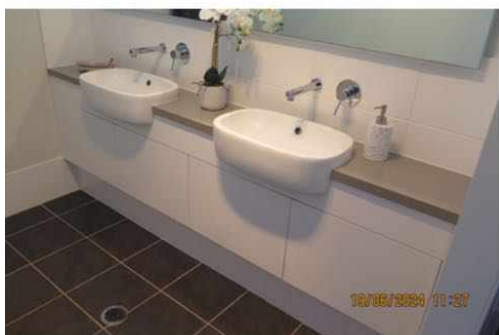
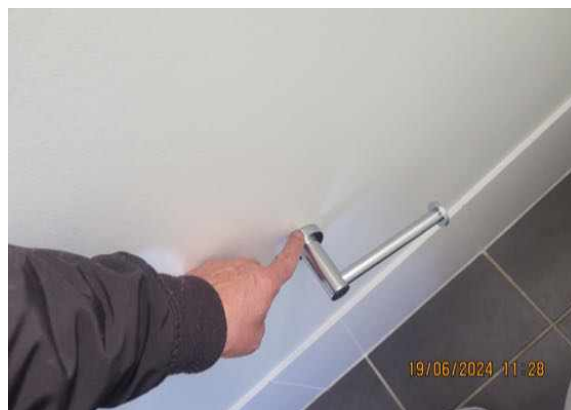
Finding 3.02

Building: Main Building
 Location: Bathroom
 Finding: Fitting or fixture - Loose
 Information: The fitting in this area is loose and requires adjustment to tighten.

If left unmanaged, the fitting may further deteriorate, causing potential for the development of other minor secondary defects.

A relevant tradesperson should be appointed to perform these rectification works at discretion of the client.

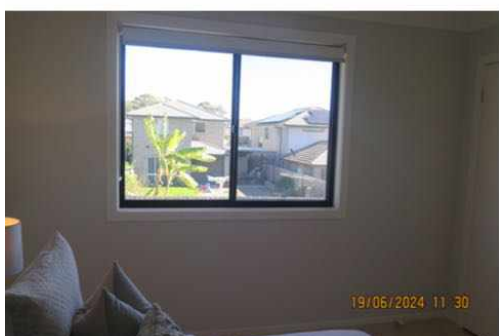
Finding 3.03

Building:	Main Building
Location:	Bedroom
Finding:	Door finish - Damaged
Information:	Breakage occurs generally when the building materials have either aged and decayed, or as a result of damage (accidental or deliberate).

Repair and/or replacement of broken elements is advised to ensure that additional secondary defects do not arise as a consequence. Such works are necessary, as all building elements play a key role in the operation and function of the overall structure and its performance.

A relevant tradesperson should be appointed to repair or replace the affected building element prior to any subsequent damage being caused.

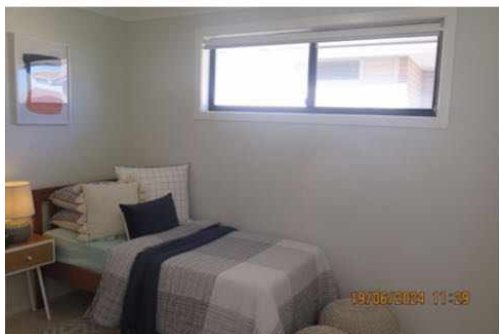
Finding 3.04

Building:	Main Building
Location:	Bedroom

Finding: Fitting or fixture - Loose
 Information: The fitting in this area is loose and requires adjustment to tighten.

If left unmanaged, the fitting may further deteriorate, causing potential for the development of other minor secondary defects.

A relevant tradesperson should be appointed to perform these rectification works at discretion of the client.

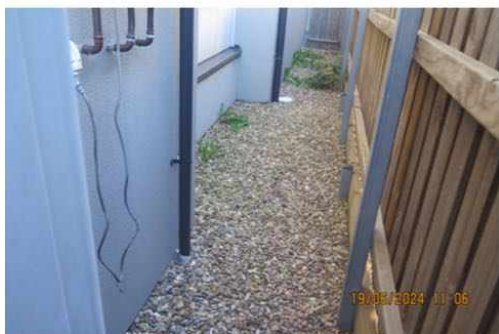
Finding 3.05

Building: Main Building
 Location: Yard - Side
 Finding: Mould - Present
 Information: Where evidence of mould growth was noted, there may be environmental, biological or health issues associated with the report. A specialist inspection by a suitably qualified environmental health inspector is warranted, where mould is extensive or where any queries regarding air quality spores or other related issues apply.

Generally, the client is advised to ensure that the general environment is free of moisture and humidity to aid in the prevention of mould formation and development. Any mould found during the inspection should be cleaned immediately by a cleaning contractor or the homeowner as applicable.

Please note that severely affected building elements may require replacement by a registered builder or qualified carpenter.

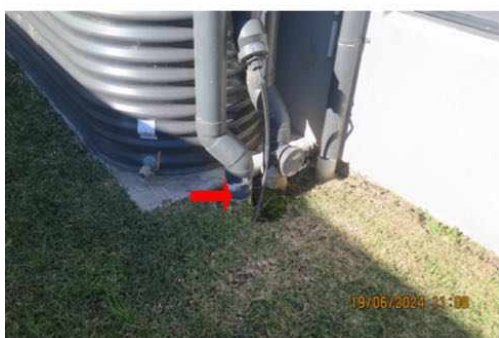
Finding 3.06

Building:	Main Building
Location:	Yard - Side
Finding:	Pipe - Damaged
Information:	Breakage occurs generally when the building materials have either aged and decayed, or as a result of damage (accidental or deliberate).

Repair and/or replacement of broken elements is advised to ensure that additional secondary defects do not arise as a consequence. Such works are necessary, as all building elements play a key role in the operation and function of the overall structure and its performance.

A relevant tradesperson should be appointed to repair or replace the affected building element prior to any subsequent damage being caused.

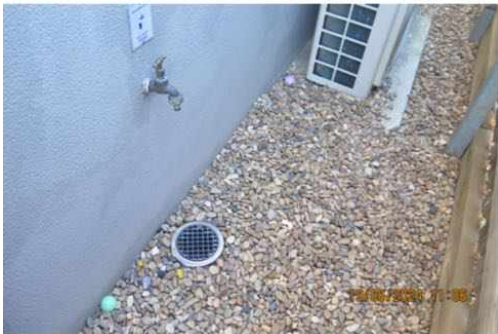
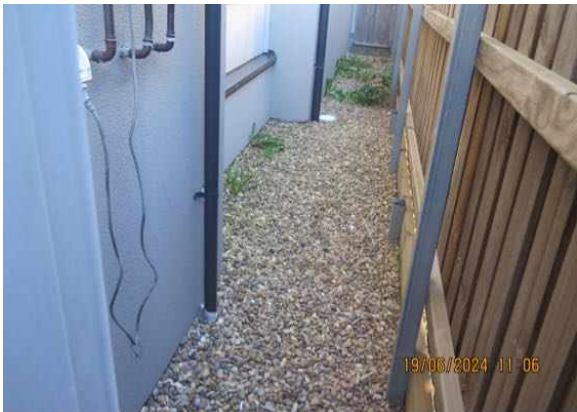
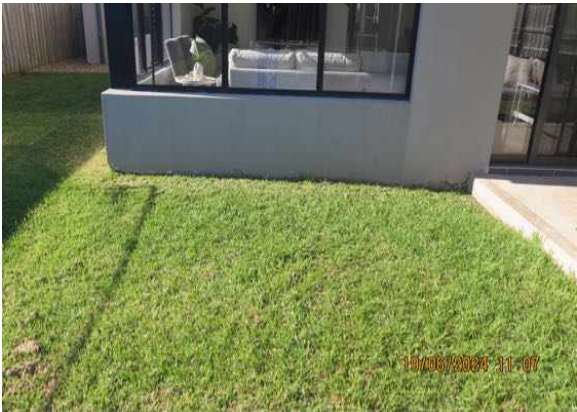
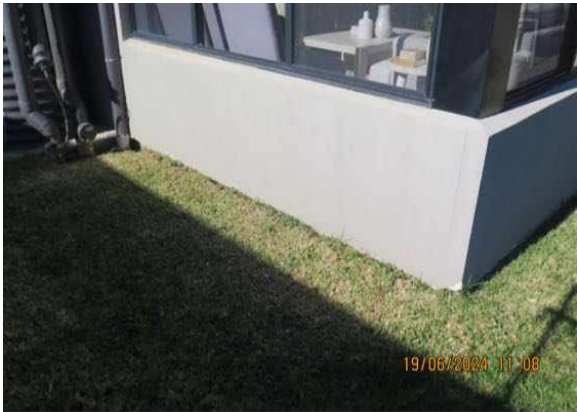
Finding 6.01

Building: Main Building
Location: All Areas
Finding: Slab Edge - Exposure
Information: An inspection zone of at least 75mm in relation to the exposed slab edge, between the bottom brick and the perimeter pavement, is required. This inspection zone should be maintained in order to force termites into the open where they can be detected more readily during regular inspections. The slab edge should not be concealed by anything that may prevent inspection of the area, including render, landscaping, soil, turf, paving, concrete cladding or other structures.

If the slab edge is not properly exposed there is a high risk of termite attack. Sometimes, in order to determine the type of slab, a suitably qualified person such as an architect or builder may be required to consult the construction plans.

Where the slab edge cannot be properly inspected, it is highly recommended that termite or timber pest inspections be carried out every 6-12 months to aid protection of the property against infestation.
