Building Inspection Report

Inspection Date: Sat, 1 Oct 2022

Property Address: 16 Prahran Ave, Frenchs Forest NSW 2086,
Australia

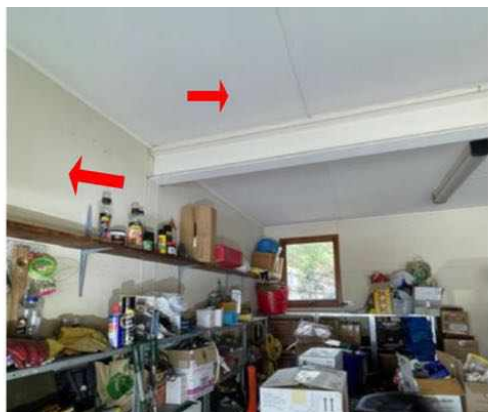
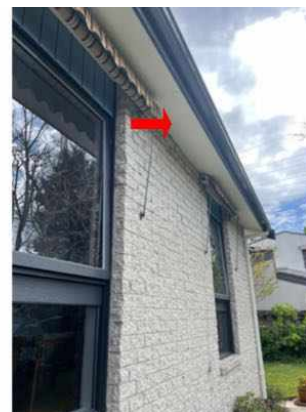
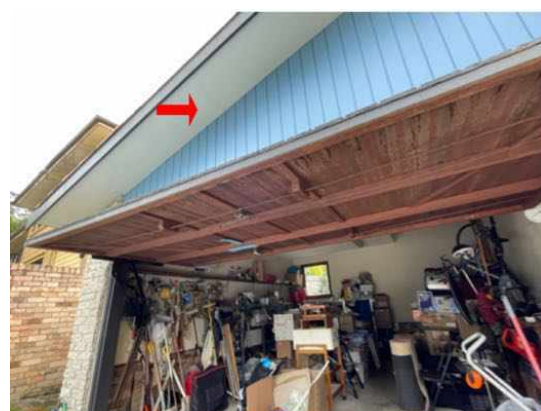
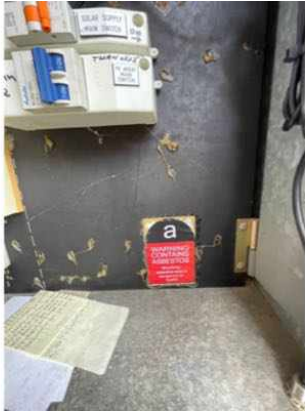
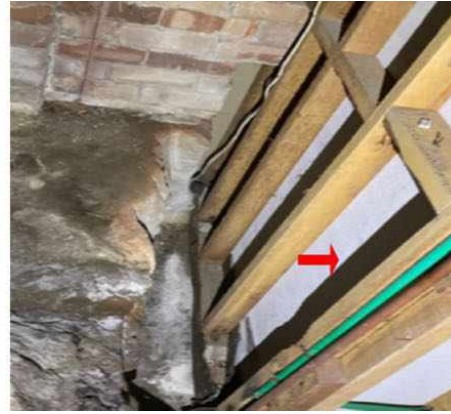
Defects 1.01

Building: Building 1
Location: All Areas
Finding: Asbestos - Suspected ACM Identified on Site
Information: Reporting on Asbestos is outside the Scope of this Report. This suspected defect is highlighted as a caution only. We suspect, based on our experience in the building industry, that there is a higher risk of the identified building element containing asbestos.

As Asbestos Reporting is outside the scope of this report, we advise that you consider a separate Asbestos Inspection and Condition Audit, which can include the taking of samples for definitive confirmation of the presence of Asbestos.

In the interim, the client is advised to act with caution, especially when considering any damage to building materials general wear and tear renovations extensions demolition and general maintenance activities due to the suspected presence of Asbestos.

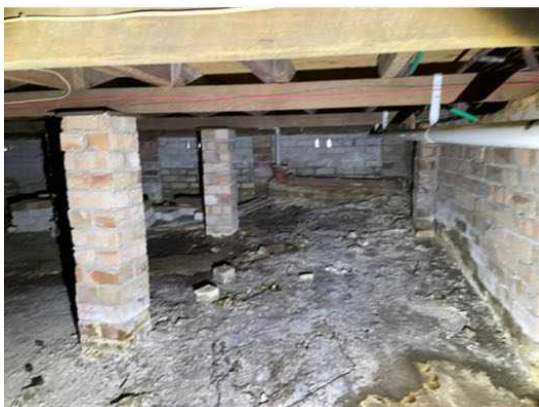
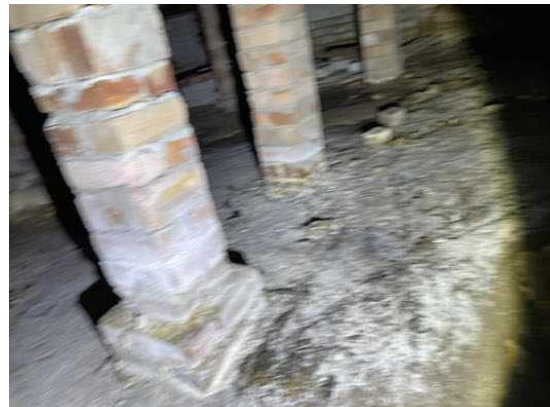
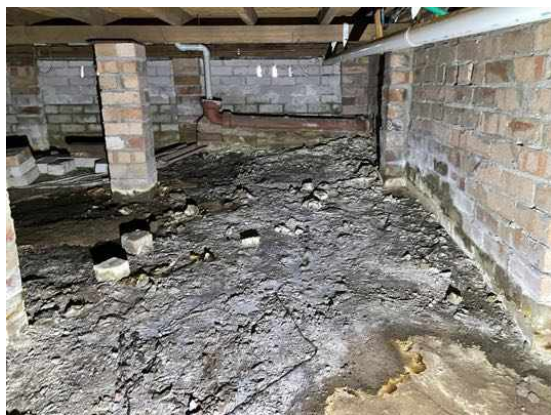
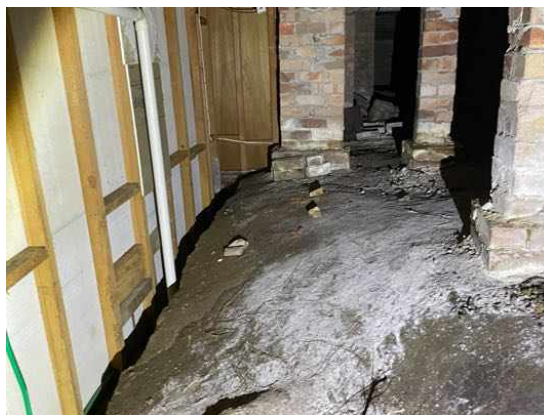
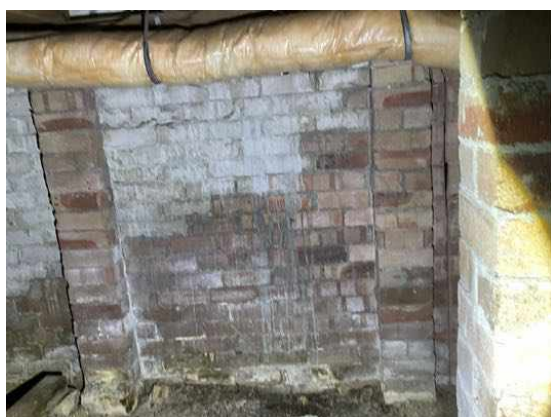
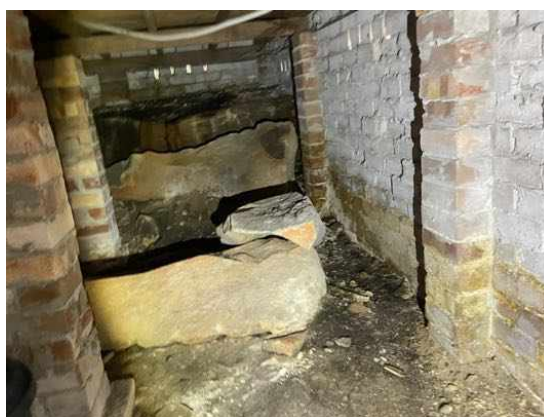
Defects 1.02

Building:	Building 1
Location:	Subfloor
Finding:	Visual mould inspection
Information:	A visual mould inspection of the property was conducted and identified areas of suspected mould and deterioration. Mould is a visible fungal growth, but may also be evidenced by a musty smell in the immediate area.

Mould, which poses a significant respiratory hazard, generally forms and develops as a result of dark and damp conditions over a prolonged period of time. These conditions,

While mould and dampness are present, the area is considered a health and safety hazard. Tenants with respiratory health conditions are advised to exercise great caution and care whilst in the area.

The first action should be to identify the cause of the mould in this area. Replacement of the affected carpet is required as a matter of urgency to ensure the safety of the area. Where required, remedial works should be undertaken to any associated walls and flooring showing evidence of mould.

Where mould is excessive, further inspection by an Environmental Health inspector is advisable.

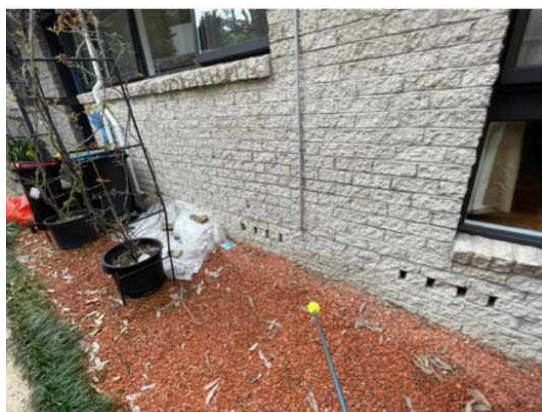
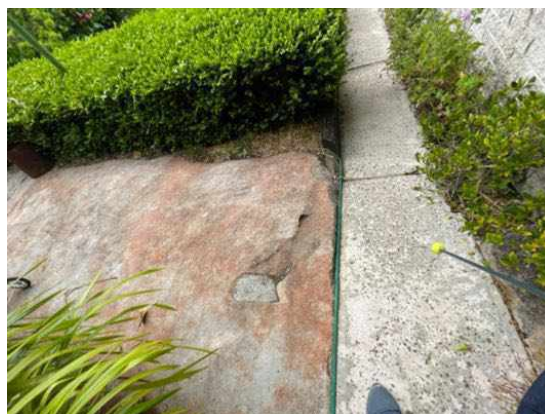
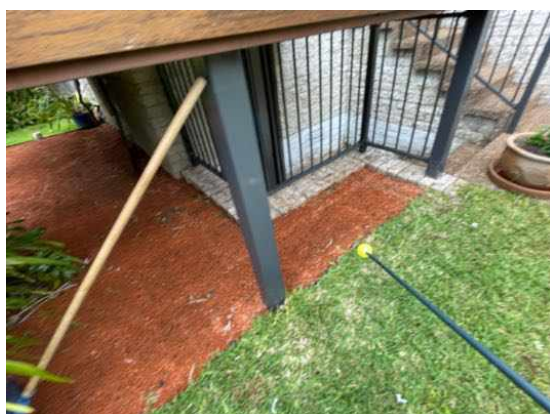
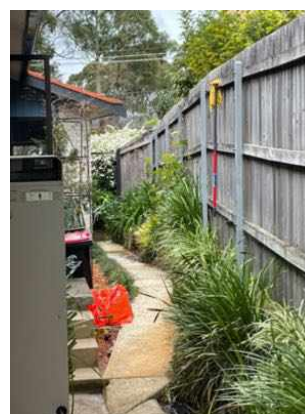
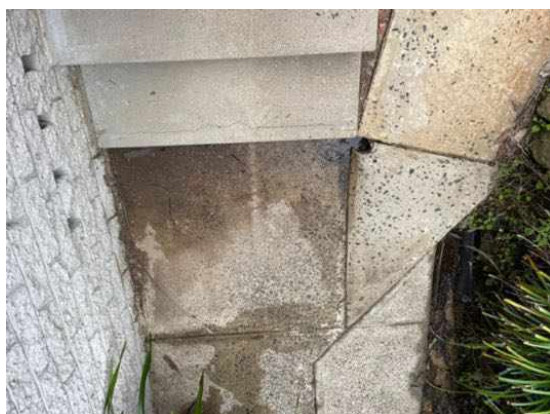
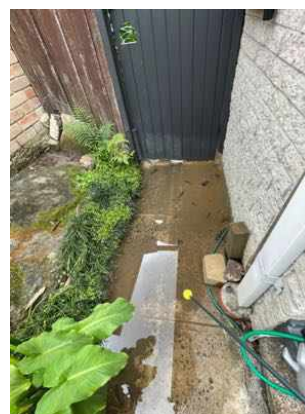
Defects 3.01

Building:	Building 1
Location:	All External Areas
Finding:	Evidence of excessive moisture was present at the time of inspection
Information:	Excessive moisture can attract termites and produce conditions that promote termite attack fungal growth and wood decay.

Excessive moisture is generally caused by deteriorated inadequate or missing roof drainage leaking plumbing pipes or fixtures poorly plumbed HWS overflows or condenser units and poor site drainage.

It is highly recommended that all plumbing and drainage fixtures and fittings be maintained regularly in order to prevent excessive moisture being present in the external / internal property.

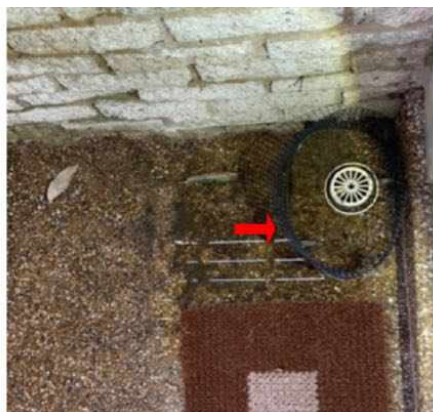
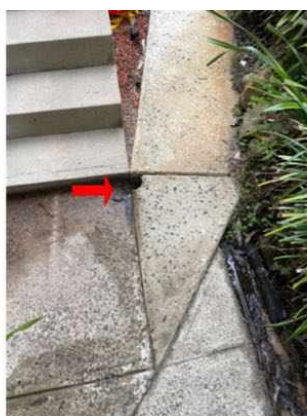
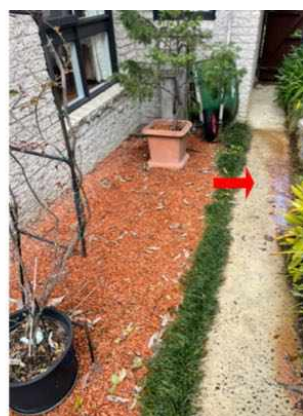
Defects 3.02

Building:	Building 1
Location:	All External Areas
Finding:	Site drainage - suspected Inadequate
Information:	The site drainage in this area was found to be suspected inadequate at the time of inspection, creating potential for subsequent water damage to associated building elements.

It is important that water does not lie against the base of walls; surrounding paths and ground levels should be sloped to drain water away from walls. Downpipes should not discharge stormwater onto lower walls or plinths. Stormwater should be carried away

by large, regularly cleaned drains. Ground levels may need to be lowered to expose a buried DPC.

Where site drainage is inadequate, installation of an Agricultural (Aggie) Drain may be required. A qualified plumber should be appointed to further inspect the property and perform any remedial works as necessary. Water damage and secondary defects are likely to occur if left unmanaged.

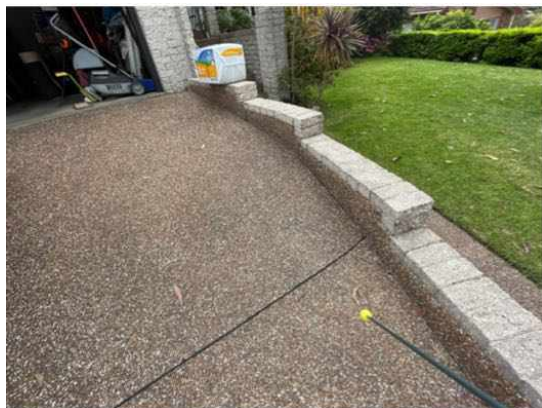
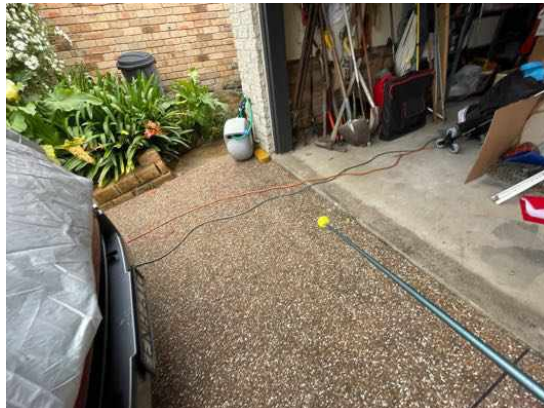
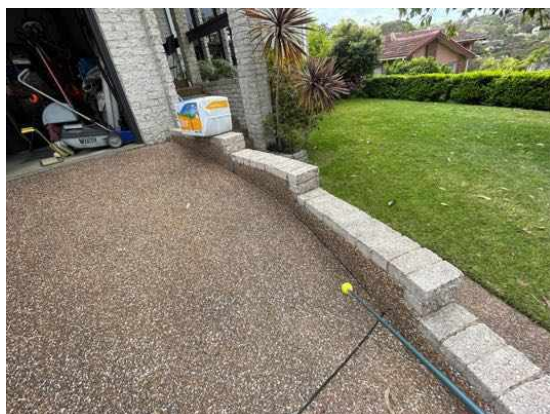
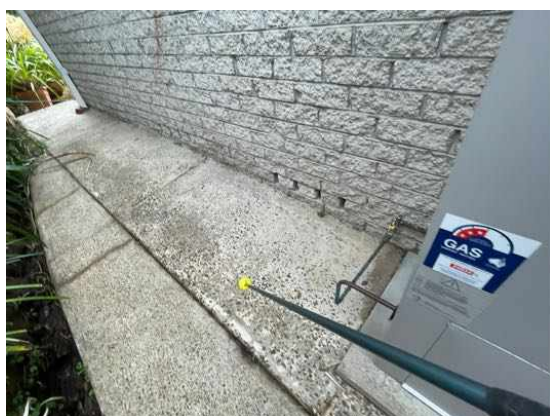
Defects 3.03

Building:	Building 1
Location:	All External Areas
Finding:	Cracking - External Concrete Paving Damage Category 1 - Fine (less than 2mm)
Information:	Fine cracks were identified in external concrete paving. Although fine cracks are quite noticeable, they are often only considered to be an appearance defect, and usually do not indicate any structural damage. To be considered a Category 1 or fine crack, the crack is found to be less than 2mm in width.

Generally the cause of a hairline crack in existing concrete paving such as driveways and pathways is indicative of the expansion and contraction of the concrete. Such causes are generally due to environmental factors, such as moisture levels, weather conditions, root systems of nearby trees or the soil types on which they are laid.

Fine cracks may also be due to poor original installation of the concrete. Factors such

as poor compaction of the sub surface and/or inadequate reinforcing of the slab may create cracking and other secondary defects.

Monitoring of all cracking should be conducted frequently. Always contact a building inspector should cracks widen, lengthen, or become more numerous.

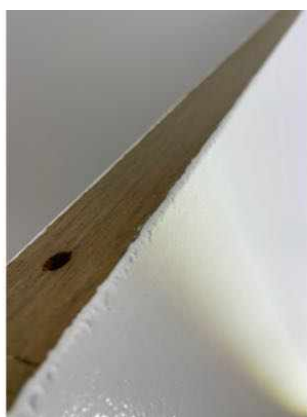
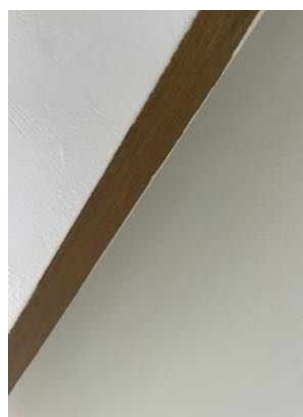
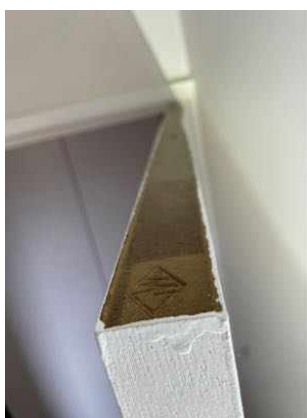
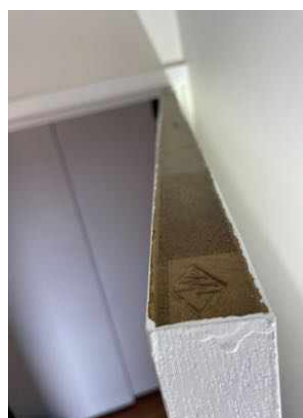
Defects 3.04

Building:	Building 1
Location:	All Areas
Finding:	Door finish - incomplete on top and bottom of door
Information:	The paint finish in this area was identified as being incomplete at the time of

inspection.

Whilst incomplete or missing paint finish is generally an appearance defect, it can also lead to the development of secondary building defects over time. Incomplete areas of paint finish exposes the area to moisture, potentially accelerating the deterioration of underlying building materials.

A painting contractor should be appointed to perform necessary works to aid the appearance of the affected area and to ensure the area is protected against further deterioration. Alternatively, the homeowner following manufacturer instructions may perform these works.

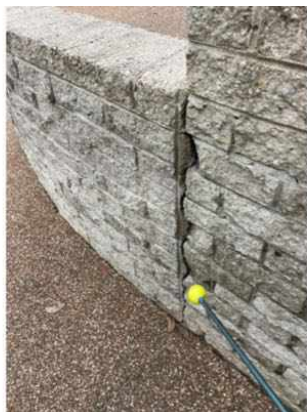
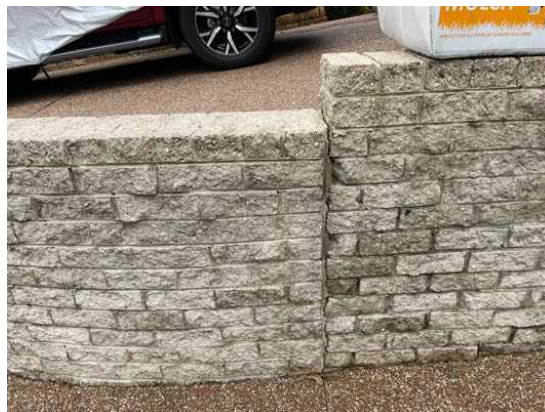
Defects 3.05

Building:	Building 1
Location:	Driveway
Finding:	Brickwork - Deteriorated mortar
Information:	Mortar, or 'bedding', is the material which fills joints and intersections between bricks in masonry walls and structures. Sections of mortar in this brickwork were identified as having deteriorated, which is generally expected for a property of this age and condition.

Mortar may deteriorate as a result of age of building materials, minor movement of bricks, or frequent exposure to weathering. Mortar should be replaced to ensure that

bricks remain in their intended location and to prevent gaps, which would allow water or moisture ingress and secondary damage as a result.

Mortar deterioration can be addressed by a bricklayer where areas of deterioration are localised and easily accessible. Alternatively, appointment of a registered builder is advised, to repoint large areas of decaying mortar. Where secondary structural defects have become evident, consultation with a structural engineer may be required.

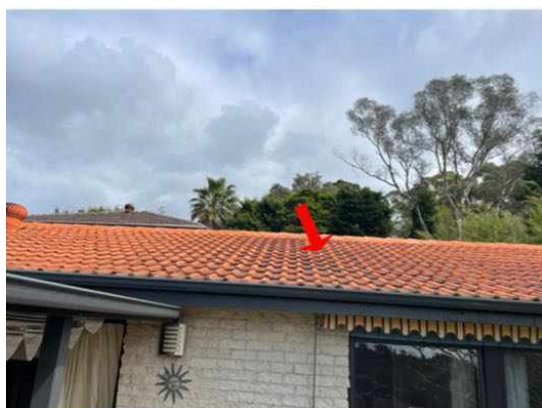
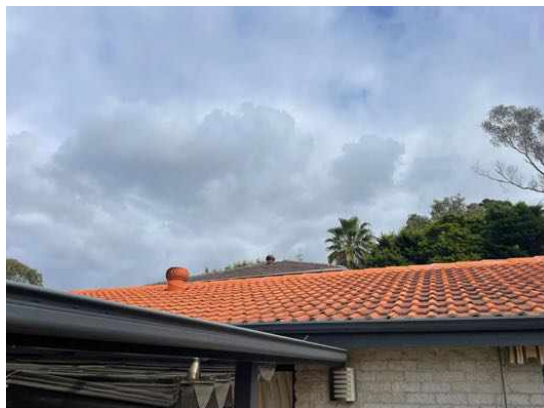
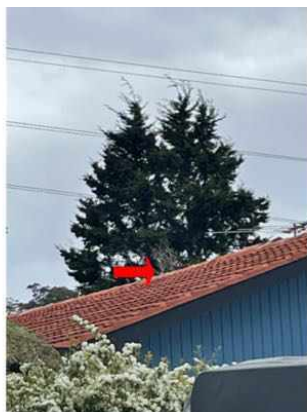
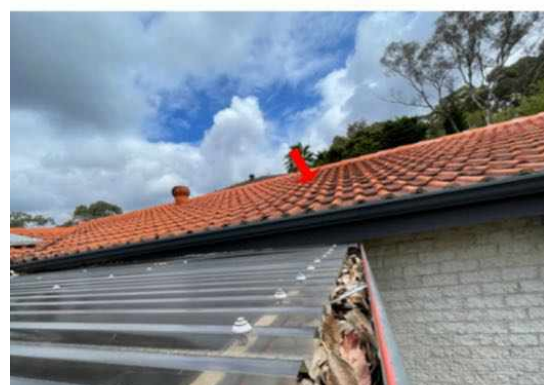
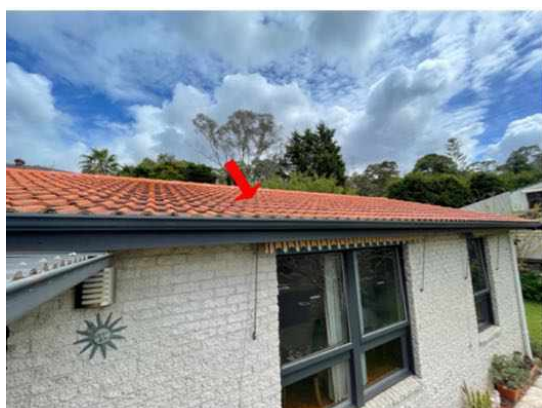
Defects 3.06

Building:	Building 1
Location:	Roof Exterior
Finding:	Roof tiles - Weathered
Information:	Upon inspection of the exterior roofing, the majority of roof tiles were considered to be in a fair condition. While weathering of the tiles is consistent with the age of the property, maintenance works are required.

Where left unmanaged, deteriorating roof tiles are likely to lead to a number of secondary defects, including minor water leaks and weather exposure to internal roofing structures.

Consultation with a roofing contractor is advised to gain advice on cost of remedial works that may be required in the short to medium term. Remedial works are likely to increase the longevity of the exterior roofing structure.

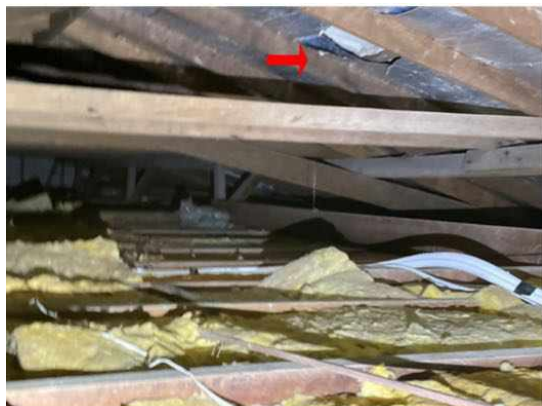
Defects 3.07

Building:	Building 1
Location:	Roof Void
Finding:	Sarking - Damaged
Information:	Sarking, a laminated aluminium foil applied to the interior of the roof covering, assists in insulating the property and acting as a vapour-barrier to the roof void and, subsequently, to the household.

Where sarking is damaged, both insulation and moisture protection of the property are inhibited. This creates a loss of energy and thus negatively impacts the energy efficiency of the property, allowing potential for moisture ingress from condensation or leaking roof tiles.

It is important to repair any holes or damaged sections of sarking to ensure that the building material is fully functional. A registered builder or qualified carpenter should be consulted to provide further advice on this defect and to perform rectification works at client discretion.

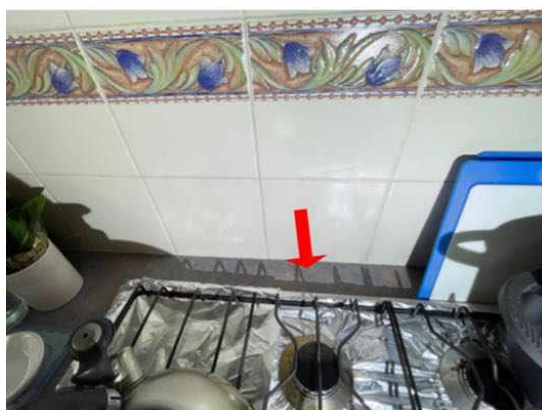
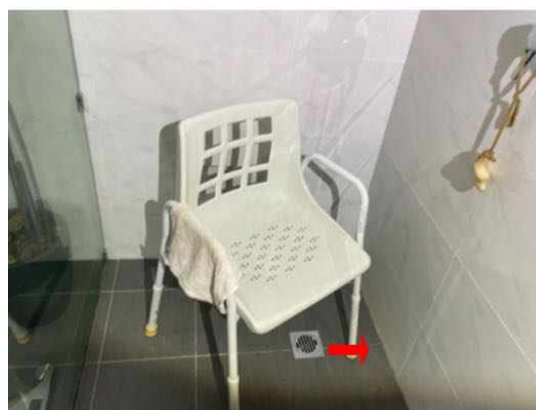
Defects 3.08

Building:	Building 1
Location:	All Areas
Finding:	Sealant - missing/ deteriorated
Information:	Flexible and mould resistant materials should be applied to affected areas to prevent any subsequent water damage that is likely to occur. Regular maintenance and replacement of damage or missing or damaged sealant and grout is highly recommended to the wet areas, as this is a regular wear and tear defect.

Sealant and grouting in areas that come into regular contact with water should be maintained for the long term care of your property. A sealant specialist or tiling contractor should be appointed to complete these works as soon as possible

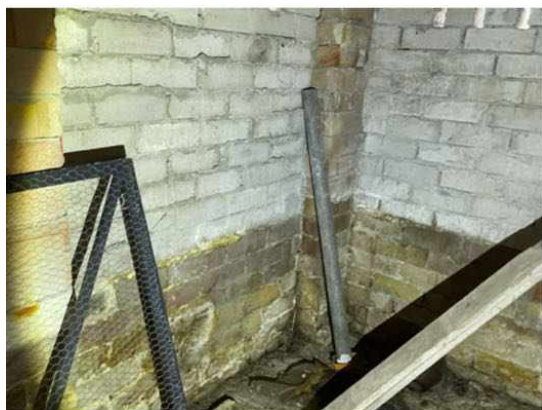
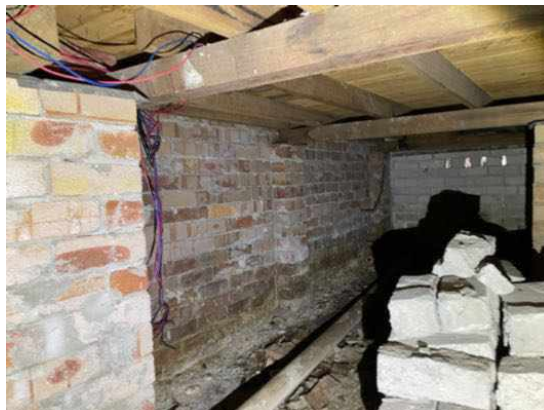
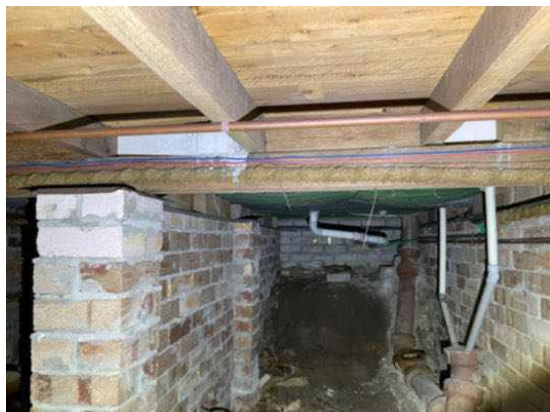
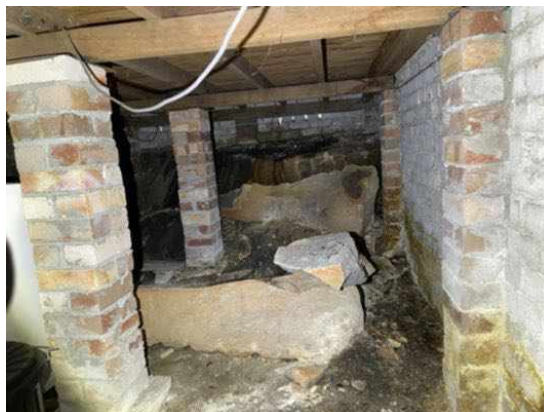
Defects 3.09

Location: Subfloor
 Finding: Evidence of excessive moisture was present at the time of inspection
 Information: Excessive moisture can attract termites and produce conditions that promote termite attack fungal growth and wood decay.

Excessive moisture is generally caused by deteriorated inadequate or missing roof drainage leaking plumbing pipes or fixtures poorly plumbed HWS overflows or condenser units and poor site drainage.

It is highly recommended that all plumbing and drainage fixtures and fittings be maintained regularly in order to prevent excessive moisture being present in the external / internal property.

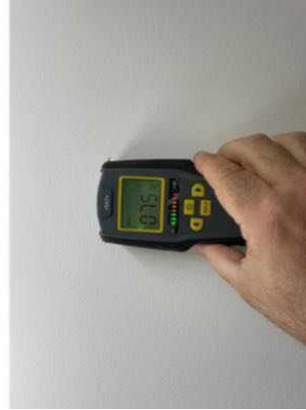
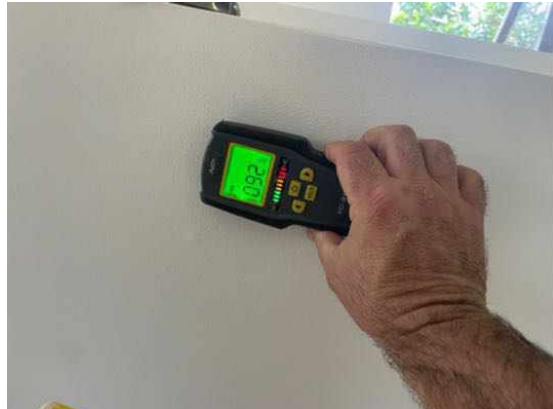
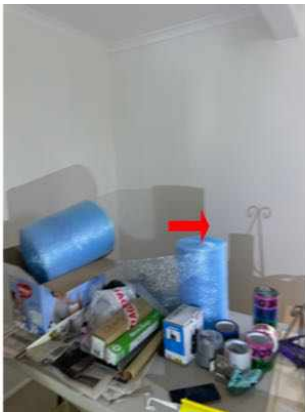
Defects 3.10

Building: Building 2
 Location: Basement
 Finding: Evidence of excessive moisture was present at the time of inspection
 Information: Excessive moisture can attract termites and produce conditions that promote termite attack fungal growth and wood decay.

Excessive moisture is generally caused by deteriorated inadequate or missing roof drainage leaking plumbing pipes or fixtures poorly plumbed HWS overflows or

condenser units and poor site drainage.

It is highly recommended that all plumbing and drainage fixtures and fittings be maintained regularly in order to prevent excessive moisture being present in the external / internal property.

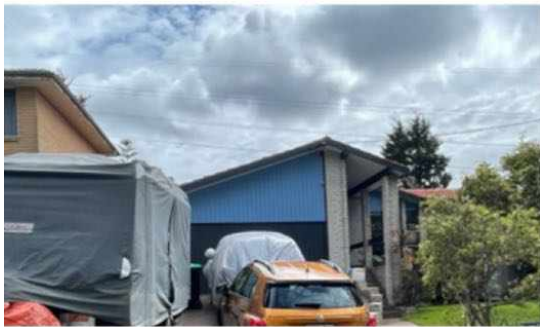
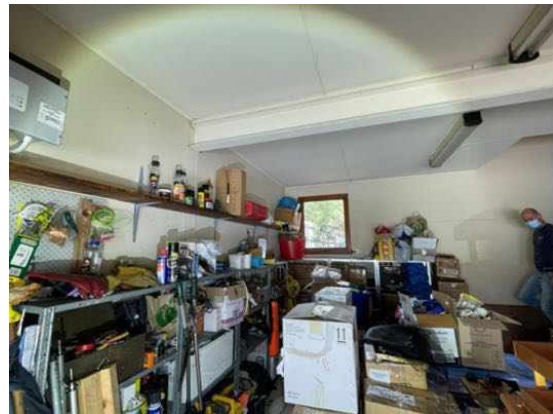
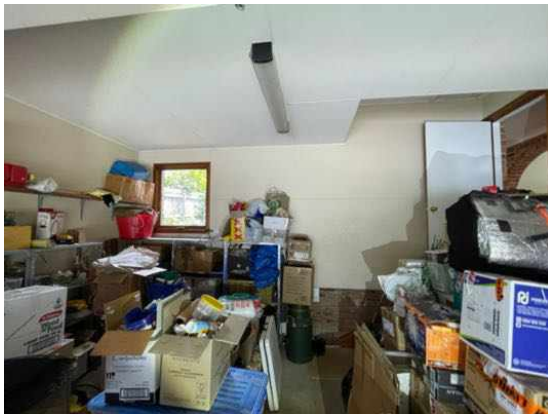
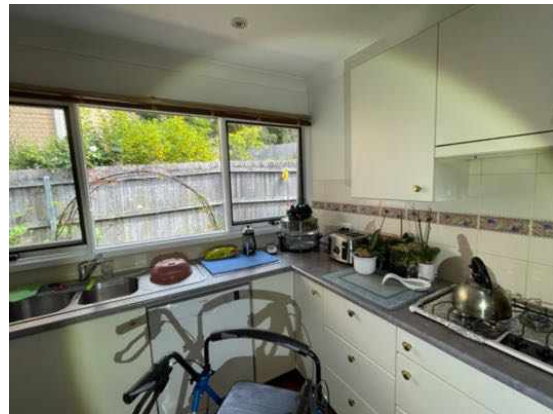
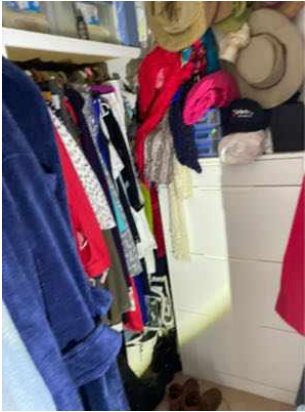
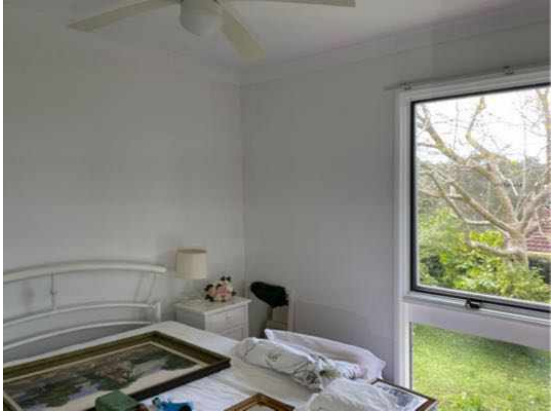
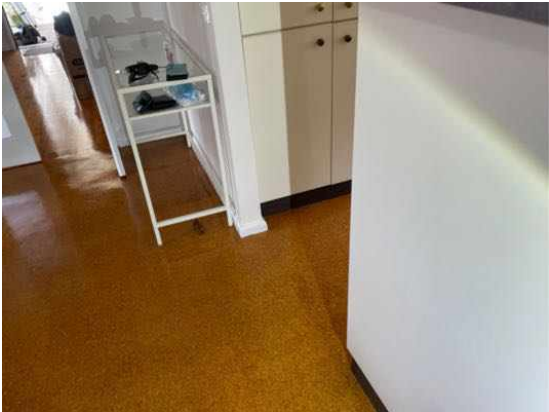
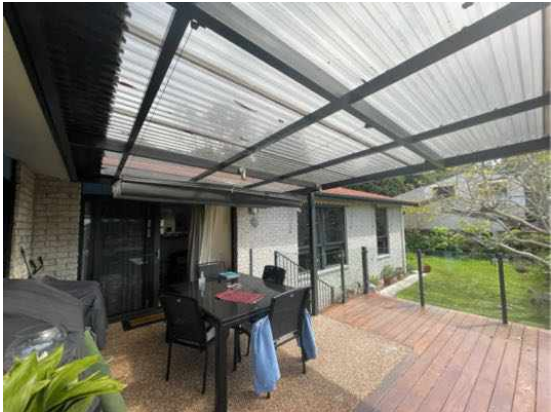
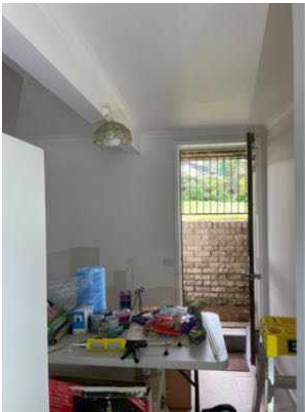
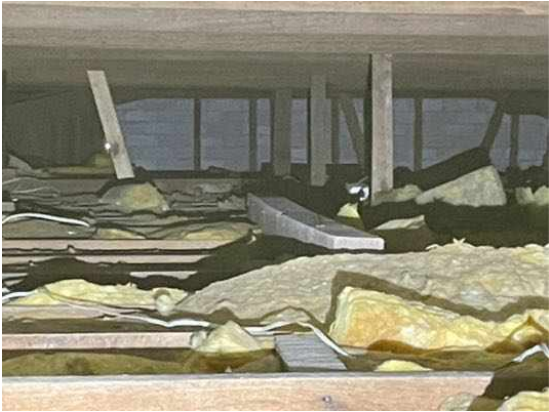
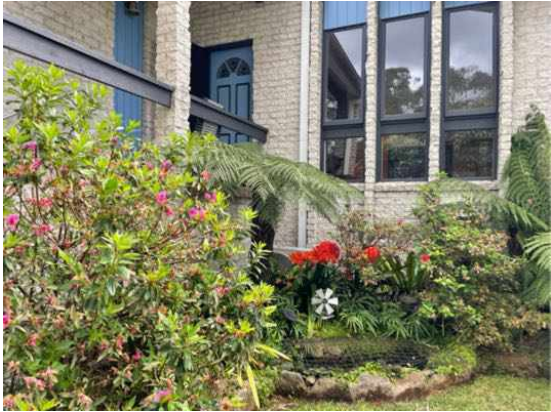
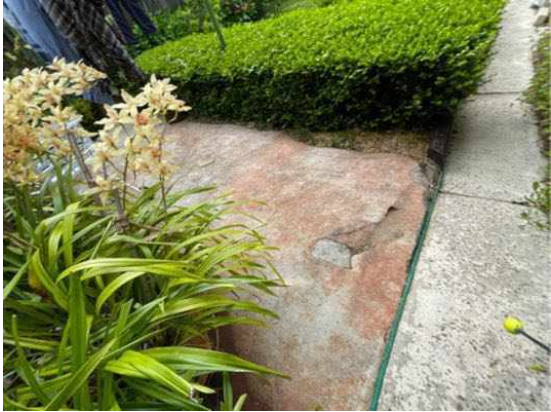
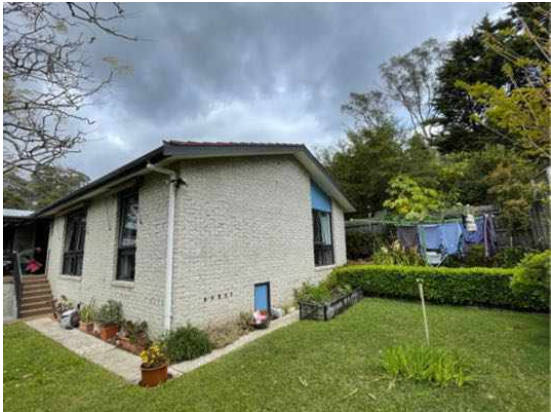
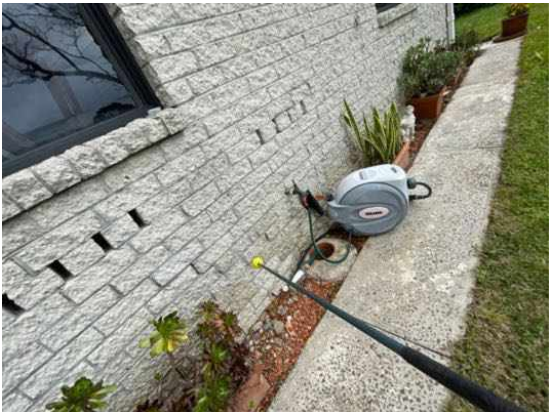
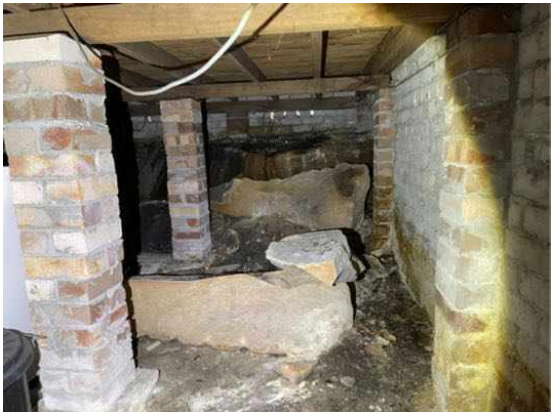
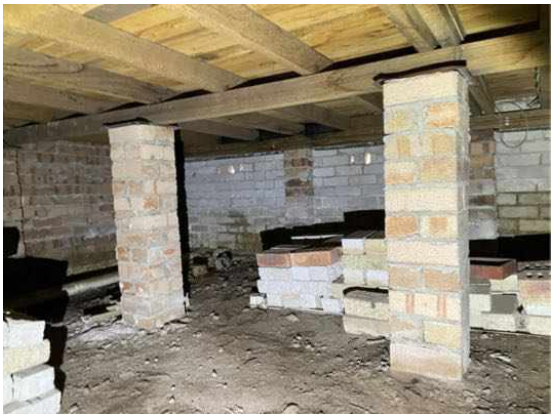
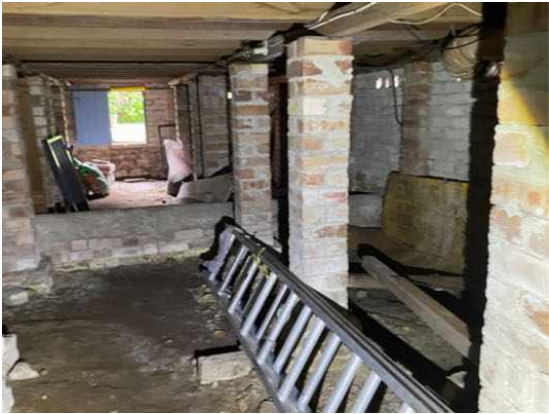
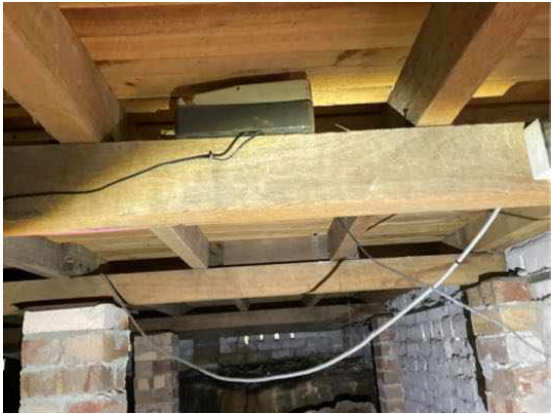
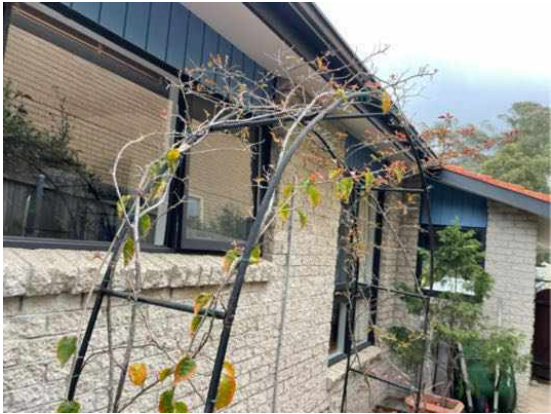
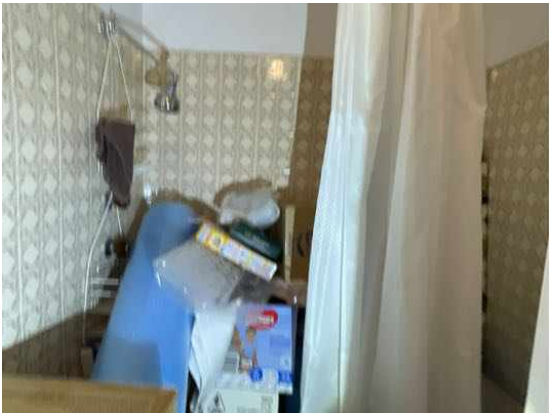
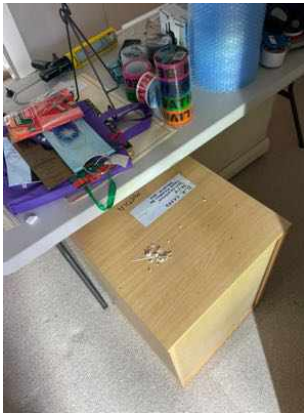
Building: Building 1
Location: All Areas
Finding: Additional Photos - Obstructions and Limitations
Information: These photographs are an indication of the obstructions and limitations which impeded full inspection of the property at the time of inspection. These obstructions can hide an array of defects and should be removed to allow full inspection to be carried out. A re-inspection is recommended once the areas are made accessible.

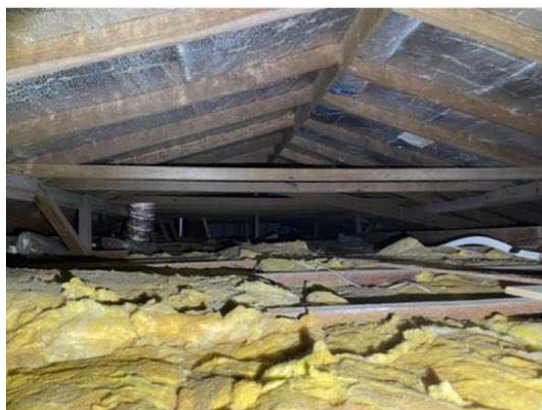
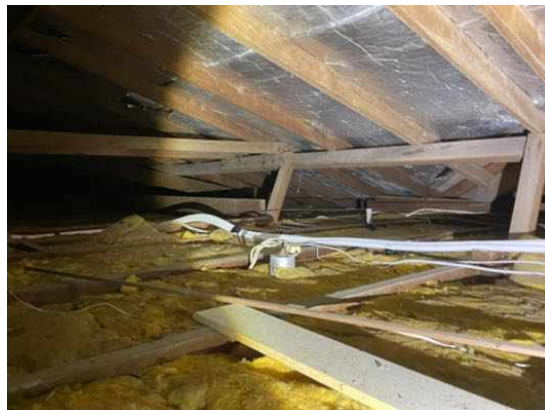
Building: Building 1
 Location: Roof Void
 Finding: Insulation- installed
 Information: Insulation is under the roof sheeting. Insulation acts as an insulator that helps with heat reduction.

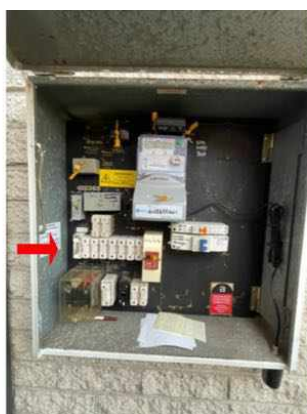
Building: Building 1
 Location: Yard - Side
 Finding: Electrical switchboard - Old ceramic fuses
 Information: The electrical switchboard while appearing to have adequate safety switches installed has old ceramic fuses in place.

While this on its own on is not considered a defect it is noted for the clients consideration that a switchboard upgrade may be required in the short to mid term to improve the functionality of the electrical system. A licensed electrician could be appointed to provide quotation for the works at the client's discretion which may in turn expose other required works to bring the system up to a compliant state.
