## Building Inspection Report

Inspection Date: Thu, 10 Nov 2022

Property Address: 28 Myra St, Frenchs Forest NSW 2086,  
Australia

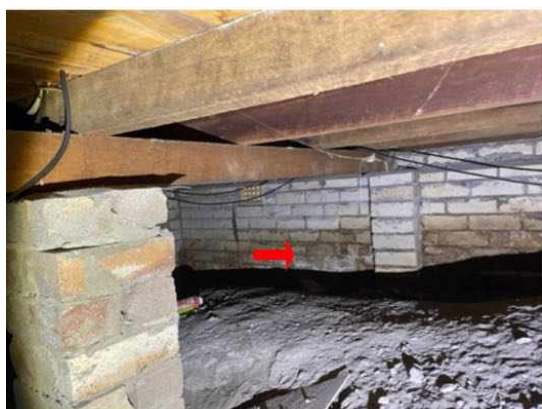
#### Defects 1.01

Building:	Building 1
Location:	Subfloor
Finding:	Visual mould inspection
Information:	A visual mould inspection of the property was conducted and identified areas of suspected mould and deterioration. Mould is a visible fungal growth, but may also be evidenced by a musty smell in the immediate area.

Mould, which poses a significant respiratory hazard, generally forms and develops as a result of dark and damp conditions over a prolonged period of time. These conditions,

While mould and dampness are present, the area is considered a health and safety hazard. Tenants with respiratory health conditions are advised to exercise great caution and care whilst in the area.

The first action should be to identify the cause of the mould in this area. Replacement of the affected carpet is required as a matter of urgency to ensure the safety of the area. Where required, remedial works should be undertaken to any associated walls and flooring showing evidence of mould.

Where mould is excessive, further inspection by an Environmental Health inspector is advisable.

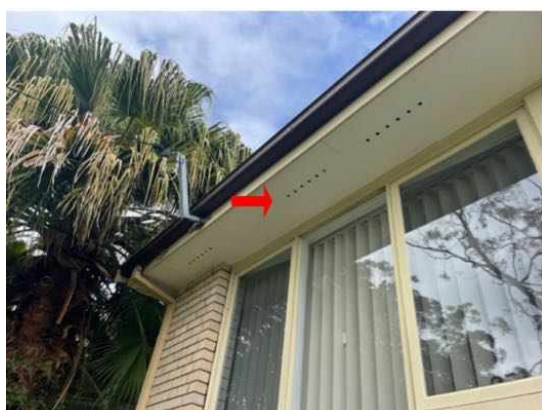
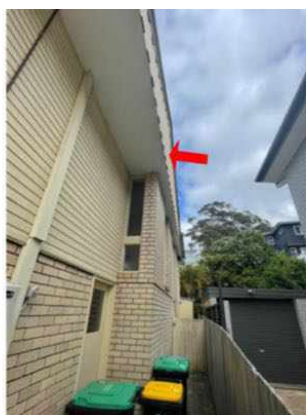
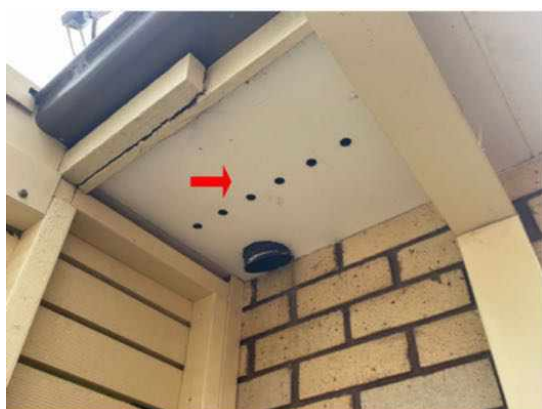
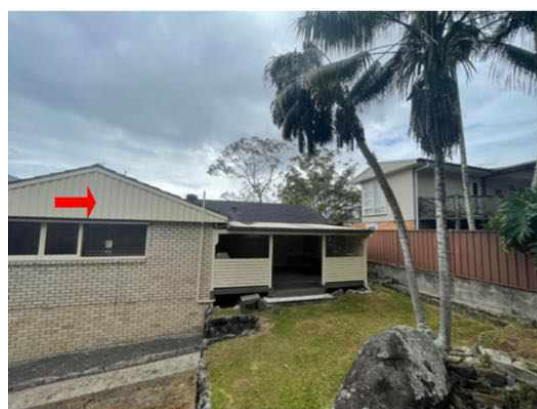
#### Defects 1.02

Building:	Building 1
Location:	All Areas
Finding:	Asbestos - Suspected ACM Identified on Site

Reporting on Asbestos is outside the Scope of this Report. This suspected defect is highlighted as a caution only. We suspect, based on our experience in the building industry, that there is a higher risk of the identified building element containing asbestos.

As Asbestos Reporting is outside the scope of this report, we advise that you consider a separate Asbestos Inspection and Condition Audit, which can include the taking of samples for definitive confirmation of the presence of Asbestos.

In the interim, the client is advised to act with caution, especially when considering any damage to building materials general wear and tear renovations extensions demolition and general maintenance activities due to the suspected presence of Asbestos.

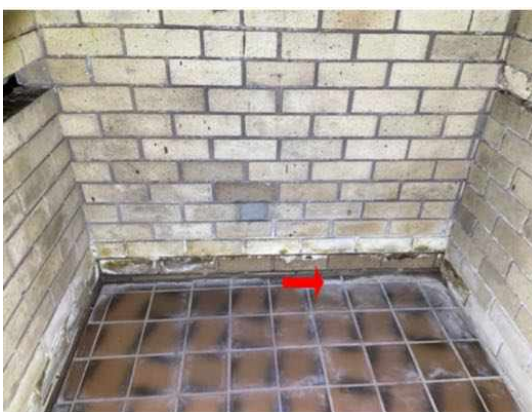
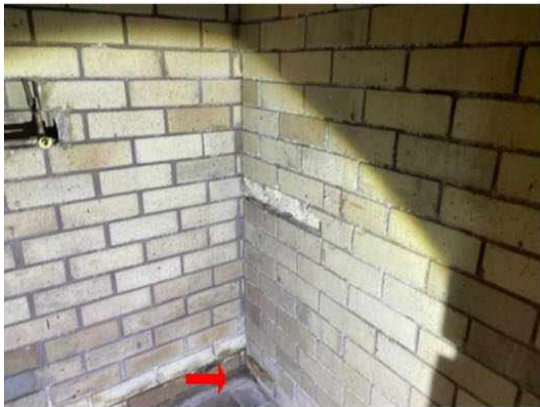
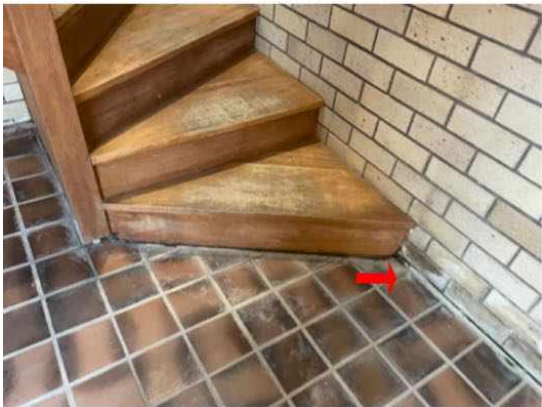
## Defects 1.03

Building:	Building 1
Location:	All Areas > Ground Level
Finding:	Visual mould inspection
Information:	A visual mould inspection of the property was conducted and identified areas of suspected mould and deterioration. Mould is a visible fungal growth, but may also be evidenced by a musty smell in the immediate area.

Mould, which poses a significant respiratory hazard, generally forms and develops as a result of dark and damp conditions over a prolonged period of time. These conditions,

While mould and dampness are present, the area is considered a health and safety hazard. Tenants with respiratory health conditions are advised to exercise great caution and care whilst in the area.

The first action should be to identify the cause of the mould in this area. Replacement of the affected carpet is required as a matter of urgency to ensure the safety of the area. Where required, remedial works should be undertaken to any associated walls and flooring showing evidence of mould.

Where mould is excessive, further inspection by an Environmental Health inspector is advisable.

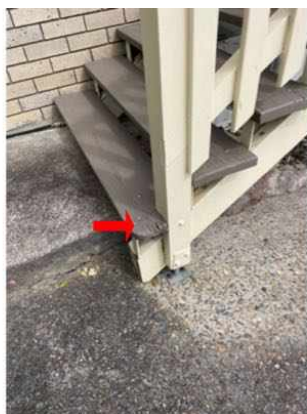
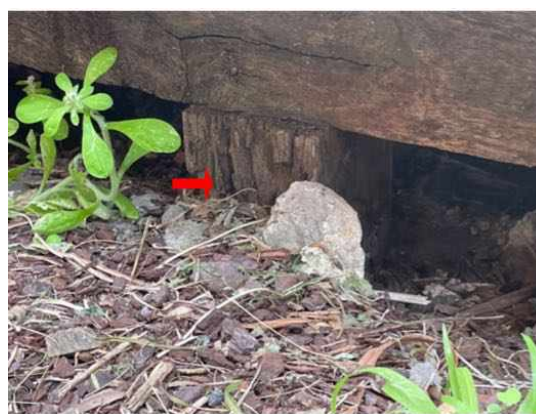
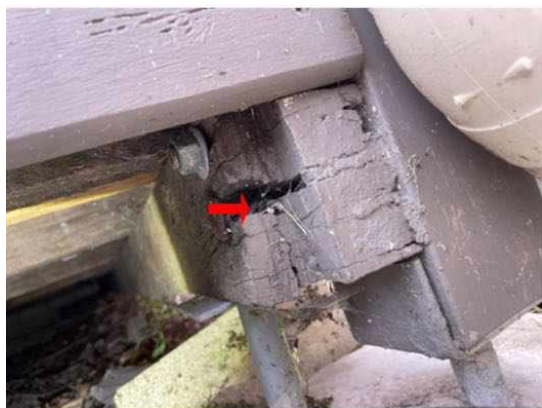
### Defects 3.01

Building:	Building 1
Location:	All Areas
Finding:	Wood rot
Information:	This building element shows evidence of wood rot. Wood rot, also known as Fungal Decay, occurs when timbers and other cellulose building materials are exposed to damp conditions on an ongoing basis. This could be the result of exposure to weathering over a prolonged period of time, or the attraction of excessive moisture from other abutting building materials. Contributing factors also include poor air ventilation in the area.

Early intervention and regular maintenance, particularly of exterior timbers, will prolong the useful life of these building elements. Prior to any works being performed, the cause of the moisture that has created the visible wood rot should be identified and addressed in a suitable manner. Replacement of affected timbers may then be a necessary step in protecting surrounding building elements from such deterioration.

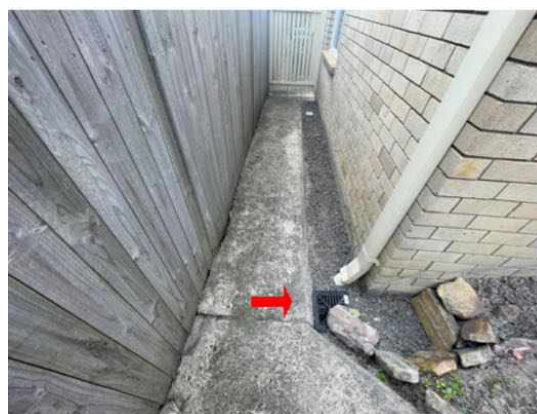
### Defects 3.02

Building:	Building 1
Location:	All External Areas
Finding:	Site drainage - suspected Inadequate
Information:	The site drainage in this area was found to be suspected inadequate at the time of inspection, creating potential for subsequent water damage to associated building elements.

It is important that water does not lie against the base of walls; surrounding paths and ground levels should be sloped to drain water away from walls. Downpipes should not discharge stormwater onto lower walls or plinths. Stormwater should be carried away by large, regularly cleaned drains. Ground levels may need to be lowered to expose a buried DPC.

Where site drainage is inadequate, installation of an Agricultural (Aggie) Drain may be required. A qualified plumber should be appointed to further inspect the property and perform any remedial works as necessary. Water damage and secondary defects are likely to occur if left unmanaged.

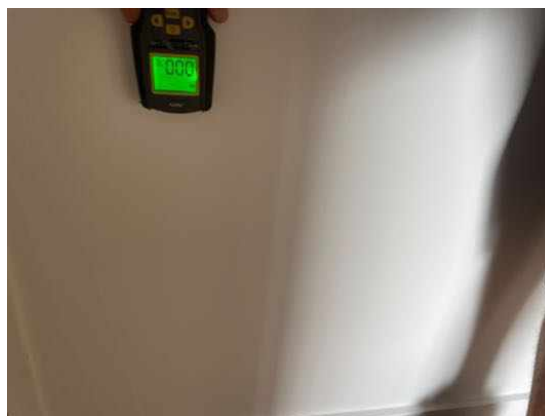
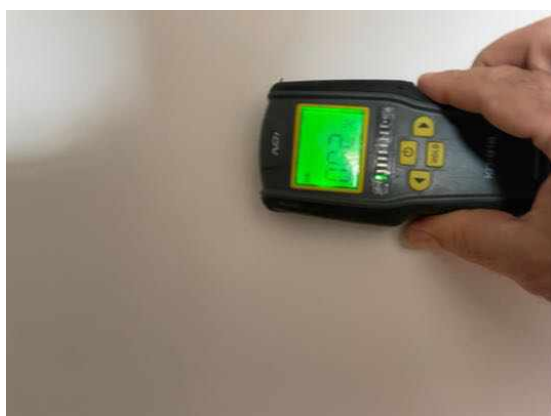
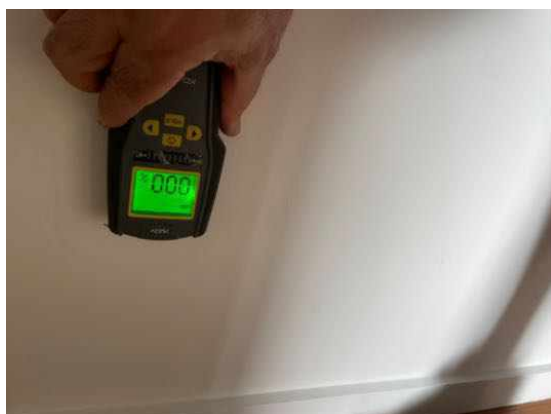
### Defects 3.03

Building:	Building 1
Location:	All Areas
Finding:	Moisture meter readings - low
Information:	The moisture meter result for the areas inspected.

The moisture reading of 0-15% is quite normal and gives no cause for concern. However, moisture readings in excess of 15% indicate the need for further inspection.

Levels between 25-30% indicate that there may be water ingress, meaning that remedial work could be required.

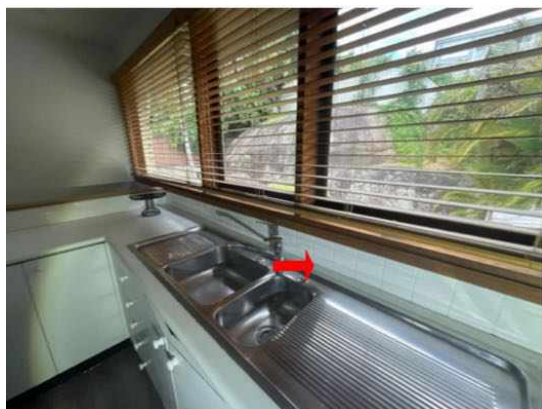
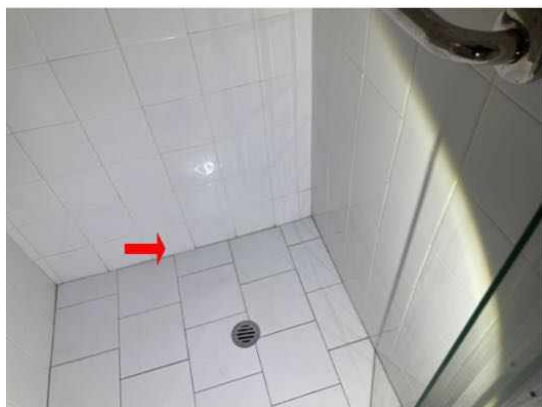
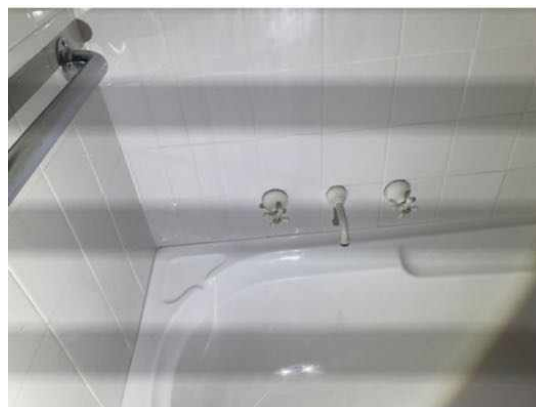
### Defects 3.04

Building:	Building 1
Location:	All Areas
Finding:	Sealant - missing/ deteriorated
Information:	Flexible and mould resistant materials should be applied to affected areas to prevent any subsequent water damage that is likely to occur. Regular maintenance and replacement of damage or missing or damaged sealant is highly recommended to the wet areas, as this is a regular wear and tear defect.

Sealant in areas that come into regular contact with water should be maintained for the long term care of your property. A sealant specialist or tiling contractor should be

appointed to complete these works as soon as possible

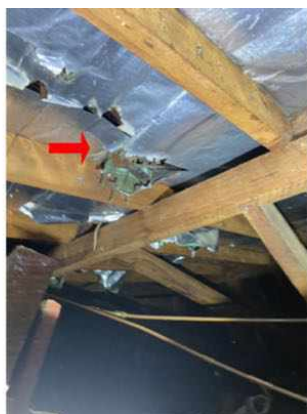
### Defects 3.05

Building:	Building 1
Location:	Roof Void
Finding:	Sarking - Damaged
Information:	Sarking, a laminated aluminium foil applied to the interior of the roof covering, assists in insulating the property and acting as a vapour-barrier to the roof void and, subsequently, to the household.

Where sarking is damaged, both insulation and moisture protection of the property are inhibited. This creates a loss of energy and thus negatively impacts the energy efficiency of the property, allowing potential for moisture ingress from condensation or leaking roof tiles.

It is important to repair any holes or damaged sections of sarking to ensure that the building material is fully functional. A registered builder or qualified carpenter should be consulted to provide further advice on this defect and to perform rectification works at client discretion.

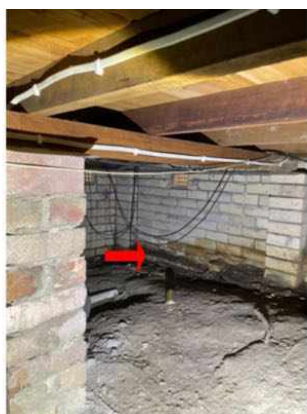
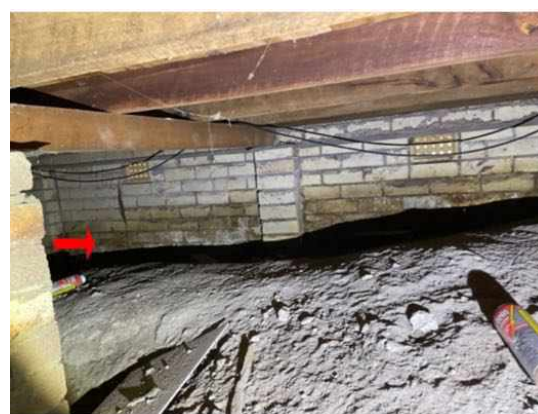
### Defects 3.06

Building:	Building 1
Location:	Subfloor > Ground Level
Finding:	Evidence of excessive moisture was present at the time of inspection
Information:	Excessive moisture can attract termites and produce conditions that promote termite attack fungal growth and wood decay.

Excessive moisture is generally caused by deteriorated inadequate or missing roof drainage leaking plumbing pipes or fixtures poorly plumbed HWS overflows or condenser units and poor site drainage.

It is highly recommended that all plumbing and drainage fixtures and fittings be maintained regularly in order to prevent excessive moisture being present in the external / internal property.

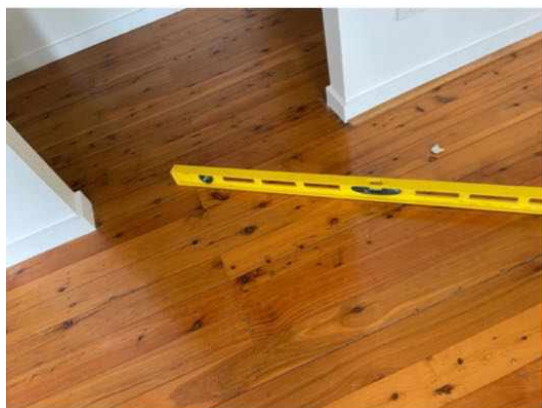
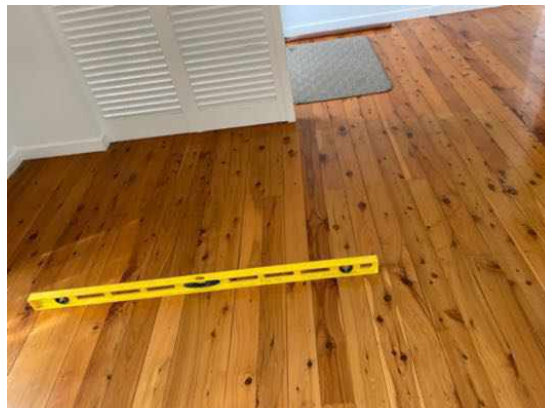
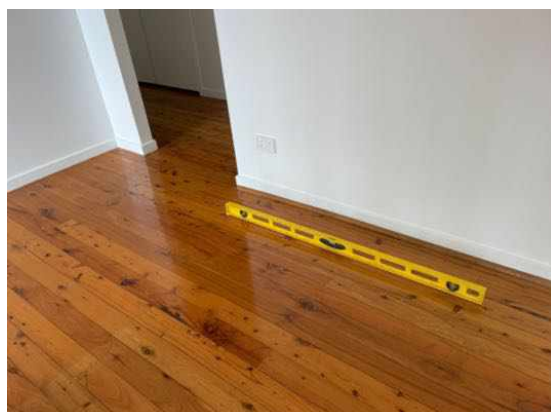
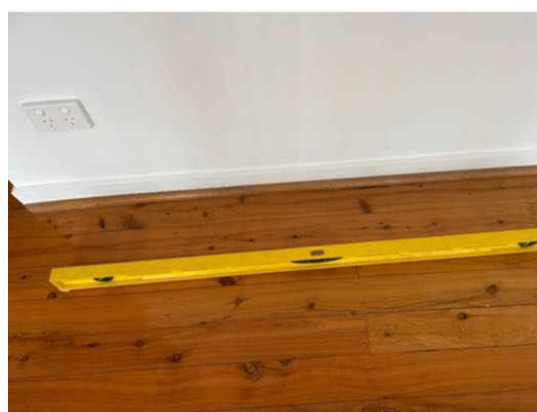
### Defects 3.07

Building:	Building 1
Location:	All Areas
Finding:	Flooring - suspected Uneven
Information:	The internal flooring in this area is out of level and uneven. Uneven flooring is likely to indicate minor defects such as expected movement of the foundations of the

It is advised that the flooring be closely monitored to identify any further movement. Where flooring remains relatively unchanged for an extended period of time (i.e. several months), it is likely that this defect has been caused by expected movement of the foundations of the property.

However, where flooring is uneven further, potentially invasive inspection of the subfloor structures in this area is required. In this case, works to repair are likely to be required, and would be carried out by a qualified builder.

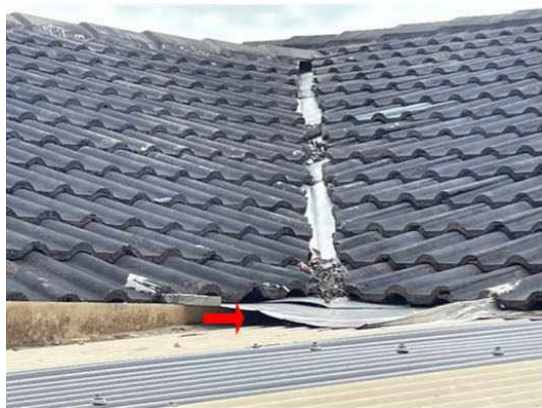
### Defects 3.08

Building:	Building 1
Location:	Roof Exterior
Finding:	Roof flashing - non-standard
Information:	The roof flashing that has been installed does not appear to comply with current building practice. However the flashing appears to be in an acceptable condition and is fulfilling its purpose in ensuring the roof covering is weather-tight.

Whilst retrospective fixing is not required if flashing begins to come loose from its fixing or deteriorates as evidenced by roof leaks a roofing plumber should be appointed immediately to replace the building element.

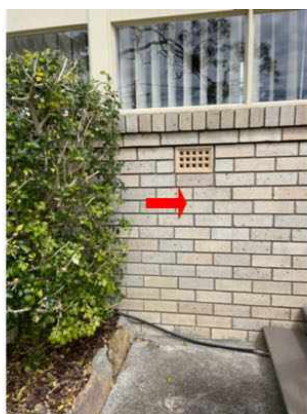
### Defects 3.09

Building:	Building 1
Location:	All External Areas
Finding:	Brickwork - Deteriorated mortar
Information:	Mortar, or 'bedding', is the material which fills joins and intersections between bricks in masonry walls and structures. Sections of mortar in this brickwork were identified as having deteriorated, which is generally expected for a property of this age and condition.

Mortar may deteriorate as a result of age of building materials, minor movement of bricks, or frequent exposure to weathering. Mortar should be replaced to ensure that bricks remain in their intended location and to prevent gaps, which would allow water or moisture ingress and secondary damage as a result.

Mortar deterioration can be addressed by a bricklayer where areas of deterioration are localised and easily accessible. Alternatively, appointment of a registered builder is advised, to repoint large areas of decaying mortar. Where secondary structural defects have become evident, consultation with a structural engineer may be required.

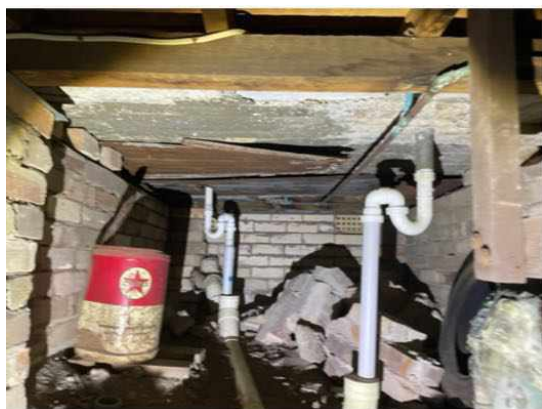
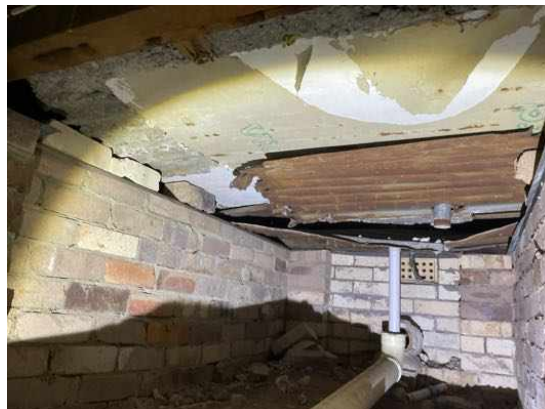
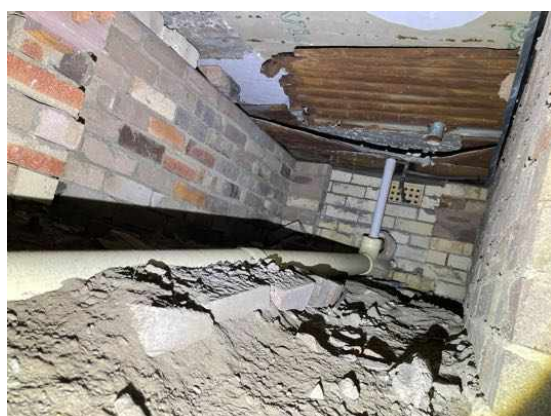
### Defects 3.10

Location: Subfloor  
 Finding: Formwork timber and corrugated iron - removal  
 Information: Sometime formwork material is not removed during construction which increases the risk of termite activity, wood rot and corrosion being present.

It is recommended that formwork to be removed from these areas.

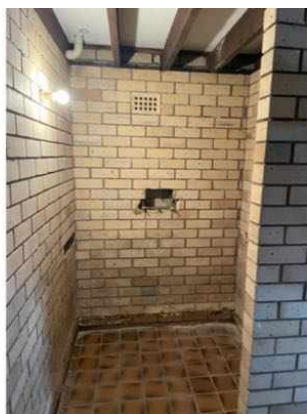
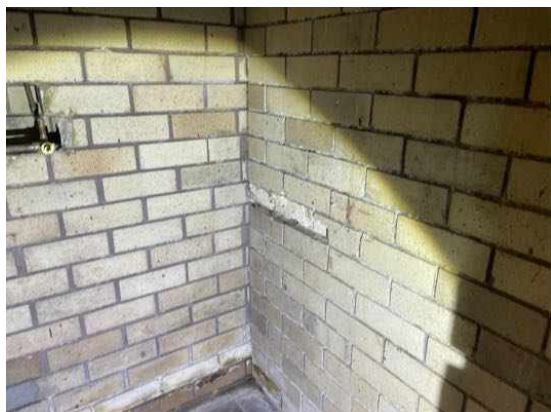
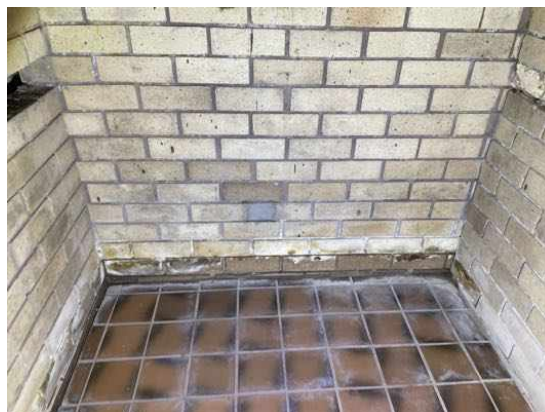
### Defects 3.12

Building:	Building 1
Location:	All Areas > Ground Level
Finding:	Evidence of excessive moisture was present at the time of inspection
Information:	Excessive moisture can attract termites and produce conditions that promote termite attack fungal growth and wood decay.

Excessive moisture is generally caused by deteriorated inadequate or missing roof drainage leaking plumbing pipes or fixtures poorly plumbed HWS overflows or condenser units and poor site drainage.

It is highly recommended that all plumbing and drainage fixtures and fittings be maintained regularly in order to prevent excessive moisture being present in the external / internal property.

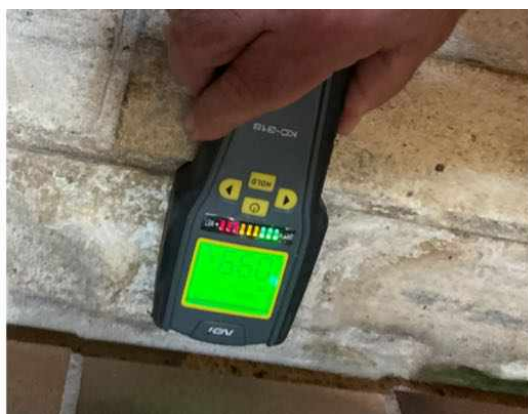
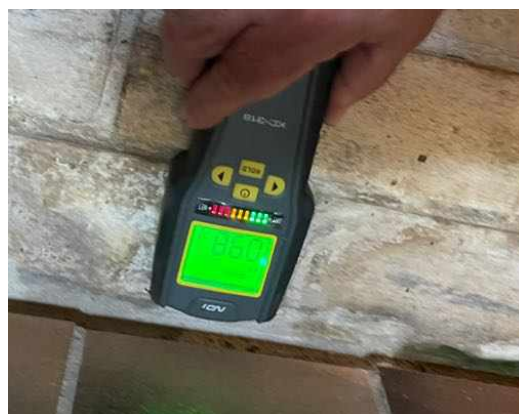
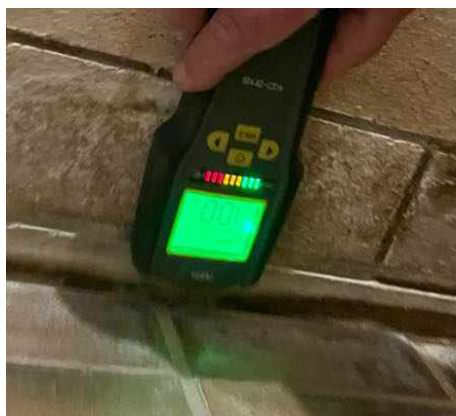
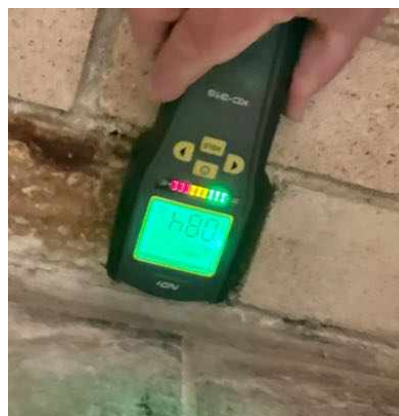
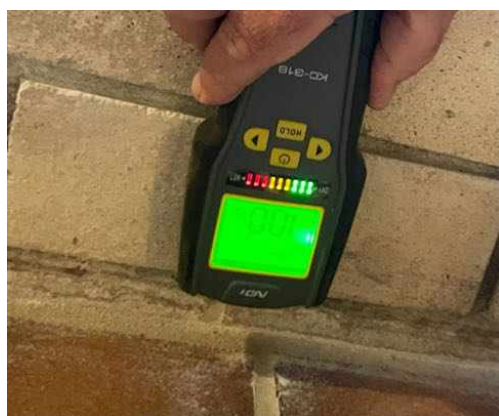
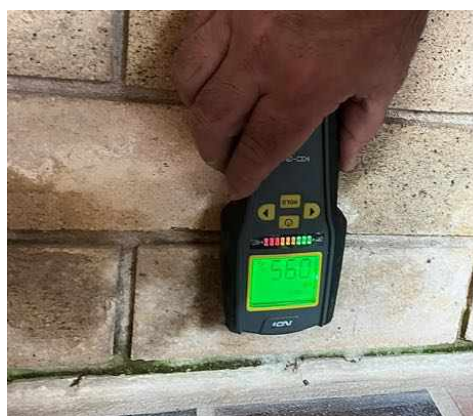
### Defects 3.13

Building: Building 1  
 Location: All Areas > Ground Level  
 Finding: Moisture meter readings - high  
 Information: The moisture meter result for the areas inspected.

The moisture reading of 0-15% is quite normal and gives no cause for concern. However, moisture readings in excess of 15% indicate the need for further inspection.

Levels between 25-30% indicate that there may be water ingress, meaning that remedial work could be required.

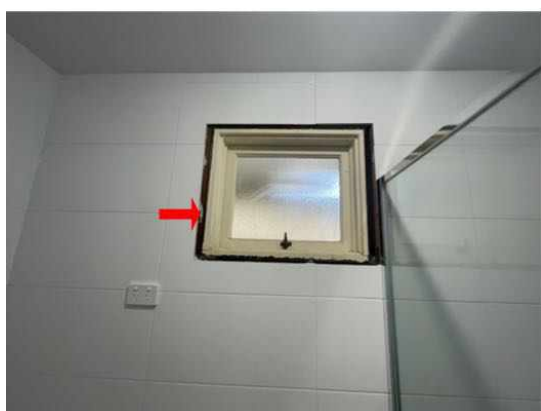
### Defects 3.14

Building: Building 1  
 Location: Bathroom  
 Finding: Installation - incomplete  
 Information: The installation of this building element appears to be incomplete.

Where installation is incomplete, the client should contact the responsible trade to undertake rectification.

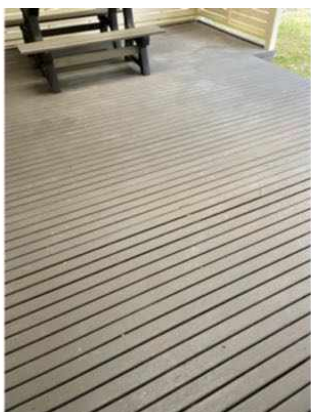
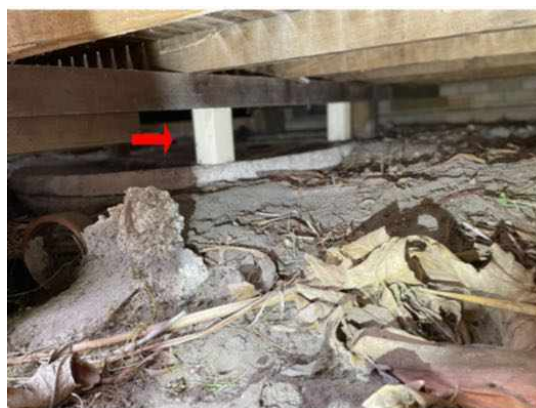
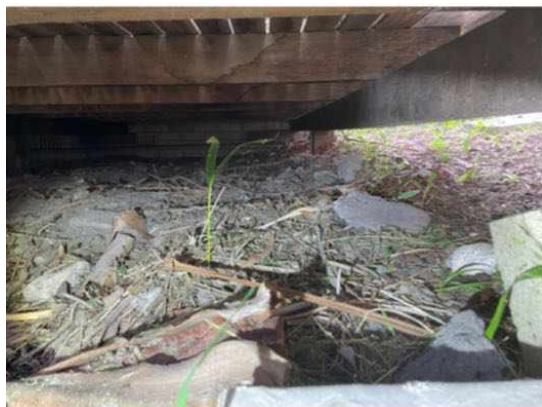
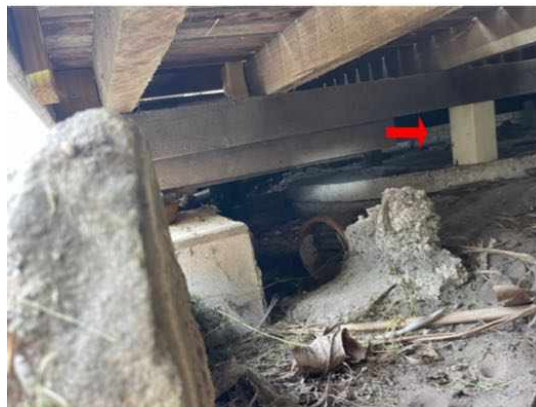
### Defects 3.15

Building: Building 1  
 Location: Deck  
 Finding: Deck - bouncy  
 Information: The deck was identified as being bouncy at the time of inspection. A bouncy deck surface generally presents as a discernible change in level as they are walked across.

A Bouncy deck generally indicate that the deck or the subfloor structures are coming loose or are not been installed correctly.

The client is advised to seek quotations for required repairs from a Builder. The potential resolution may range from packing gaps in subfloor structures through to replacement of subfloors timbers and refixing of deck.

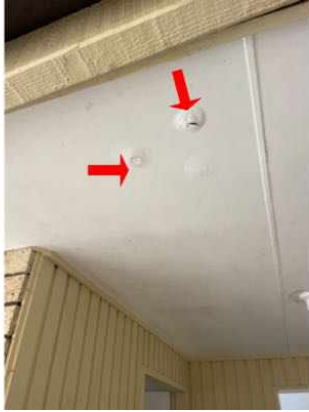
### Defects 3.16

Building: Building 1  
 Location: All Areas  
 Finding: Painted surface - Bubbling  
 Information: Sections of paint in this area was found to have bubbled and deteriorated. Paint bubbling is generally an indication of excessive moisture in the area, that is currently hidden by the painted surface.

The presence of excessive moisture can have major implications on associated

building elements if left unattended. While only seemingly minor at this stage, the damage cannot be determined due to the paint obstructing any further inspection of the damage.

It is advised that the affected paint be cleaned to allow a further, more invasive inspection. Failure to act on this defect may necessitate major works in the future.

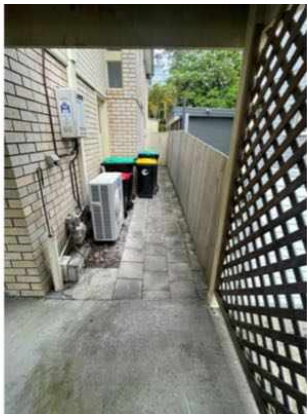
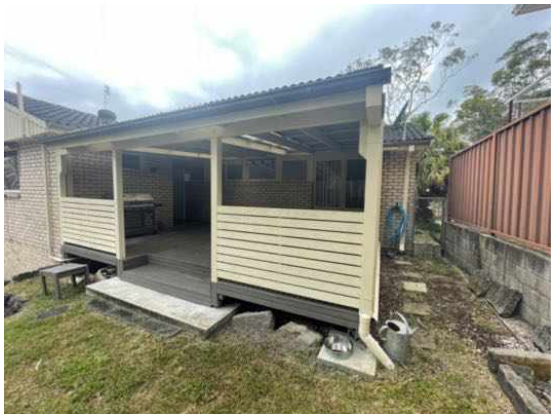
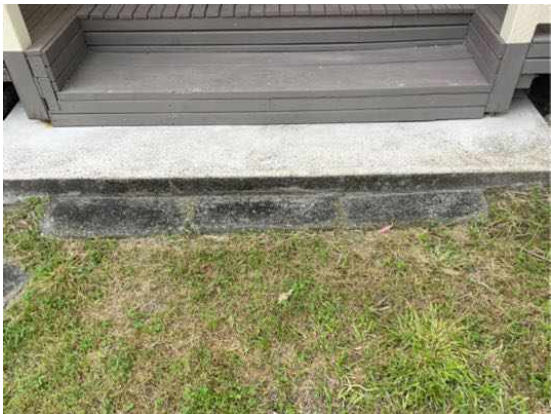
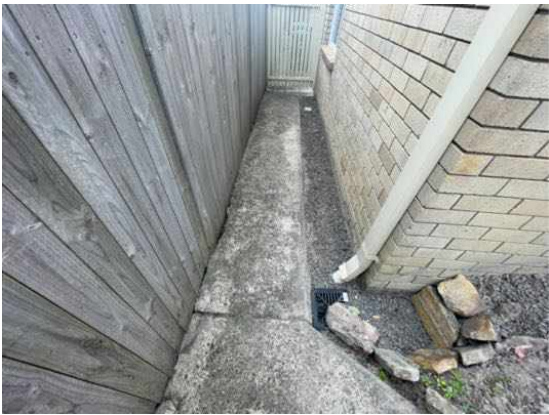
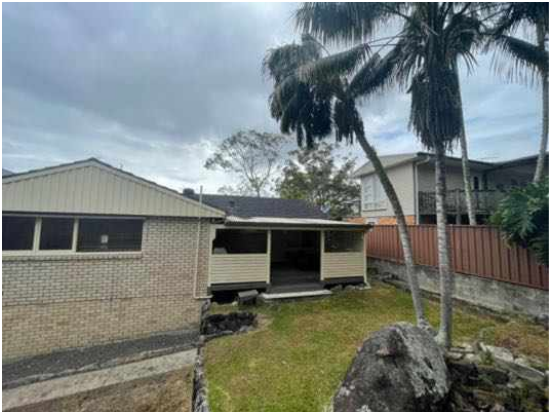
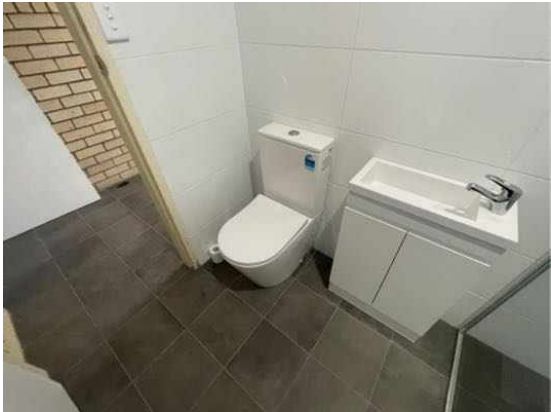
Building: Building 1  
Location: All Areas  
Finding: Additional Photos - Obstructions and Limitations  
Information: These photographs are an indication of the obstructions and limitations which impeded full inspection of the property at the time of inspection. These obstructions can hide an array of defects and should be removed to allow full inspection to be carried out.

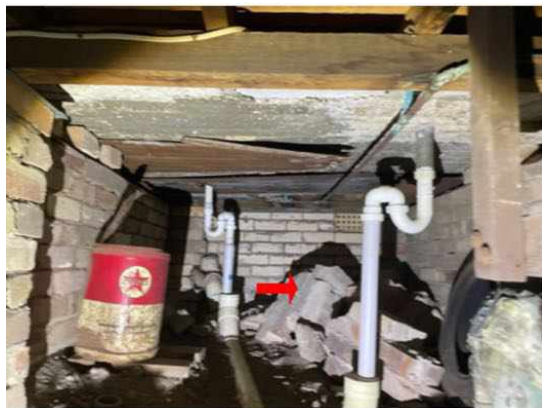
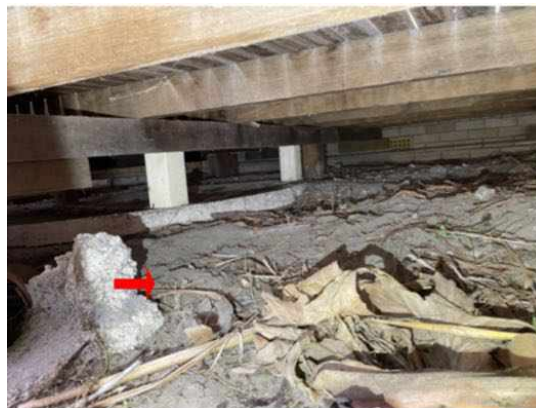
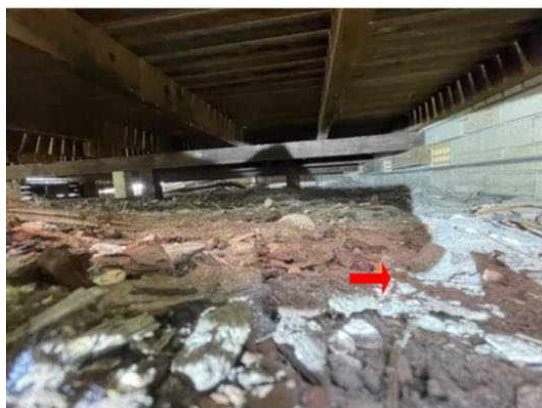
Information: An array of debris was found in the subfloor area at the time of inspection. Debris in this area restricts subfloor ventilation and creates potential for concealed pest entry. Stored timbers and other materials may also make the area susceptible to termite activity and wood rot.

A clear and empty subfloor will be better ventilated and easier to maintain in a dry condition. The removal of any timber debris is vital in minimising the risk of termite or wood borer activity.

Debris in the subfloor should be removed as soon as possible. Depending on the location and amount of debris and stored items, the homeowner may elect to undertake this task. Alternatively there are a large number of rubbish removal subcontractors that could undertake these works.

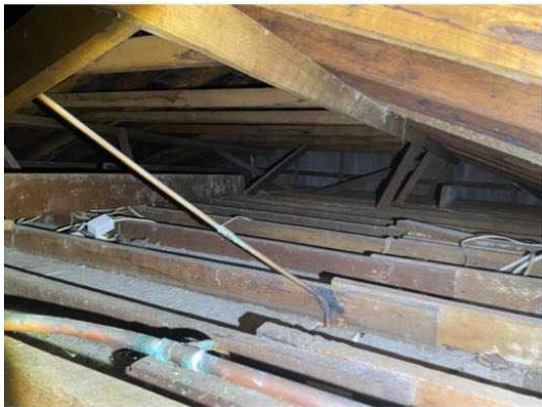
Building: Building 1  
 Location: Roof Void  
 Finding: Insulation - not present  
 Information: Upon inspection of the roof void it was noted that there is was no insulation.

Caution should be exercised when accessing the roof void. Do not attempt to stand on the framework to the underside of the trusses and be aware there is a potential for electric shock if contact is made with exposed or faulty electrical wiring.
