Building Inspection Report

Inspection Date: Wed, 20 May 2020

Property Address: 26 Barnes Rd, Frenchs Forest NSW 2086, Australia

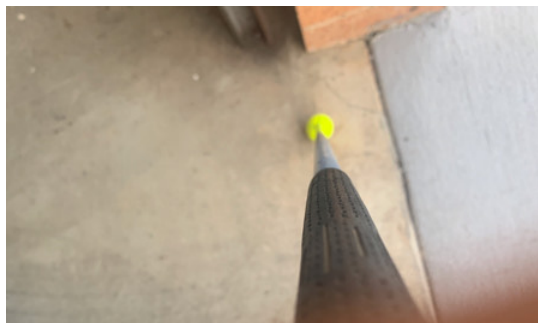
Defects 3.01

Building: Building 1
Location: Garage
Finding: Crack in concrete slab - Category 0
Information: A crack coded as Category 0 was identified in the slab. A Category 0 crack is described as a hairline crack, representing insignificant movement of slab from level.

The approximate width of the crack to be considered Category 0 is 0.3mm, or change in offset of <8mm when a 3m straight edge is placed over the defect.

No rectification is required at this time. However, all cracking should be monitored over a 12 month period to identify any further damage in the area.

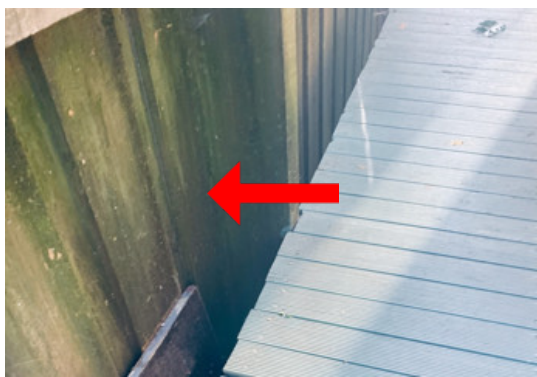
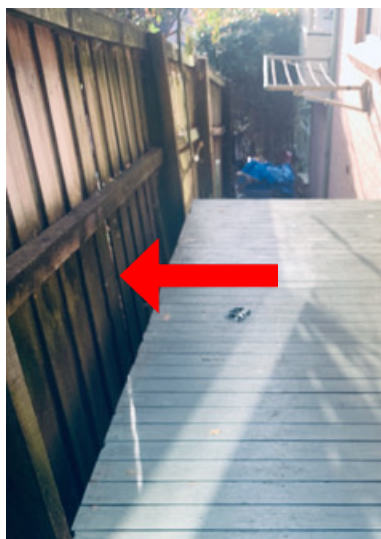
Defects 3.02

Building:	Building 1
Location:	All Areas
Finding:	Fencing - Deteriorated
Information:	It was noted at the time of inspection that sections of the fencing throughout the property is showing signs of deteriorated. Typically fencing deteriorates due to age and or wear, rot and or rust which is generally expected for a structure of this age, due to prolonged exposure to weather conditions.

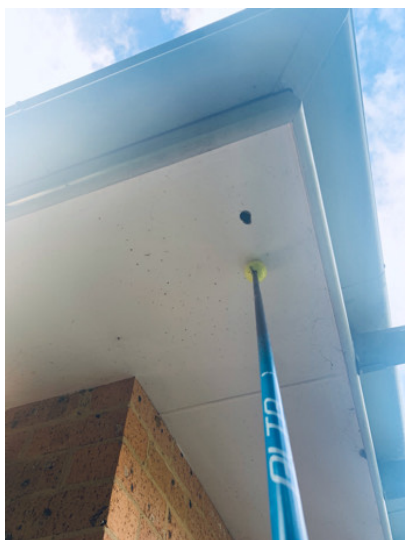
Defects 3.03

Building: Building 1
Location: Yard - Side
Finding: Surface - Hole
Information: A Hole in surfaces was noticed at the the time of inspection.

Repair of the affected building element is recommended to ensure that any secondary defects are minimised. A qualified carpenter or general handyperson should be appointed to perform these works.

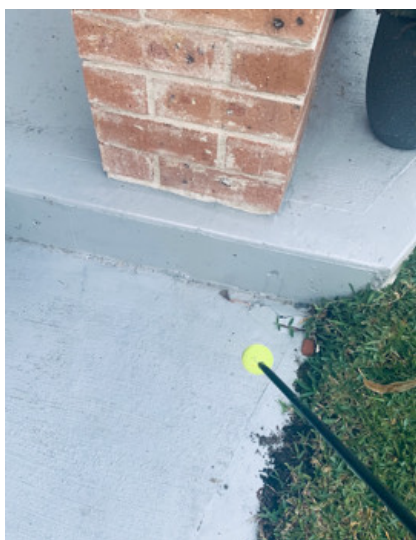
Defects 3.04

Building: Building 1
Location: Yard - Front
Finding: Cracking - External Concrete Paving Damage Category 0 - Hairline (less than 1mm)
Information: Hairline cracks were identified in external concrete paving. Hairline cracks are very minor in nature and generally are only ever an appearance defect. To be classified as a Category 0 or hairline crack, the crack width would be $<0.3\text{mm}$.

While such cracking may be noticeable in some cases, it is common and does not indicate any structural damage.

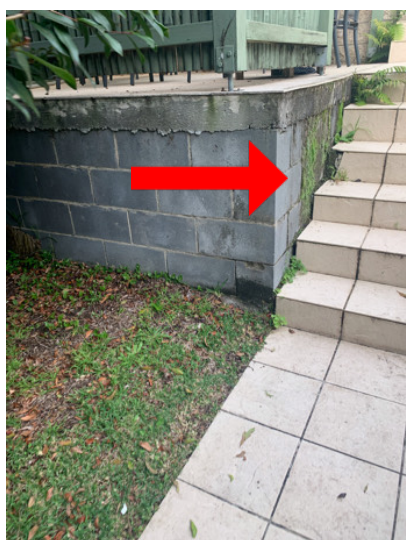
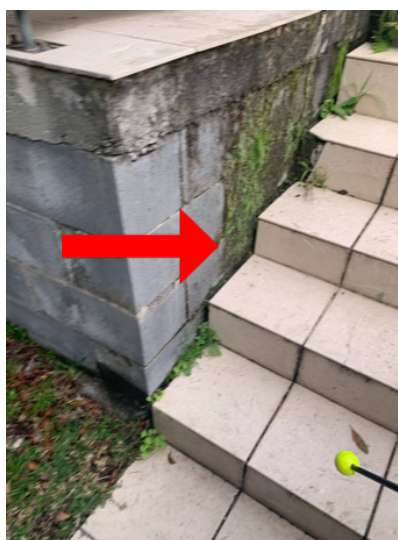
Defects 3.05

Building: Building 1
Location: Yard - Back
Finding: Evidence of excessive moisture was present at the time of inspection
Information: Excessive moisture can attract termites and produce conditions that promote termite attack fungal growth and wood decay.

Excessive moisture is generally caused by deteriorated inadequate or missing roof drainage leaking plumbing pipes or fixtures poorly plumbed HWS overflows or condenser units and poor site drainage.

It is recommended that all plumbing and drainage fixtures and fittings be maintained regularly in order to prevent excessive moisture being present in the external / internal property.

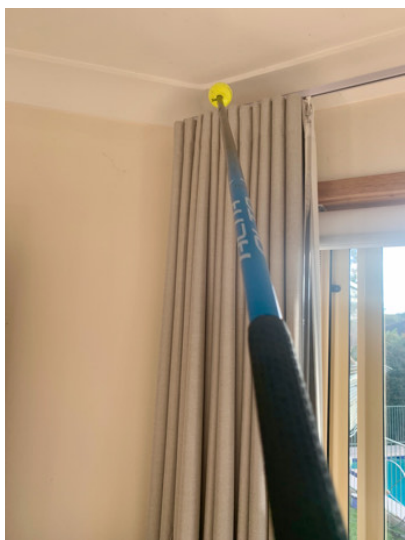
Defects 3.06

Building:	Building 1
Location:	Bedroom
Finding:	Cracking - Damage Category 0 - Hairline (less than 1mm)
Information:	Hairline cracks are very minor in nature and generally are only ever an appearance defect. While such cracking may be noticeable in some cases, it is quite common and does not indicate any structural damage.

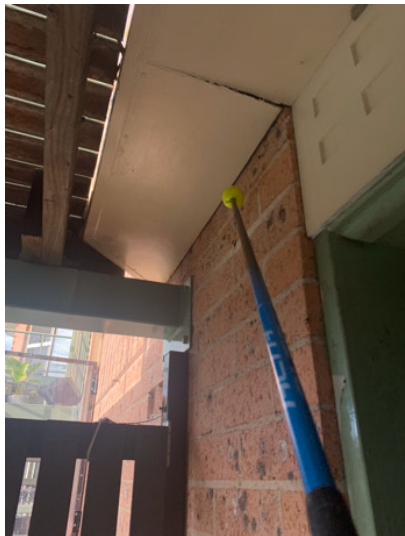
Defects 3.07

Building:	Building 1
Location:	Yard - Back
Finding:	Eaves - Damaged
Information:	Damage to the eave sheeting in this area detracts from the appearance.

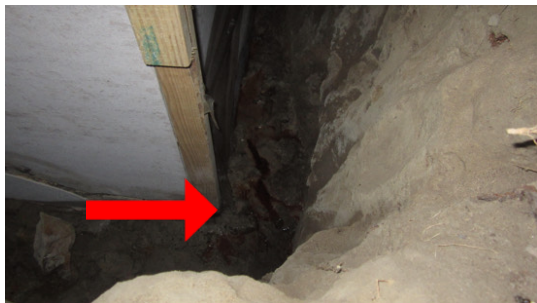
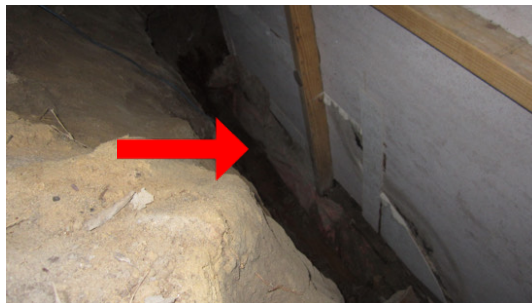
Defects 3.08

Building:	Building 1
Location:	Subfloor
Finding:	Evidence of excessive moisture was present at the time of inspection
Information:	Excessive moisture can attract termites and produce conditions that promote termite attack fungal growth and wood decay.

Excessive moisture is generally caused by deteriorated inadequate or missing roof drainage leaking plumbing pipes or fixtures poorly plumbed HWS overflows or condenser units and poor site drainage.

It is highly recommended that all plumbing and drainage fixtures and fittings be maintained regularly in order to prevent excessive moisture being present in the external / internal property.

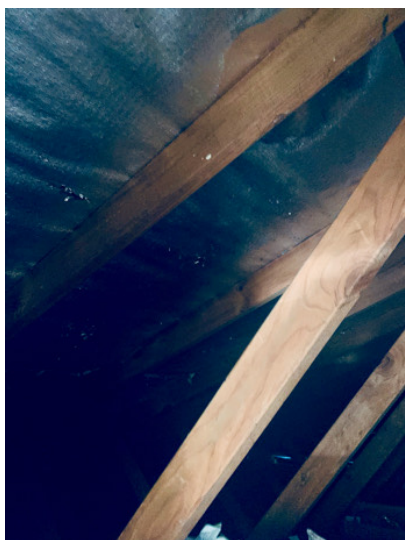
Building: Building 1
Location: Roof Void
Finding: Sarking - installed
Information: Sarking, a laminated aluminium foil applied to the interior of the roof covering, assists in insulating the property and acting as a vapour-barrier to the roof void and, subsequently, to the household.
