Timber Pest Inspection Report

Inspection Date: Wed, 28 Sep 2022

Property Address: 6 Ocean View Way, Belrose NSW 2085,
Australia

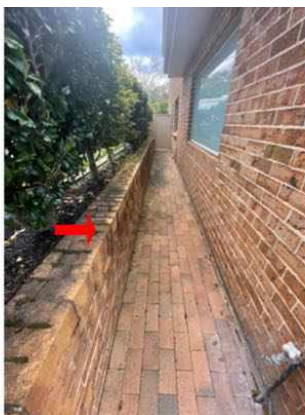
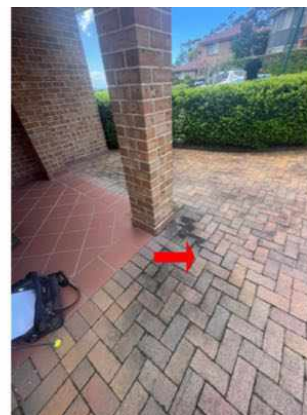
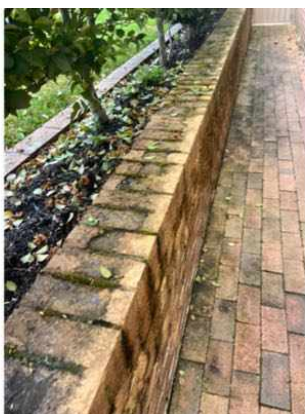
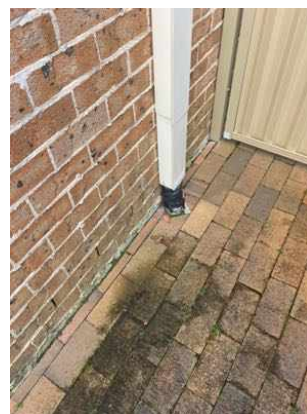
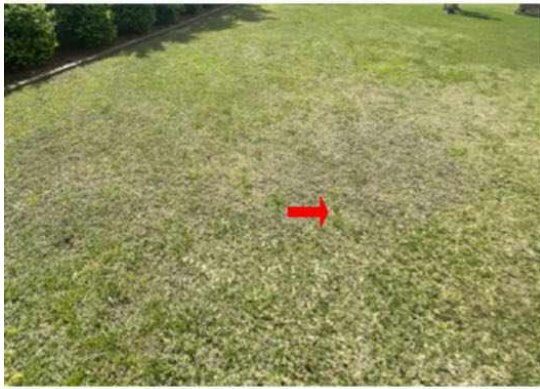
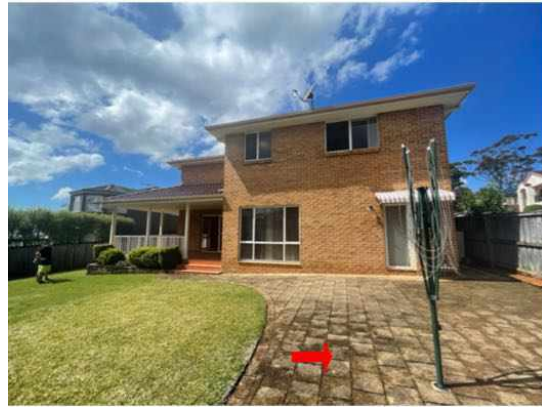
Termite and Timber Pest 1.01

Building:	Building 1
Location:	All Areas
Finding:	Site drainage - suspected Inadequate
Information:	The site drainage in this area was found to be inadequate at the time of inspection, creating potential for subsequent water damage to associated building elements.

It is important that water does not lie against the base of walls; surrounding paths and ground levels should be sloped to drain water away from walls. Downpipes should not discharge stormwater onto lower walls or plinths. Stormwater should be carried away by large, regularly cleaned drains. Ground levels may need to be lowered to expose a buried DPC.

Where site drainage is inadequate, installation of an Agricultural (Aggie) Drain may be required. A qualified plumber should be appointed to further inspect the property and perform any remedial works as necessary. Water damage and secondary defects are likely to occur if left unmanaged.

The current site drainage should be assessed by a qualified plumber.

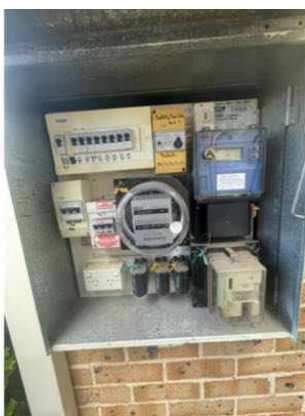
Termite and Timber Pest 1.02

Building:	Building 1
Location:	All Areas
Finding:	Termite Management System - no evidence of a chemical installation
Information:	The application of a post-construction chemical termite barrier is highly recommended for all properties, particularly if live termite activity has been found on the site previously. Such barriers are highly effective in preventing termite attack on any timber building elements throughout the property.

A durable notice should be placed in the switchboard unit to indicate current termite barriers. At the time of inspection, it appeared as though no termite management system has been installed, with no evidence to suggest preventative works taking place.

The client may consider gaining further advice from a pest controller as to the costs and procedures involved with this application. It is recommended that obtaining such advice be a short-term priority.

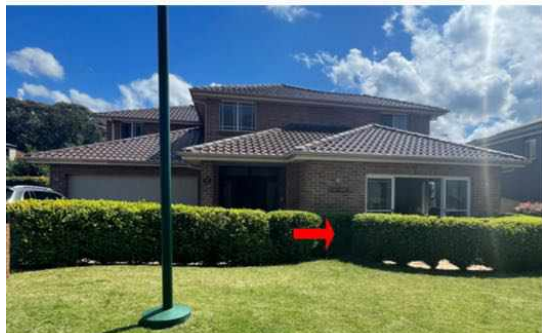
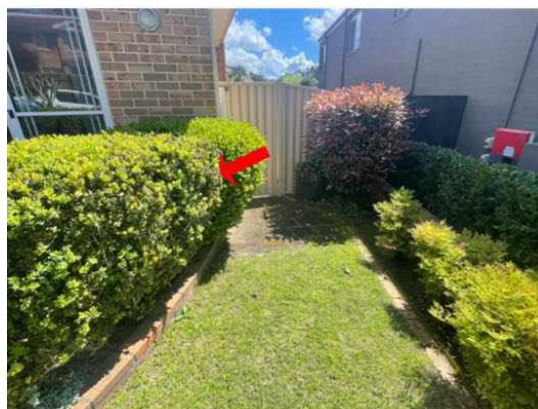
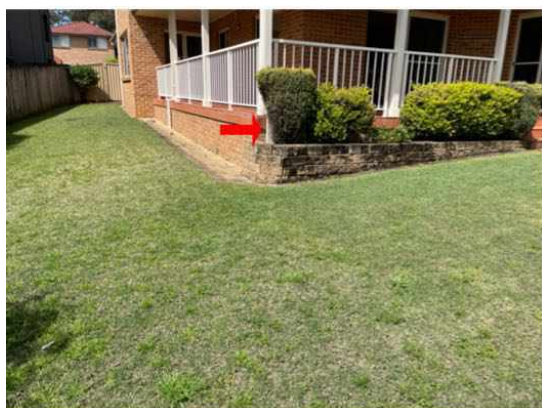
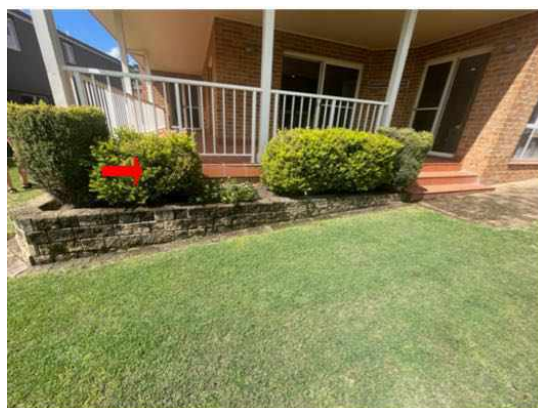
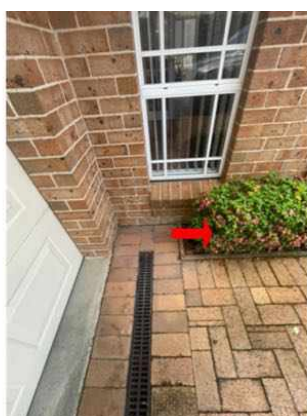
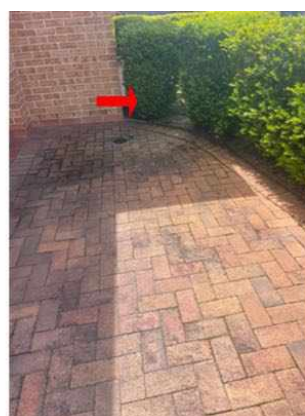
Termite and Timber Pest 1.03

Building:	Building 1
Location:	All Areas

Finding: Garden Beds - Conditions Conducive to Termites
Information: Garden beds were found to be evident in the garden area. These garden beds can include untreated timber, and with a combination of moisture from watering hosing can make conditions conducive to termite activity and termite ingress.

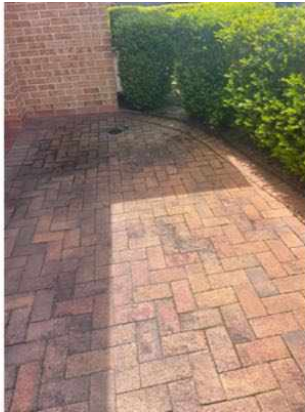
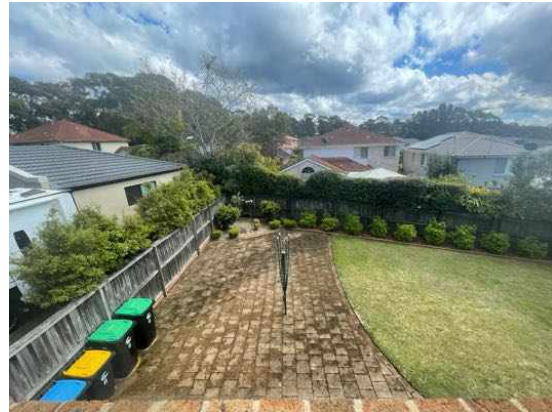
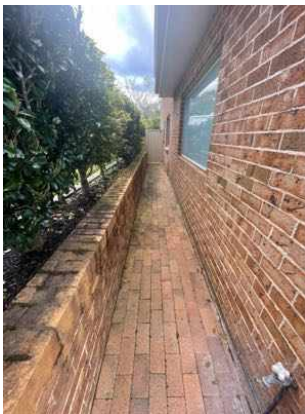
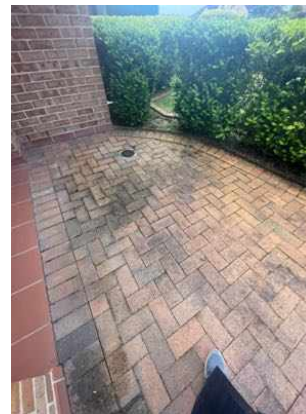
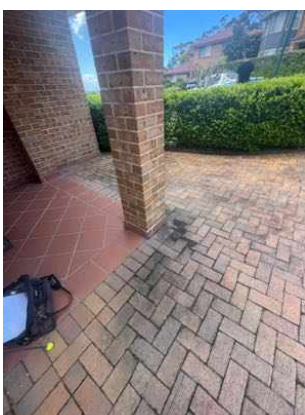
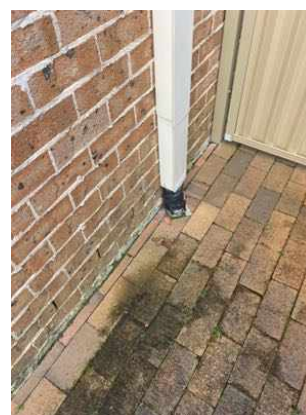
Termite and Timber Pest 1.04

Building: Building 1
Location: All Areas
Finding: Evidence of excessive moisture was present at the time of inspection
Information: Excessive moisture can attract termites and produce conditions that promote termite attack fungal growth and wood decay.

Excessive moisture is generally caused by deteriorated inadequate or missing roof drainage leaking plumbing pipes or fixtures poorly plumbed HWS overflows or condenser units and poor site drainage.

It is highly recommended that all plumbing and drainage fixtures and fittings be maintained regularly in order to prevent excessive moisture being present in the external / internal property.

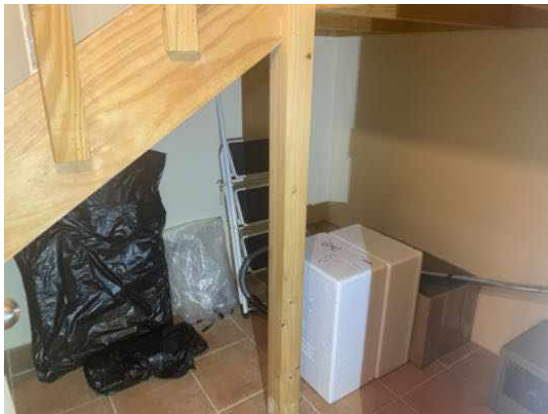
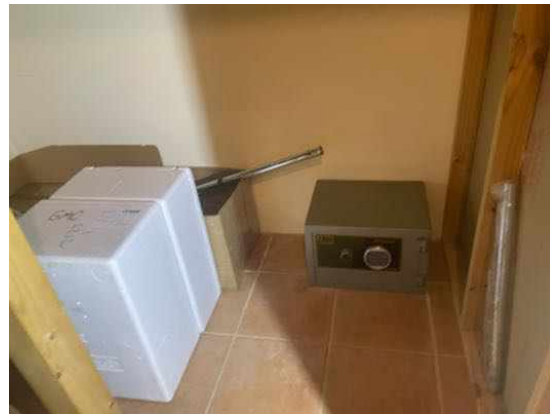
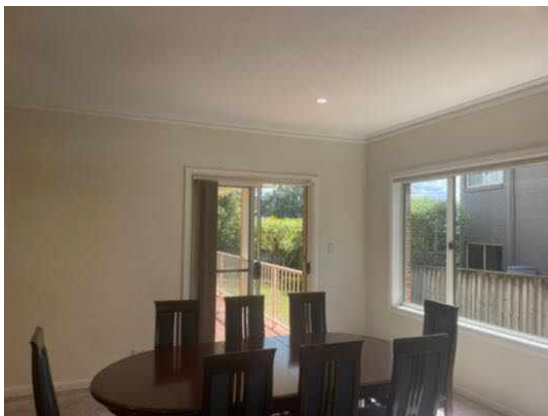
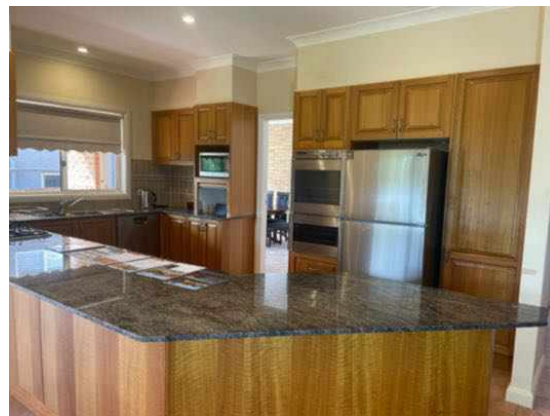
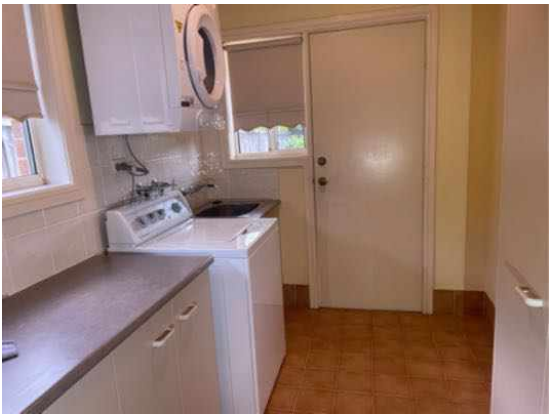
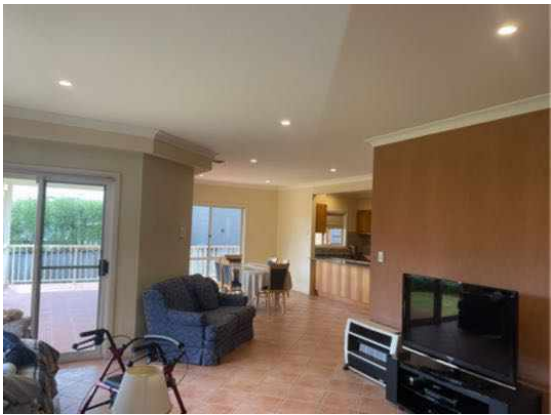
Noted Item

Building: Building 1
Location: All Areas
Finding: Additional Photos - Obstructions and Limitations
Information: These photographs are an indication of the obstructions and limitations which impeded full inspection of the property at the time of inspection. These obstructions can hide an array of defects and should be removed to allow full inspection to be carried out.
