Timber Pest Inspection Report

Inspection Date: Mon, 19 Aug 2019

Property Address: 11 Lee Road, Beacon Hill NSW, Australia

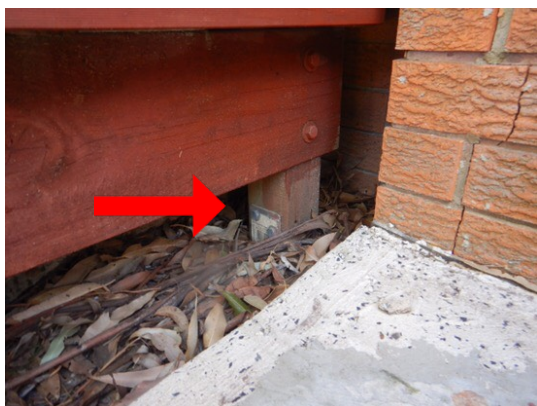
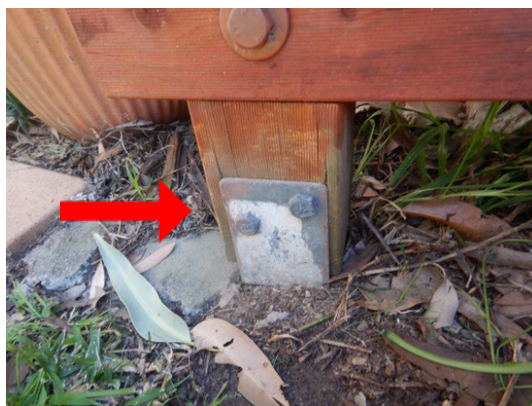
Building: Main Building
Location: Yard - Back
Finding: Building materials in direct ground contact - conducive to termites
Information: Where timber elements are in direct contact with the ground and consequently moisture or dampness they become conducive to termite activity. Whether timber is used as a building element part of a fencing structure or stored as an unused item they can provide an environment that is attractive to termite infestation.

When met with excessive moisture timber begins to decay and develop wood rot. Any timbers that are in direct contact with external grounds especially if left untreated or non-durable also provide ingress for subterranean termites into that particular element.

The removal of any such materials that may be conducive to termite activity should be removed as soon as possible to minimise the risk of termite attack.

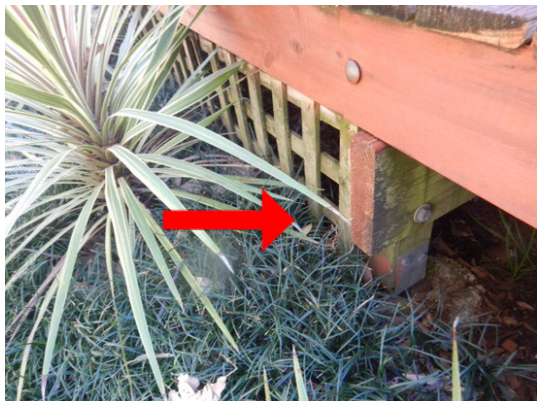
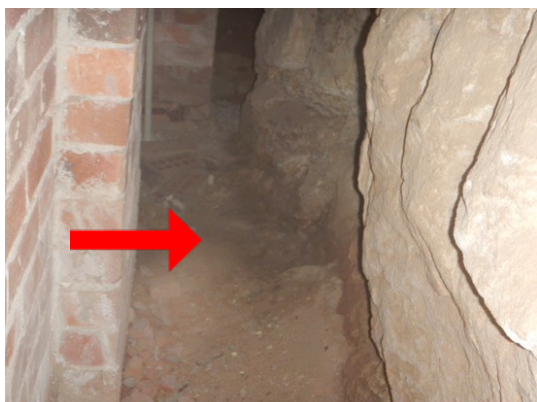
Building:	Main Building
Location:	Subfloor
Finding:	Excessive moisture - identified
Information:	Excessive moisture can attract termites and produce conditions that promote fungal growth and wood decay.
	Excessive moisture is generally caused by deteriorated inadequate or missing roof drainage leaking plumbing pipes or fixtures poorly plumbed HWS overflows or condenser units and poor site drainage.

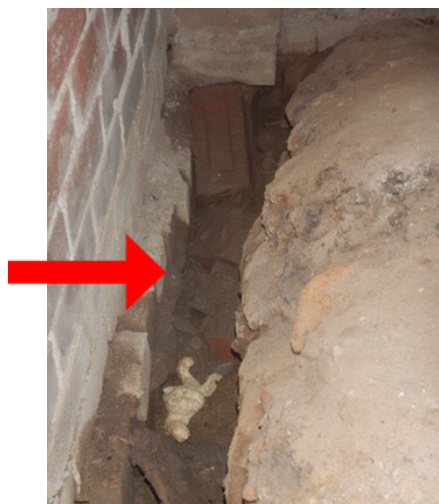
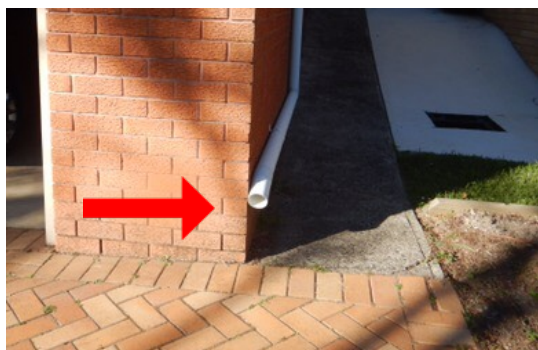
Building:	Main Building
Location:	Yard - Front
Finding:	Overflow - Not plumbed for drainage
Information:	The overflow is not plumbed or connected to suitable drainage, which has resulted in the surrounding area becoming excessively damp.

These damp conditions can lead to secondary defects such as rot, rust or corrosion of associated building elements, the formation of fungal decay, or even the creation of potential slip hazards. When coupled with poor site drainage, pooling of water may also attract termite activity to this area.

It is highly recommended that a qualified plumber be appointed to install adequate drainage to the overflow. These works will ensure that the area remains dry and free of any secondary defects.

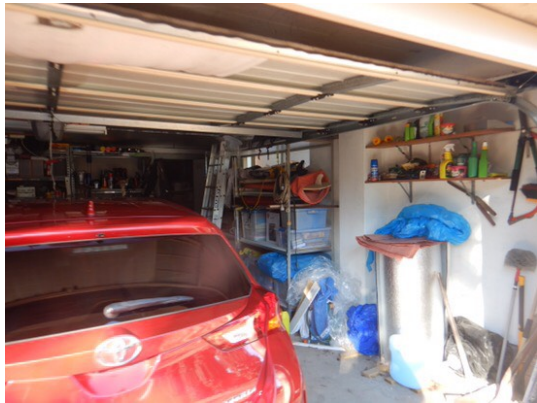
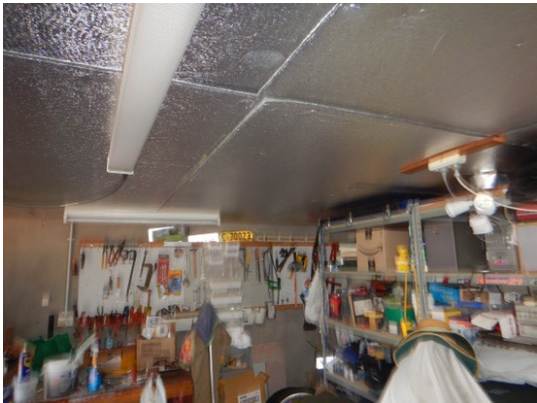
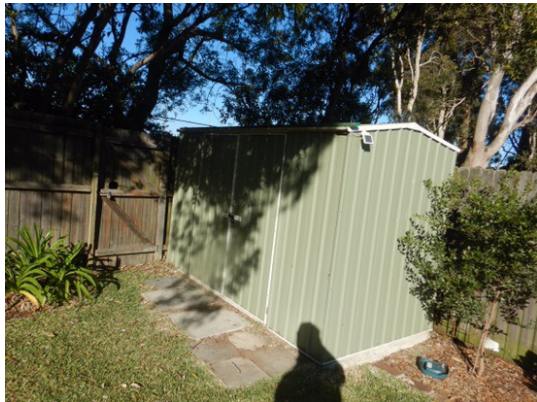
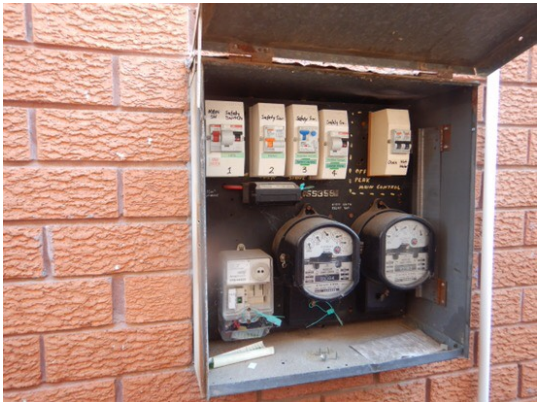
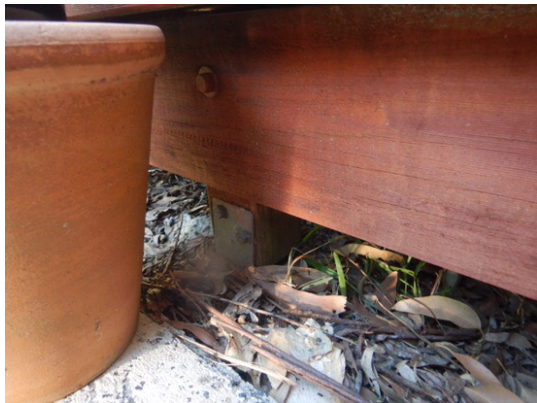
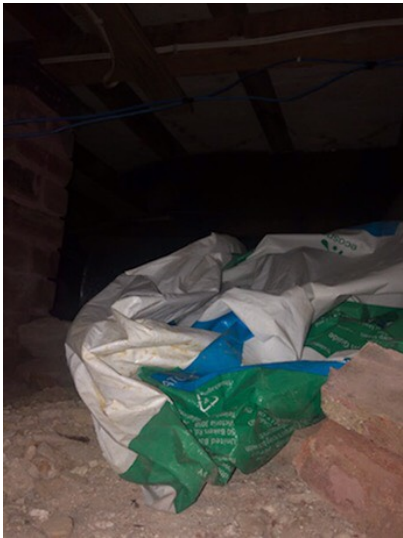
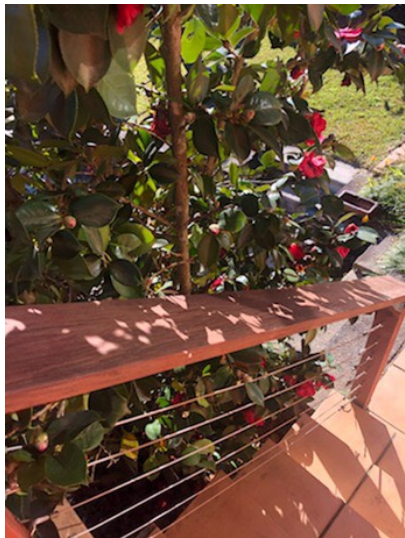
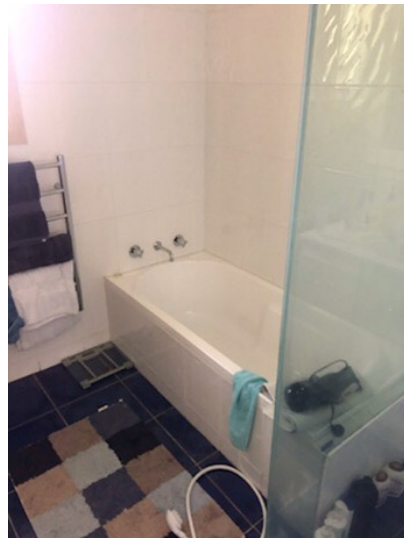
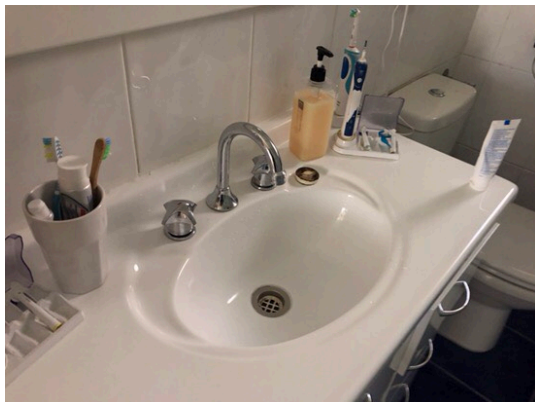
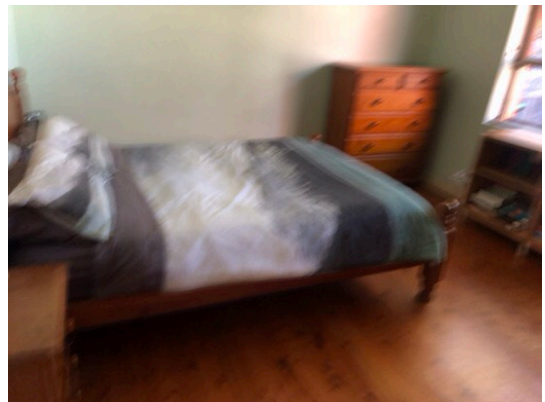
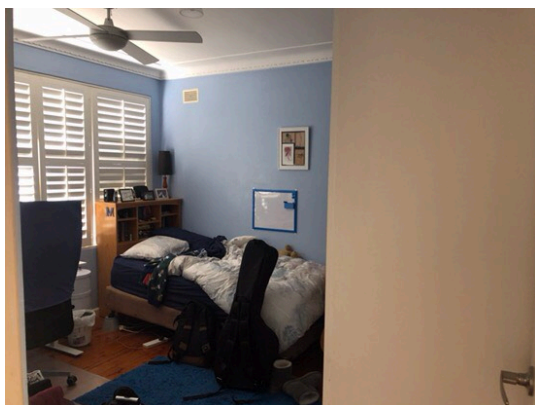
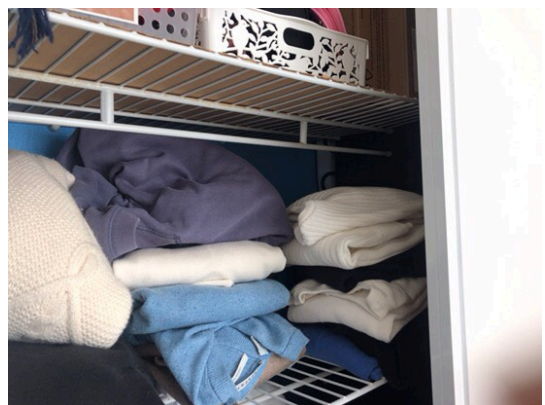
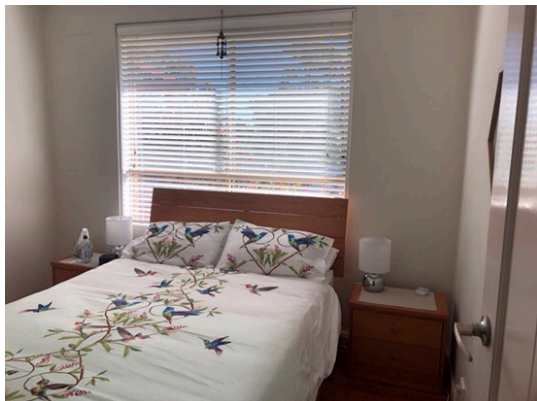
These photographs are an indication of the obstructions and limitations which impeded full inspection of the property at the time of inspection.

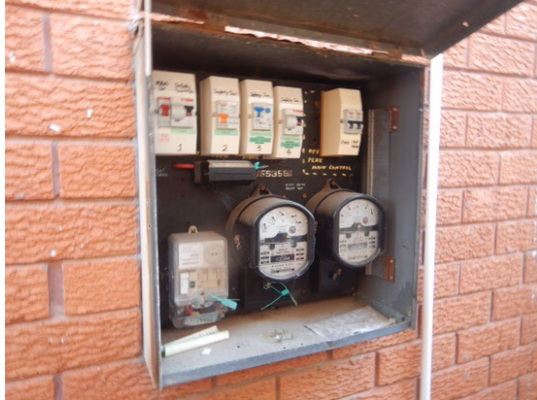
Building: Main Building
Location: All Areas
Finding: Termite Management System - no evidence of installation
Information: The application of a post-construction chemical termite barrier is highly recommended for all properties, particularly if live termite activity has been found on the site previously. Such barriers are highly effective in preventing termite attack on any timber building elements throughout the property.

A durable notice should be placed in the switchboard unit to indicate current termite barriers. At the time of inspection, it appeared as though no termite management system has been installed, with no evidence to suggest preventative works taking place.

The client may consider gaining further advice from a pest controller as to the costs and procedures involved with this application. It is recommended that obtaining such advice be a short-term priority.
