Timber Pest Inspection Report

Inspection Date: Tue, 15 Nov 2022

Property Address: 7 Romford Rd, Frenchs Forest NSW 2086,
Australia

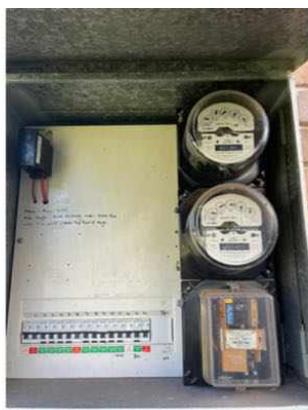
Termite and Timber Pest 1.01

Building:	Building 1
Location:	All Areas
Finding:	Termite Management System - no evidence of a chemical installation
Information:	The application of a post-construction chemical termite barrier is highly recommended for all properties, particularly if live termite activity has been found on the site previously. Such barriers are highly effective in preventing termite attack on any timber building elements throughout the property.

A durable notice should be placed in the switchboard unit to indicate current termite barriers. At the time of inspection, it appeared as though no termite management system has been installed, with no evidence to suggest preventative works taking place.

The client may consider gaining further advice from a pest controller as to the costs and procedures involved with this application. It is recommended that obtaining such advice be a short-term priority.

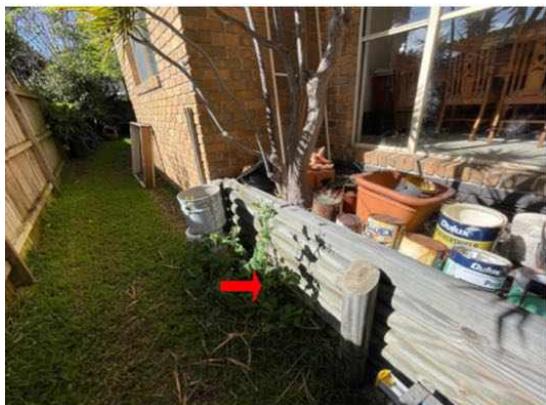
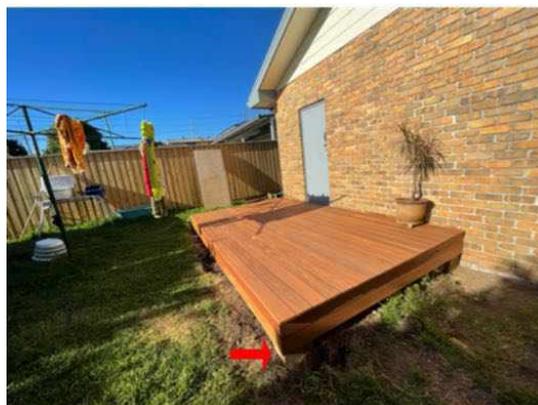
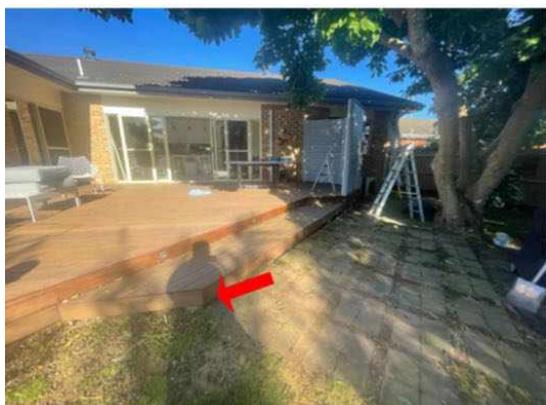
Termite and Timber Pest 1.02

Building:	Building 1
Location:	All Areas
Finding:	Building materials in direct ground contact - conducive to termites
Information:	Where timber elements are in direct contact with the ground and consequently moisture or dampness they become conducive to termite activity.

Whether timber is used as a building element part of a fencing structure or stored as an unused item they can provide an environment that is attractive to termite infestation.

When met with excessive moisture timber begins to decay and develop wood rot. Any timbers that are in direct contact with external grounds especially if left untreated or non- durable also provide ingress for subterranean termites into that particular element.

The removal of any such materials that may be conducive to termite activity should be removed as soon as possible to minimise the risk of termite attack.

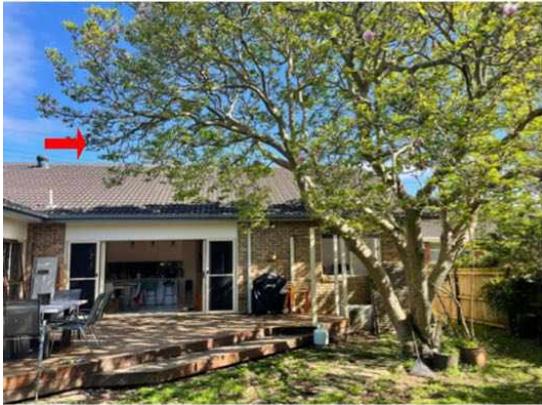
Termite and Timber Pest 1.03

Building:	Building 1
Location:	All Areas
Finding:	Trees - Overhanging and filling gutters
Information:	Overhanging trees often result in excessive amounts of leaf debris accumulating in gutters.

Gutters are a critical part of the building's management of storm water and rain. It is therefore important that they be kept clear to prevent secondary damage to associated building elements, including exterior and interior walls, ceiling linings and any adjoining building elements. Where gutters are blocked, pooling of rainwater is likely to occur, fast-tracking rust and corrosion of the roof plumbing elements.

It is highly advised that all overhanging tree branches be removed as soon as possible

to prevent any further damage. Repair and/or replacement of sections of damaged guttering may also be required where the extent of the damage necessitates.

Such works should be performed by the homeowner; however, appointment of a landscape contractor or an arborist may be required. Consultation with a licensed roof plumber is required where guttering has been damaged.

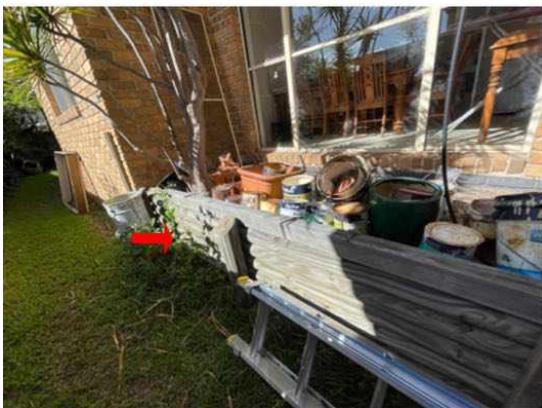
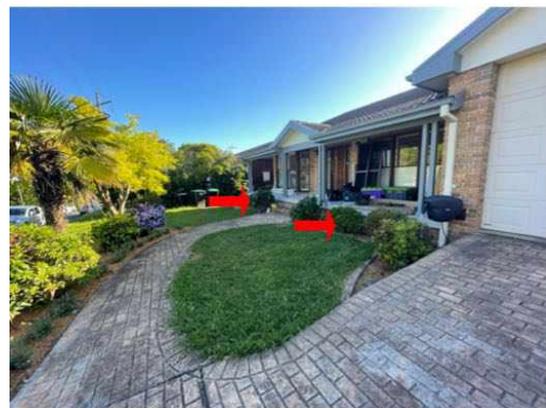
Termite and Timber Pest 1.04

Building:	Building 1
Location:	All Areas
Finding:	Garden Beds - Conditions Conducive to Termites
Information:	Garden beds were found to be evident in the garden area. These garden beds can include untreated timber, and with a combination of moisture from watering hosing can make conditions conducive to termite activity and termite ingress.

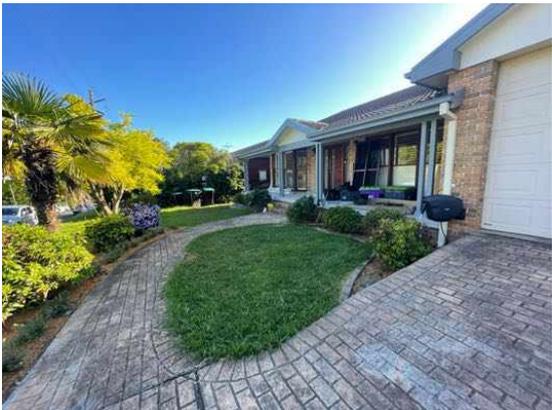
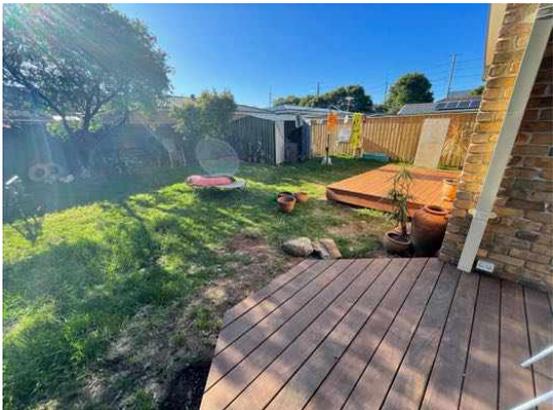
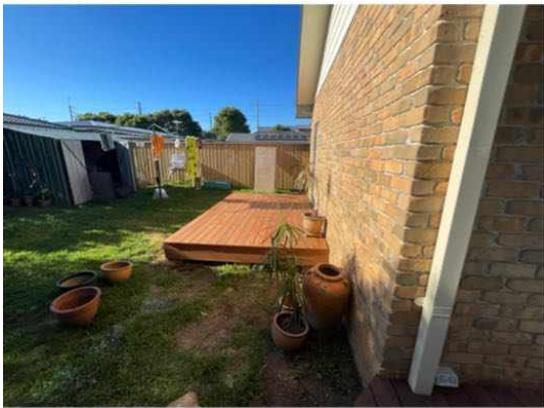
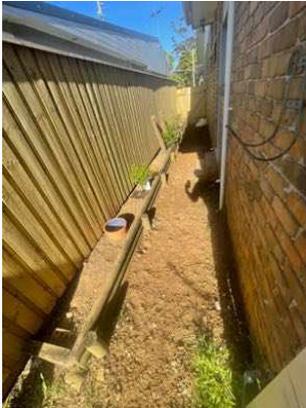
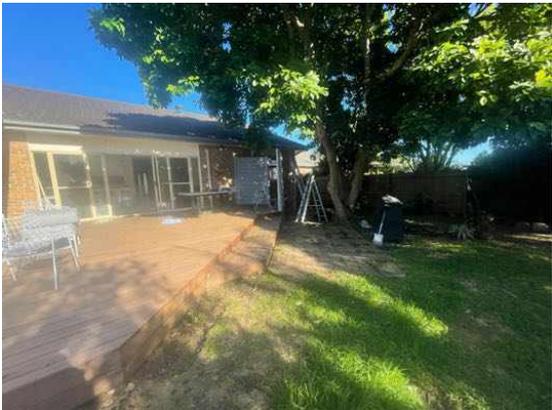
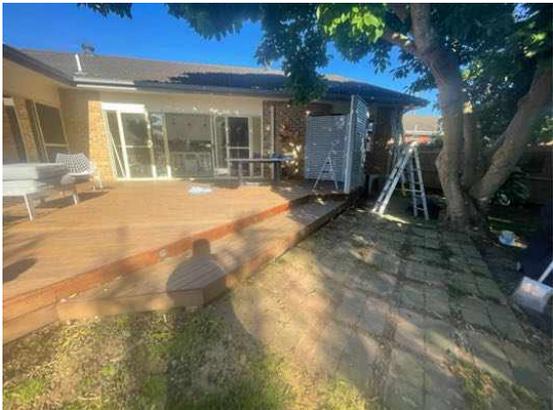
Noted Item

Building: Building 1
Location: All Areas
Finding: Additional Photos - Obstructions and Limitations
Information: These photographs are an indication of the obstructions and limitations which impeded full inspection of the property at the time of inspection.
