## **VISUAL VENDOR MAINTENANCE BUILDING INSPECTION REPORT** **25206-2017**

Date Inspection carried out: Thursday, 15th JUNE 2017

**22 Inverness Avenue, FRENCHS FOREST.**

**Comprehensive Building Inspections Pty. Limited**

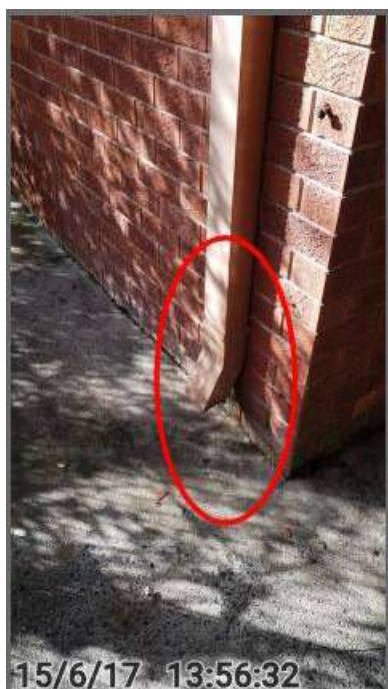
Some sections of the gutters and downpipes are damaged or rusting. These should be repaired or replaced as necessary. A further detailed investigation (by a competent person e.g. licensed roof plumber contractor) is recommended to determine as to the need or otherwise for rectification or repair works and associated costs.

Some downpipes do not appear to be connected to a stormwater dispersal system. The situation will allow excess roof water, during heavy rain conditions to pond or flow directly adjacent to the main house structure and footings. As a result localised differential settlement can occur to the foundation areas and cause structural damage to the house structure. Recommend all downpipes be connected to a legal point of discharge. A licensed roof plumber should be called to make a further evaluation and repairs or rectification as needed and to advise of likely associated costs.

Leaves and debris are present in gutters. These should be cleared. Water is ponding in the gutters and they require realigning.

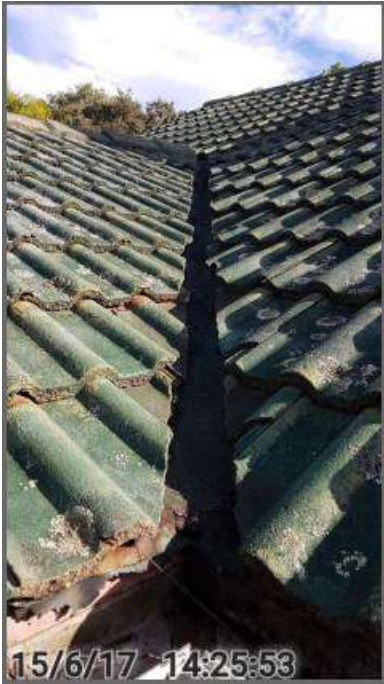
The overall condition of the valley metal is poor and should be treated or replaced as required. A further detailed investigation (by a competent person e.g. a licensed roofing contractor) is recommended to determine as to the need or otherwise rectification or repair works and associated costs.

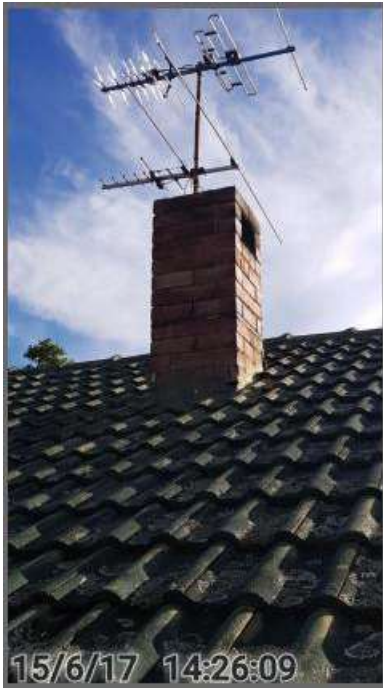
Flashings / seals to chimney penetrations are a potential source of water leakage. Early and then periodical checking for defects will be required. A further detailed investigation (by a competent person e.g. a licensed roofing contractor) is recommended to determine as to the need or otherwise rectification or repair works.

The chimney should be tested and cleaned prior to being put into use by a suitably qualified person.

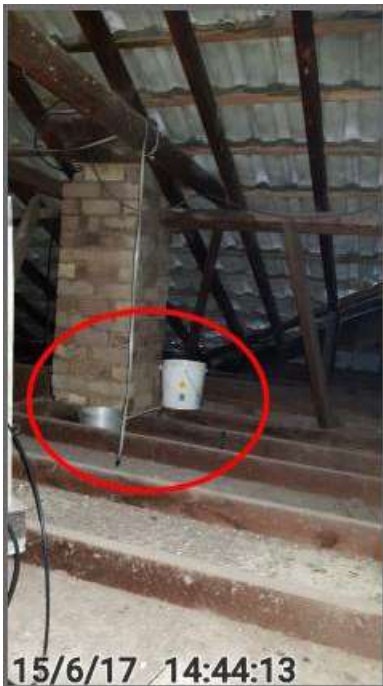
Containers placed inside the ceiling cavity may suggest active roof leakage. A licensed roofing contractor should be called to make further evaluation and repairs as needed and to determine expected costs.

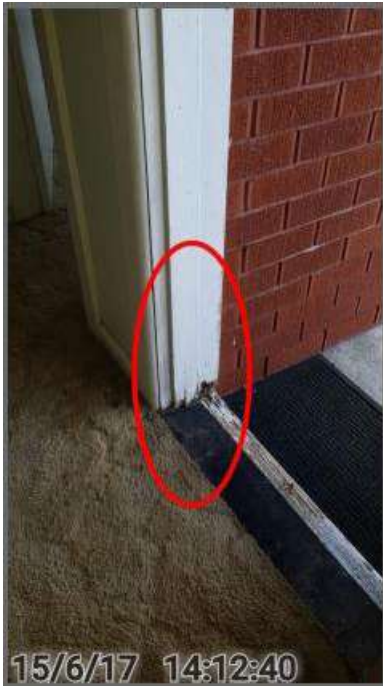
Wet rot decay damage was evident to base of door jamb. Patching / replacement of damaged sections may be required, prior to re-paint. A licensed carpenter should be called to make a further evaluation and repairs or rectification as needed.

Moderate degradation is evident to most painted surfaces. Moderate surface preparation will be required, prior to re-paint.

A licensed painting contractor should be called to make a further evaluation and repairs or rectification as needed. A licensed carpenter should be called to make a further evaluation and repairs or rectification as needed.

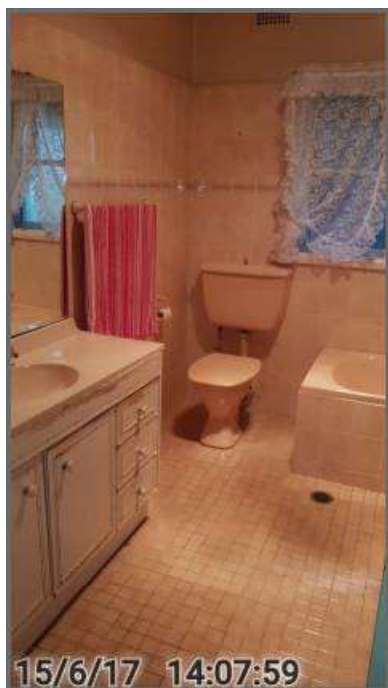
Bathroom facility appears to have been upgraded since original.

The most common cause of leaking showers is due to building movement and settlement causing weakening or cracking of grout, or the waterproof membrane under the tiles fails. At the time of the inspection the shower enclosures were tiled. Accordingly it is impossible to establish if an Australian Standards approved seamless waterproofing membrane system has been installed. Neither shower flooding or water testing or the use of moisture meters can necessarily detect defective showers. It is possible that the vendor may have applied a liquid re-waterproofing system which given time or increased usage may fail. It is also possible that the shower is not in use and that previous signs or leakage have been obscured. Accordingly it is suggested that you discuss the condition of the showers with the vendor and satisfy yourself that the showers do not leak.

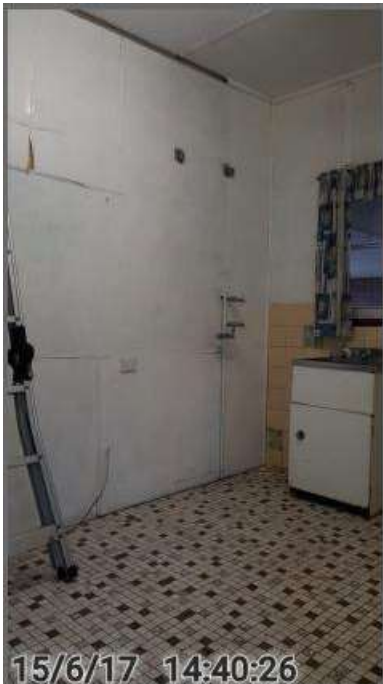
Laundry facility appears to be mainly original, therefore it is considered normal for age and water / exposure degradation to be evident to surrounding areas. This area is generally in acceptable condition.

It is likely that the internal walls / ceilings to the wet areas (bathroom / Laundry facilities) are lined with asbestous cement sheeting.

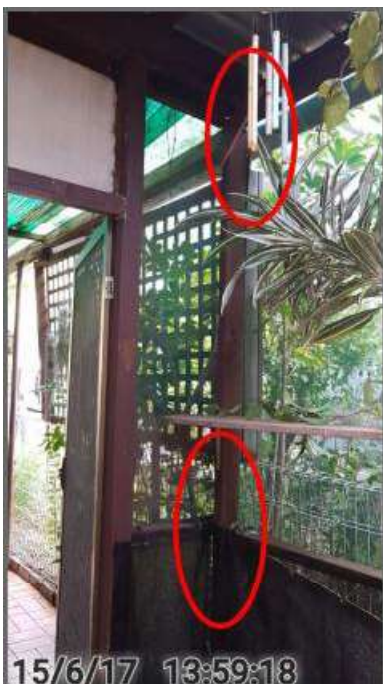
Moderate wood decay is present to the structure. Some repairs or maintenance will be required. A licensed carpenter should be called to make a further evaluation and repairs or rectification as needed.

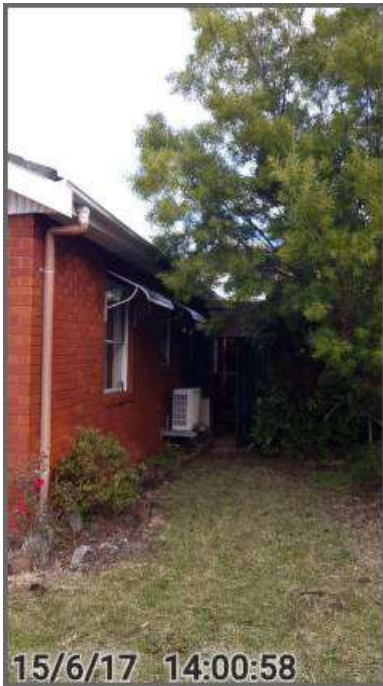
It was noted that trees have been planted within close proximity to the building structure. Their growth should be monitored, and where necessary precautions taken to ensure that their root systems do not compromise the integrity of the paved areas and/or building. Early and then periodical trimming of "die-back" limbs will be required to reduce risk of damage to roof covering and/or roof drainage provisions.

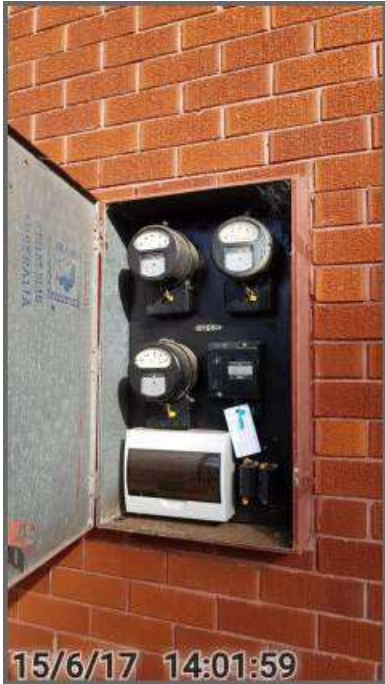
Main electrical supply meters and fittings appear to have been modestly upgraded since original, however allowance could be made for further general upgrading and installation of approved "Safety" devices (R.C.D Residual Current Device) and "Hard-Wired" "Smoke-detectors" in the short term to satisfy current building codes. A further detailed investigation (by a competent person e.g. a licensed electrical contractor) is recommended to determine the rectification or repair work costs.

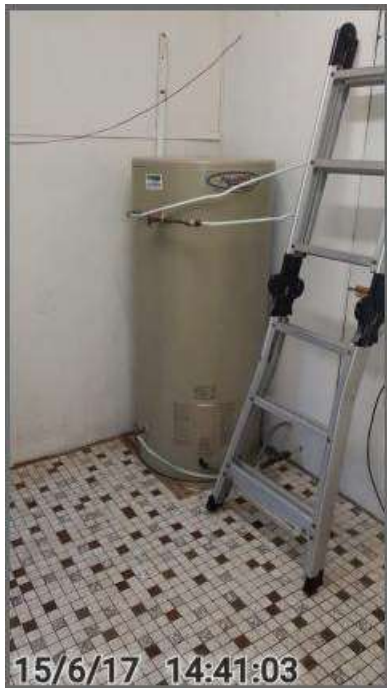
Mains electric hot water system: Mains pressure: Located in the laundry: The hot water system appears to be in working condition. No specific tests other than running the hot water from a tap was carried out. No determination has been made as to the suitability or adequacy of the hot water system in relation to capacity or otherwise.
