DATE: 7.12.2021

PRE-SALE BUILDING INSPECTION STANDARD REPORT
(Australian Standards No 4349.1 - 2007)

ON DWELLING: **48 Charlestown Road**
 NEW LAMBTON HEIGHTS, NSW

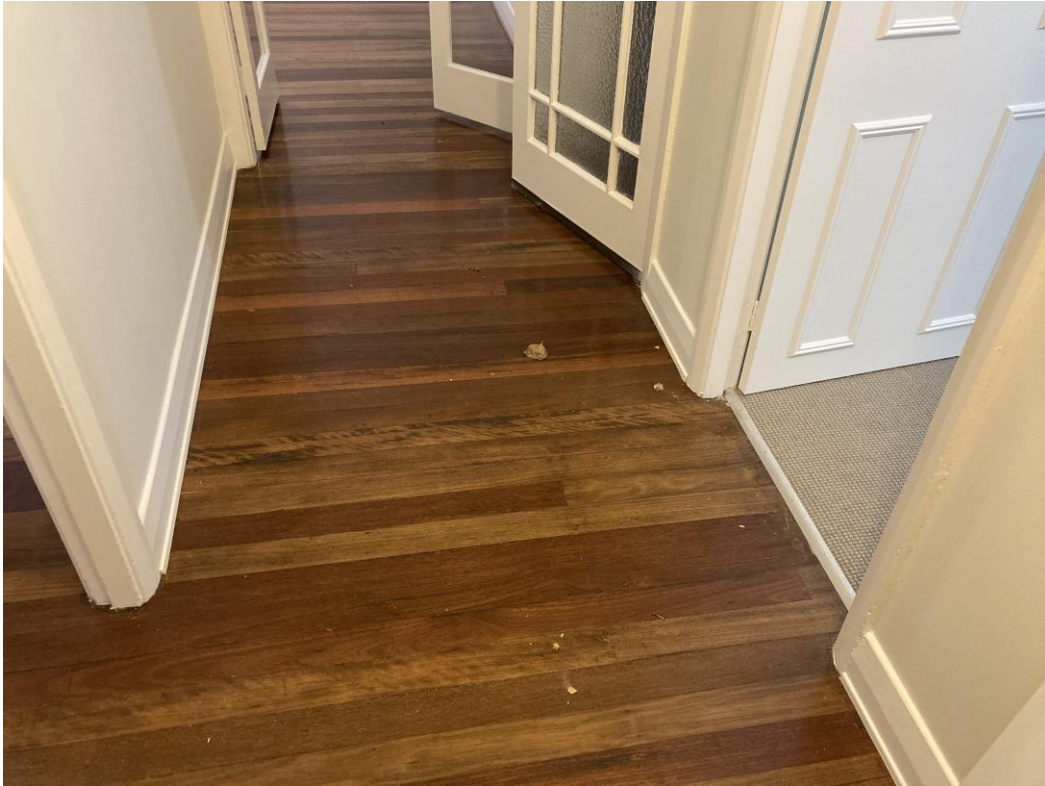
2 – Hall

There is a variation in the floor frame level sloping down towards the north-west corner, as a result of pier and footing settlements.

Pier & footing settlements are caused by moisture changes in foundation soils resulting in expansion & contraction. As the foundation soils become saturated or dry quickly the weight of the building causes the structure to settle downwards. Pier & footing settlements are common to a home of this age especially with minimal site drainage provisions installed around the perimeter of the building. Variations in floor levels are evident throughout the building.

The floor frame creaks underlive load adjacent to loungeroom requiring additional packing to tops of masonry wall and piers with a non compressible material.

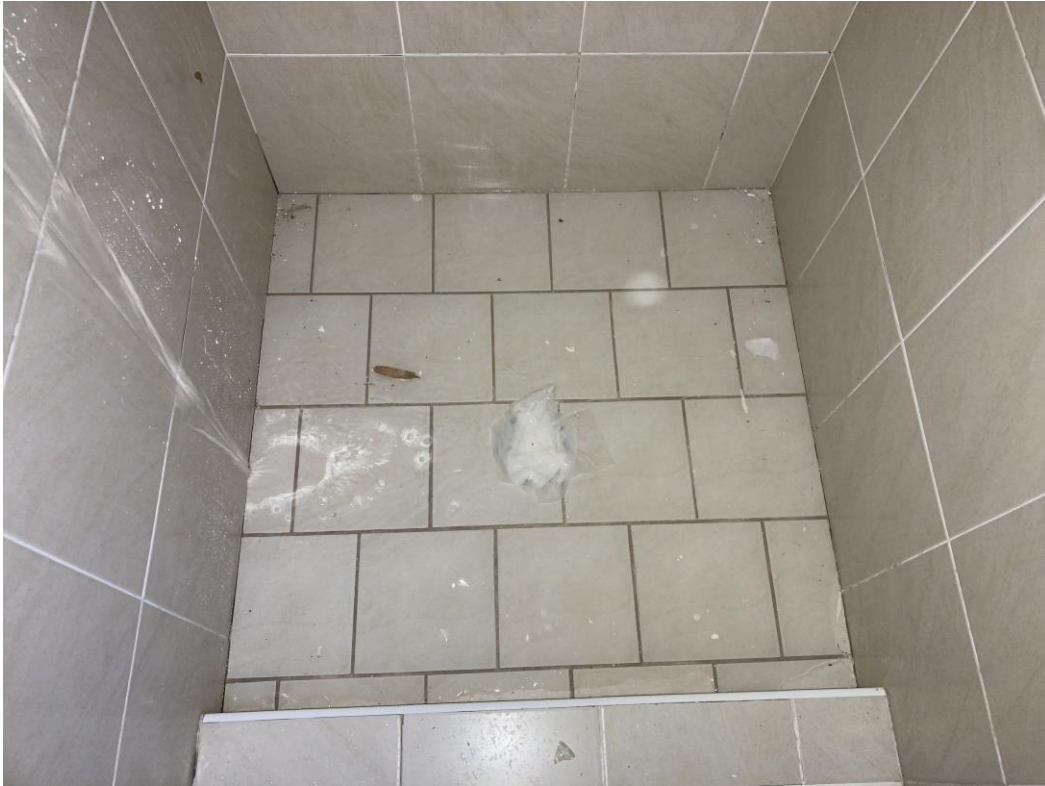
5 – Bathroom

The shower recess' waterproofing membrane was water pressure tested; moisture readings of bottom sections of walls were low, which indicated that the waterproofing membrane was in good order at the time of the inspection. Grouting is lifting at the ceramic floor and wall tile junctions needs resealing with flexible sealant.

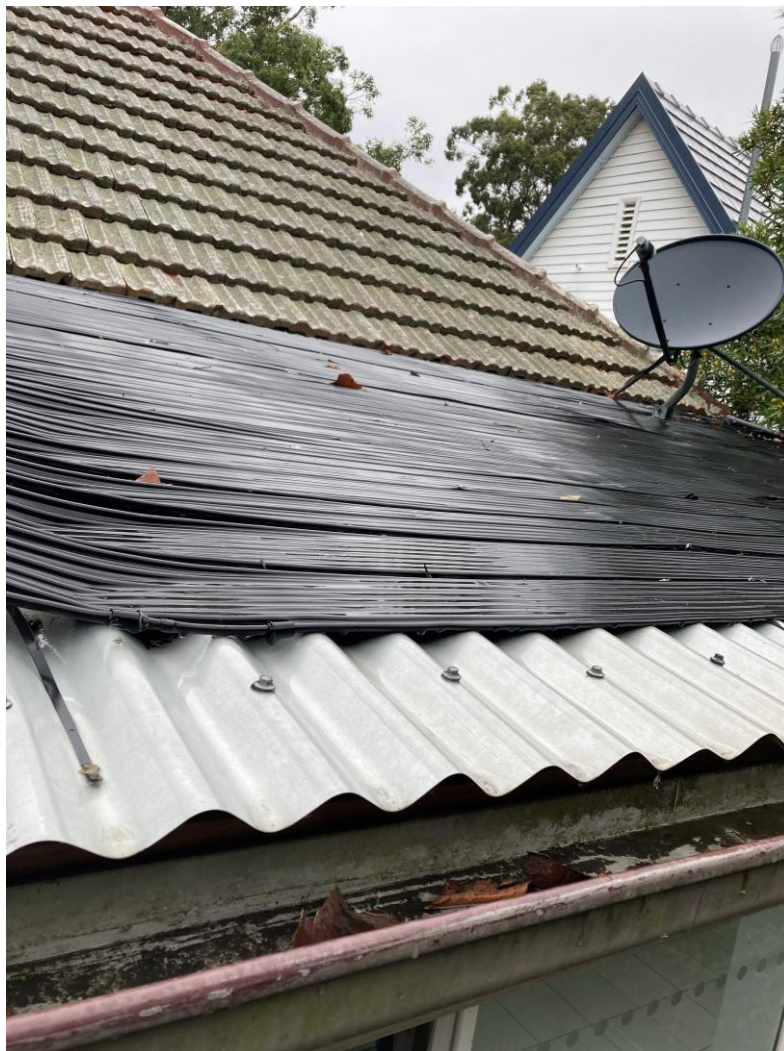
10 - Sunroom

The roof frame is skillion construction, and there has been water ingress into the roof void tracking to the rear south-west corner; the water ingress is occurring in under the junction between the roof sheets and terracotta roof tiles.

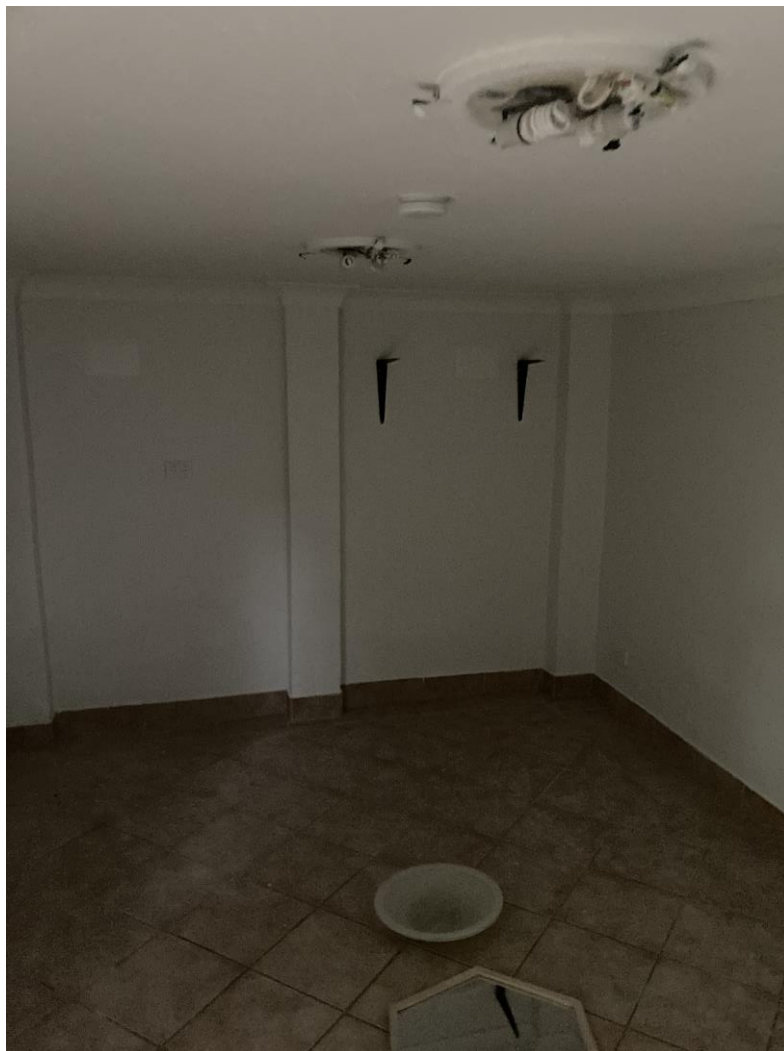
11 – Storeroom

The storeroom is deemed a non-habitable room area; the building code requirements state that the ceiling heights in a habitable room area are to be 2.4 metres.

Ground salts are appearing to the bottom sections of the brickwork which is indicating lateral moisture penetration; it is expected that the edge of the concrete slab and the masonry walls will become damp during pro-longed wet weather conditions.

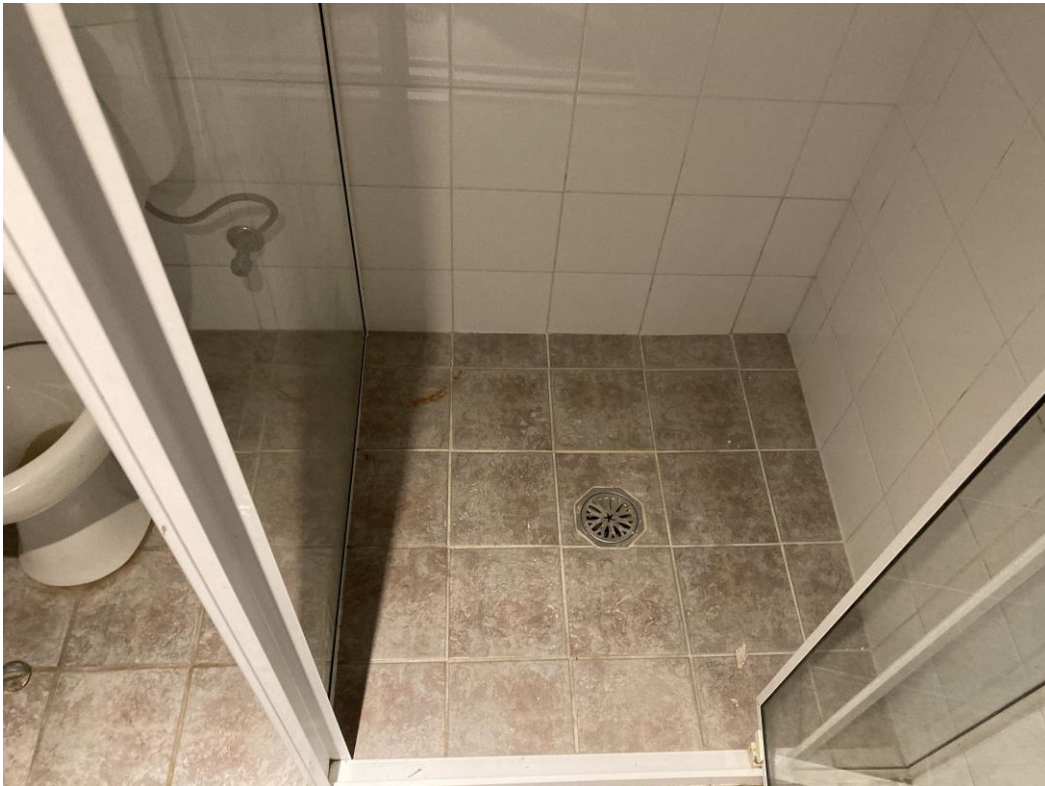
12 - Bathroom

The shower recess' has not been in use for some time; therefore a quick water pressure test may give false readings.

The internal door is binding within the door frame requiring minor adjustments.

Monitor the waterproofing membrane for water escape after the shower has been in constant use.

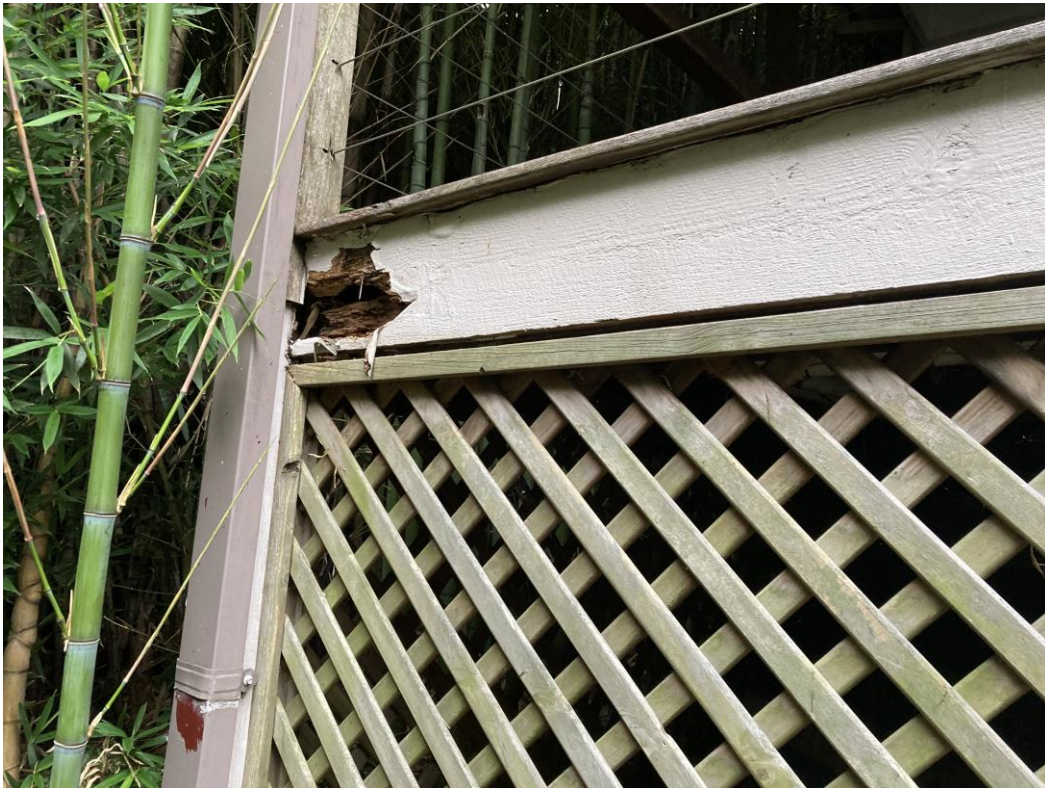
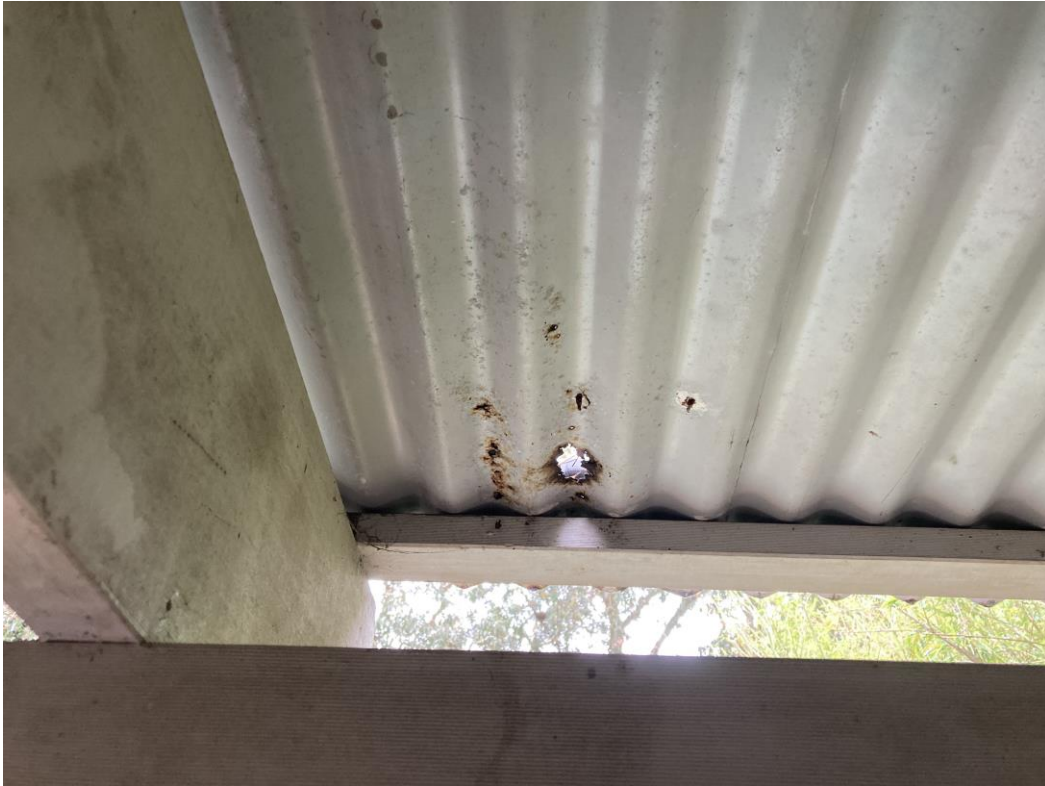
23 – Rear Deck

The timber roof rafters do not have any metal fixings brackets connecting to the roof beam.

The gutter has dislodged from the timber roof frame.

The timber entrance steps have recently been repaired in reasonable condition only.

Metal roof sheets are oxidising in several areas.

The timber floor frame fascia on the western side does exhibit fungal decay.

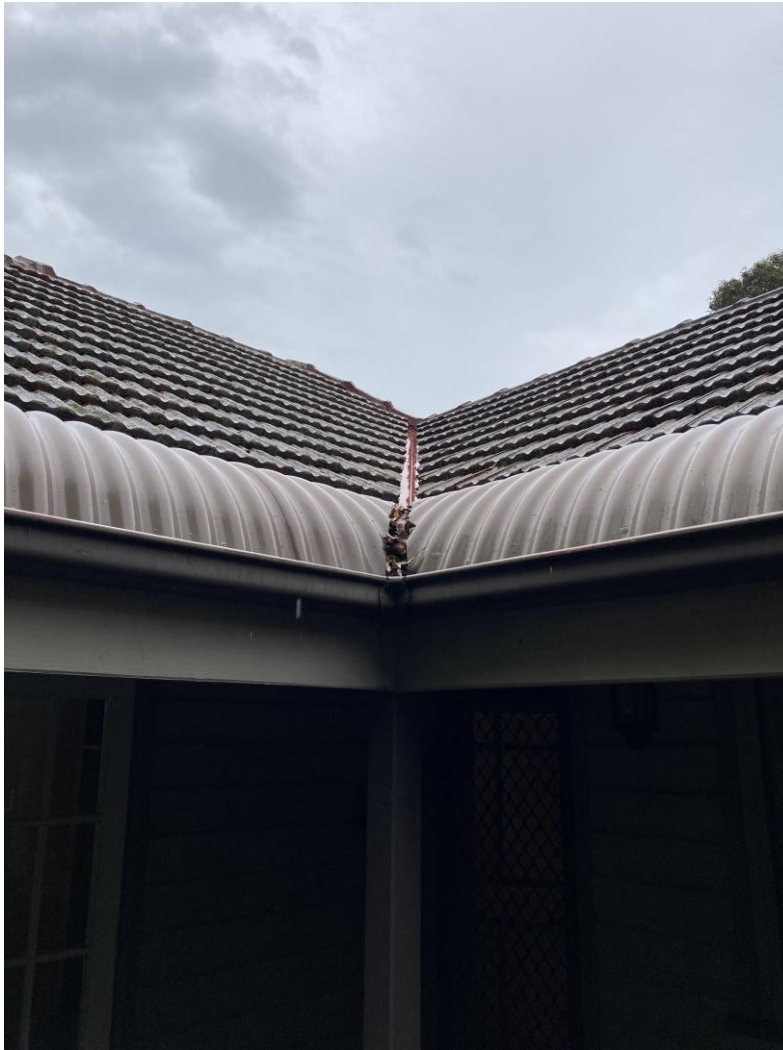
24 – Front Entry

The roof valley is allowing rainwater ingress adjacent to the entrance door opening as the valley easily blocks with tree and leaf debris requiring regular cleaning.

The gable end timber pickets are in poor condition need renailling.

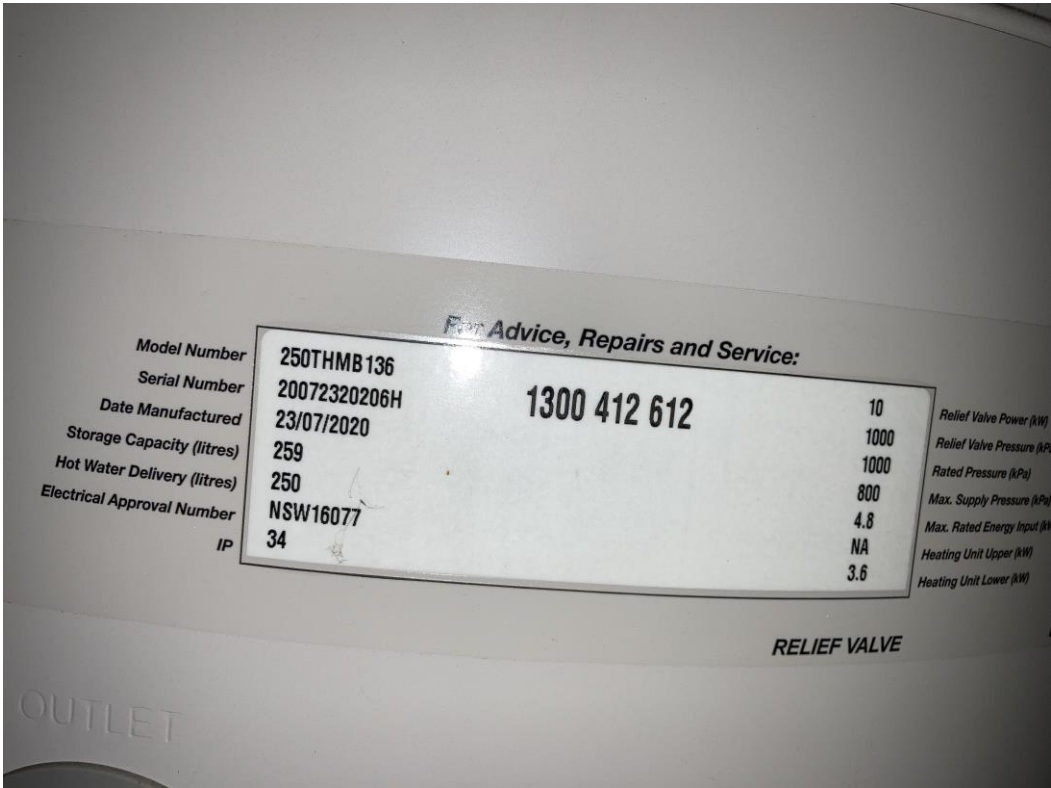
27 – Hot Water Unit

The electric hot water unit is a 2020 model, 250 litre capacity and in good order located in the sub floor area.

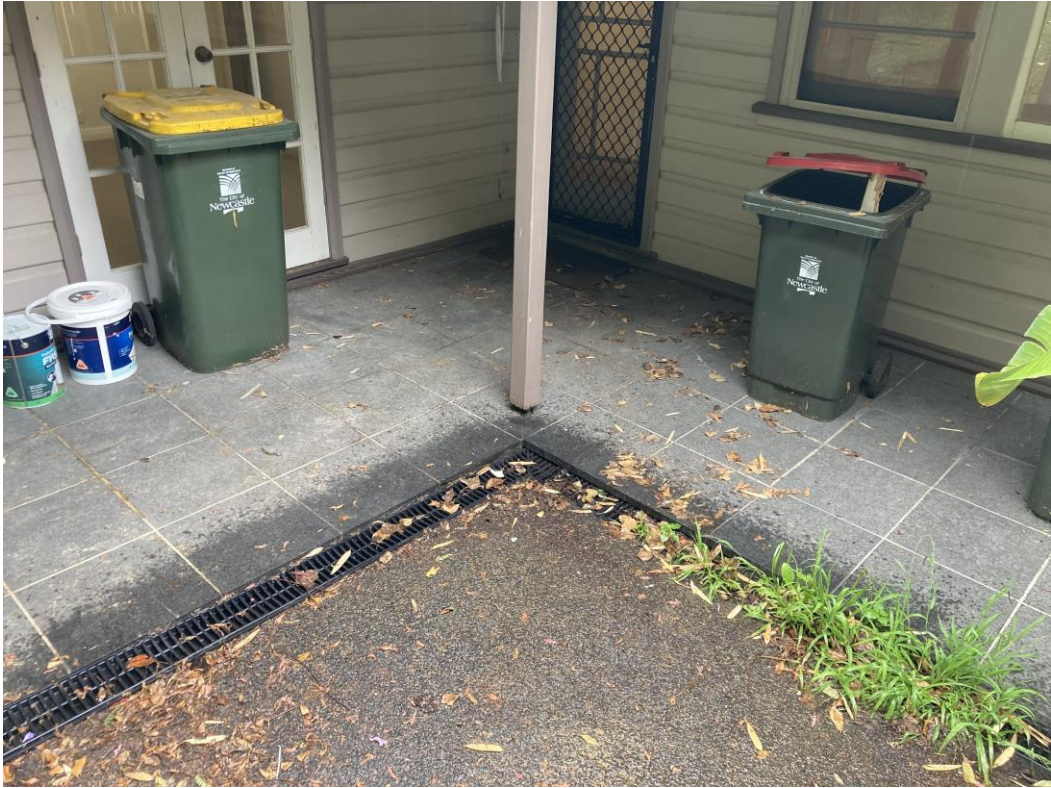
28 – Site Drainage

Minimal site drainage provisions have been installed around the perimeter of the dwelling.

The channel drain adjacent to the front entry has been poorly installed lifting outer ground soils and not serving its intended purpose of removing surface water ingress away from the building.

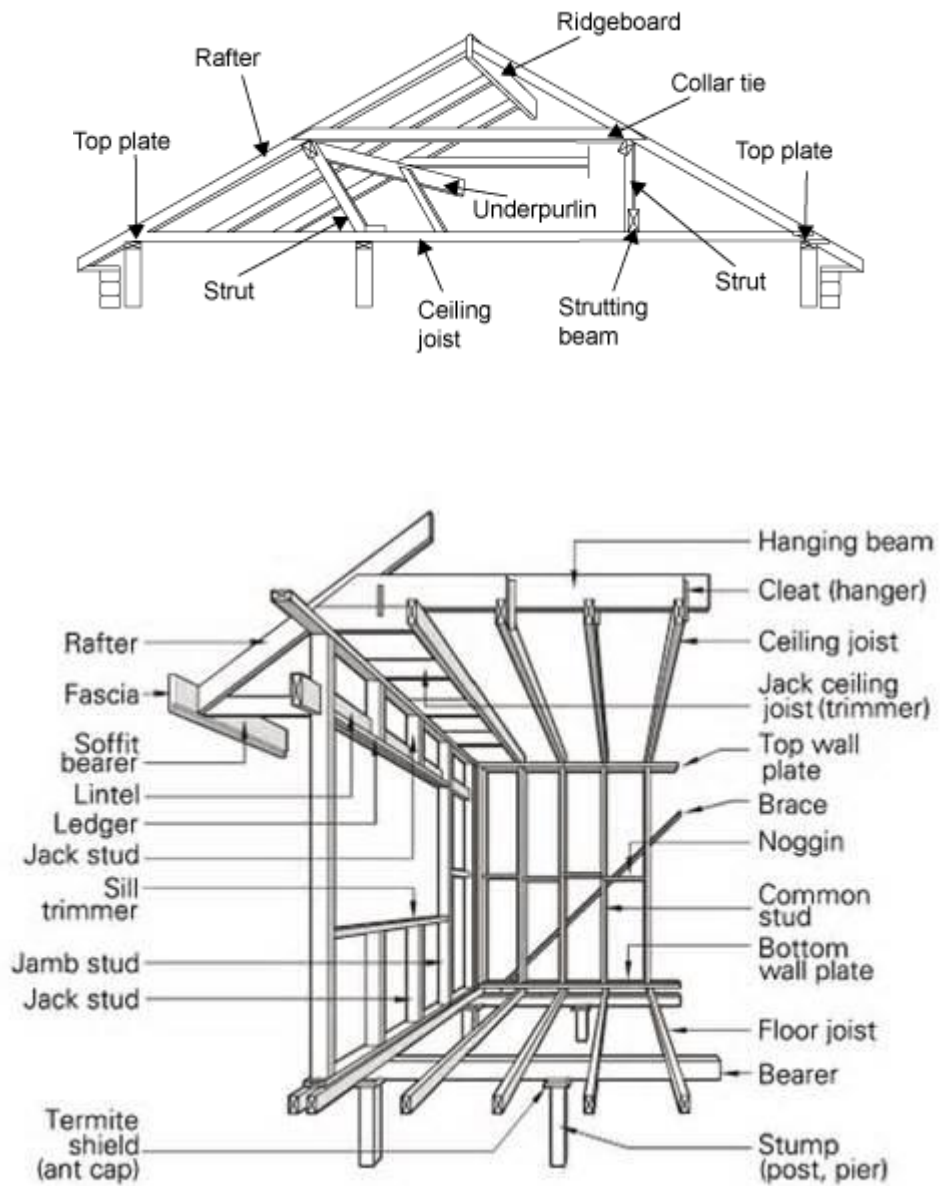
CONVENTIONAL TYPE ROOF FRAME

The roof frame is a hardwood conventional type construction (refer enclosed diagram).

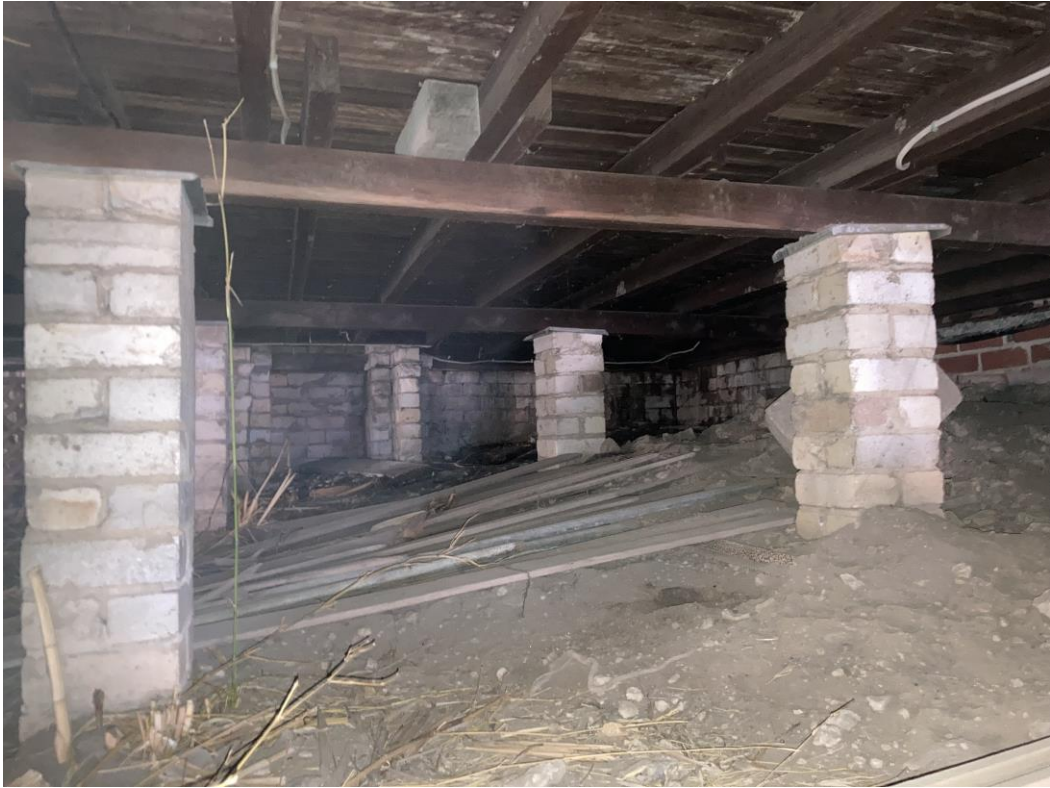
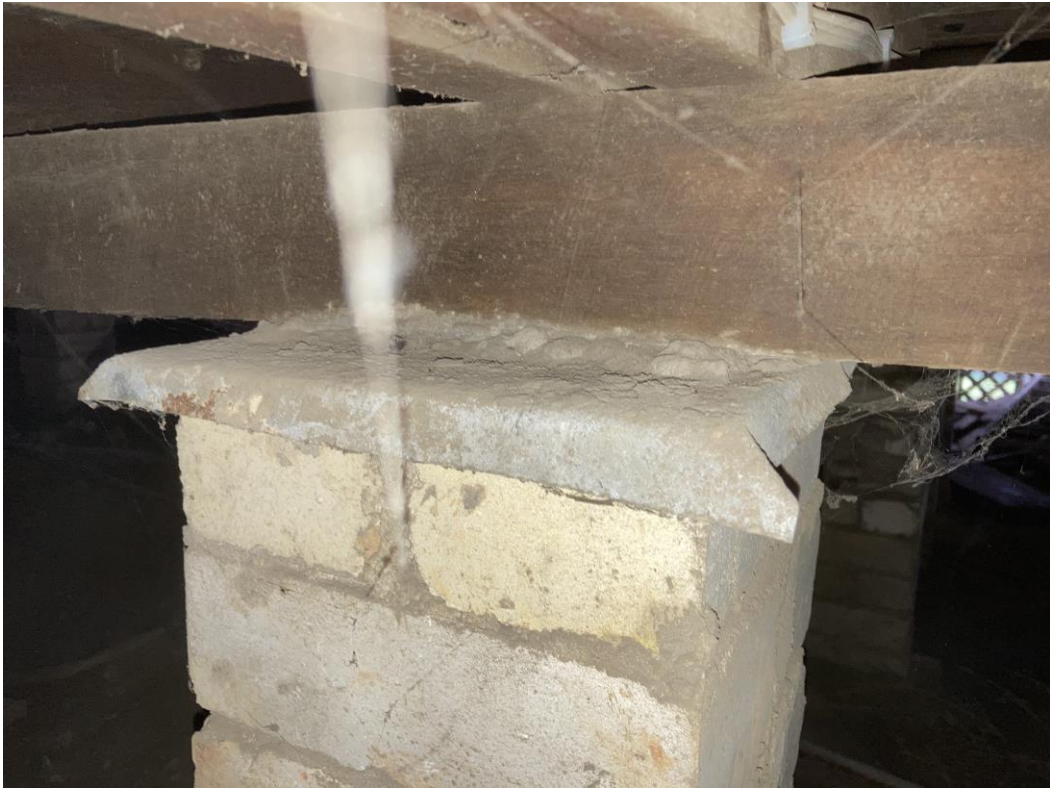
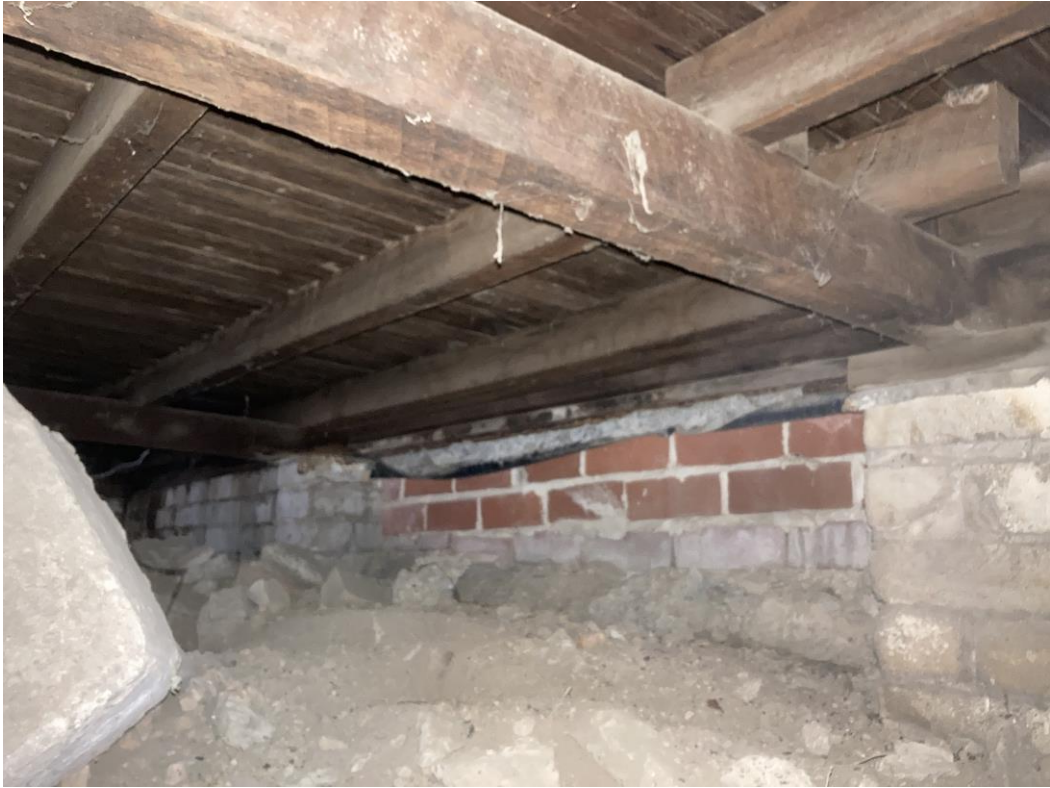
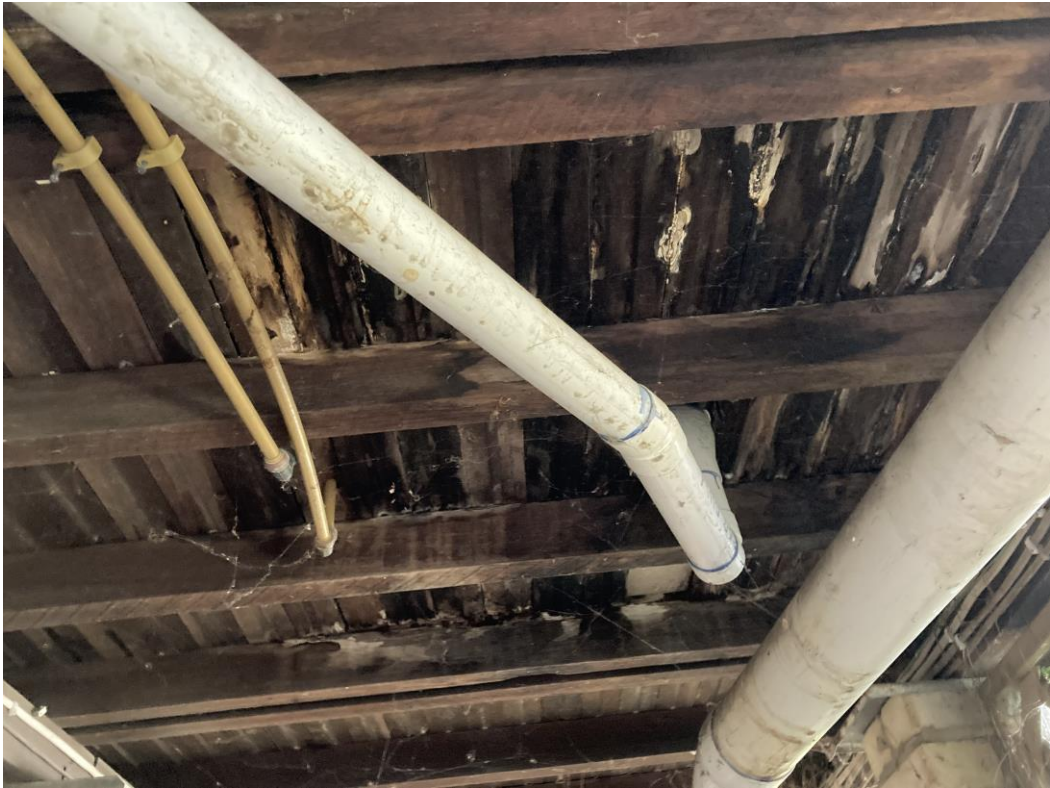
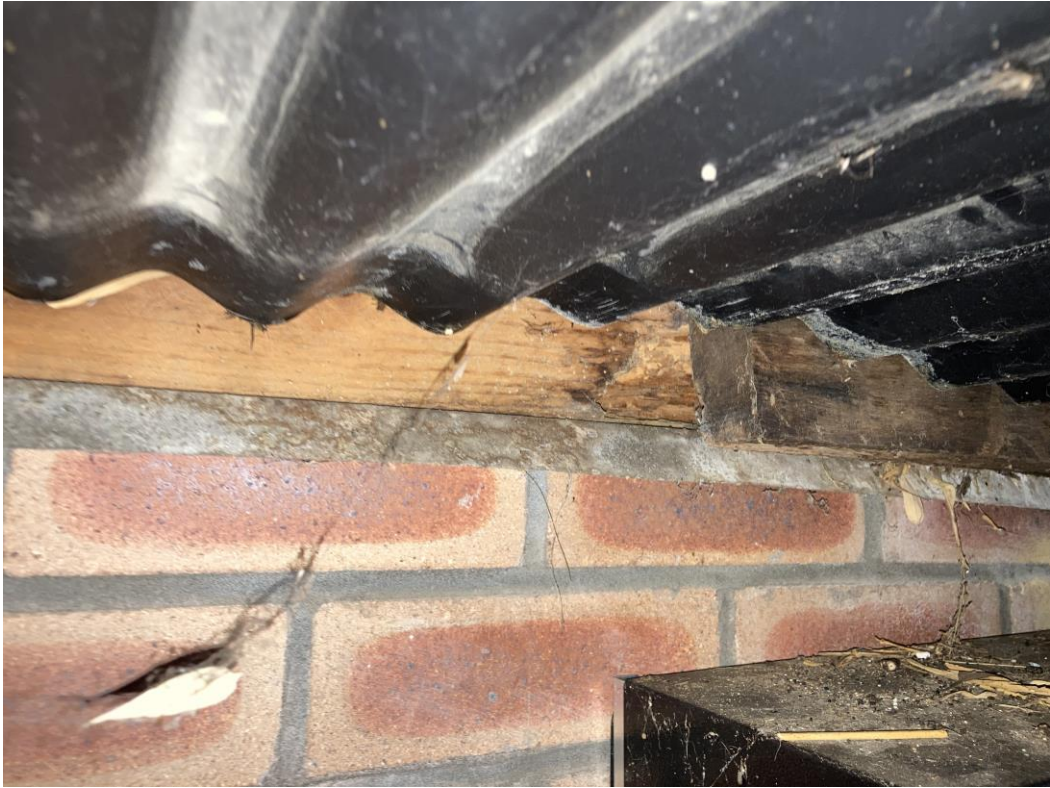
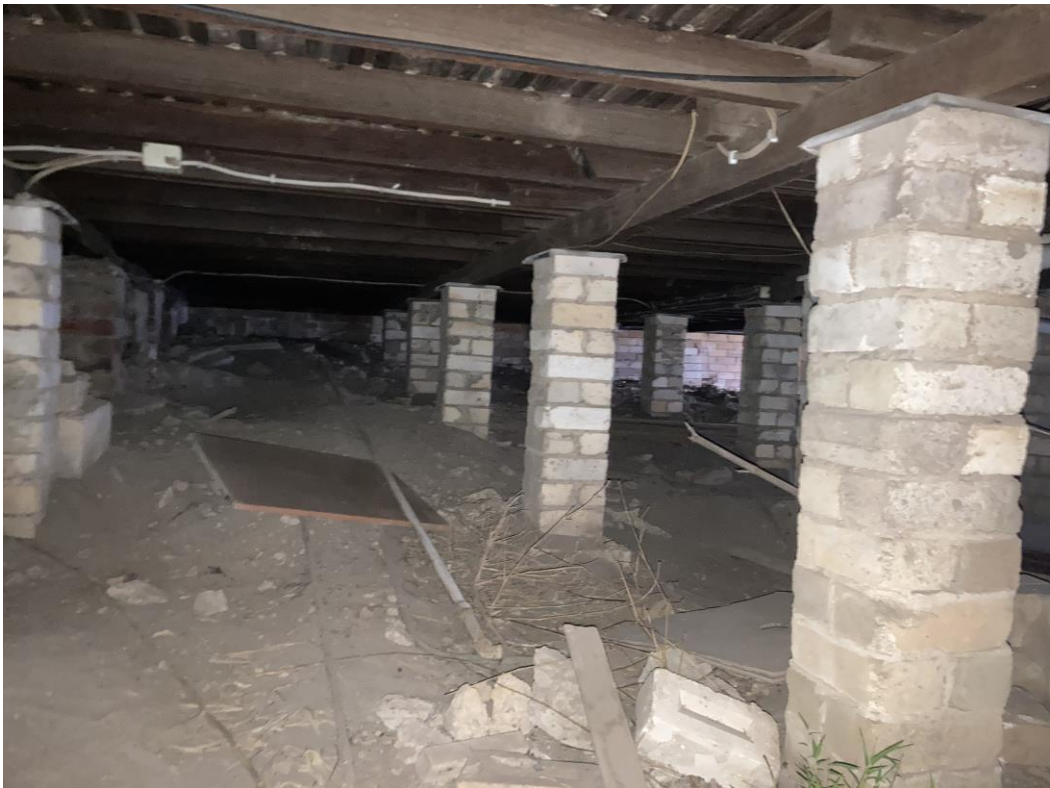
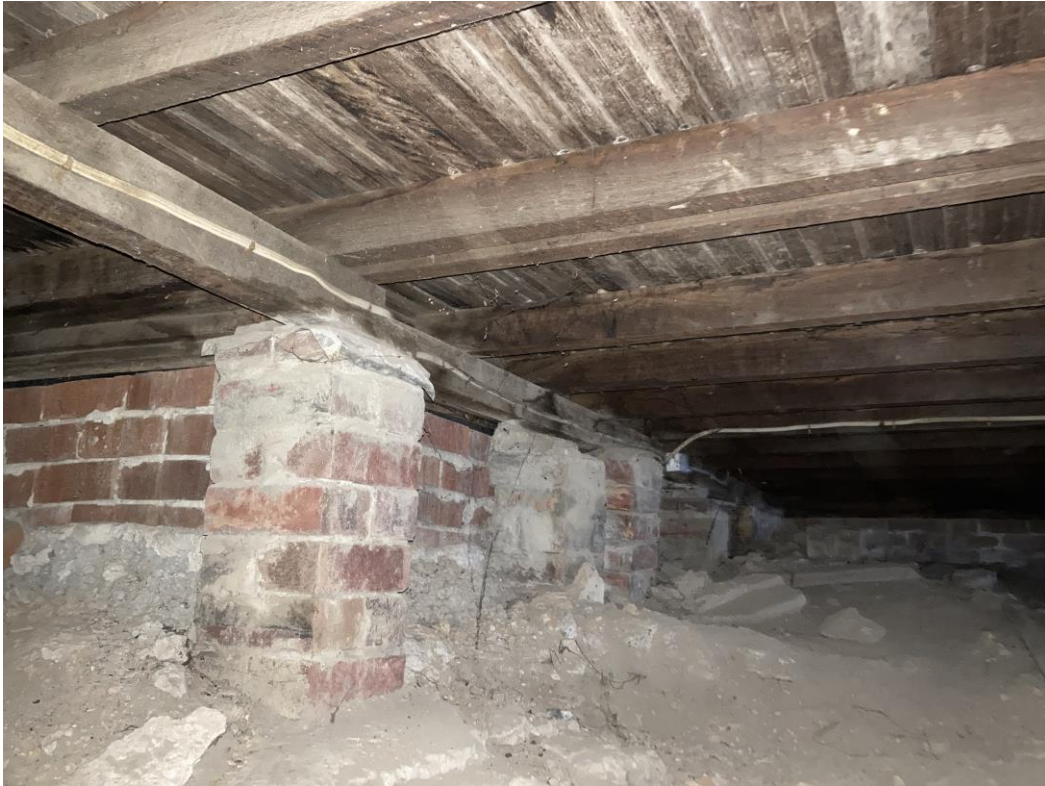
30 – Floor Frame

The floor frame is constructed from hardwood bearers and joists, and timber tongue and groove floorboards.

The timber floor frame is structurally adequate due to its long-term performance.

Ventilation into the front north-east corner of the building is poor due to the close proximity of the floor frame above ground level, this also restricted crawl space access.

Ant-capping to the tops of the masonry walls and piers is inadequate and therefore it is recommended regular pest inspections be undertaken to ensure timber destroying pests do not enter the building undetected.

Drainage in preventing surface and seepage water from entering the subfloor area is reasonable.

It is anticipated that natural seepage water will ingress the subfloor area during prolonged wet weather.

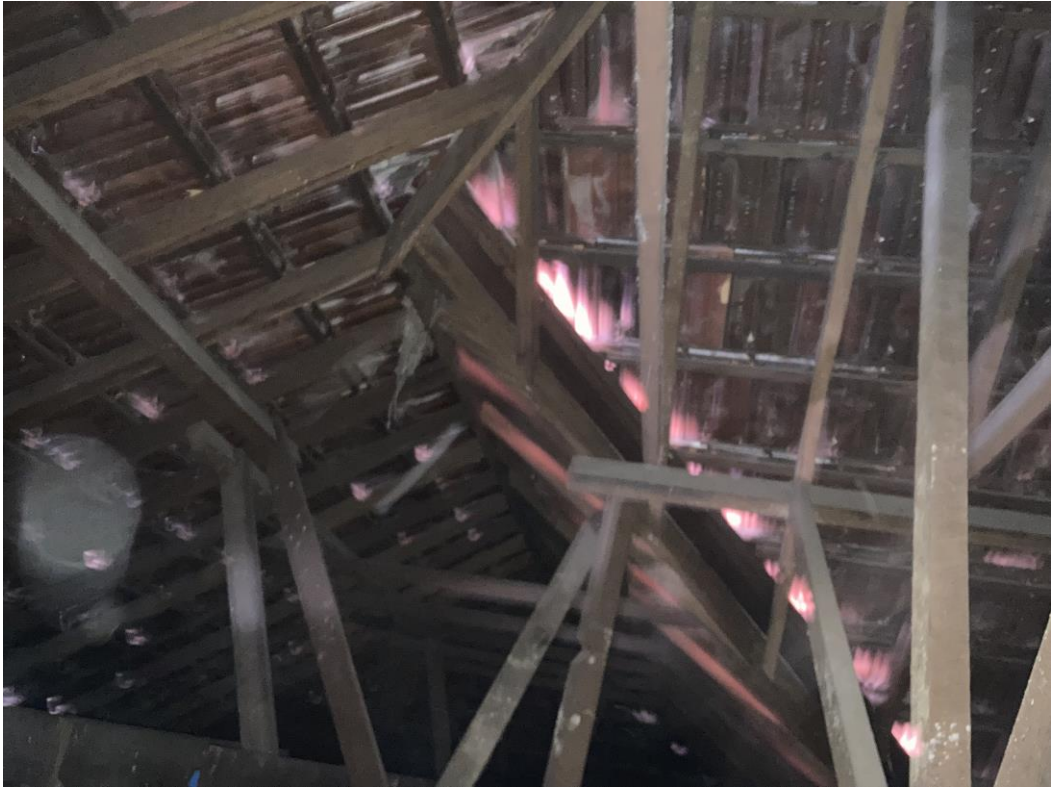
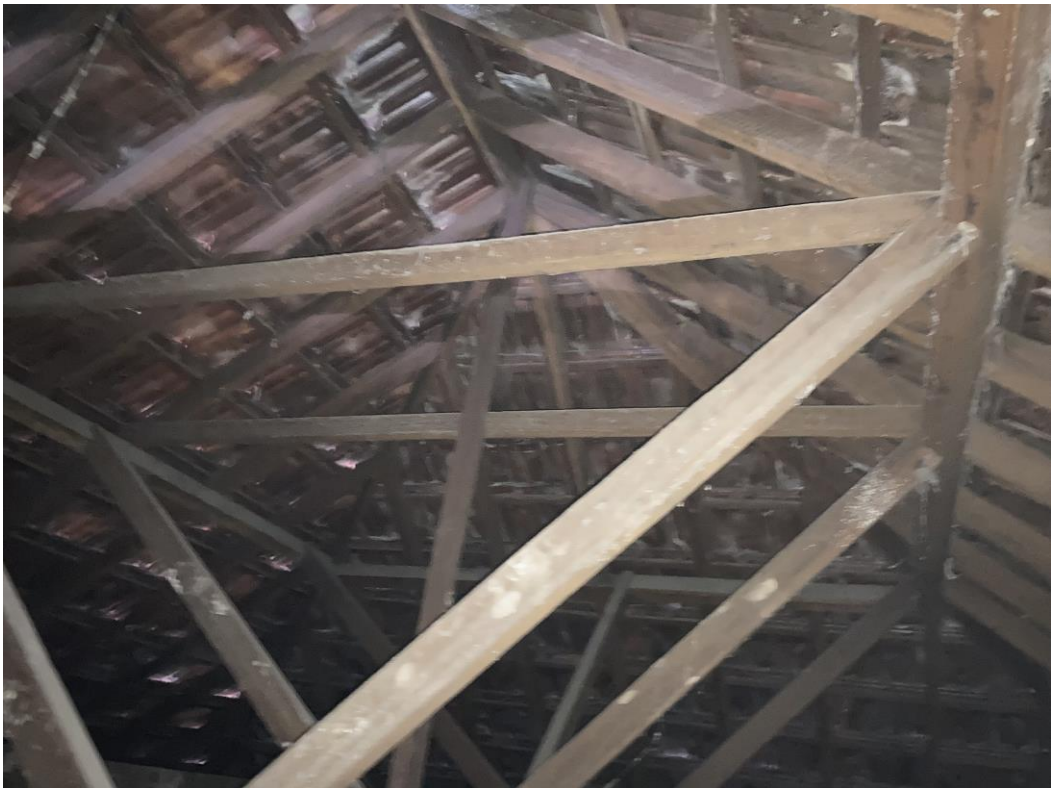
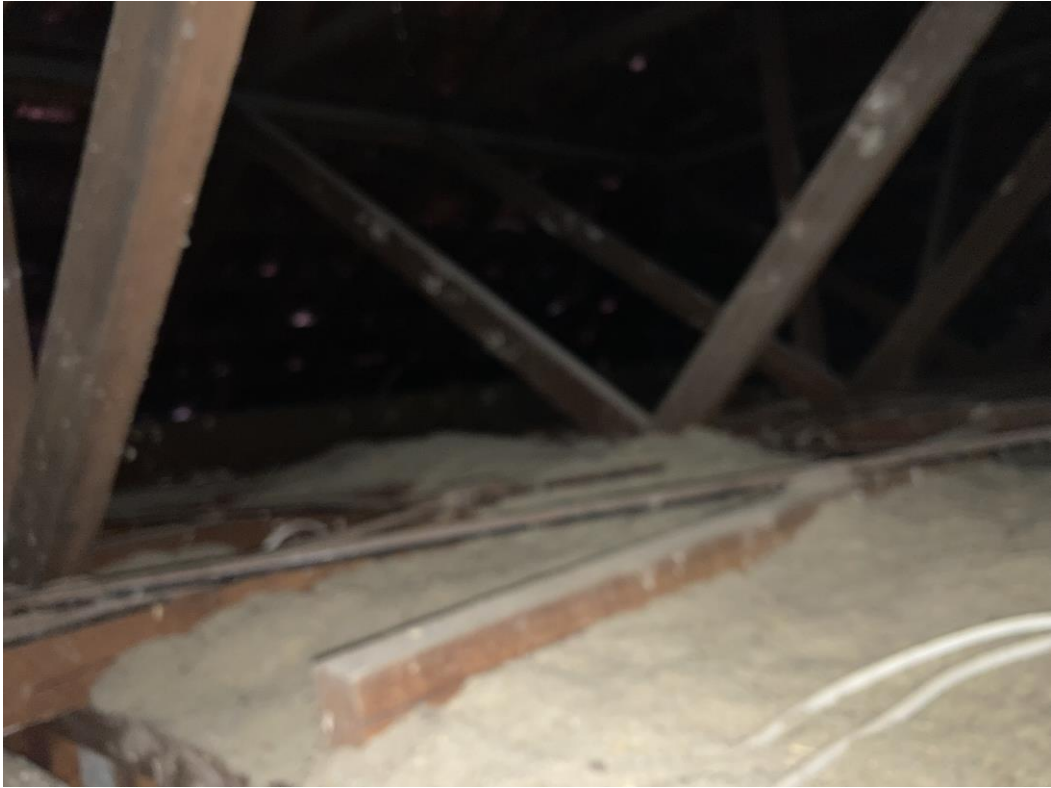
32 – Roof Frame

Due to the timber roof frame's long-term performance, it is presumed to be structurally adequate.

No foil sarking has been installed to the underside of terracotta roof tiles as a secondary moisture and thermal barrier.

The tops of the ceilings are insulated with cellose fibre.
