# Building Inspection Report

Inspection Date: Sat, 25 Jul 2020

Property Address: 25 Daren St, Beacon Hill NSW 2100, Australia

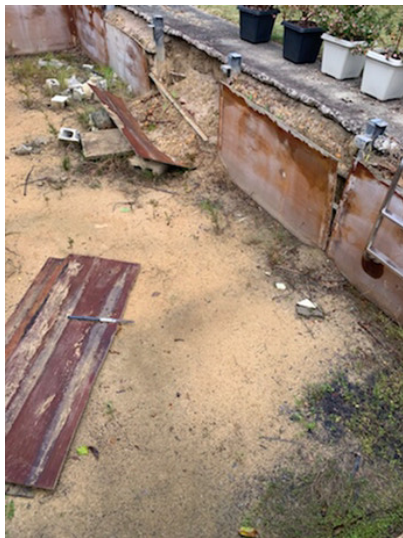
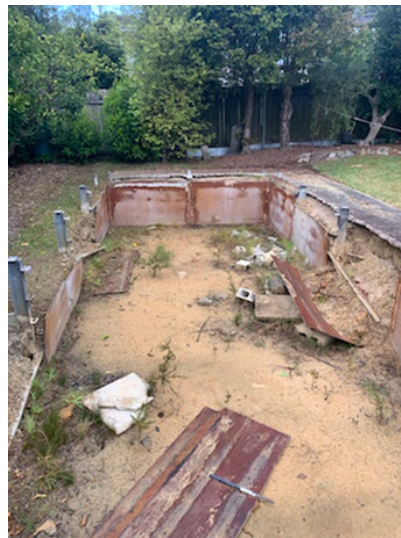
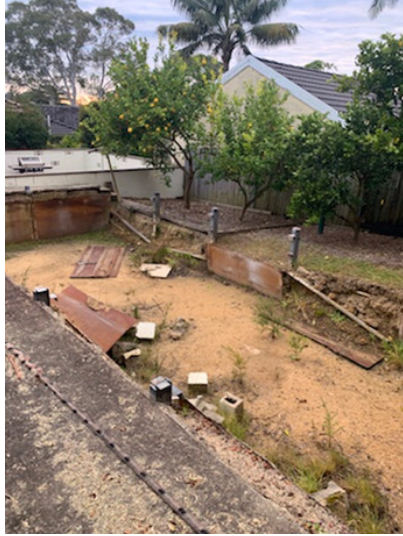
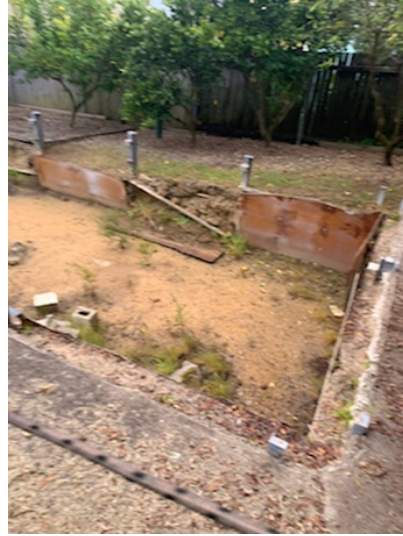
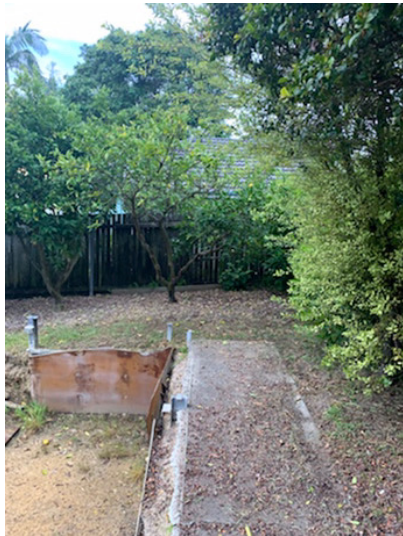
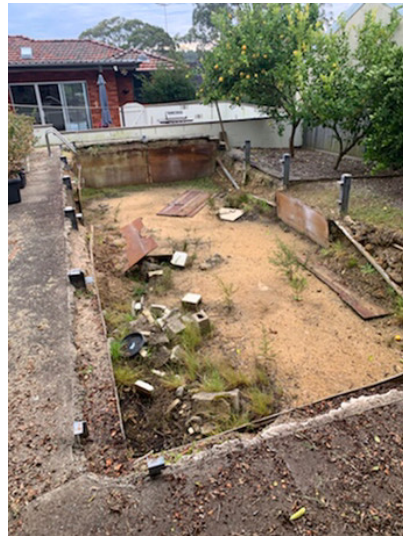
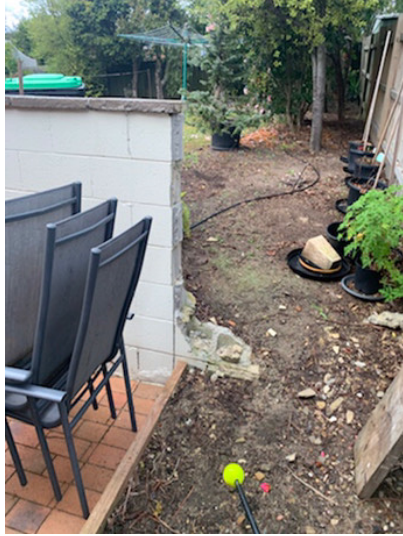
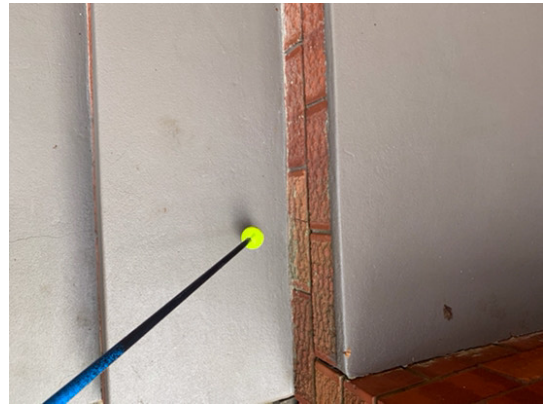
#### Defects 1.01

Building: Building 1  
Location: Yard - Back  
Finding: Incomplete or substandard works  
Information: The works to this area appear to be incomplete or have been completed to a substandard level.

Works that have not been completed to a satisfactory level create potential for the development of building defects and may impede on the safety and integrity of the overall structure.

It is recommended that the relevant trades be appointed to complete these works and ensure the safety of the area and the longevity of all associated building elements.

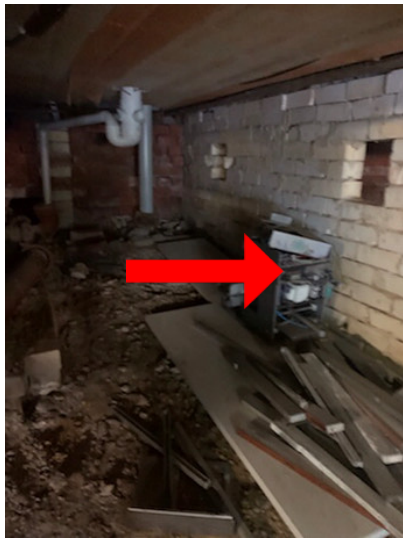
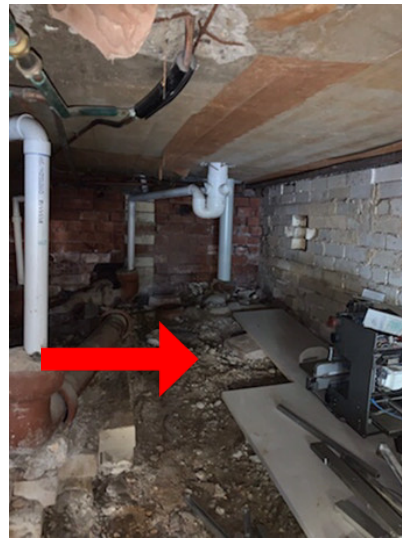
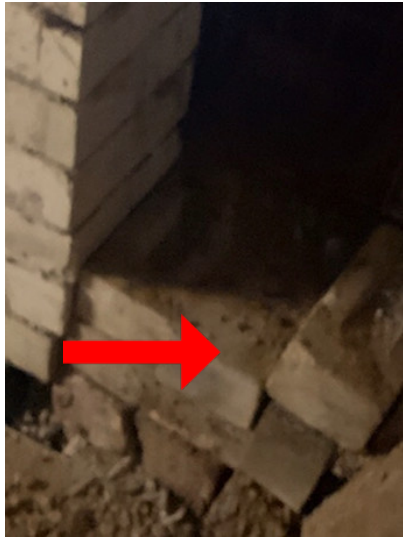
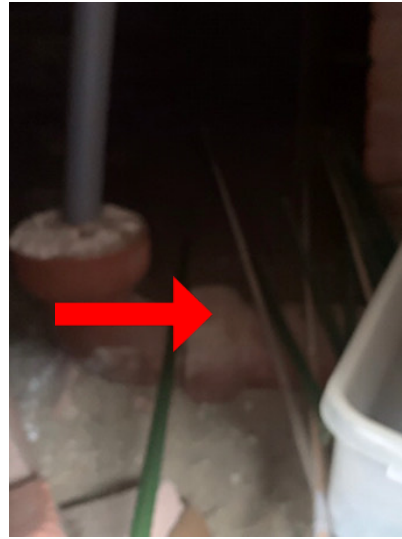
### Defects 3.01

Building: Building 1

Location: Subfloor

Finding: Subfloor - Debris

Information: An array of debris was found in the subfloor area at the time of inspection. Debris in this area restricts subfloor ventilation and creates potential for concealed pest entry. Stored timbers and other materials may also make the area susceptible to termite activity and wood rot.

A clear and empty subfloor will be better ventilated and easier to maintain in a dry condition. The removal of any timber debris is vital in minimising the risk of termite or wood borer activity.

Debris in the subfloor should be removed as soon as possible. Depending on the location and amount of debris and stored items, the homeowner may elect to undertake this task. Alternatively there are a large number of rubbish removal subcontractors that could undertake these works.

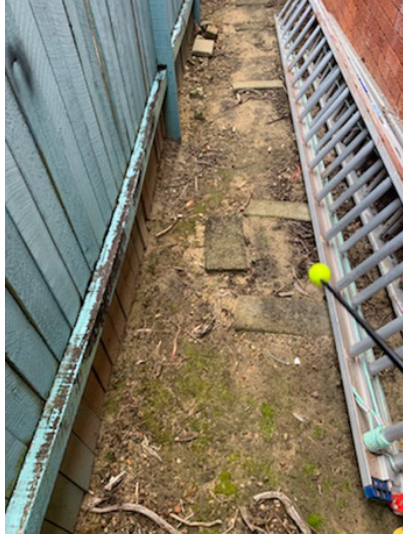
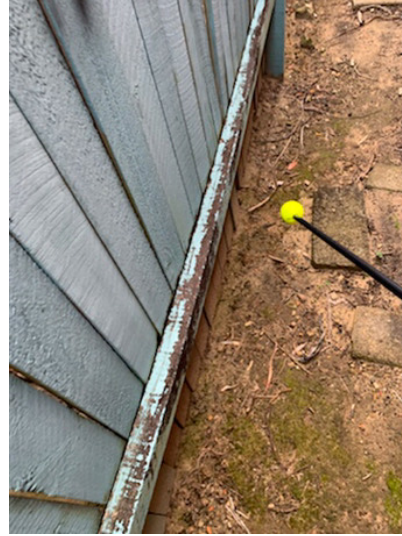
### Defects 3.02

Building: Building 1  
Location: Yard - Side  
Finding: Evidence of excessive moisture was present at the time of inspection  
Information: Excessive moisture can attract termites and produce conditions that promote termite attack fungal growth and wood decay.

Excessive moisture is generally caused by deteriorated inadequate or missing roof drainage leaking plumbing pipes or fixtures poorly plumbed HWS overflows or condenser units and poor site drainage.

It is recommended that all plumbing and drainage fixtures and fittings be maintained regularly in order to prevent excessive moisture being present in the external / internal property.

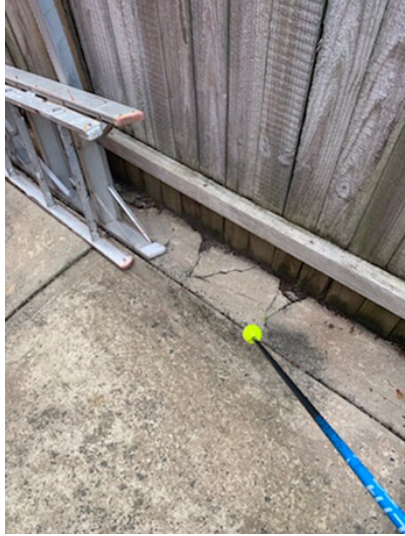
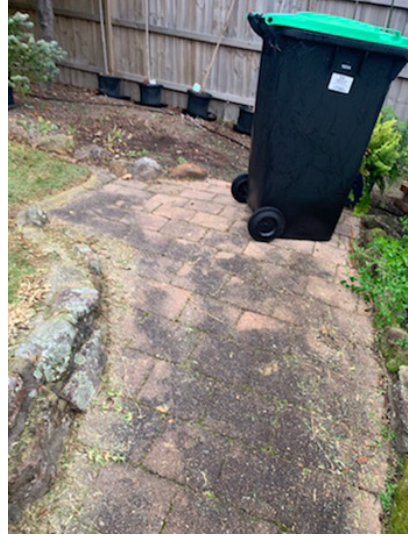
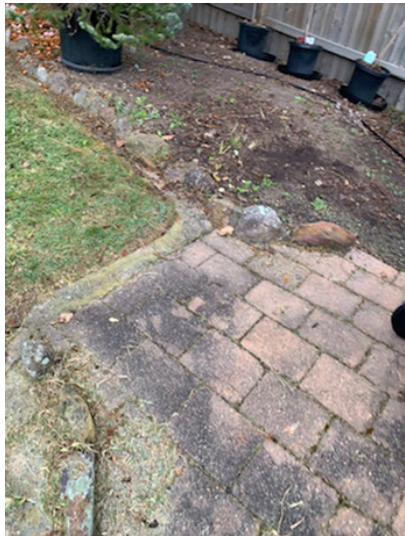
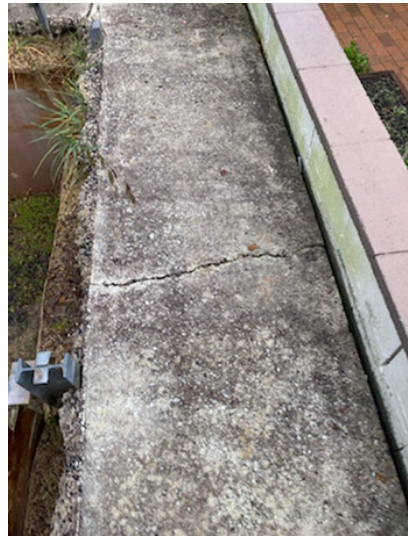
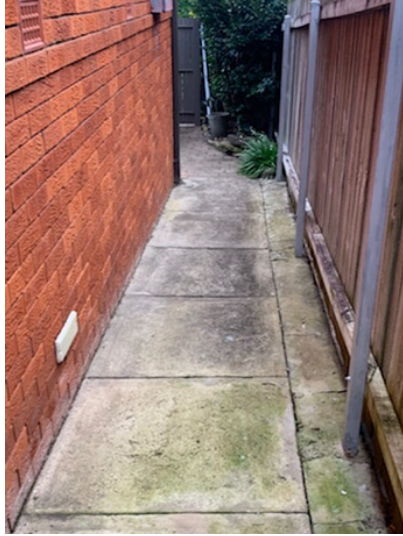
### Defects 3.03

Building:	Building 1
Location:	Yard - Back
Finding:	Cracking - External Concrete Paving Damage Category 1 - Fine (less than 2mm)
Information:	Fine cracks were identified in external concrete paving. Although fine cracks are quite noticeable, they are often only considered to be an appearance defect, and usually do not indicate any structural damage. To be considered a Category 1 or fine crack, the crack is found to be <2mm in width.

Monitoring of all cracking should be conducted frequently. Always contact a builder should cracks widen, lengthen, or become more numerous.

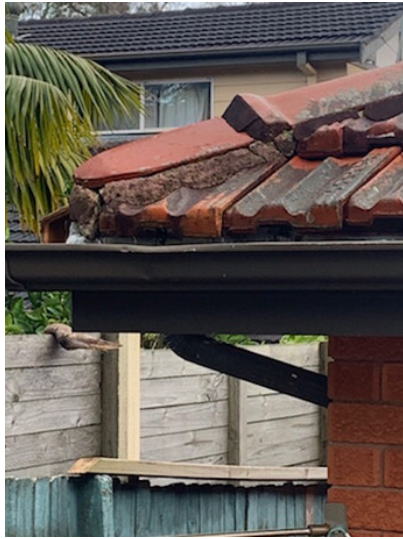
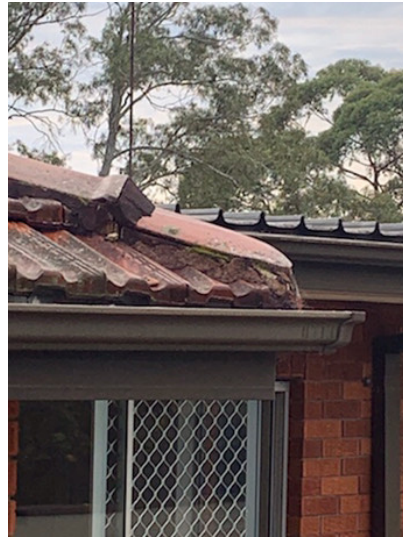
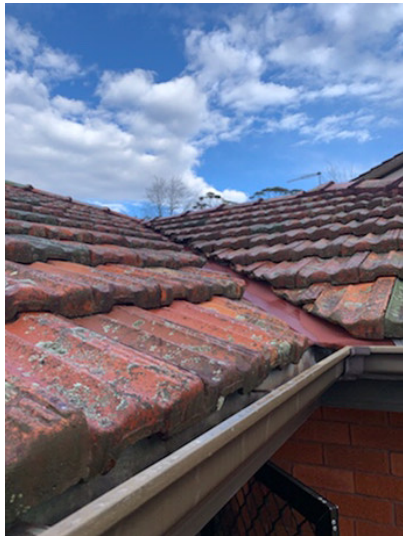
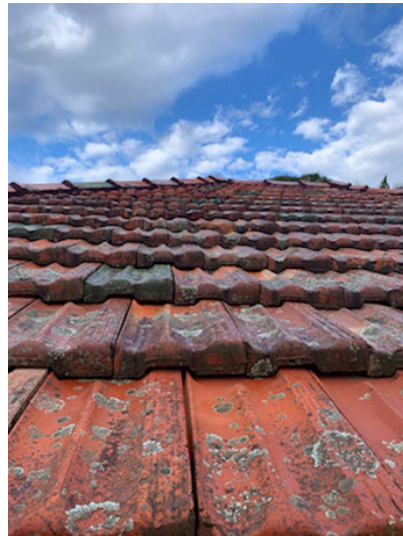
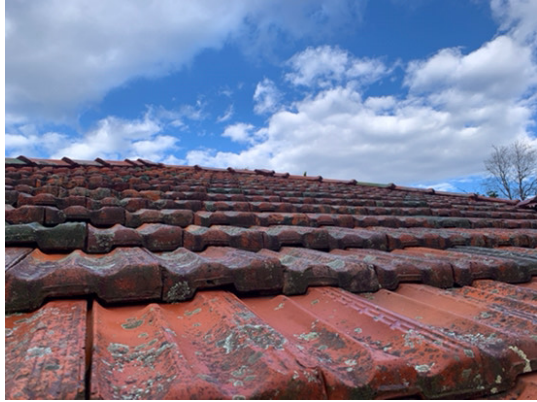
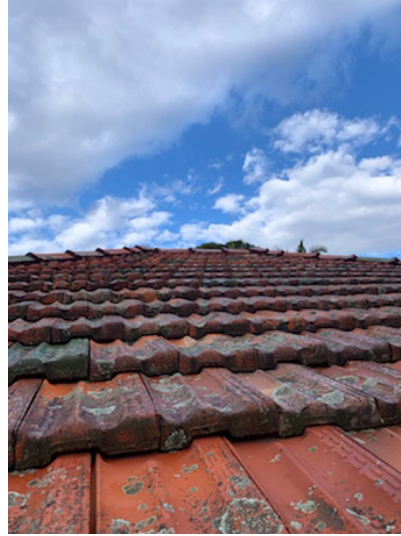
### Defects 3.04

Building:	Building 1
Location:	Roof Exterior
Finding:	Roof tiles - Weathered
Information:	Upon inspection of the exterior roofing, the roof tiles were considered to be in a fair condition. While weathering of the tiles is consistent with the age of the property, maintenance works are required.

Where left unmanaged, deteriorating roof tiles are likely to lead to a number of secondary defects, including minor water leaks and weather exposure to internal roofing structures.

Consultation with a roofing contractor is advised to gain advice on cost of remedial works that may be required in the short to medium term. Remedial works are likely to increase the longevity of the exterior roofing structure.

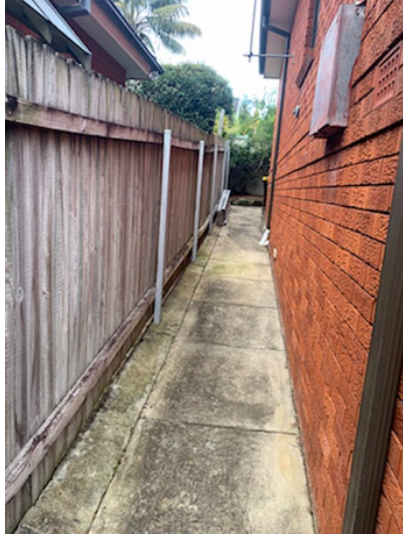
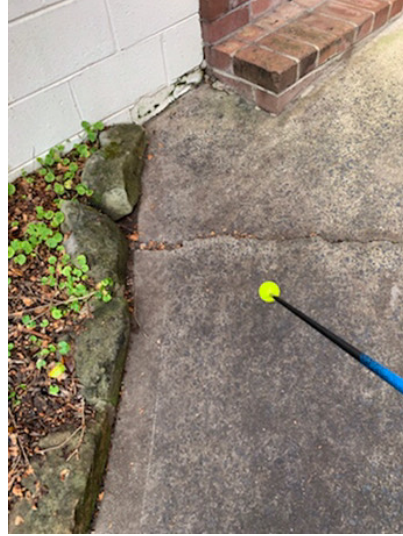
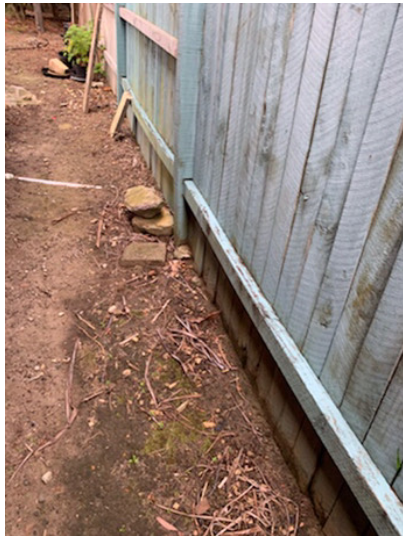
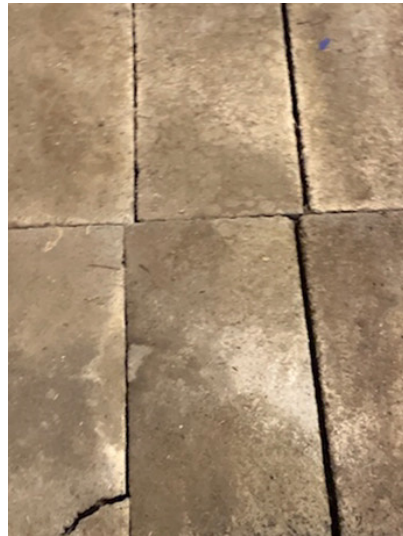
### Defects 3.05

Building:	Building 1
Location:	Yard - Side
Finding:	Surface - Requires cleaning
Information:	Regular cleaning and maintenance improves the longevity of all building elements. A build up of dirt and debris can reduce the useful life of building materials and may result in earlier replacement of items being required.

Excessive dirt is also likely to lead to secondary hazards, including potential health hazards, as the building elements begin to harbour bacteria and/or mould.

Remedial cleaning is recommended in order to improve the appearance of this area as well as to counteract the development of bacteria. Such works can be performed by a cleaning contractor and should be completed at the discretion of the client.

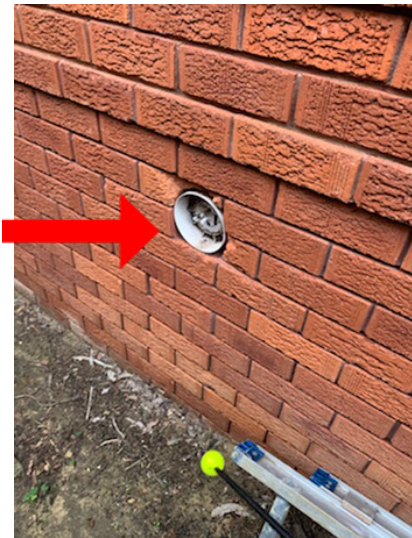
## Defects 3.06

Building:	Building 1
Location:	Yard - Side
Finding:	Electrical fitting - Broken
Information:	The electrical fitting in this area was found to be broken at the time of inspection. Breakage occurs generally when the building materials have aged and decayed, but may also be indicative of impact damage to the building element (accidental or deliberate).

Left unmanaged, the fitting is unlikely to cause further damage to surrounding building elements. However, the broken fitting does expose electrical works, and may create a safety hazard if there is potential contact with persons in the area.

Repair and/or replacement of the broken fitting is advised. A Licensed electrician should be appointed to repair/replace the fitting immediately.

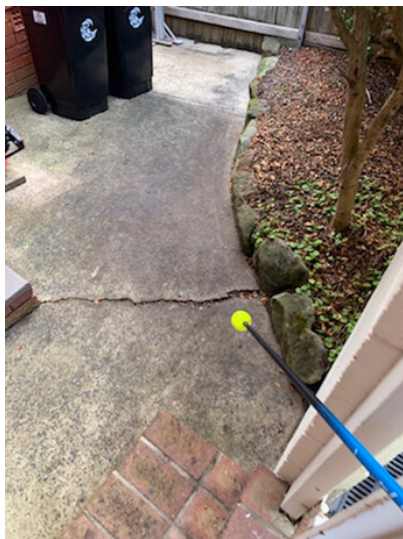
## Defects 3.07

Building:	Building 1
Location:	Yard - Front
Finding:	Subsidence - Local trees and vegetation
Information:	Trees and other vegetation can have a significant local effect on drying of soils. Over a number of years, especially during drought conditions, adjacent trees and vegetation may draw excessive moisture from the soils. The opposite may also occur, where swelling of the soil results when the trees decline or are removed.

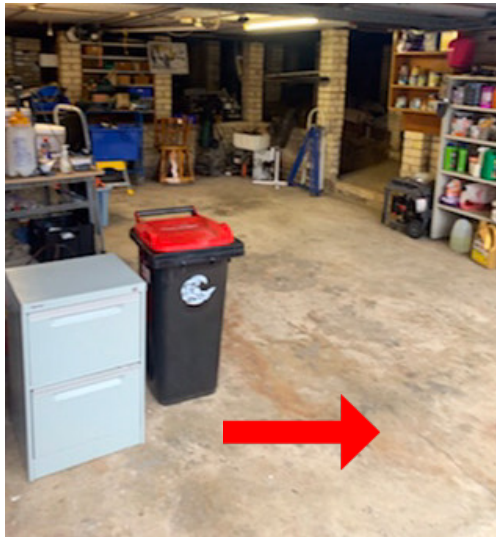
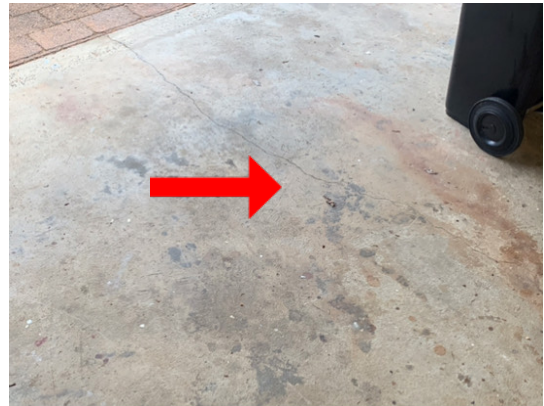
## Defects 3.08

Building: Building 1

Location: Garage

Finding: Crack in concrete slab - Category 2

Information: A crack coded as Category 2 was identified in the slab. A Category 2 crack is described as a distinct crack, with the slab being noticeably curved or changed in level.

To be considered Category 2, the approximate width of the crack is <math><1.0\text{mm}</math>, or a change in offset of <math><10\text{mm}</math> when a 3m straight edge is placed over the defect.

Category 2 cracks to slabs should be monitored for a period of 12 months. At the end of the monitoring period, cracks rated greater than Category 2 are considered defects that require rectification.

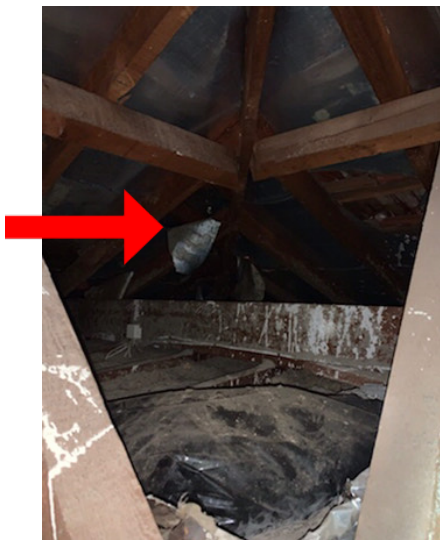
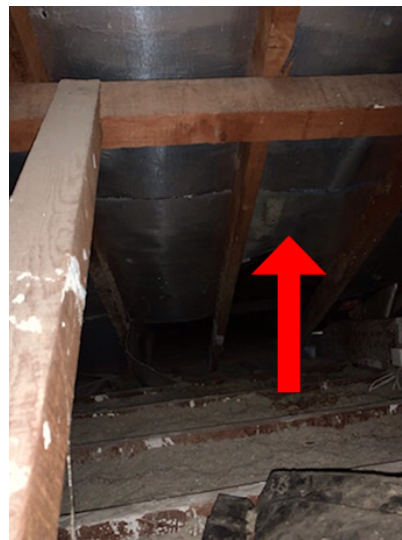
## Defects 3.09

Building:	Building 1
Location:	Roof Void
Finding:	Sarking - Damaged
Information:	Sarking, a laminated aluminium foil applied to the interior of the roof covering, assists in insulating the property and acting as a vapour-barrier to the roof void and, subsequently, to the household.

Where sarking is damaged, both insulation and moisture protection of the property are inhibited. This creates a loss of energy and thus negatively impacts the energy efficiency of the property, allowing potential for moisture ingress from condensation or leaking roof tiles.

It is important to repair any holes or damaged sections of sarking to ensure that the building material is fully functional. A registered builder or qualified carpenter should be consulted to provide further advice on this defect and to perform rectification works at client discretion.

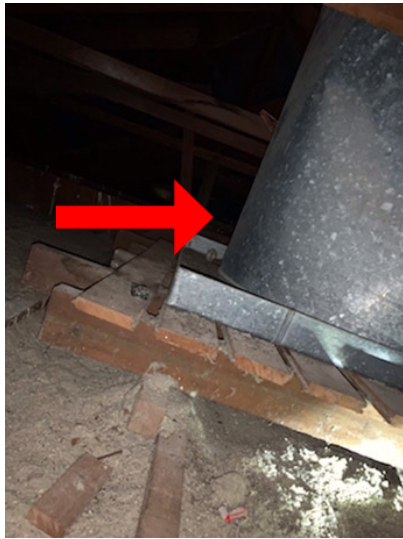
## Noted Item

Building: Building 1  
Location: Roof Void  
Finding: Gravity-Fed HWS - Disconnected  
Information: It was noted at the time of inspection that a disconnected gravity-fed hot water system (HWS) remains in this area.

Despite this plumbing structure being unused, it is likely to be storing residual water, and is therefore susceptible to rust and corrosion. If allowed to continue, rust and corrosion is likely to lead to damage to adjoining building elements, and may also make the area susceptible to termite or timber pest activity.

While it is a costly exercise to remove the disused gravity-fed HWS, it is advisable in the short-term future to prevent any further damage to the area. Further consultation with a licensed plumber is required to gain further advice on removal of the structure.
