## **VISUAL BUILDING AND PEST INSPECTION REPORT**

Vendor Report

22 Greendale Avenue, Frenchs Forest

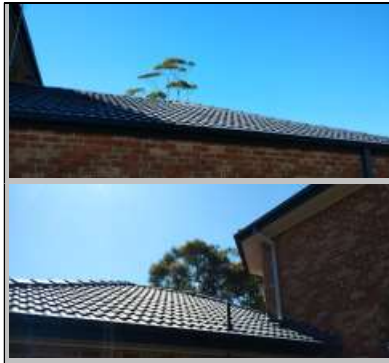
The roof is of pitched construction.

No access was possible to part of the external roof area due to the roof not being accessible from a 3.6 meter ladder.

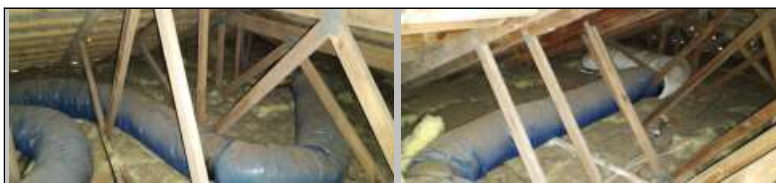
Insulation is present in the roof cavity. This restricted inspection to some roofing timbers. Removal of insulation is not within the scope of a standard visual inspection report, however as in accordance with "industry best standard" the inspector will lift insulation in 3 areas in roof void.

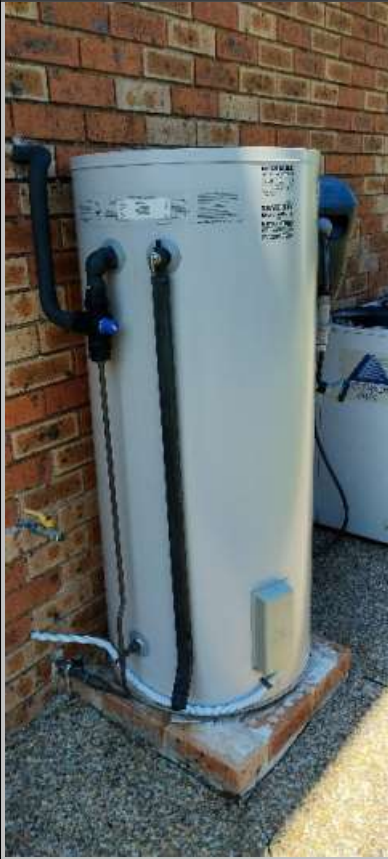
| Type/Condition: | Mains electric hot water system: Mains pressure: Located externally: The hot water system appears to be in working condition. No specific tests other than running the hot water tap were carried out. No determination has been made as to the suitability or adequacy of the hot water system in relation to capacity or otherwise. |

The unit was manufactured in 2020.

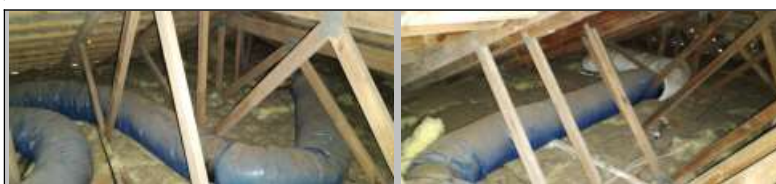
Insulation is present in the roof cavity. This restricted inspection to some roofing timbers. Removal of insulation is not within the scope of a standard visual inspection report, however as in accordance with "industry best standard" the inspector will lift insulation in 3 areas in roof void.
