Building and Timber Pest Inspection Report VR

Inspection Date: Mon, 5 Jun 2023

Property Address: 118 Westminster St, Schofields NSW 2762, Australia

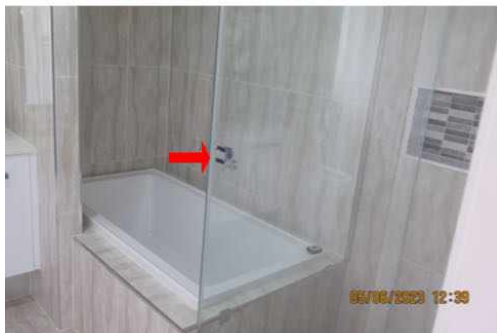
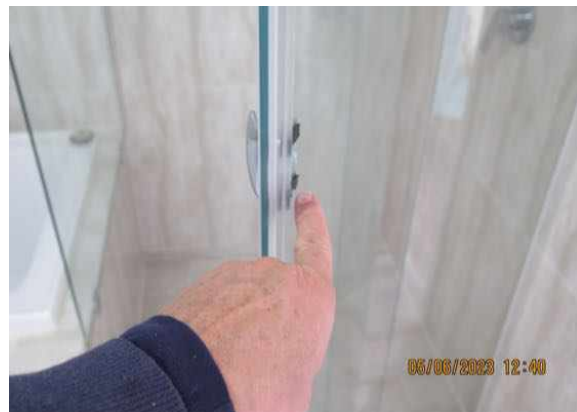
Finding 3.01

Building: Main Building
 Location: Bathroom
 Finding: Door - Broken handle
 Information: The door handle in this area was found to be broken at the time of inspection. Breakage occurs generally when the building materials have aged and decayed, but may be indicative of impact damage (accidental or deliberate).

Repair and/or replacement of the broken door handle is advised to improve the operational state of the associated door.

A qualified carpenter or general handyman should be appointed to repair/replace the door handle at the client's discretion.

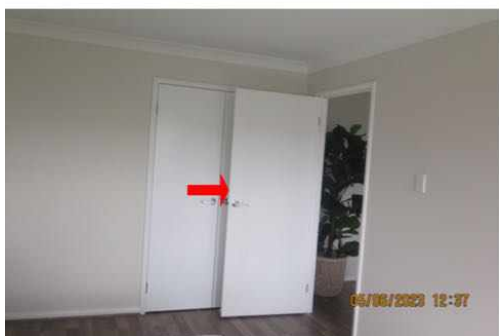
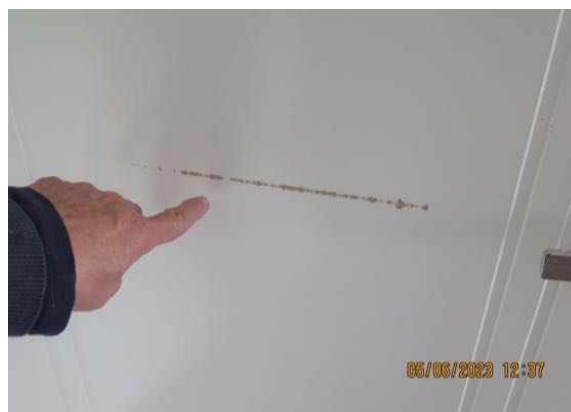
Finding 3.02

Building: Main Building
 Location: Bedroom
 Finding: Surface - Chipped
 Information: The surface of this building element appears to have chipped as a result of general wear and tear. While being an appearance defect, such damage is expected of a

property of this age and condition.

Chipped surfaces rarely impede on the structure or functionality of the affected building element and generally only create a blemish on its appearance. Chipped surfaces may be left in situ at client discretion, as no repairs or replacement are necessarily required. However, the client may wish to seek quotations for the cost of refurbishment or replacement of the identified building element.

A qualified carpenter or cabinet maker should be appointed to repair chipped surfaces and replace building elements where major damage has occurred.

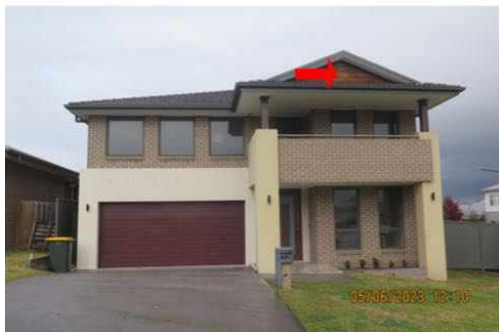
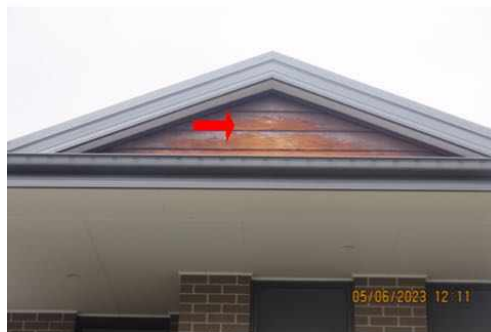
Finding 3.03

Building:	Main Building
Location:	Yard - Front
Finding:	Painted surface - Bubbling
Information:	Sections of paint in this area was found to have bubbled and deteriorated. Paint bubbling is generally an indication of excessive moisture in the area, that is currently hidden by the painted surface.

The presence of excessive moisture can have major implications on associated building elements if left unattended. While only seemingly minor at this stage, the damage cannot be determined due to the paint obstructing any further inspection of the damage.

It is highly advised that the affected paint be cleaned to allow a further, more invasive inspection by a licensed plumber. Failure to act on this defect may necessitate major works in the future.

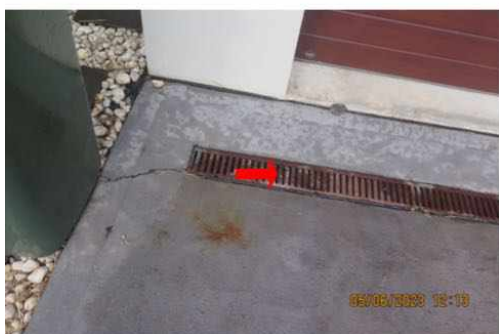
Finding 3.04

Building:	Main Building
Location:	Yard - Front
Finding:	Drain - Rusted or corroded
Information:	This building element shows evidence of rusting and corrosion, which is likely to have developed as a result of excessive exposure to moisture and or inadequate coatings.

As surface rust provides no protection to the underlying iron, the deteriorating condition is likely to worsen if not addressed in the short-term future.

Where possible, the use of galvanized (treated) metals or aluminium coated metals aid in rust prevention, as does regular general maintenance. Rust formation can be controlled with coatings, such as paint, that isolate the iron from the environment.

Rusting and corrosion should be managed by ideally removing or limiting the affected surface from exposure to moisture. A registered builder may be appointed to replace any building elements that have been severely affected by rust or water damage.

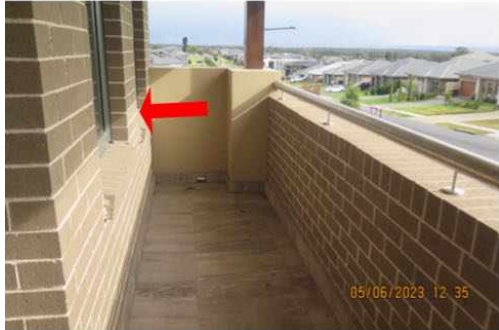
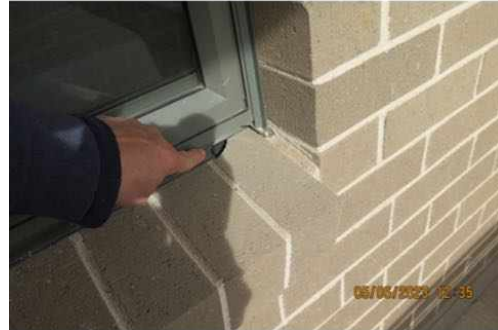
Finding 3.05

Building:	Main Building
Location:	Balcony
Finding:	Flashing - missing

Information: Flashing is required to be installed wherever walls are interrupted by openings within the cavity where the roof abuts a cavity wall or the like at the base of cavities and where masonry chimney's abut the roof. Instances where flashing is missing in locations nominated by BCA3.3.4.7 this should be reinstated.

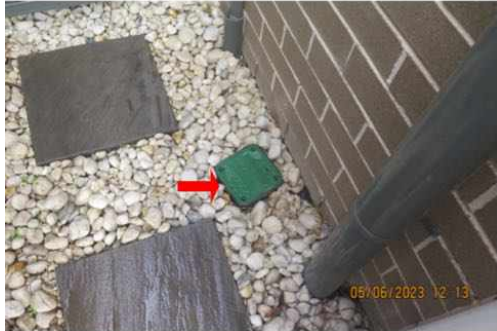
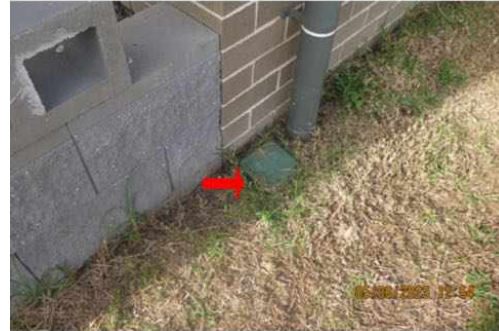
Building: Main Building
 Location: All Areas
 Finding: Evidence of a previous termite management system was identified
 Information: There are a number of factors which indicate the presence of a previously installed or applied termite barrier. The most common are a durable notice (to the inside of your meter box) observable physical barriers installed to building perimeter and in ground

reticulation systems.

Where a Termite Management System has been identified you should refer to the type of barrier date of installation warranty conditions and any documentation provided by a builder or past owner. Consult the company who installed the barrier to confirm whether the system is still under warranty.

Most chemical termite management systems expire and require replenishment and all physical systems are primarily designed to prevent concealed entry.
