Timber Pest Inspection Report

Inspection Date: Wed, 28 Aug 2019

Property Address: 18 Holland Crescent, Frenchs Forest NSW, Australia

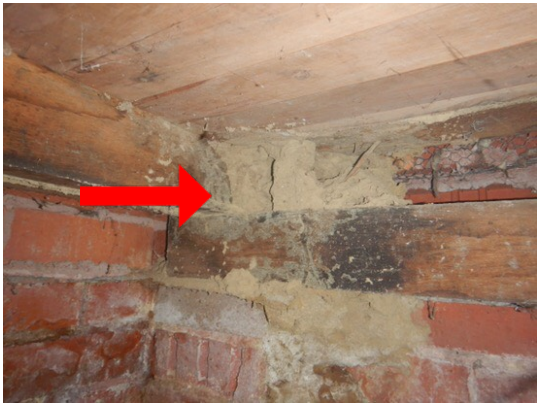
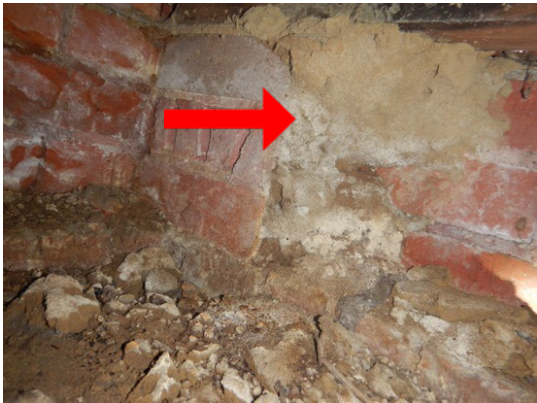
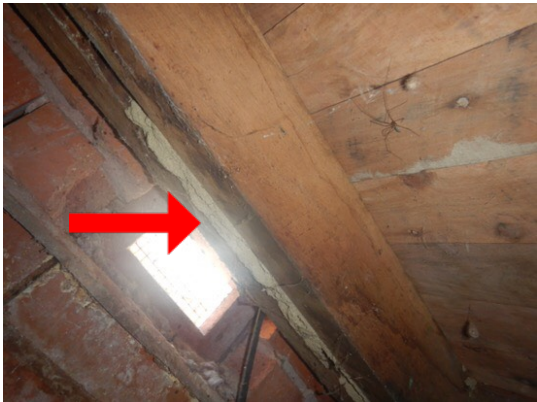
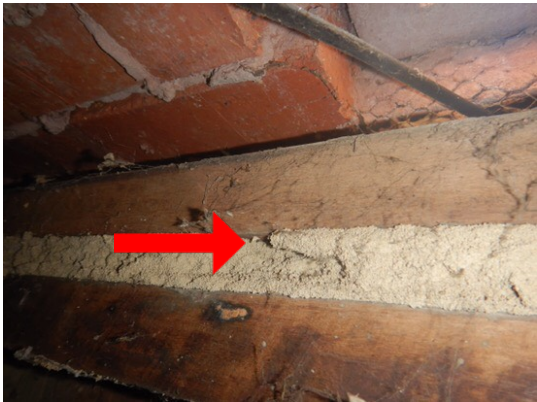
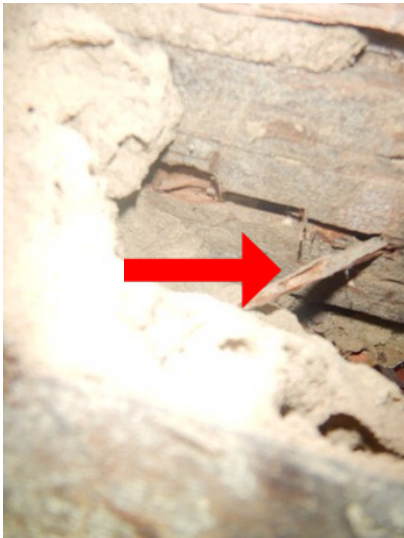
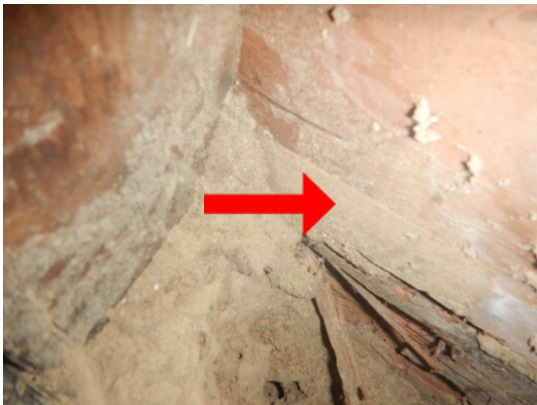
Building:	Main Building
Location:	Subfloor
Finding:	Evidence of termite damage - minor
Information:	Despite no live termite or timber pest activity being indicated, previous termite damage was found to have affected this area. This damage is considered to be inactive and is minor in nature.

It is advised that the area be visually inspected frequently to ensure that the condition of affected building materials does not worsen. At the time of inspection, damage is not structural and is only considered to be superficial.

A building contractor may be appointed to provide a further invasive inspection if further damage is evident.

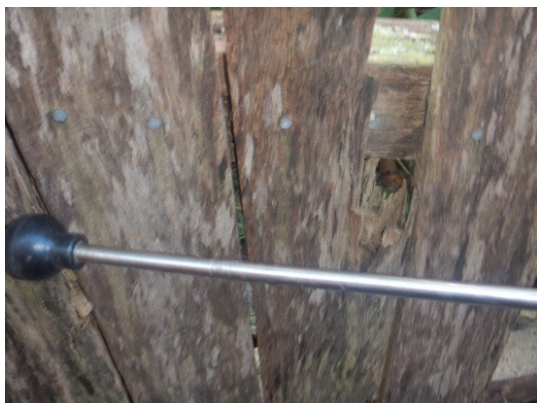
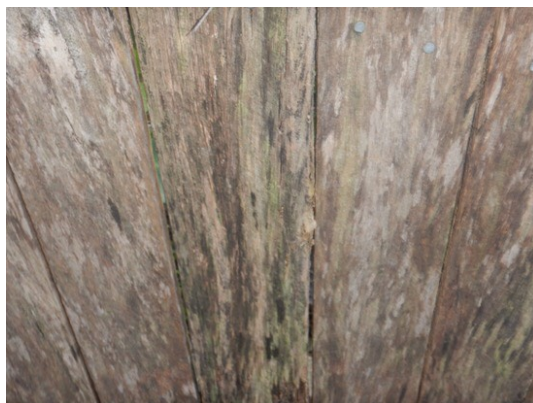
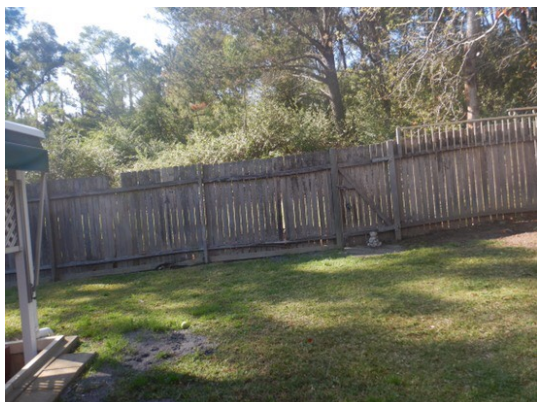
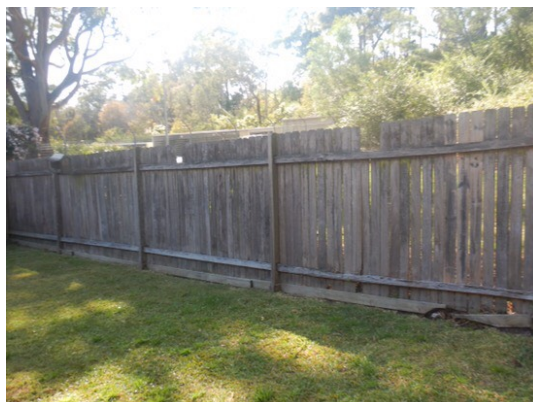
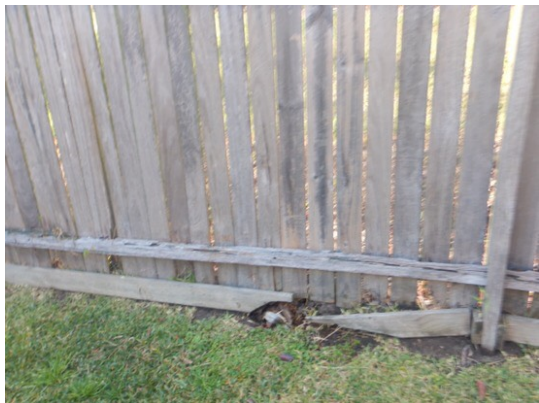
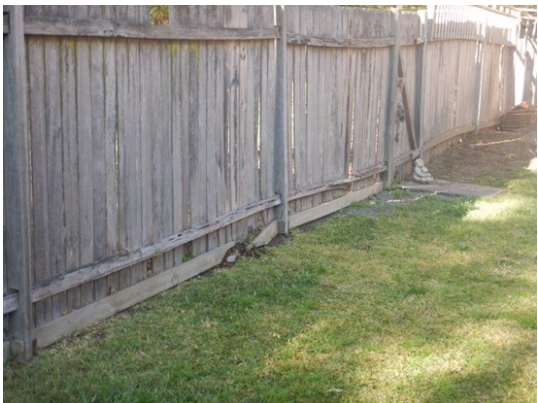
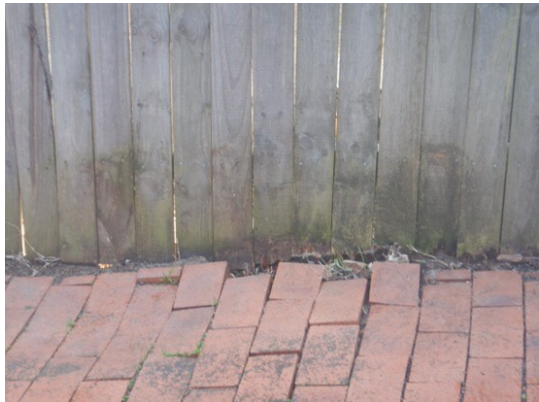
Building:	Main Building
Location:	Yard - Side
Finding:	Evidence of termite damage - minor
Information:	Despite no live termite or timber pest activity being indicated, previous termite damage was found to have affected this area. This damage is considered to be inactive and is minor in nature.

It is advised that the area be visually inspected frequently to ensure that the condition of affected building materials does not worsen. At the time of inspection, damage is not structural and is only considered to be superficial.

A building contractor may be appointed to provide a further invasive inspection if further damage is evident.

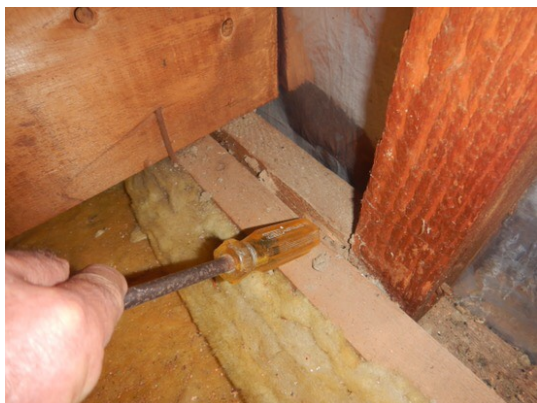
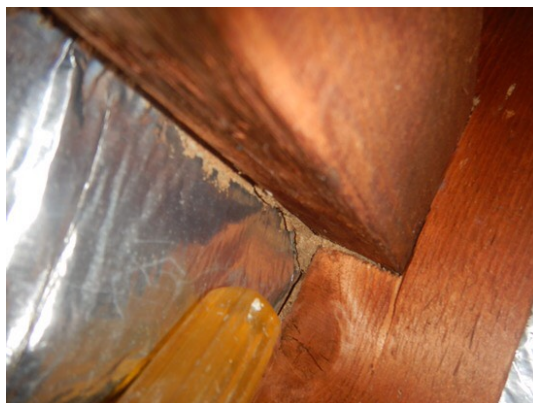
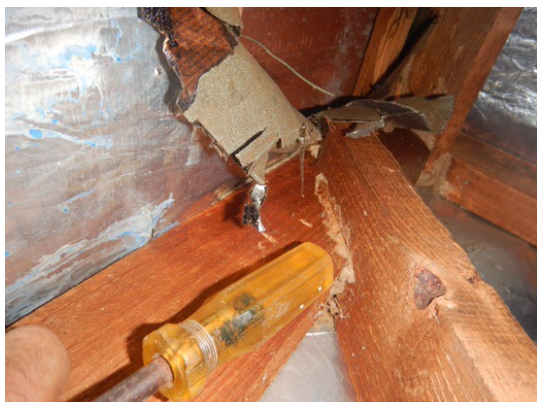
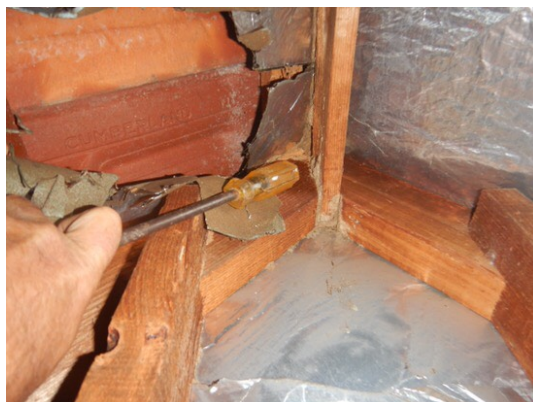
Building:	Main Building
Location:	Roof Void
Finding:	Evidence of termite damage - minor
Information:	Despite no live termite or timber pest activity being indicated, previous termite damage was found to have affected this area. This damage is considered to be inactive and is minor in nature.

It is advised that the area be visually inspected frequently to ensure that the condition of affected building materials does not worsen. At the time of inspection, damage is not structural and is only considered to be superficial.

A building contractor may be appointed to provide a further invasive inspection if further damage is evident.

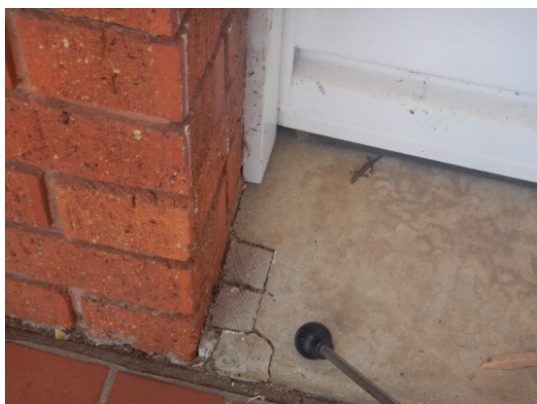
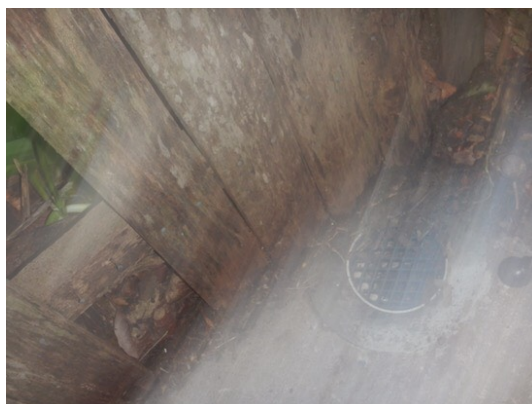
Finding: In ground contact

Information: Any timbers in direct ground contact provide opportunity for concealed termite entry and are likely to be subject to premature rot and decay as the soil retains moisture or damp conditions against the timbers.

Remove untreated timber that is in direct contact with external grounds. Consider replacement with more durable materials i.e. treated timber or non timber elements. Frequent pest inspections are advised to readily identify any termite activity in these areas.

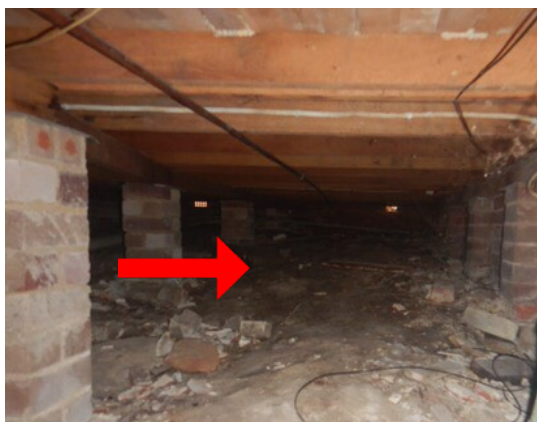
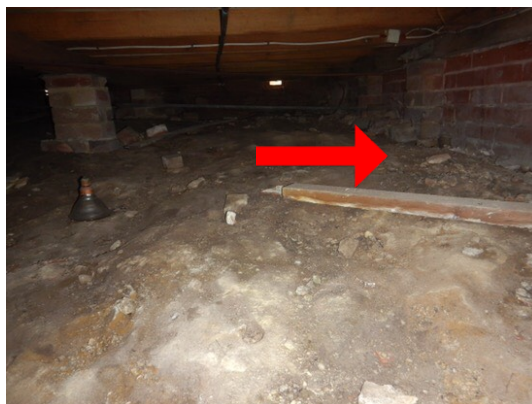
Building:	Main Building
Location:	Subfloor
Finding:	Evidence of excessive moisture was present at the time of inspection
Information:	Excessive moisture can attract termites and produce conditions that promote termite attack fungal growth and wood decay.

Excessive moisture is generally caused by deteriorated inadequate or missing roof drainage leaking plumbing pipes or fixtures poorly plumbed HWS overflows or condenser units and poor site drainage.

It is highly recommended that all plumbing and drainage fixtures and fittings be maintained regularly in order to prevent excessive moisture being present in the external / internal property.

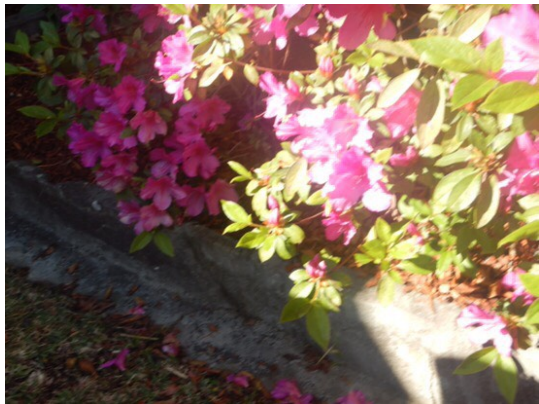
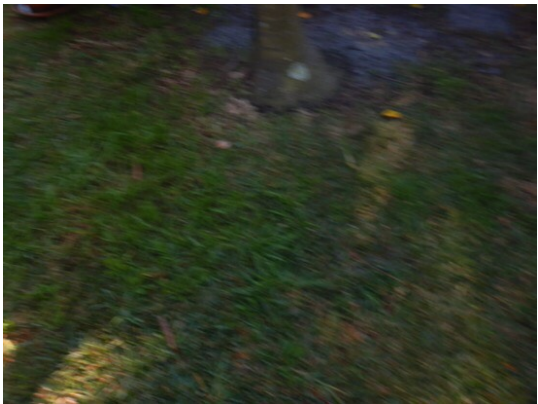
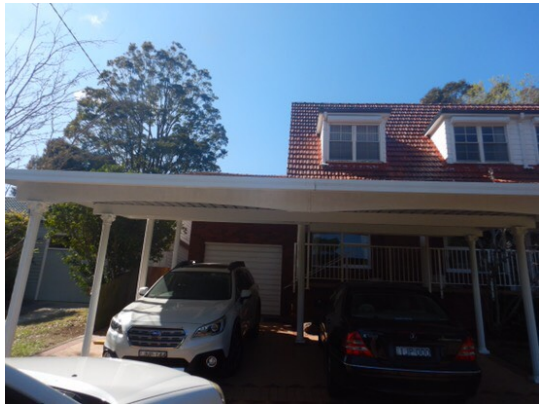
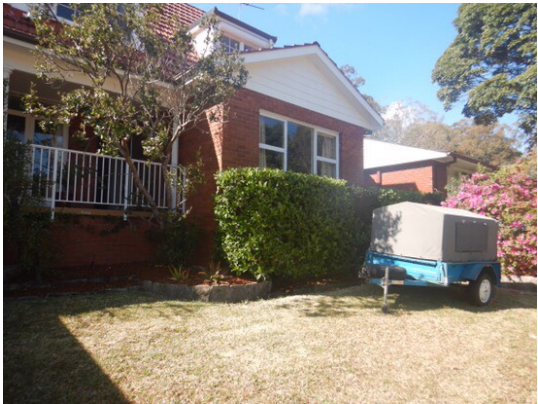
Building:
Location:
Finding: Additional Photos - Obstructions and Limitations
Information: These photographs are an indication of the obstructions and limitations which impeded full inspection of the property at the time of inspection.

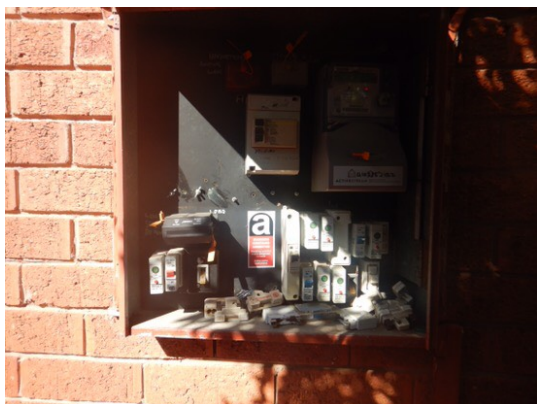
Finding: Termite Management System - no evidence of installation

A durable notice should be placed in the switchboard unit to indicate current termite barriers. At the time of inspection, it appeared as though no termite management system has been installed, with no evidence to suggest preventative works taking place.

Information: The application of a post-construction chemical termite barrier is highly recommended for all properties, particularly if live termite activity has been found on the site previously. Such barriers are highly effective in preventing termite attack on any timber building elements throughout the property.

The client may consider gaining further advice from a pest controller as to the costs and procedures involved with this application. It is recommended that obtaining such advice be a short-term priority.
