## Building and Timber Pest Inspection Report

Inspection Date: Wed, 2 Jun 2021

Property Address: 69 Iris St, Frenchs Forest NSW 2086,  
Australia

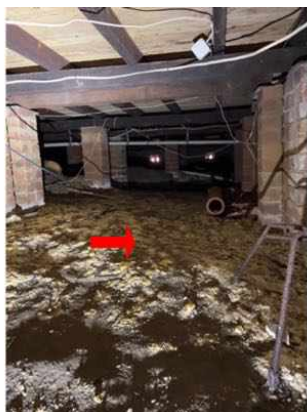
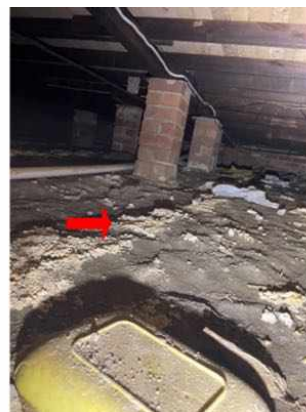
#### Defects 1.01

| Information: | Where evidence of mould growth was noted, there may be environmental, biological or health issues associated with the report. A specialist inspection by a suitably qualified environmental health inspector is warranted, where mould is extensive or where any queries regarding air quality spores or other related issues apply. |

Generally, the client is advised to ensure that the general environment is free of moisture and humidity to aid in the prevention of mould formation and development. Any mould found during the inspection should be cleaned immediately by a cleaning contractor or the homeowner as applicable.

Please note that severely affected building elements may require replacement by a registered builder or qualified carpenter.

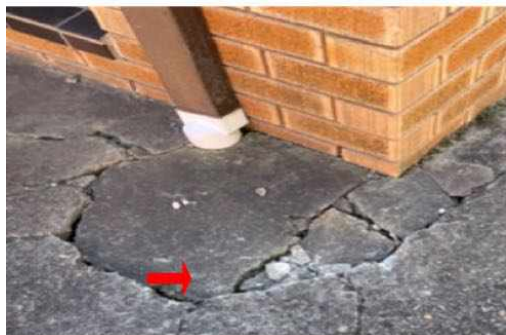
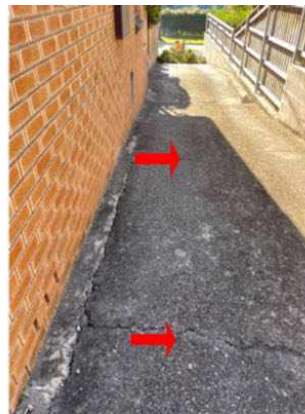
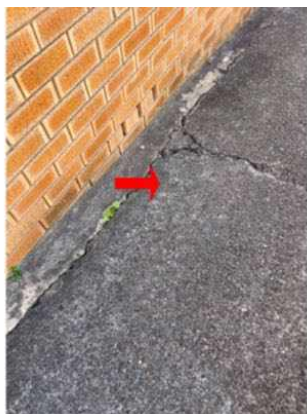
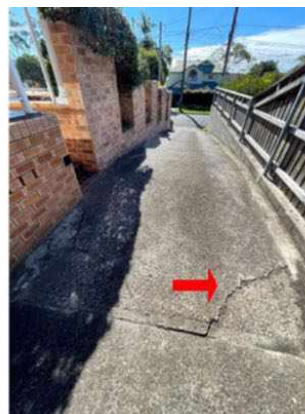
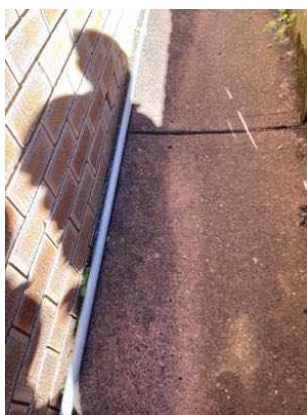
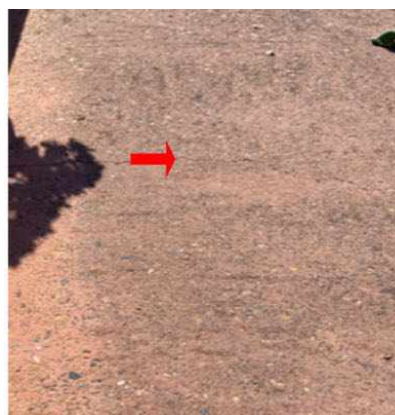
#### Defects 3.01

| Finding: | Crack in concrete slab - Category 3 |

Information: A crack coded as Category 3 was identified in the slab. A Category 3 crack is described as a wide crack with obvious curvature or change in level, affecting the slab.

The approximate width of the crack to be considered Category 3 is greater than 2.0mm, or a change in offset of 15-25mm when a 3m straight edge is placed over the defect.

Category 3 cracks to slabs exceed allowable Standards and Tolerances, and are considered defects requiring rectification.

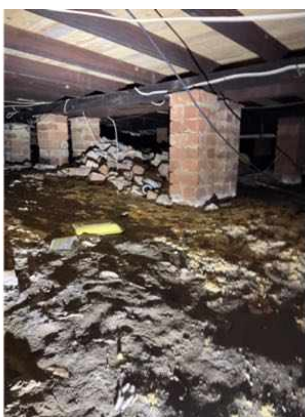
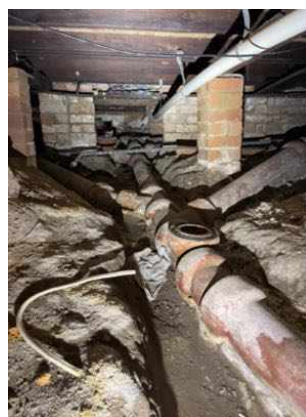
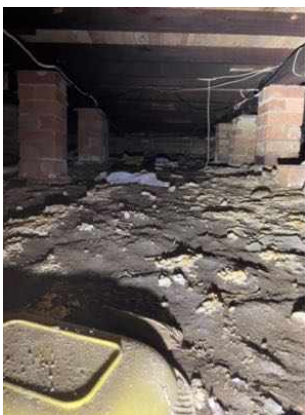
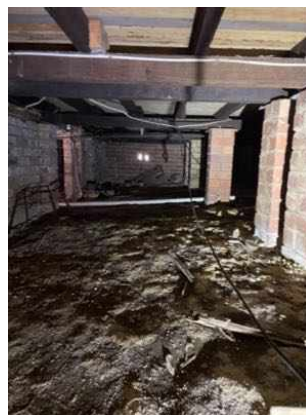
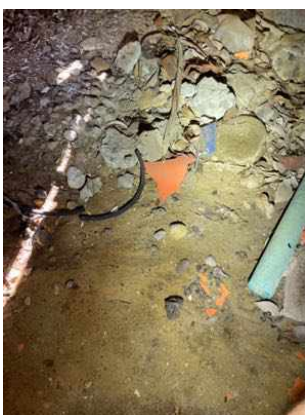
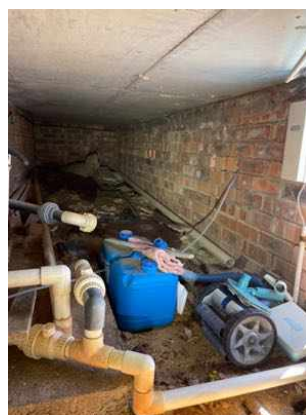
## Defects 3.02

Building: Building 1  
 Location: Subfloor

Finding: Evidence of excessive moisture was present at the time of inspection

Information: Excessive moisture can attract termites and produce conditions that promote termite attack fungal growth and wood decay.

Excessive moisture is generally caused by deteriorated inadequate or missing roof drainage leaking plumbing pipes or fixtures poorly plumbed HWS overflows or condenser units and poor site drainage.

It is highly recommended that all plumbing and drainage fixtures and fittings be maintained regularly in order to prevent excessive moisture being present in the external / internal property.

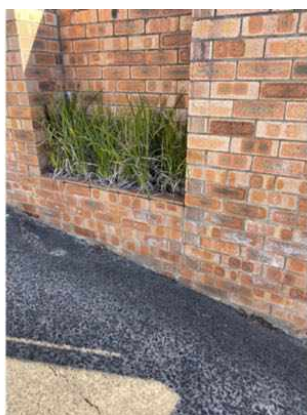
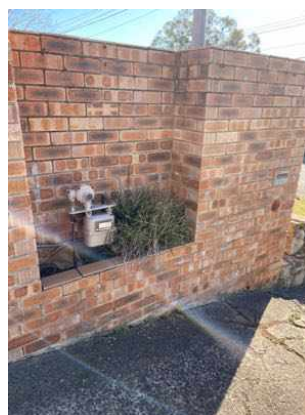
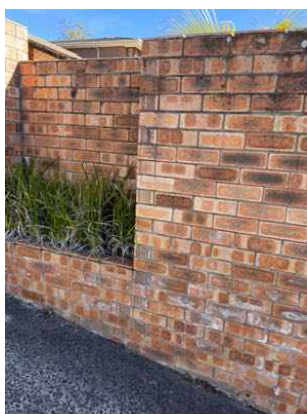
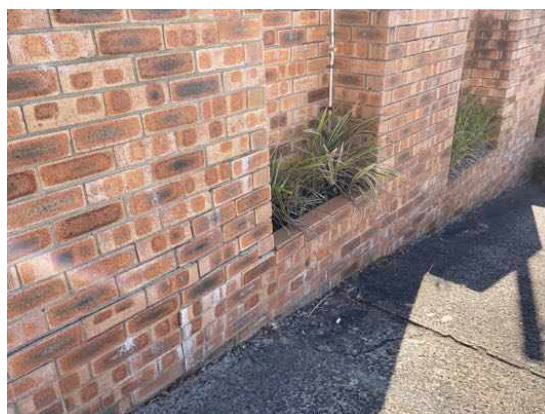
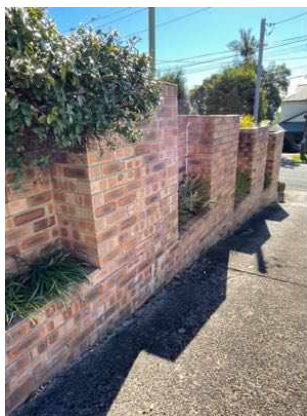
## Defects 3.03

| Information: | Trees and other vegetation can have a significant local effect on drying of soils. Over a number of years, especially during drought conditions, adjacent trees and vegetation may draw excessive moisture from the soils. The opposite may also occur, where swelling of the soil results when the trees decline or are removed. |

As the cumulative moisture deficient is reversed, the surface level around the tree (and adjoining subfloor) will rise and expand laterally. This is often damaging to buildings unless the foundations have been strengthened or designed to cope with the effect.

Subsidence can have complex and varying causes, which will influence the required remedial works. It is advised to begin by consulting a structural engineer to determine the required scope of works. This generally includes some form of underpinning, as well as addressing the underlying cause. Consultation with a geotechnical engineer may also be necessary.

A registered builder specialising in re-stumping would then generally carry out works as advised by an Engineer.

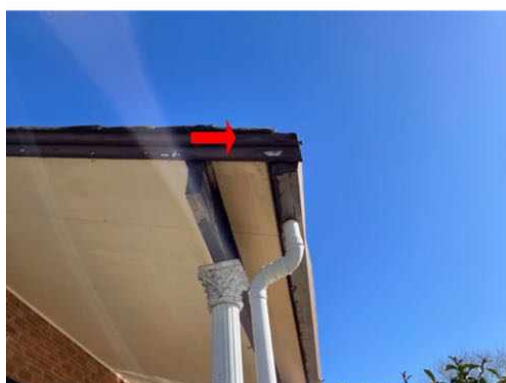
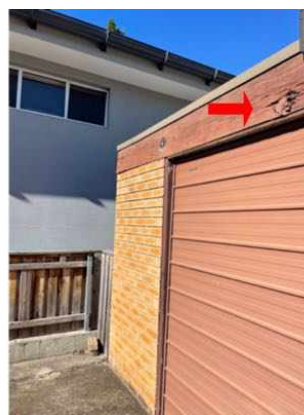
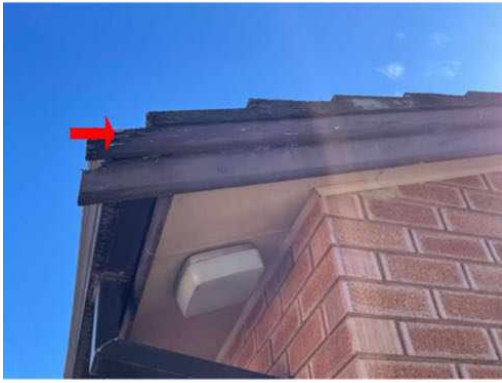
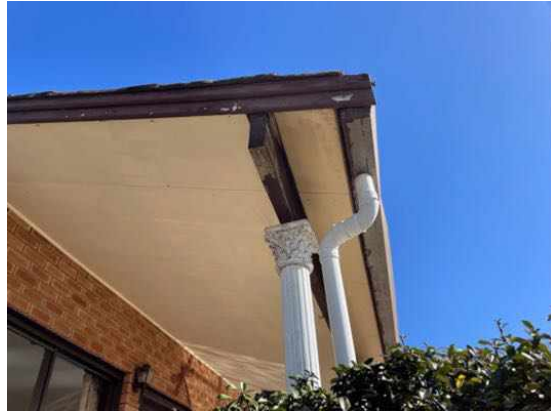
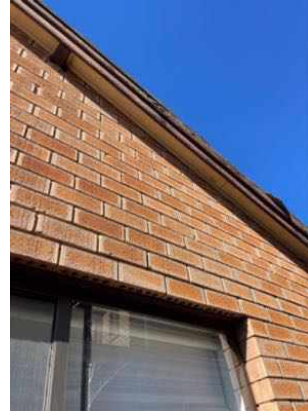
### Defects 3.04

| Finding: | Wood rot |
| Information: | This building element shows evidence of wood rot. Wood rot, also known as Fungal Decay, occurs when timbers and other cellulose building materials are exposed to damp conditions on an ongoing basis. This could be the result of exposure to weathering over a prolonged period of time, or the attraction of excessive moisture from other abutting building materials. Contributing factors also include poor air ventilation in the area. |

Early intervention and regular maintenance, particularly of exterior timbers, will prolong the useful life of these building elements. Prior to any works being performed, the cause of the moisture that has created the visible wood rot should be identified and addressed in a suitable manner. Replacement of affected timbers may then be a necessary step in protecting surrounding building elements from such deterioration.

A qualified carpenter or registered builder may also be required to replace affected building materials.

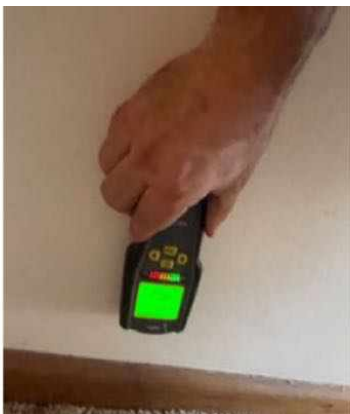
### Defects 3.05

| Finding: | Suspected water leak - Internal |
| Information: | A suspected water leak was found in this area at the time of inspection. Internal water leaks can be detrimental to surrounding building elements; their potential causes include damage to plumbing fittings and fixtures, through to water damage and deterioration of associated building elements. It is highly advised that internal water leaks be addressed by a licensed plumber as a matter of relative urgency. |

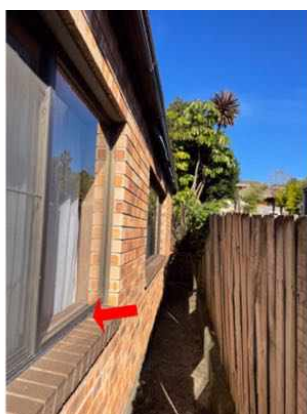
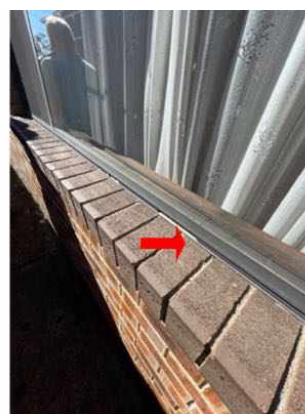
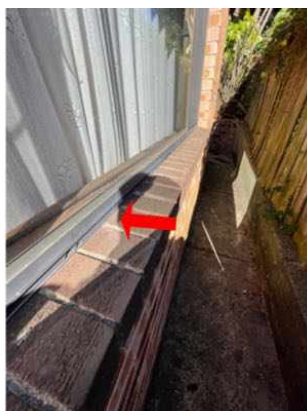
### Defects 3.06

Finding: Window seals - deteriorated

Information: The window seals have deteriorated and are in a generally poor condition. Due to frequent exposure to weather conditions and subsequent moisture, deterioration of window seals is expected in a property of this condition and age.

Where window seals have deteriorated, the window is no longer weather-tight; rain penetration and subsequent water damage is therefore likely to ensue. Insulation of the area against external weather conditions will also be compromised.

It is recommended that all deteriorated window seals be replaced by a general handyman or sealant expert to prevent any further damage and to restore the window to a fully functional level.

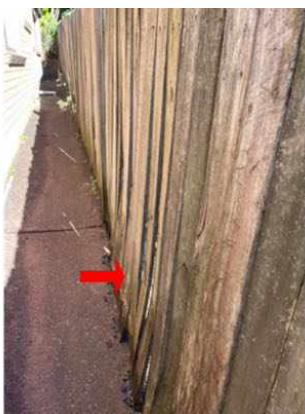
### Defects 3.07

Finding: Fencing - Deteriorated

Information: It was noted at the time of inspection that sections of the fencing throughout the property have deteriorated. Typically fencing deteriorates due to age and or wear, rot and or rust which is generally expected for a structure of this age, due to prolonged

exposure to weather conditions. Sometimes inadequate installation or maintenance can be to blame.

If left unattended, it is likely that further damage will occur. It is suspected that repair of several elements of the fencing may be required however replacement may be a consideration of the client also.

A licensed fencing contractor should be appointed to provide further advice and perform rectification works as necessary.

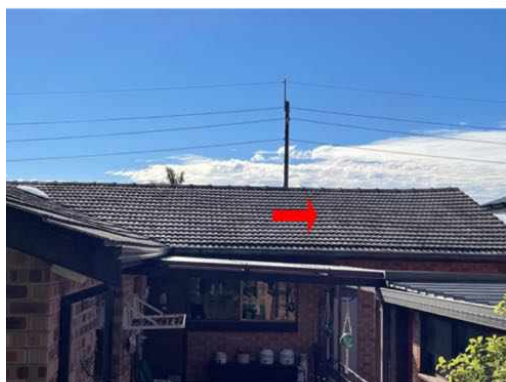
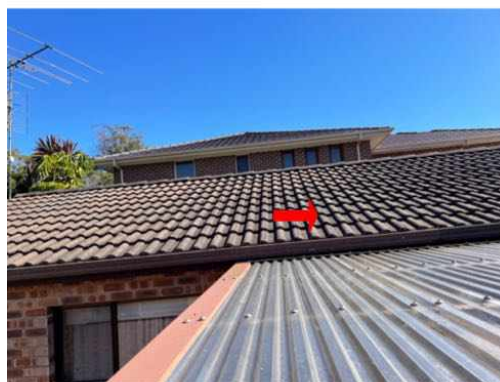
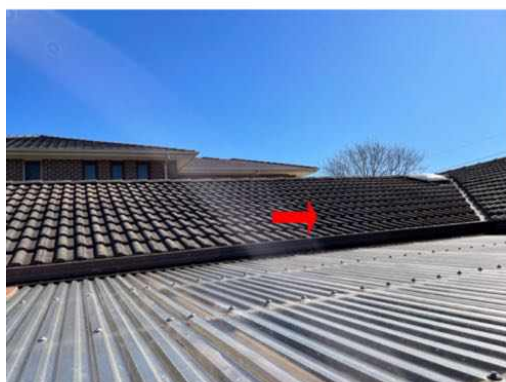
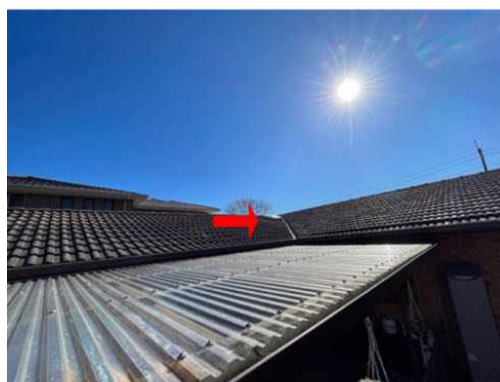
### Defects 3.08

| Information: | Upon inspection of the exterior roofing, the majority of roof tiles were considered to be in a fair condition. While weathering of the tiles is consistent with the age of the property, maintenance works are required. |

Isolated areas of mortar have come loose in the valleys and minor cracking is also present. Re-pointing and re-sealing the may be considered as an interim solution by the client to help preserve and extend the life span of the tiles.

Where left unmanaged, deteriorating roof tiles are likely to lead to a number of secondary defects, including minor water leaks and weather exposure to internal roofing structures.

Consultation with a roofing contractor is highly advised to gain advice on cost of remedial works that may be required in the short to medium term. Remedial works are likely to increase the longevity of the exterior roofing structure.

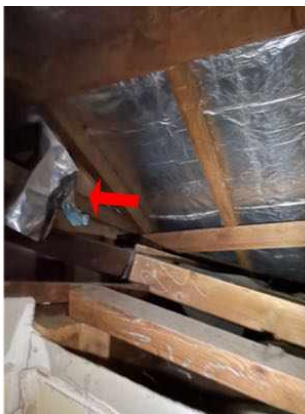
### Defects 3.09

| Finding: | Sarking - Damaged |

Where sarking is damaged, both insulation and moisture protection of the property are inhibited. This creates a loss of energy and thus negatively impacts the energy efficiency of the property, allowing potential for moisture ingress from condensation or leaking roof tiles.

It is important to repair any holes or damaged sections of sarking to ensure that the building material is fully functional. A registered builder or qualified carpenter should be consulted to provide further advice on this defect and to perform rectification works at client discretion.

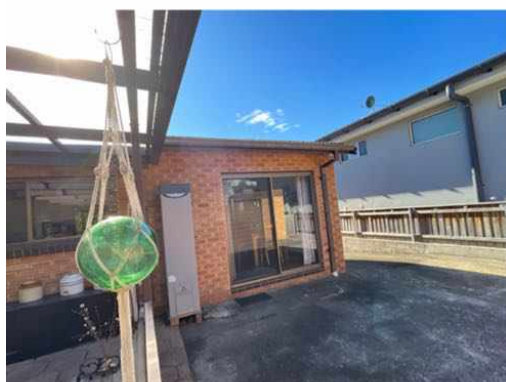
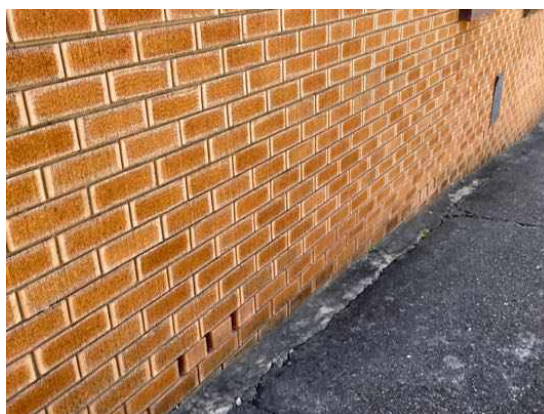
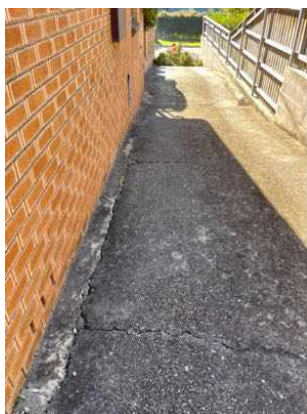
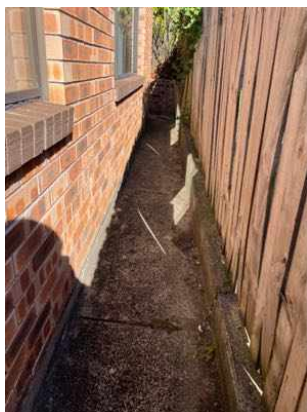
### Defects 3.10

| Finding: | Site drainage - Inadequate |
| Information: | The site drainage in this area was found to be inadequate at the time of inspection, creating potential for subsequent water damage to associated building elements. |

It is important that water does not lie against the base of walls; surrounding paths and ground levels should be sloped to drain water away from walls. Downpipes should not discharge stormwater onto lower walls or plinths. Stormwater should be carried away by large, regularly cleaned drains. Ground levels may need to be lowered to expose a buried DPC.

Where site drainage is inadequate, installation of an Agricultural (Aggie) Drain may be required. A qualified plumber should be appointed to further inspect the property and perform any remedial works as necessary. Water damage and secondary defects are likely to occur if left unmanaged.

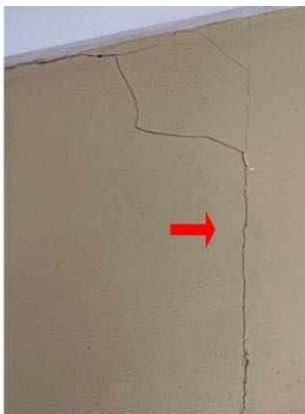
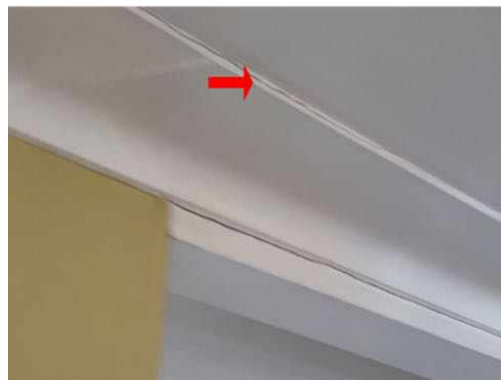
### Defects 3.11

| Finding: | Cracking - Damage Category 0 - Hairline (less than 1mm) |
| Information: | Hairline cracks are very minor in nature and generally are only ever an appearance defect. While such cracking may be noticeable in some cases, it is quite common and does not indicate any structural damage. |

Cracking of this nature can generally be repaired with minor sanding, filling and/or repainting. Such works should be performed by a qualified painter or a general handyman.

Monitoring of all cracking should be conducted frequently. Always contact a building inspector should cracks widen, lengthen, or become more numerous.

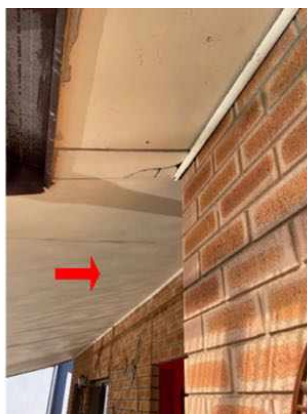
### Defects 3.12

| Information: | Sections of paint in this area was found to have bubbled and deteriorated. Paint bubbling is generally an indication of excessive moisture in the area, that is currently hidden by the painted surface. |

The presence of excessive moisture can have major implications on associated building elements if left unattended. While only seemingly minor at this stage, the damage cannot be determined due to the paint obstructing any further inspection of the damage.

It is highly advised that the affected paint be cleaned to allow a further, more invasive inspection by a licensed plumber. Failure to act on this defect may necessitate major works in the future.

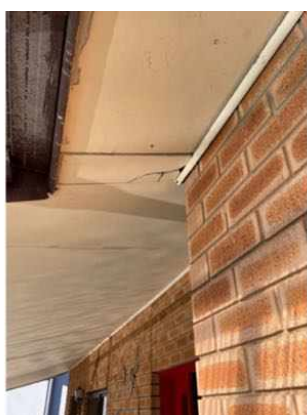
### Defects 3.13

| Finding: | Eaves - Damaged |
| Information: | The eaves around the external property were found to be in a visibly poor condition. The damage may have been sustained as a result of a number of possible causes, including poor roof drainage, leaking roof plumbing or minor impact damage. |

The damage to the eave sheeting in this area detracts from the appearance of the structure, as well as potentially compromising the structural integrity of the roofing area.

Where eaves show moderate to severe damage, remedial works may be required. Where water damage is suspected as being the underlying cause, appointment of a licensed plumber is advised as a matter of urgency to identify the source of the water leak.

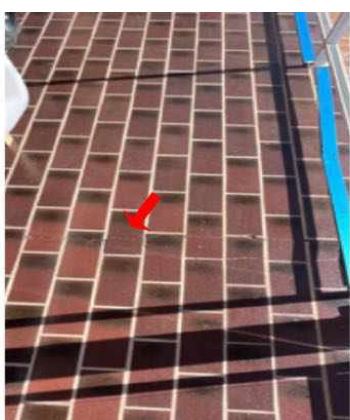
### Defects 3.14

| Finding: | Tiles - Cracked or damaged |

**Information:** Cracking was evident to the tiling in this area at the time of inspection. While the cracking appears to be minor, this area is frequently exposed to water, allowing potential for water penetration into adjoining sections of walls or flooring.

If left unmanaged, water penetration to these areas may lead to subsequent water damage, which is likely necessitate repair work to affected building elements.

A tiling contractor should be appointed to ensure that no further water damage occurs. The re-application of silicone and grouting throughout remaining tile work is also advised, to further protect the area against water penetration.

Where water penetration has led to water damage, appointment of a relevant tradesperson may be required to repair damaged building elements.

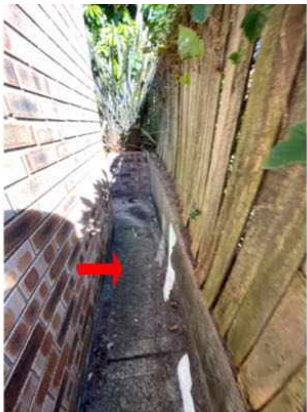
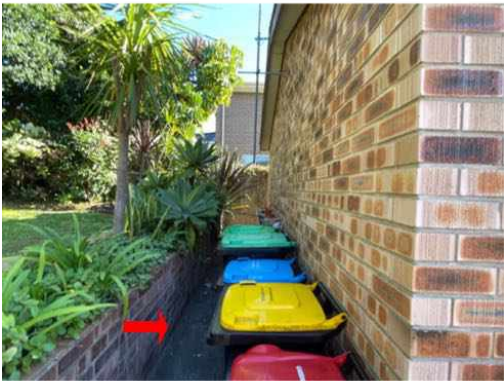
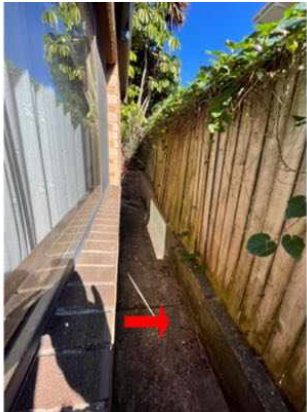
### Defects 3.15

**Building:** Building 1

**Finding:** Evidence of excessive moisture was present at the time of inspection

**Information:** Excessive moisture can attract termites and produce conditions that promote termite attack fungal growth and wood decay.

Excessive moisture is generally caused by deteriorated inadequate or missing roof drainage leaking plumbing pipes or fixtures poorly plumbed HWS overflows or condenser units and poor site drainage.

It is highly recommended that all plumbing and drainage fixtures and fittings be maintained regularly in order to prevent excessive moisture being present in the external / internal property.

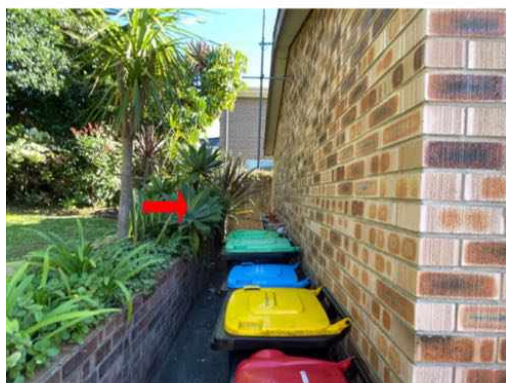
Building: Building 1  
 Location: All External Areas  
 Finding: Garden Beds - Conditions Conducive to Termites  
 Information:

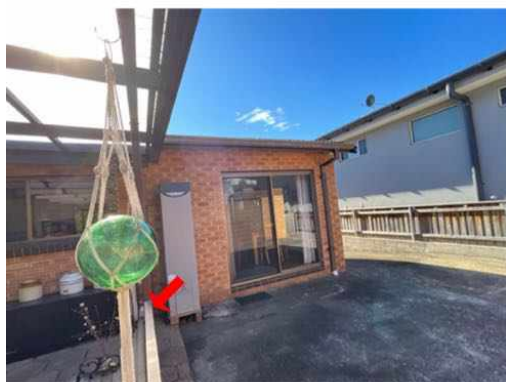
Building: Building 1  
 Location: All External Areas  
 Finding: Building materials in direct ground contact - conducive to termites  
 Information: Where timber elements are in direct contact with the ground and consequently moisture or dampness they become conducive to termite activity. Whether timber is used as a building element part of a fencing structure or stored as an unused item they can provide an environment that is attractive to termite infestation. When met with excessive moisture timber begins to decay and develop wood rot. Any timbers that are in direct contact with external grounds especially if left untreated or non-durable also provide ingress for subterranean termites into that particular element. The removal of any such materials that may be conducive to termite activity should be removed as soon as possible to minimise the risk of termite attack.

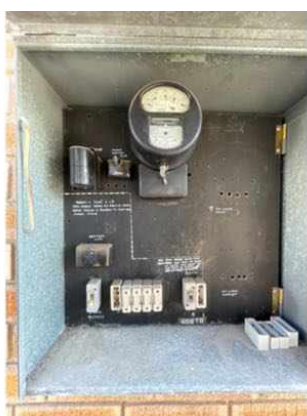
Building: Building 1  
 Location: Yard - Side  
 Finding: Termite Management System - no evidence of installation  
 Information: The application of a post-construction chemical termite barrier is highly recommended for all properties, particularly if live termite activity has been found on the site previously. Such barriers are highly effective in preventing termite attack on any timber building elements throughout the property.

A durable notice should be placed in the switchboard unit to indicate current termite barriers. At the time of inspection, it appeared as though no termite management system has been installed, with no evidence to suggest preventative works taking place.

The client may consider gaining further advice from a pest controller as to the costs and procedures involved with this application. It is recommended that obtaining such advice be a short-term priority.

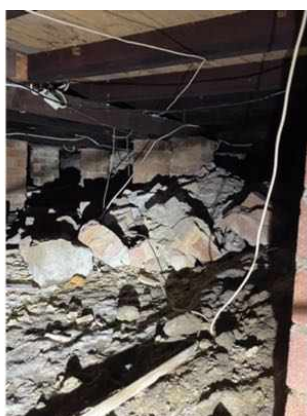
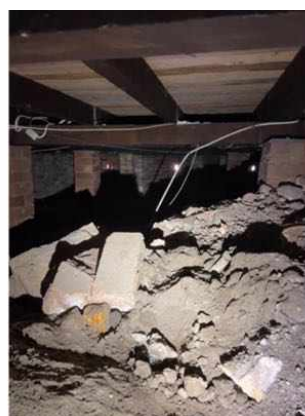
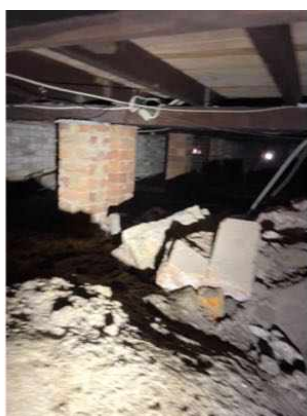
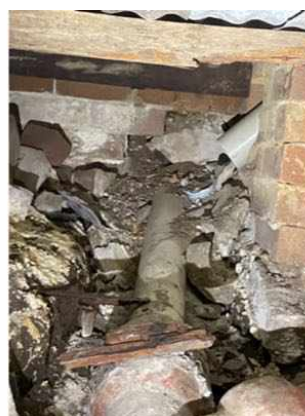
Building: Building 1  
 Location: All Areas

Information: An array of debris was found in the subfloor area at the time of inspection. Debris in this area restricts subfloor ventilation and creates potential for concealed pest entry. Stored timbers and other materials may also make the area susceptible to termite activity and wood rot.

A clear and empty subfloor will be better ventilated and easier to maintain in a dry condition. The removal of any timber debris is vital in minimising the risk of termite or wood borer activity.

Debris in the subfloor should be removed as soon as possible. Depending on the location and amount of debris and stored items, the homeowner may elect to undertake this task. Alternatively there are a large number of rubbish removal subcontractors that could undertake these works.

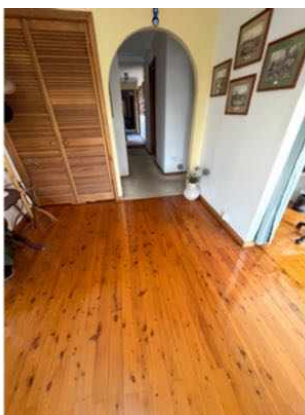
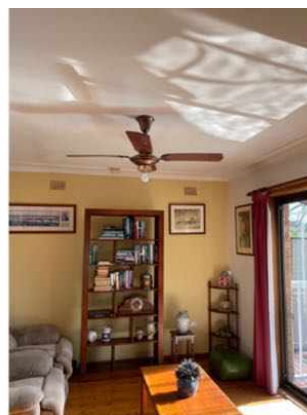
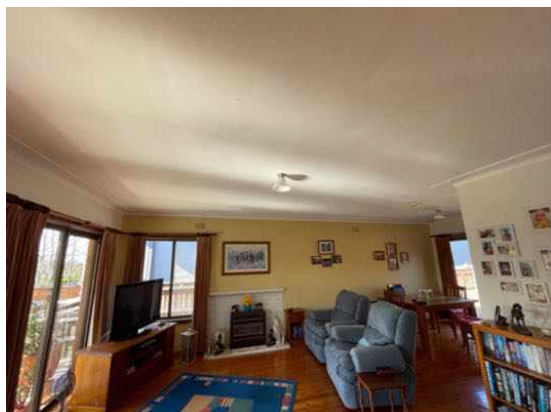
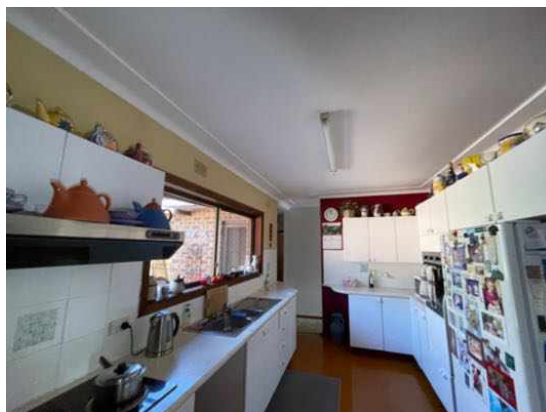
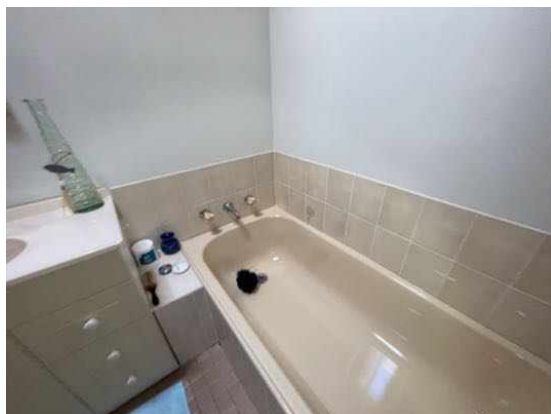
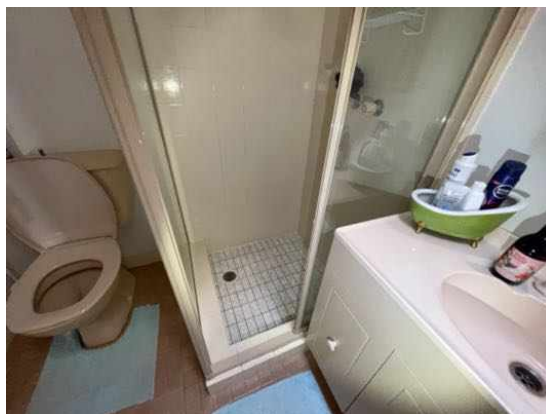
Information: These photographs are an indication of the obstructions and limitations which impeded full inspection of the property at the time of inspection. These obstructions can hide an array of defects and should be removed to allow full inspection to be

carried out. A re-inspection is recommended once the areas are made accessible.
