2 Berrinda Place, Frenchs Forest NSW 2086

## Pre-Purchase Standard Property & Timber Pest Report

25th Nov, 2023

Report number:	
Inspection Date:	24th Nov, 2023
Property Address	2 Berrinda Place, Frenchs Forest NSW 2086

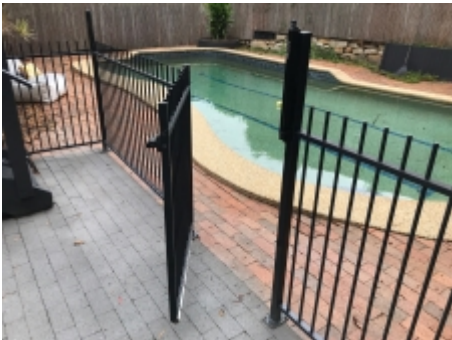
Showing the pool fence gate

Pool barrier fence/gate was not compliant with the closure code and needs immediate general maintenance to reduce the risk of people drowning.

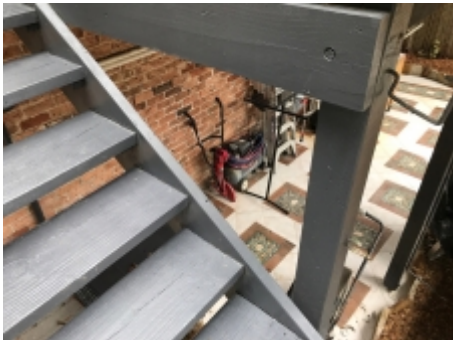
Showing example of insufficient balustrades

Insufficient balustrades to trafficable areas or stairs with a fall greater than 1000mm. Current rules require a minimum of 1000mm high balustrade or 865mm high to stairs measured vertically from the nosing of the tread. A 125mm sphere must not pass through any areas of the balustrade. Recommend engaging a carpenter to rectify where required, to reduce the risk of personal injury.

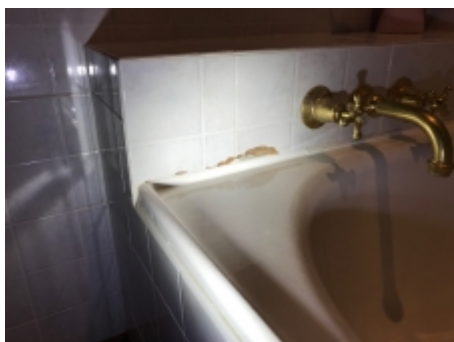
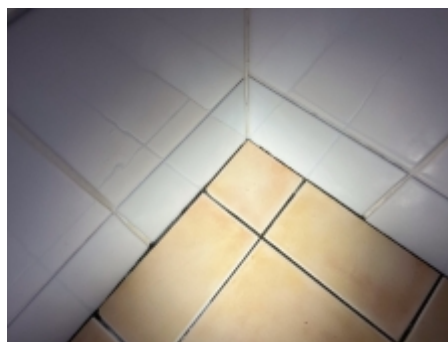
A few cracked tiles to the wet areas. Needs repair/replacing to reduce the risk of water leaks and damage. Recommend engaging a tiler and/or waterproofing technician for further advice

The sealants and/or grout to wet areas require repair where they are incomplete, defective, or no sealant or grout is installed. Recommend engaging a plumber or tiler to rectify to reduce the risk of water penetration and further deterioration.

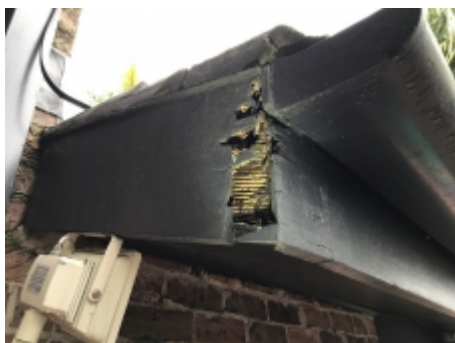
Aged, weathered and deteriorated timber fascia/barge boards - recommend a carpenter to repair/replace as required to reduce the risk of further deterioration of the building.

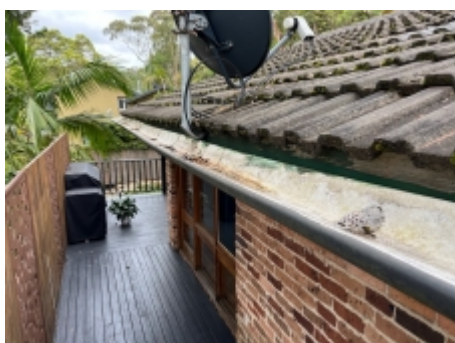
Insufficient fall to parts of the gutter, recommend engaging a plumber to rectify and adjust falls to prevent water ponding and moisture related issues.

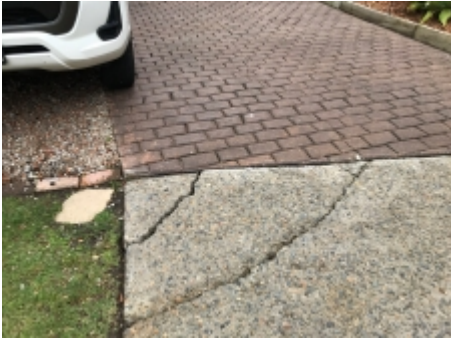
Showing example of movement cracking to driveway

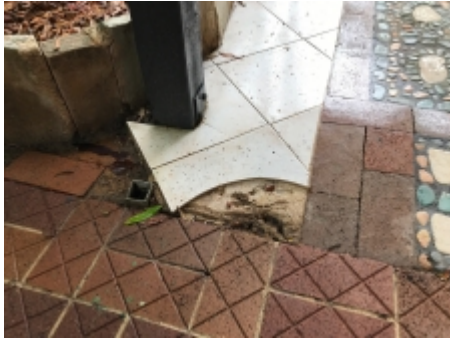
Showing example of cracked/missing floor tiles

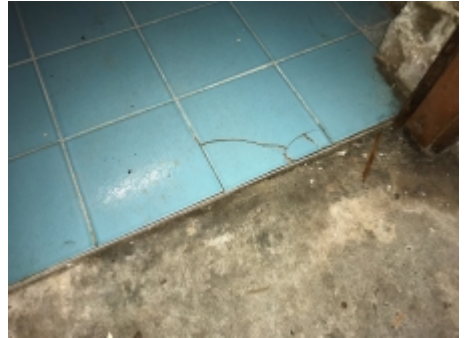
Showing example of cracked/missing floor tiles

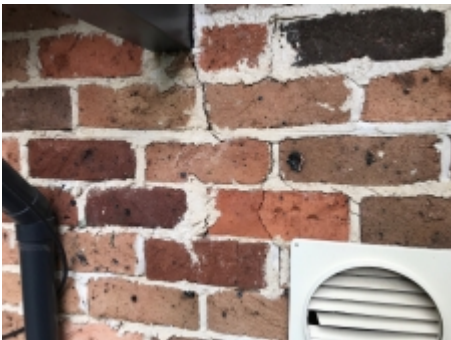
Showing example of settlement/movement cracking to external walls

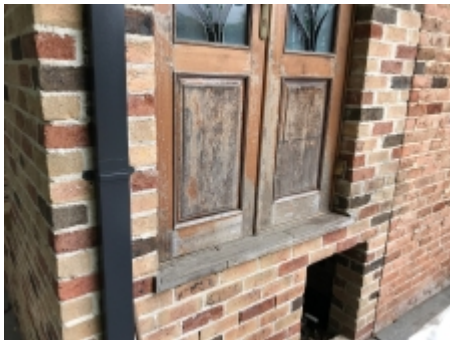
Showing example of weathered exterior timbers

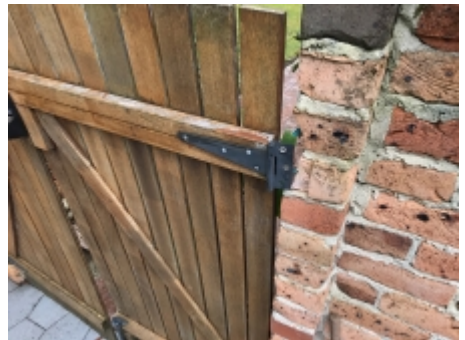
Showing the damaged front gate

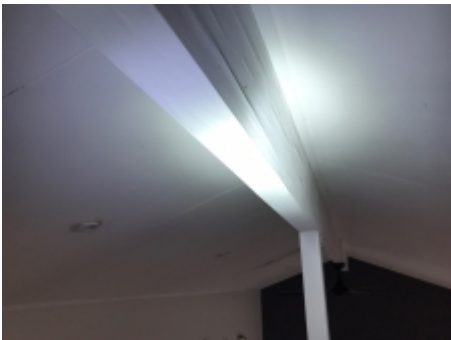
Showing example of painting/finishing defects

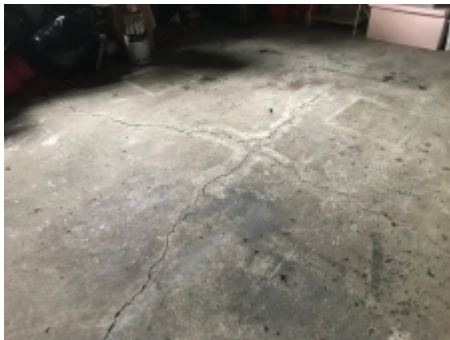
Showing example of movement cracking to garage floor slab

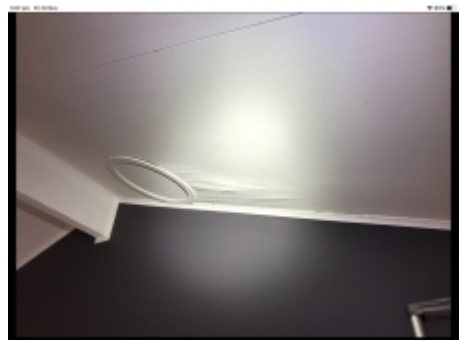
Showing dampness affected living room ceiling

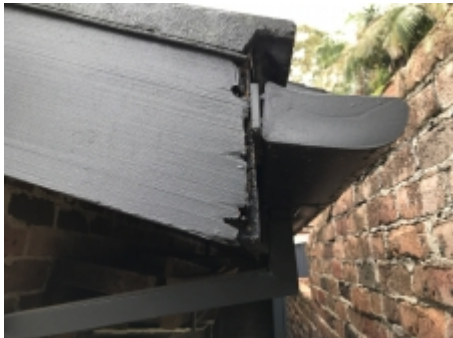
Showing example of wood rot

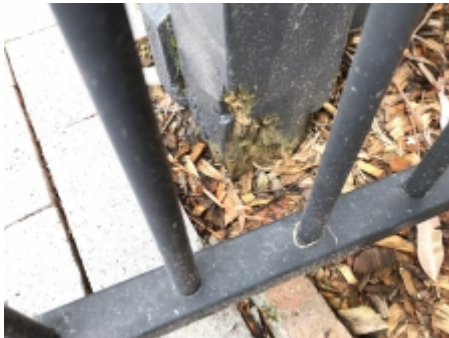
Showing example of wood rot

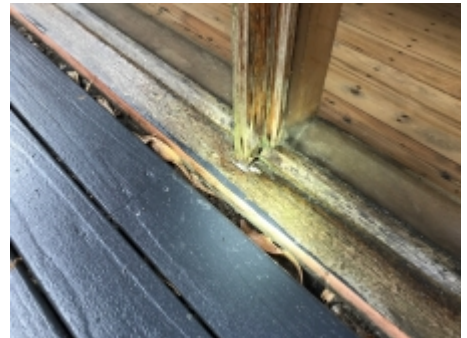
Showing example of wood rot

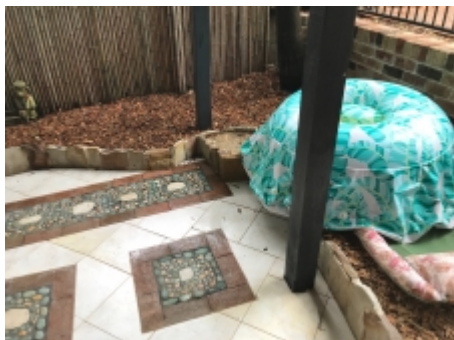
Additional Comments	-Timbers in contact with the ground - recommend exposing 75mm under timbers to allow for visual inspection zone and to prevent the risk of wood rot and termite attack.
---------------------	---

Showing example of timbers in direct ground contact

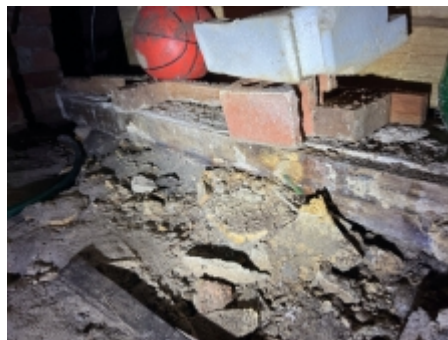
Showing example of timbers in direct ground contact to subfloor
