## **VISUAL BUILDING & PEST INSPECTION REPORT**

Complies with Australian Standard 4349.1 & 4349.6

### **Vendor Report**

**43 Epping Drive, Frenchs Forest**

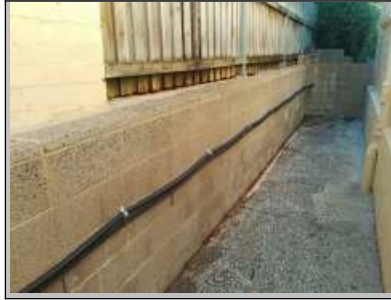
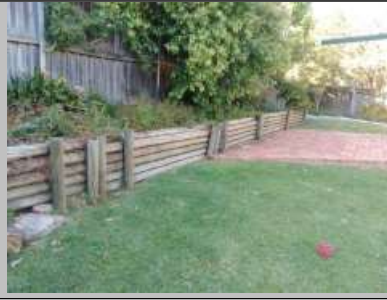
The timber retaining walls show deterioration and should be monitored for additional movement.

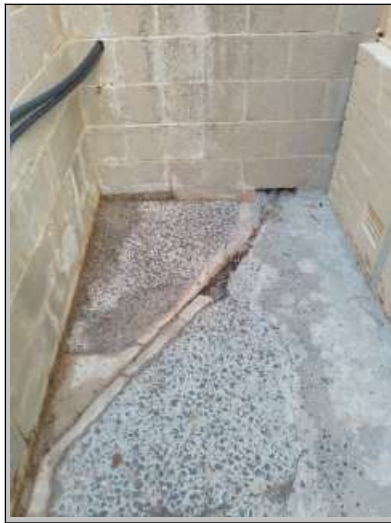
Site drainage appears to be acceptable. However, the site should be monitored during heavy rain to determine whether the existing drains can cope and function. Some patching required to eastern side.

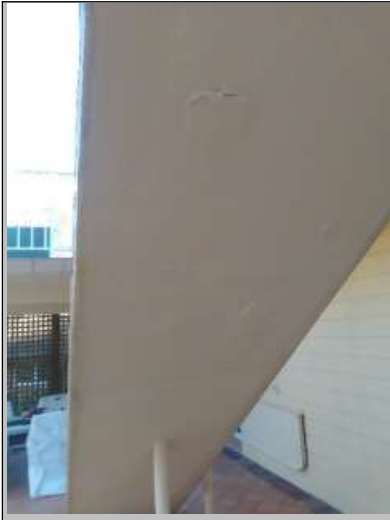
**STAIRS REAR**

Stairs Condition: The stairs are constructed primarily from masonry. The overall condition of the stairs are fair. Concrete spalling is present to the stair area and this damage should be repaired.

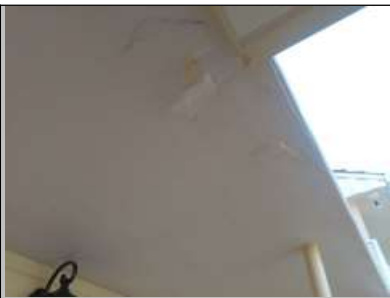
Concrete spalling and is present to this area and this damage to the concrete should be repaired.

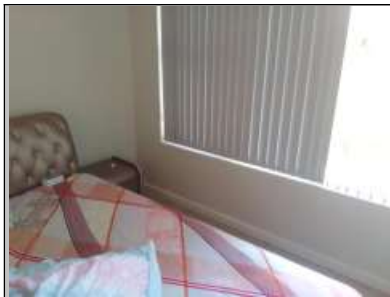
Bedroom four.

The condition of the walls is generally fair. Rising damp is evident to the base of some masonry walls. Damp proof coursing material may not be installed, have been bridged or should be replaced. Quotations should be obtained from a suitably qualified contractor to rectify damp areas. Cost to replace damp proof coursing material can range upwards from \$250.00 per linear meter excluding re-instatement of wall finishes.

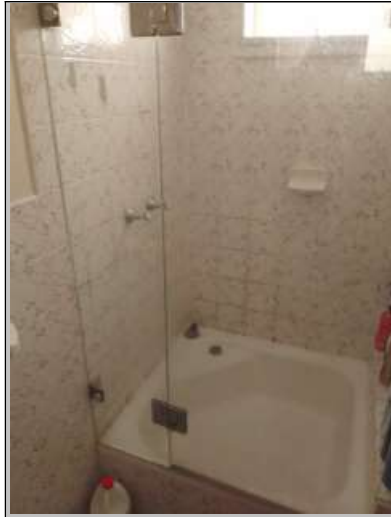
Level one.

The shower is located over the bathtub. The area will need to be kept well sealed to prevent water penetration to surrounding areas.

The toilet appears to be in working order. Toilet area is restrictive and the door swings inwards. In case of an emergency the door cannot be readily removed from the outside. Recommend liftoff hinges be installed to the door to comply with current Standards.

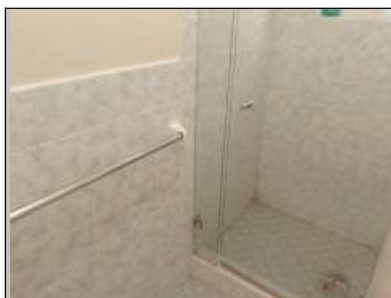
Ground floor.

The shower recess was tested and found to be leaking. Rectification will be required and evaluation of extent of works should be requested from a Licensed Builder.

The toilet appears to be in working order. Toilet area is restrictive and the door swings inwards. In case of an emergency the door cannot be readily removed from the outside. Recommend liftoff hinges be installed to the door to comply with current Standards.
