**VISUAL BUILDING AND PEST INSPECTION REPORT**

Complies with Australian Standard 4349.1 & 4349.3

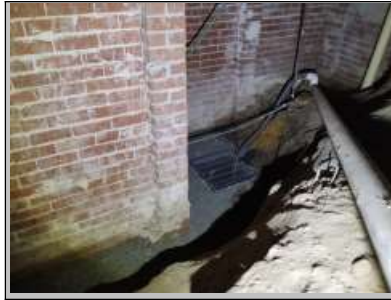
Site drainage appears to be acceptable. However, the site should be monitored during heavy rain to determine whether the existing drains can cope and function. Submersible pump will require periodic maintenance.

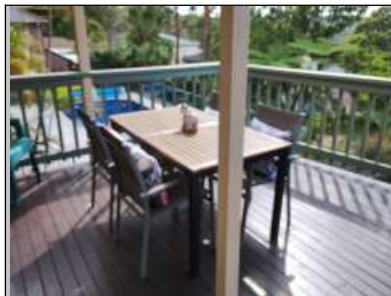
Rear elevation.

Where an external structure is constructed from timber or has significant timber components, and exposed to the elements, a suitably qualified engineer should inspect the structure to determine if it is structurally sound. We cannot determine or advise what weight the structure can hold, The general condition of this structure is fair.

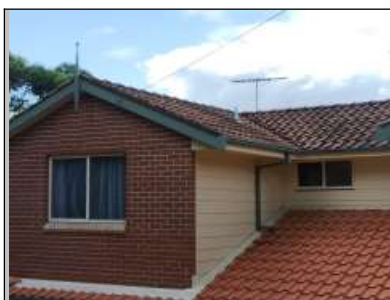
The roof is of pitched construction.

The overall condition of the roof coverings is good.

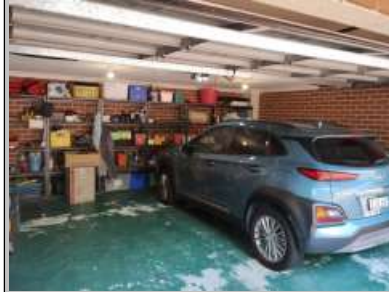
Garage.

The structure is generally in good condition.

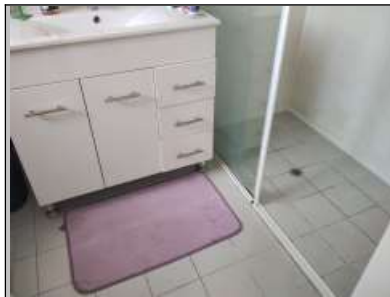
Rear.

The shower recess was tested and there was no visible water penetration to surrounding areas. IMPORTANT NOTE: This test may not reveal water leaks until the shower is put into constant use and surrounding areas monitored over a period of time.

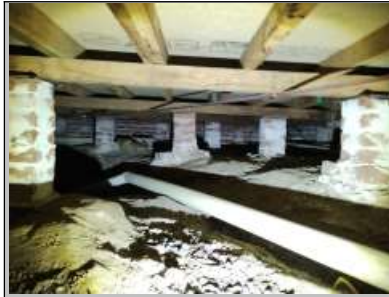
The building is constructed on a combination of strip footings, piers and concrete slab. The footings appear to be generally sound.

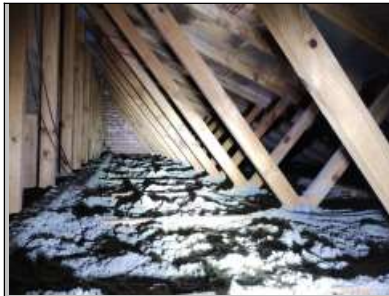
Insulation is present in the roof cavity. This restricted inspection to some roofing timbers. Removal of insulation is not within the scope of a standard visual inspection report, however as in accordance with "industry best standard" the inspector will lift insulation in 3 areas in roof void. Sarking membrane covered tile battens restricting inspection.

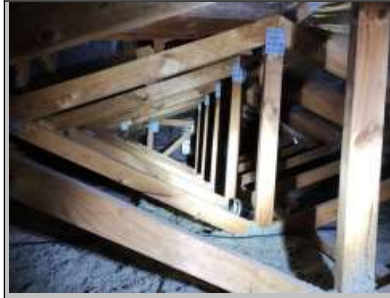
The truss roof system is adequate for the roof covering.

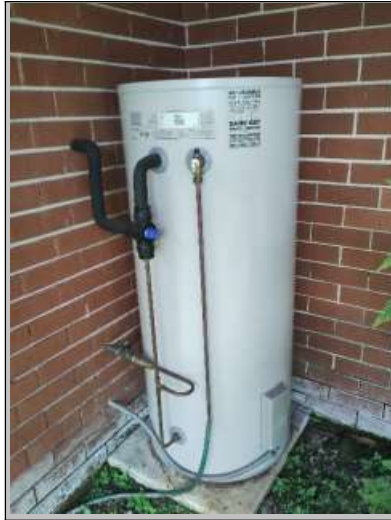
Mains electric hot water system: Mains pressure: Located externally: The hot water system appears to be in working condition. No specific tests other than running the hot water tap were carried out. No determination has been made as to the suitability or adequacy of the hot water system in relation to capacity or otherwise.

The unit was manufactured in 2022.

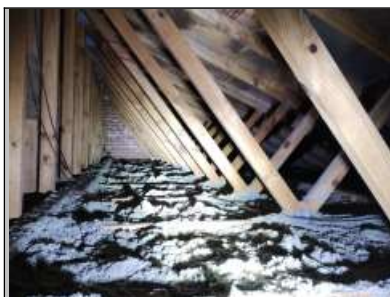
Insulation is present in the roof cavity. This restricted inspection to some roofing timbers. Removal of insulation is not within the scope of a standard visual inspection report, however as in accordance with "industry best standard" the inspector will lift insulation in 3 areas in roof void. Sarking membrane covered tile battens restricting inspection.
