Building Inspection Report

Inspection Date: Thu, 6 Oct 2022

Property Address: 7 Trigalana Pl, Frenchs Forest NSW 2086,
Australia

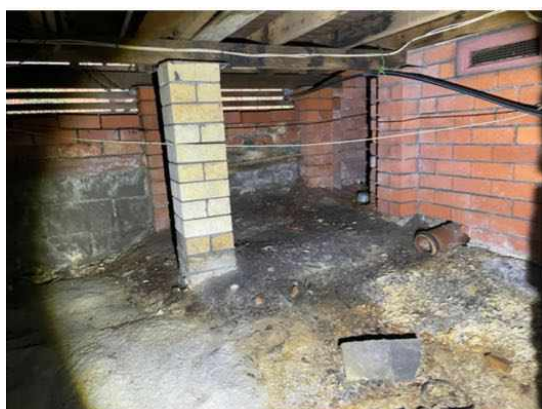
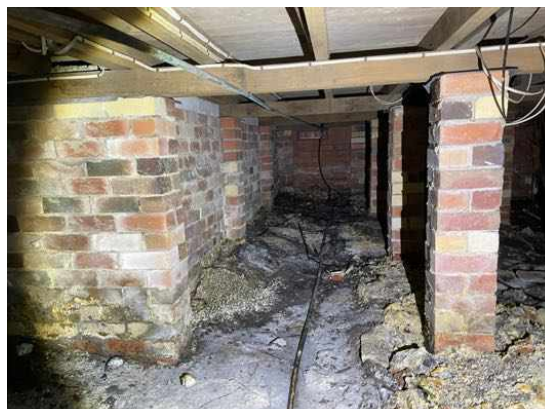
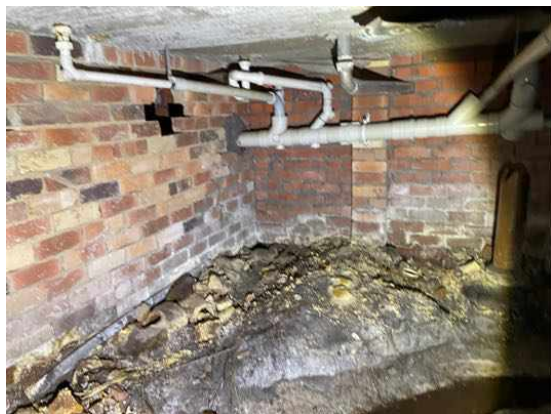
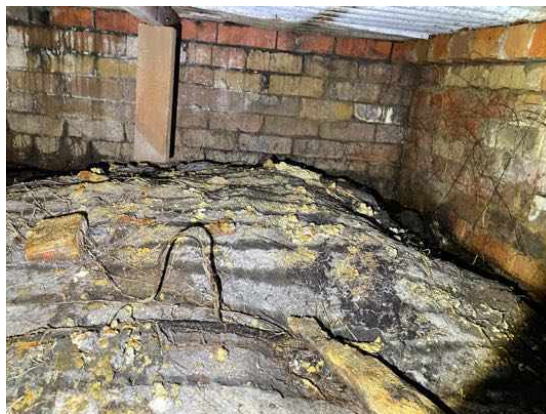
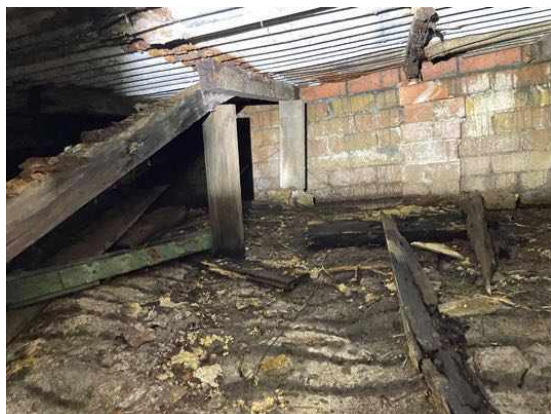
Defects 1.01

Building:	Building 1
Location:	Subfloor
Finding:	Visual mould inspection
Information:	A visual mould inspection of the property was conducted and identified areas of suspected mould and deterioration. Mould is a visible fungal growth, but may also be evidenced by a musty smell in the immediate area.

Mould, which poses a significant respiratory hazard, generally forms and develops as a result of dark and damp conditions over a prolonged period of time. These conditions,

While mould and dampness are present, the area is considered a health and safety hazard. Tenants with respiratory health conditions are advised to exercise great caution and care whilst in the area.

The first action should be to identify the cause of the mould in this area. Replacement of the affected carpet is required as a matter of urgency to ensure the safety of the area. Where required, remedial works should be undertaken to any associated walls and flooring showing evidence of mould.

Where mould is excessive, further inspection by an Environmental Health inspector is advisable.

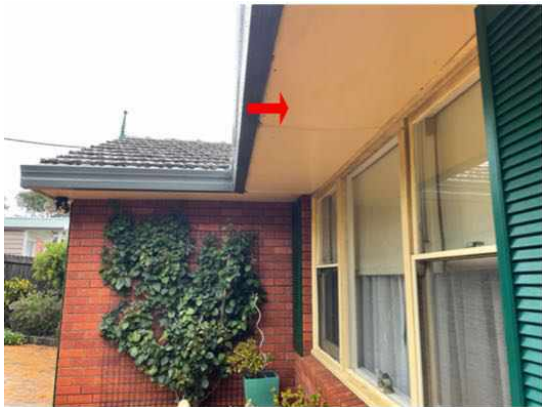
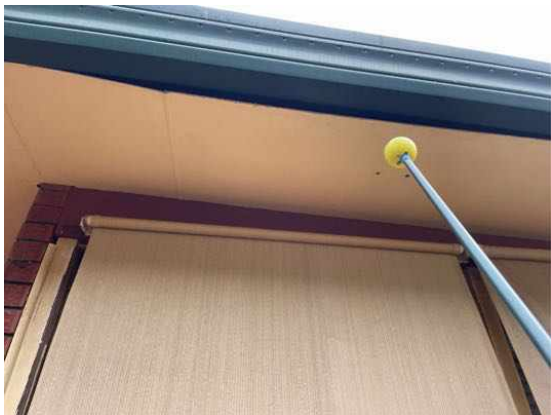
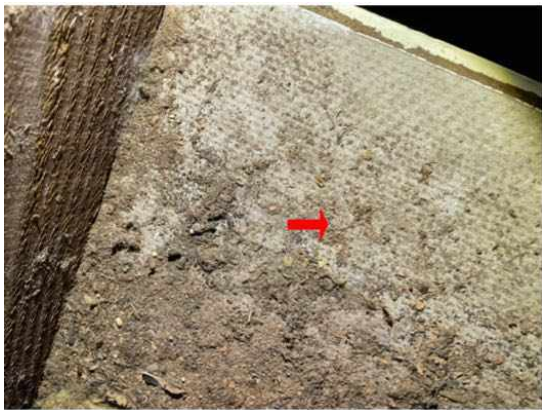
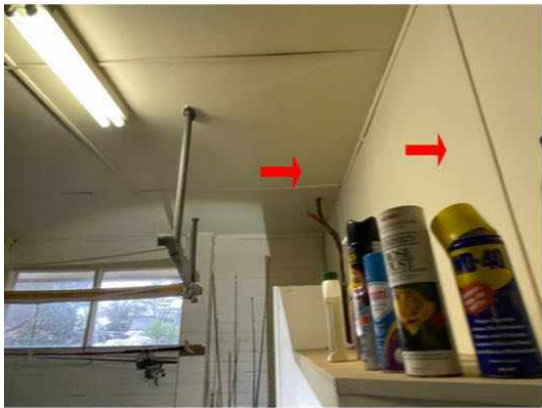
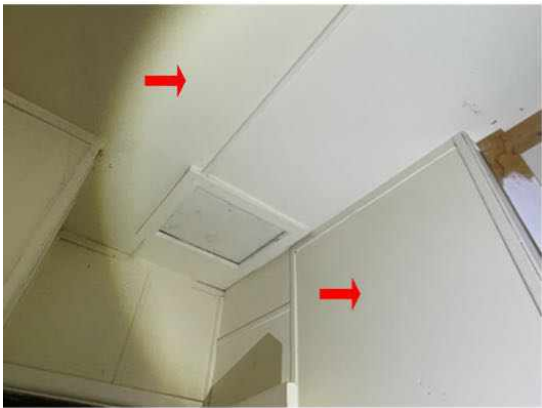
Defects 1.02

Building:	Building 1
Location:	All Areas
Finding:	Asbestos - Suspected ACM Identified on Site
Information:	Reporting on Asbestos is outside the Scope of this Report. This suspected defect is highlighted as a caution only. We suspect, based on our experience in the building industry, that there is a higher risk of the identified building element containing asbestos.

As Asbestos Reporting is outside the scope of this report, we advise that you consider a separate Asbestos Inspection and Condition Audit, which can include the taking of samples for definitive confirmation of the presence of Asbestos.

In the interim, the client is advised to act with caution, especially when considering any damage to building materials general wear and tear renovations extensions demolition and general maintenance activities due to the suspected presence of Asbestos.

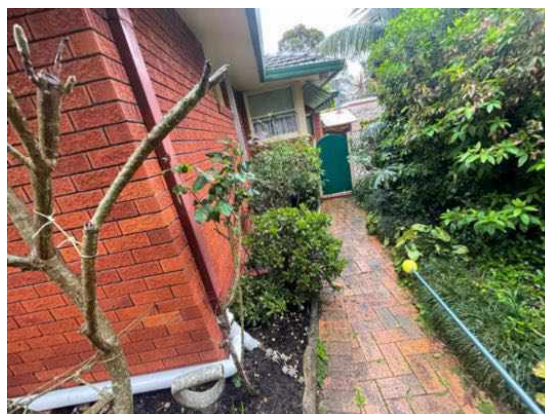
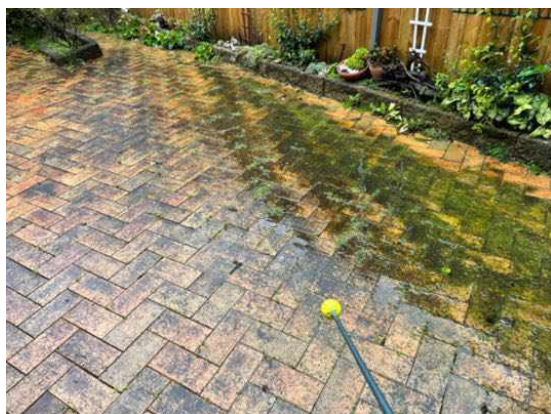
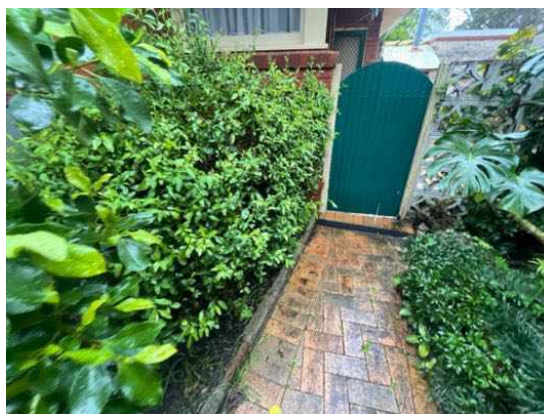
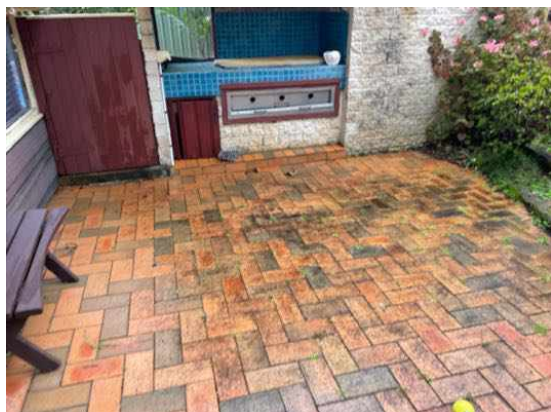
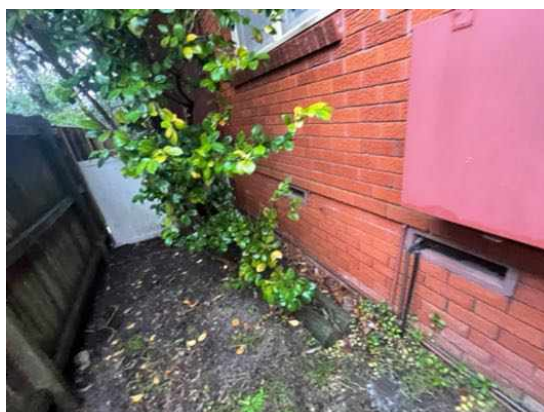
Defects 3.01

Building:	Building 1
Location:	All External Areas
Finding:	Site drainage - suspected Inadequate
Information:	The site drainage in this area was found to be suspected inadequate at the time of inspection, creating potential for subsequent water damage to associated building elements.

It is important that water does not lie against the base of walls; surrounding paths and ground levels should be sloped to drain water away from walls. Downpipes should not disgorge stormwater onto lower walls or plinths. Stormwater should be carried away by large, regularly cleaned drains. Ground levels may need to be lowered to expose a buried DPC.

Where site drainage is inadequate, installation of an Agricultural (Aggie) Drain may be required. A qualified plumber should be appointed to further inspect the property and perform any remedial works as necessary. Water damage and secondary defects are likely to occur if left unmanaged.

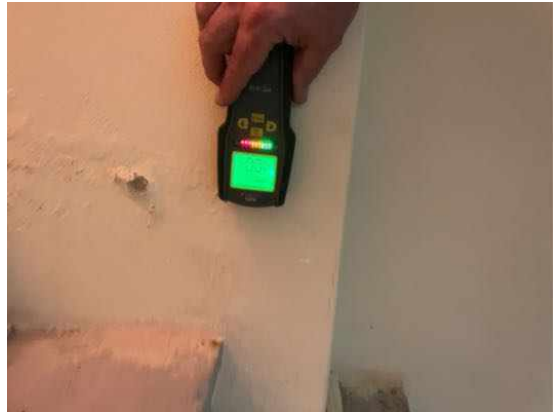
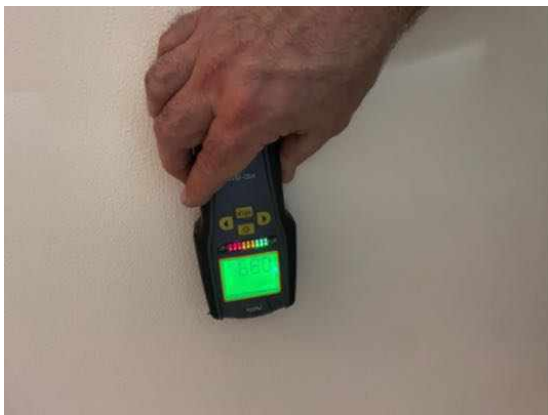
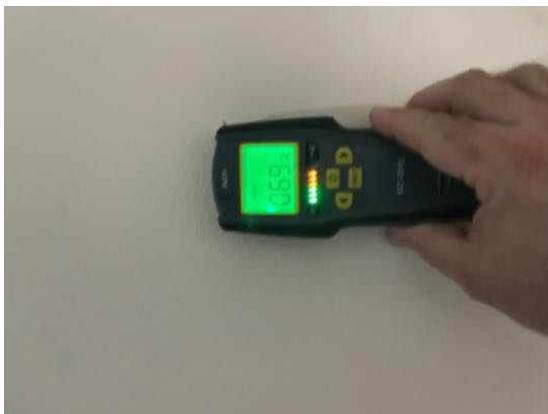
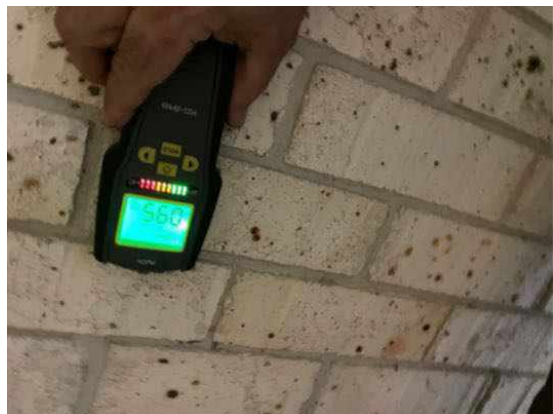
Defects 3.02

Building:	Building 1
Location:	Basement
Finding:	Evidence of excessive moisture was present at the time of inspection
Information:	Excessive moisture can attract termites and produce conditions that promote termite attack fungal growth and wood decay.

Excessive moisture is generally caused by deteriorated inadequate or missing roof drainage leaking plumbing pipes or fixtures poorly plumbed HWS overflows or condenser units and poor site drainage.

It is highly recommended that all plumbing and drainage fixtures and fittings be

maintained regularly in order to prevent excessive moisture being present in the external / internal property.

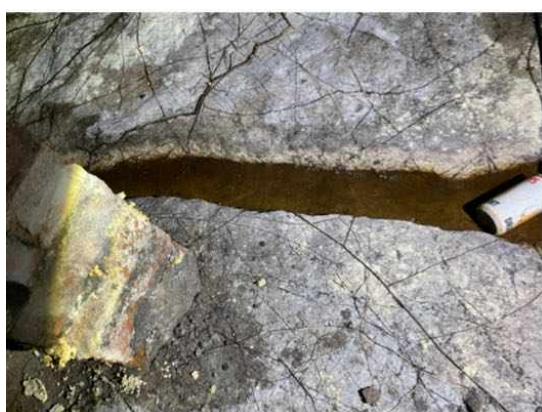
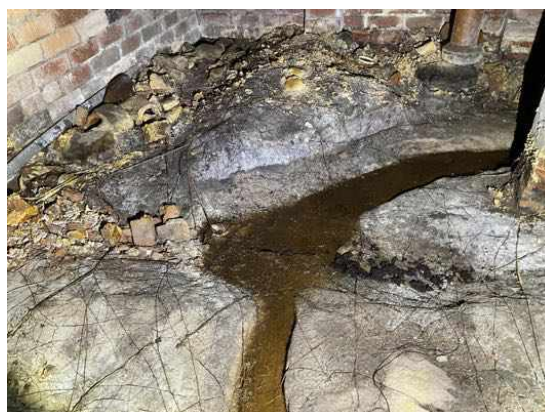
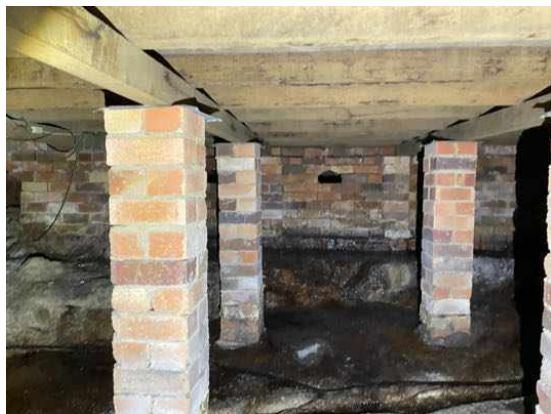
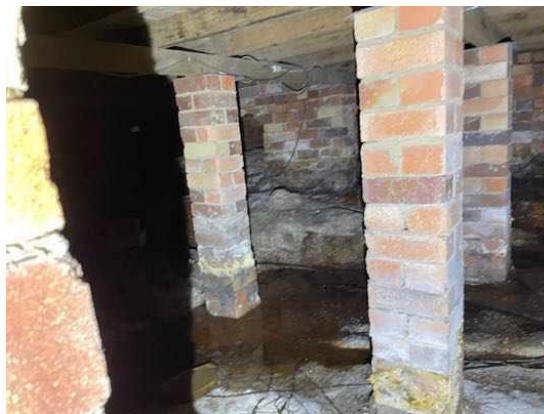
Defects 3.03

Building:	Building 1
Location:	Subfloor
Finding:	Site drainage - suspected Inadequate
Information:	The site drainage in this area was found to be inadequate at the time of inspection, creating potential for subsequent water damage to associated building elements.

It is important that water does not lie against the base of walls; surrounding paths and ground levels should be sloped to drain water away from walls. Downpipes should not discharge stormwater onto lower walls or plinths. Stormwater should be carried away by large, regularly cleaned drains. Ground levels may need to be lowered to expose a buried DPC.

Where site drainage is inadequate, installation of an Agricultural (Aggie) Drain may be required. A qualified plumber should be appointed to further inspect the property and perform any remedial works as necessary. Water damage and secondary defects are likely to occur if left unmanaged.

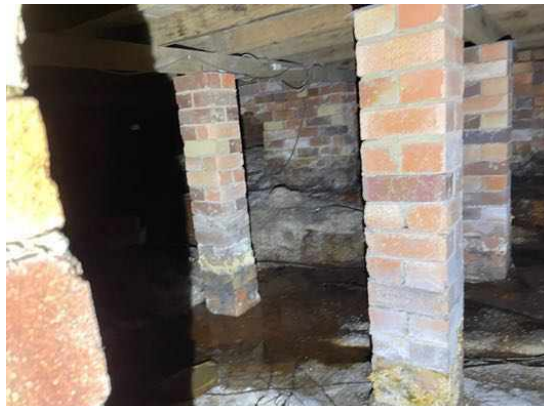
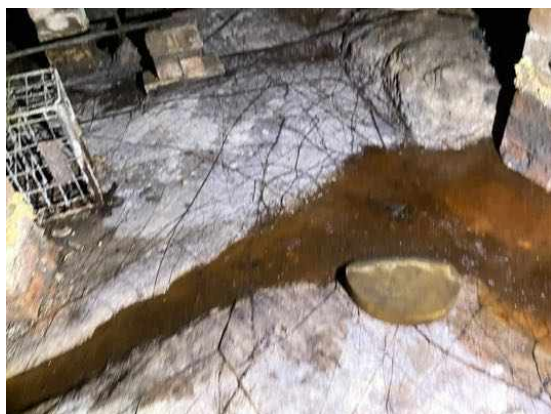
Defects 3.04

Building: Building 1
 Location: Subfloor
 Finding: Water pooling - subfloor
 Information: Water appears to be pooling in the subfloor. It is suspected that this is a result of poor site drainage but may also be due to excessive moisture from an unidentified source.

Where water is pooling in the subfloor water damage to the external wall cladding is imminent.

Such water pooling also increases the risk of termite activity and the development of fungal decay in the area.

Consult a Plumber regarding the cost of potential site drainage rectification works.

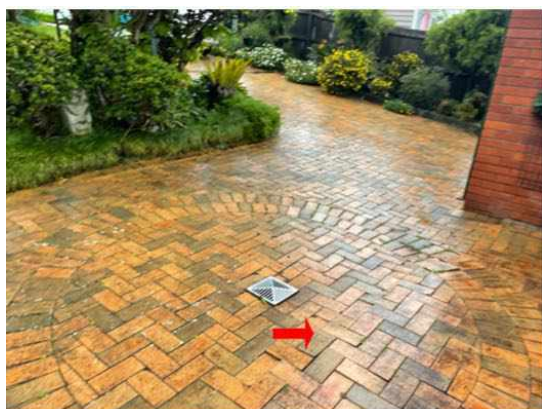
Defects 3.05

Information: Sections of the external paved area are uneven, creating a potential trip hazard. It appears as though the area has been subject to rough installation, or that paving sections have lifted due to movements in the foundation of the property.

Where paving creates a trip hazard, personal injury may ensue if due caution is not taken by all persons within this area.

Re-paving of the area is required as soon as possible to remedy this situation. Further consultation with a specialist concreter is advised.

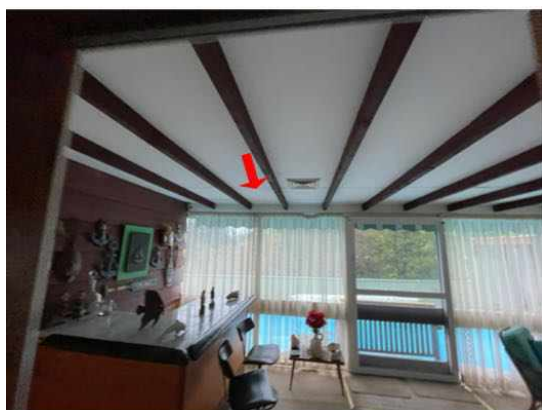
Defects 3.06

Finding: Cracking - Damage Category 1 - Fine (up to 1mm)

Information: Although fine cracks are quite noticeable, they are often only considered to be an appearance defect, and usually do not indicate any structural damage. Generally, the cause of a fine crack is indicative of a separation between building materials and

Cracking of this nature can generally be repaired with minor sanding, filling and/or repainting. Such works should be performed by a qualified painter or a general handyman.

Monitoring of all cracking should be conducted frequently. Always contact a building inspector should cracks widen, lengthen, or become more numerous.

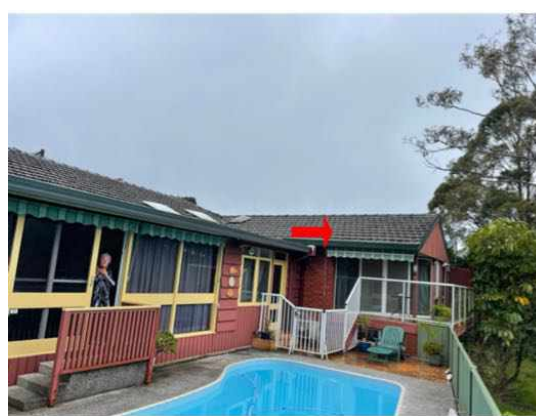
Defects 3.08

Building:	Building 1
Location:	Roof Exterior
Finding:	Roof tiles - Weathered
Information:	Upon inspection of the exterior roofing, the majority of roof tiles were considered to be in a fair condition. While weathering of the tiles is consistent with the age of the property, maintenance works are required.

Where left unmanaged, deteriorating roof tiles are likely to lead to a number of secondary defects, including minor water leaks and weather exposure to internal roofing structures.

Consultation with a roofing contractor is advised to gain advice on cost of remedial works that may be required in the short to medium term. Remedial works are likely to increase the longevity of the exterior roofing structure.

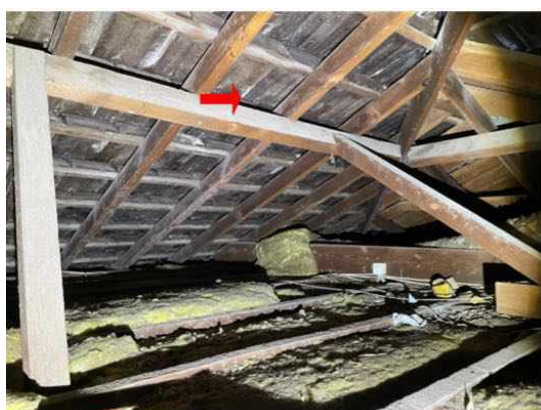
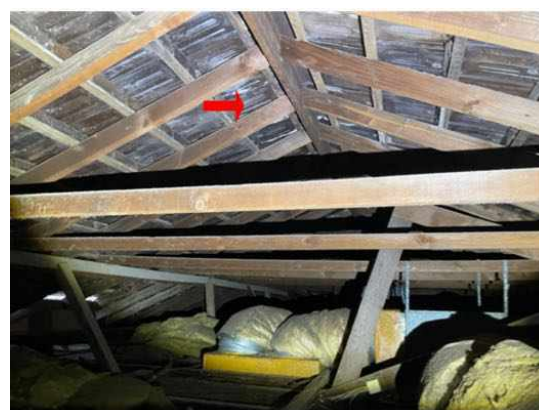
Defects 3.09

Building:	Building 1
Location:	Roof Void
Finding:	Sarking - Missing
Information:	Sarking is missing under the roof sheeting. Sarking acts as an insulator that helps with noise reduction and protects against water penetration. Sarking plays a key role in the operation and function of the overall roofing structure and its performance.

Although not a requirement at the time of construction, replacement of any missing building element is advisable (although this can be quite expensive to do after the time of construction). Where sarking is missing, regular inspections of the roof tiles for cracking and potential moisture penetration is required.

Sarking may be retrospectively fitted by a registered builder at the discretion of the client.

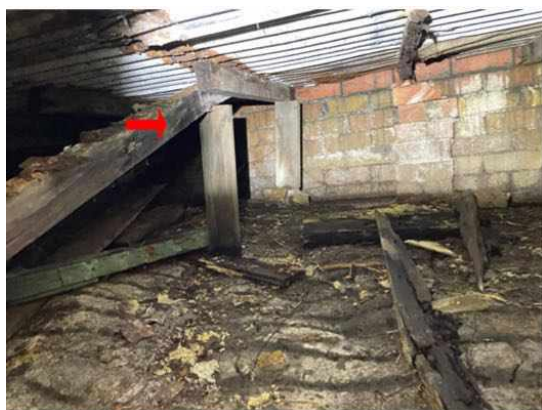
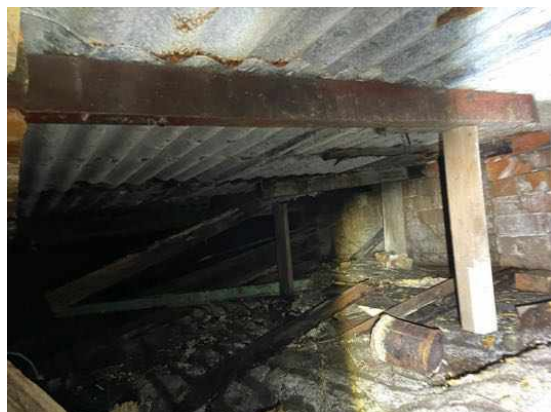
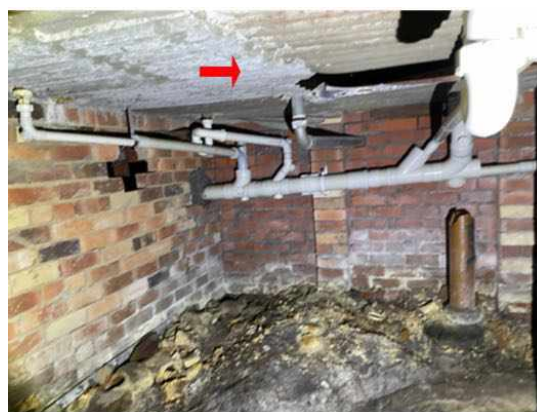
Defects 3.11

Building:	Building 1
Location:	Subfloor
Finding:	Formwork timber and corrugated iron - removal
Information:	Sometime formwork material is not removed during construction which increases the risk of termite activity, wood rot and corrosion being present.

It is recommended that formwork to be removed from these areas.

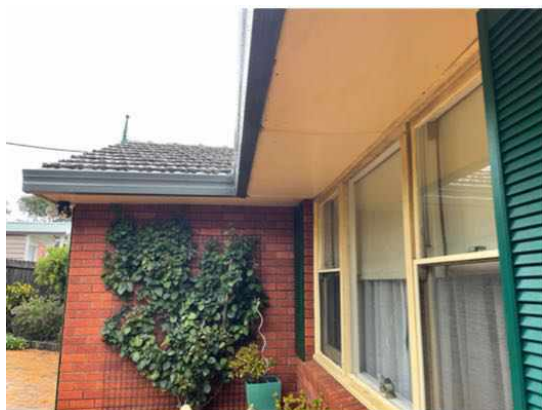
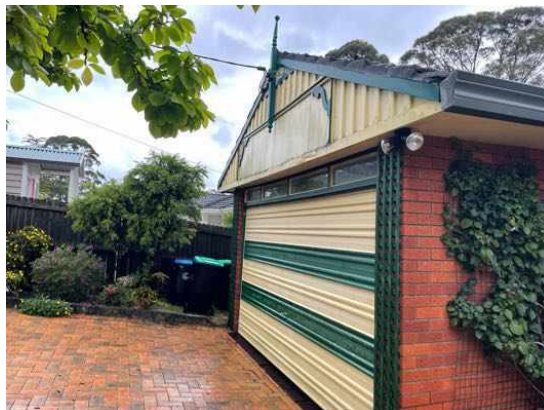
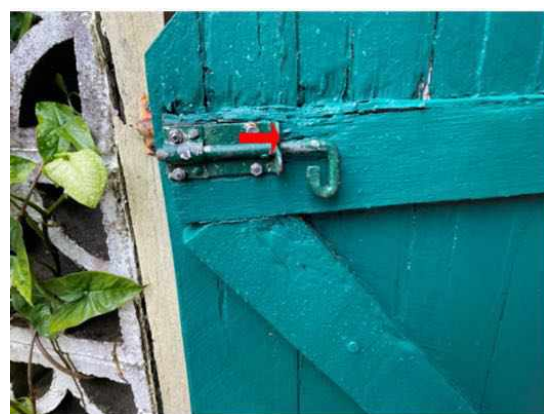
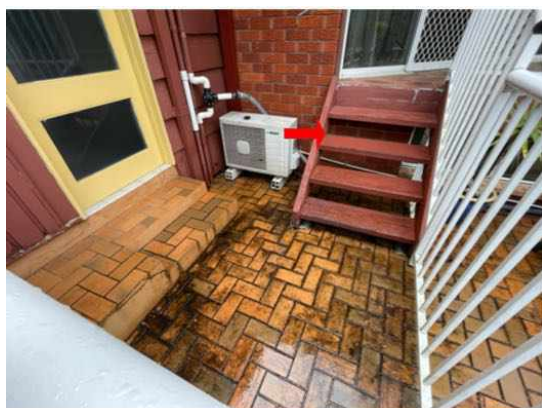
Defects 3.12

Building:	Building 1
Location:	All External Areas
Finding:	External painting deteriorated
Information:	Much of the external paintwork including but not limited to windows, fascias, guttering, veranda and other external fitments have been neglected and require attention to prepare and re-paint.

Whilst incomplete or missing paint finish is generally an appearance defect, it can also lead to the development of secondary building defects over time. Incomplete areas of paint finish expose the area to moisture, potentially accelerating the deterioration of underlying building materials.

Degraded paint finishes should be sanded back, filled, leveled and painted, as applicable. Where inadequate or missing paint protection has led to the deterioration of the associated building element, repair and/or replacement of this building element may be required.

A painting contractor should be appointed as soon as possible to perform necessary works to aid the appearance of the affected area and to ensure the area is protected against further deterioration. Alternatively, the homeowner following manufacturer instructions may perform these works.

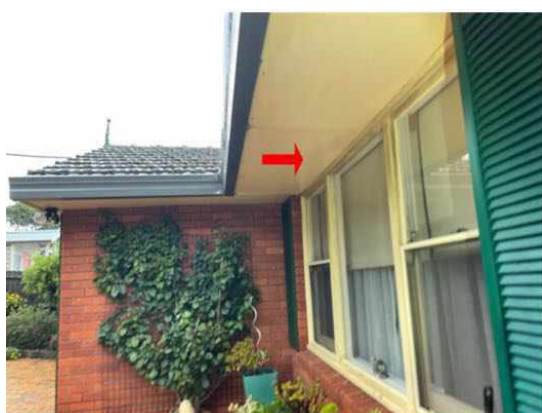
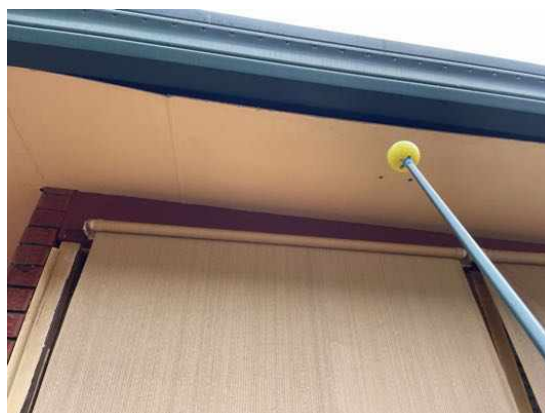
Defects 3.15

Information: Sagging to the eaves was evident in this area at the time of inspection. This type of defect is generally consistent with older properties, where the eave sheeting has worn over time.

Eaves are important in preventing water ingress to associated walls by promoting adequate water run-off from roofing structures. Their secondary function is to prevent shelter to adjoining structures from excessive moisture and hence prevent water damage to these areas.

Sagging eaves are susceptible to the attraction of excessive moisture, and are therefore considered non-functional. This defect also detracts from the overall appearance and condition of the roofing structure and any associated structures.

A roofing plumbing or general handyman is recommended to perform rectification works as soon as possible. Subsequent water damage is likely to result over time if left unattended.

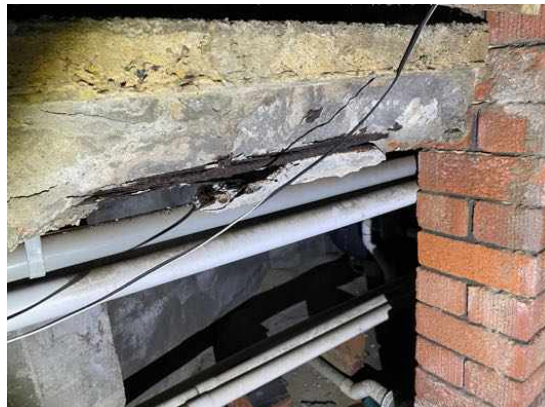
Defects 3.17

Building: Building 1
 Location: Subfloor
 Finding: Concrete - Cancer
 Information: Concrete cancer is the common term used to describe a number of factors which cause concrete construction to deteriorate. Generally, water penetration causes the concrete reinforcement to rust and expand, creating stresses on the surrounding concrete and in turn causing it to spall (or break away). Alternatively, if the cement component is too alkaline, reactions with the general atmosphere occurs and star-shaped cracks appear which allow rainwater to penetrate. Concrete cancer may also originate from poor original water proofing.

In some instances, repairs are possible; however, repair works will generally involve extensive works, including removal of affected concrete and the treatment or replacement of any exposed steel. Some injection of resins or special mortars may also be possible, however this depends on the size and extent of consequent damage.

Ultimately, the cause of the concrete cancer (e.g. poor water proofing) must also be addressed, otherwise the problem is likely to recur. Treatment of concrete cancer can be expensive and, left unmanaged, the problem is likely to worsen over time, potentially leading to the development of major structural defects or safety hazards.

The client is advised to exercise caution and to prepare for the potential cost of remedial and / or replacement works. A structural engineer should be appointed to provide estimates on the required works.

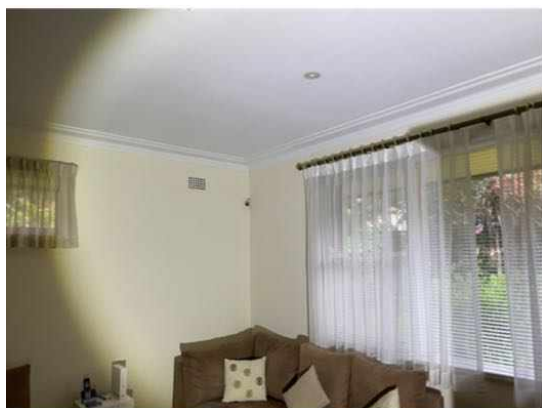
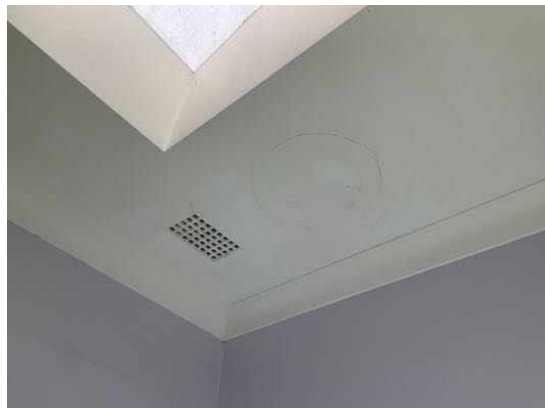
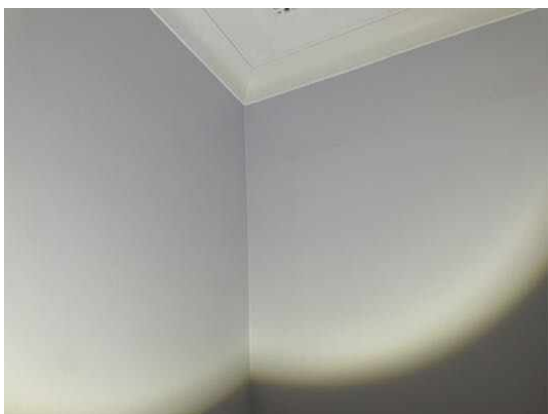
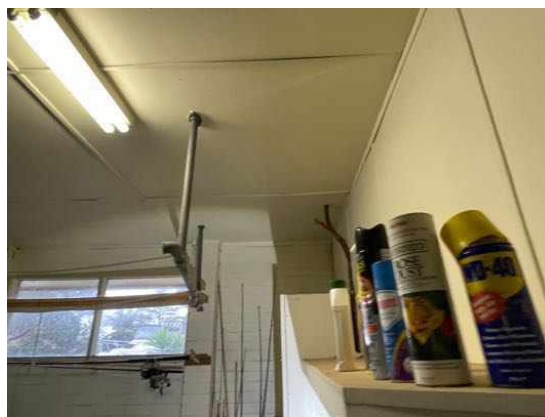
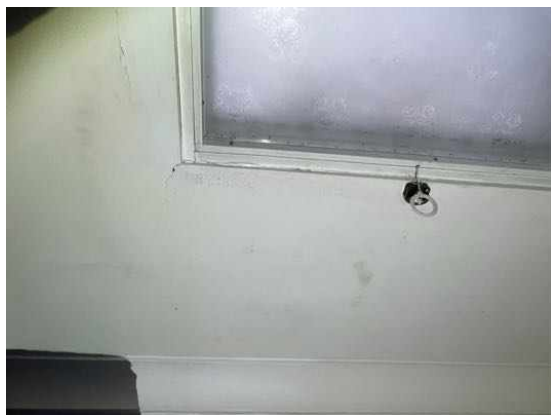
Defects 3.18

Finding: painting deteriorated

Information: Whilst incomplete or missing paint finish is generally an appearance defect, it can also lead to the development of secondary building defects over time. Incomplete areas of paint finish exposes the area to moisture, potentially accelerating the deterioration of underlying building materials.

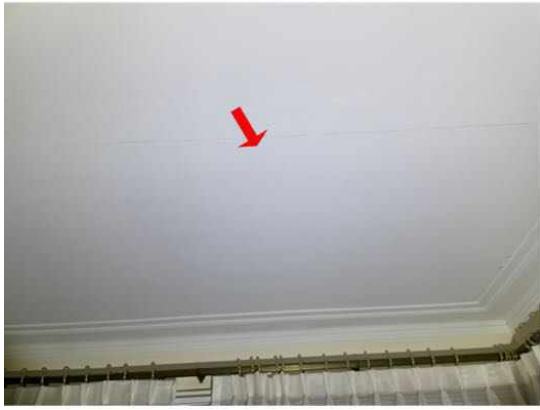
Defects 3.19

Building:	Building 1
Location:	All Areas
Finding:	Cracking - Damage Category 0 - Hairline (less than 1mm)
Information:	Hairline cracks are very minor in nature and generally are only ever an appearance defect. While such cracking may be noticeable in some cases, it is quite common and does not indicate any structural damage.

Cracking of this nature can generally be repaired with minor sanding, filling and/or repainting. Such works should be performed by a qualified painter or a general handyman.

Monitoring of all cracking should be conducted frequently. Always contact a building inspector should cracks widen, lengthen, or become more numerous.

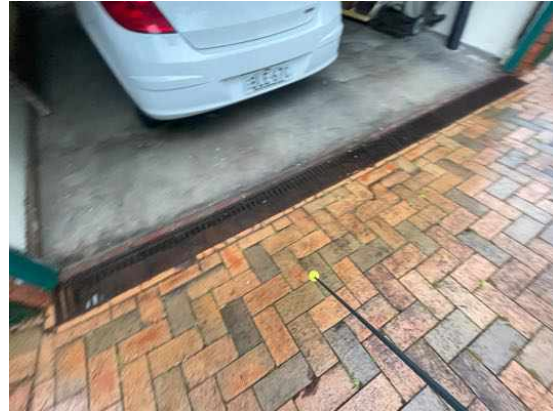
Defects 3.20

Building:	Building 1
Location:	All External Areas
Finding:	Cracked pavers
Information:	Cracking in the pavers was evident in this area at the time of inspection. It is suspected that this cracking has occurred as a result of minor settlement .

Cracked pavers detract from the overall appearance of the affected areas however it is unlikely to create or lead to any secondary defects.

While not considered a matter of urgency, replacement of pavers is recommended at the clients discretion.
