Timber Pest Inspection Report

Inspection Date: Thu, 13 Oct 2022

Property Address: 51A Iris St, Frenchs Forest NSW 2086,
Australia

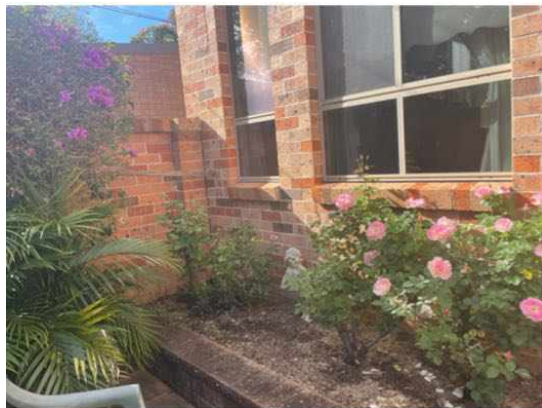
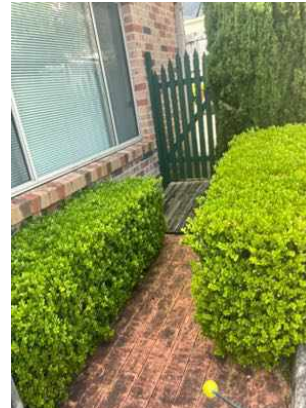
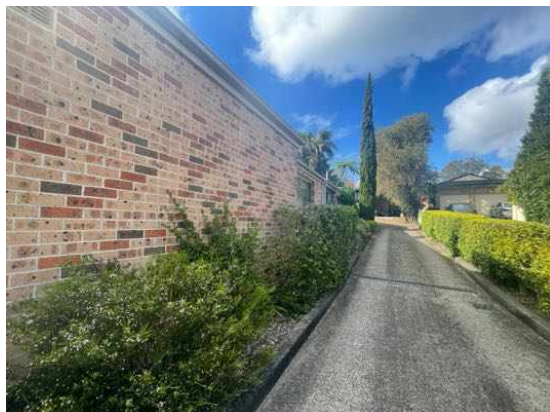
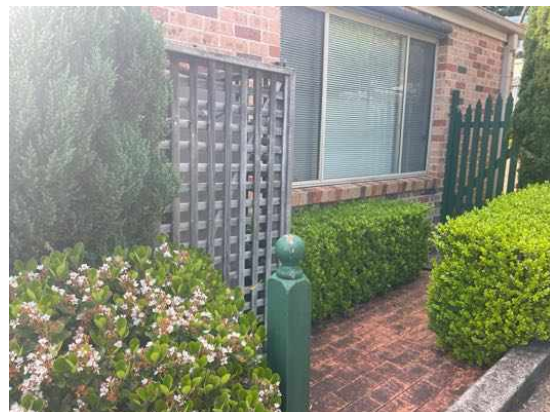
Termite and Timber Pest 1.01

Building:	Building 1
Location:	All Areas
Finding:	Garden Beds - Conditions Conducive to Termites
Information:	Garden beds were found to be evident in the garden area. These garden beds can include untreated timber, and with a combination of moisture from watering hosing can make conditions conducive to termite activity and termite ingress.

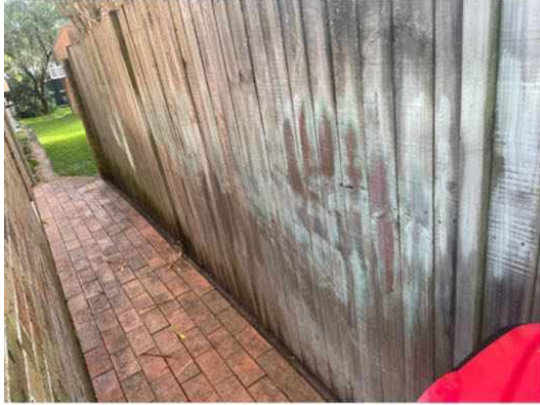
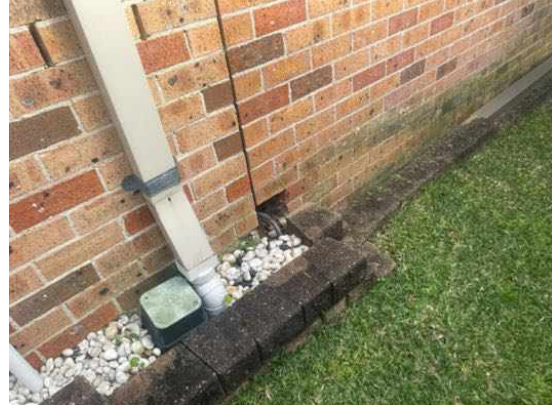
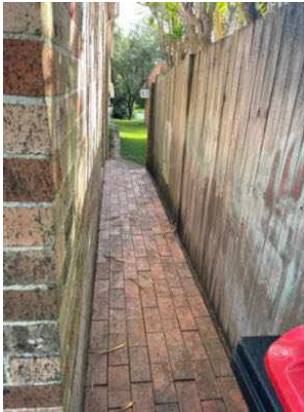
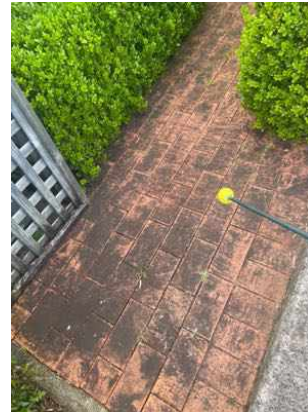
Termite and Timber Pest 1.02

Building:	Building 1
Location:	All Areas
Finding:	Evidence of excessive moisture was present at the time of inspection
Information:	Excessive moisture can attract termites and produce conditions that promote termite attack fungal growth and wood decay.

Excessive moisture is generally caused by deteriorated inadequate or missing roof drainage leaking plumbing pipes or fixtures poorly plumbed HWS overflows or

condenser units and poor site drainage.

It is highly recommended that all plumbing and drainage fixtures and fittings be maintained regularly in order to prevent excessive moisture being present in the external / internal property.

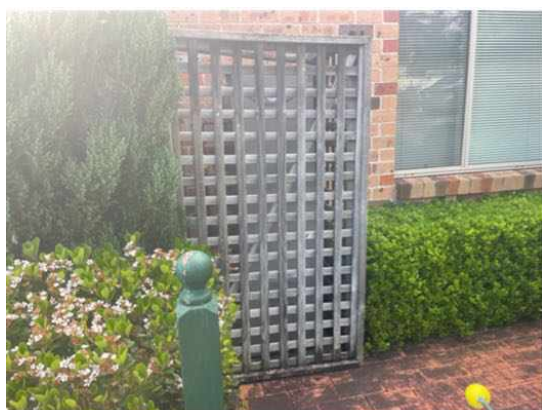
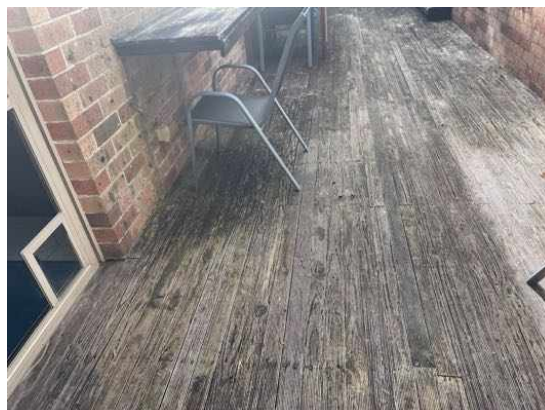
Termite and Timber Pest 1.03

Building:	Building 1
Location:	All Areas
Finding:	Building materials in direct ground contact - conducive to termites
Information:	Where timber elements are in direct contact with the ground and consequently moisture or dampness they become conducive to termite activity.

Whether timber is used as a building element part of a fencing structure or stored as an unused item they can provide an environment that is attractive to termite infestation.

When met with excessive moisture timber begins to decay and develop wood rot. Any timbers that are in direct contact with external grounds especially if left untreated or non- durable also provide ingress for subterranean termites into that particular element.

The removal of any such materials that may be conducive to termite activity should be

removed as soon as possible to minimise the risk of termite attack.

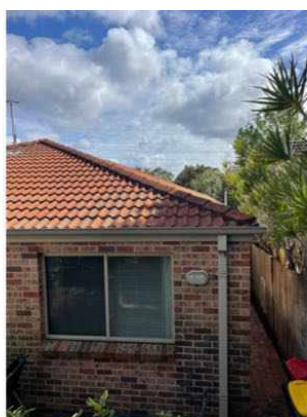
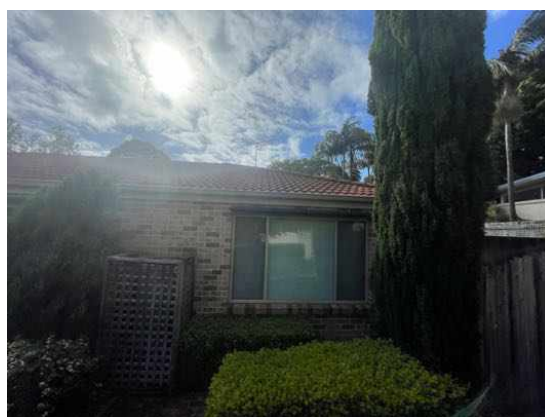
Termite and Timber Pest 1.04

Building:	Building 1
Location:	All Areas
Finding:	Trees - Overhanging and filling gutters
Information:	Overhanging trees often result in excessive amounts of leaf debris accumulating in gutters.

Gutters are a critical part of the building's management of storm water and rain. It is therefore important that they be kept clear to prevent secondary damage to associated building elements, including exterior and interior walls, ceiling linings and any adjoining building elements. Where gutters are blocked, pooling of rainwater is likely to occur, fast-tracking rust and corrosion of the roof plumbing elements.

It is highly advised that all overhanging tree branches be removed as soon as possible to prevent any further damage. Repair and/or replacement of sections of damaged guttering may also be required where the extent of the damage necessitates.

Such works should be performed by the homeowner; however, appointment of a landscape contractor or an arborist may be required. Consultation with a licensed roof plumber is required where guttering has been damaged.

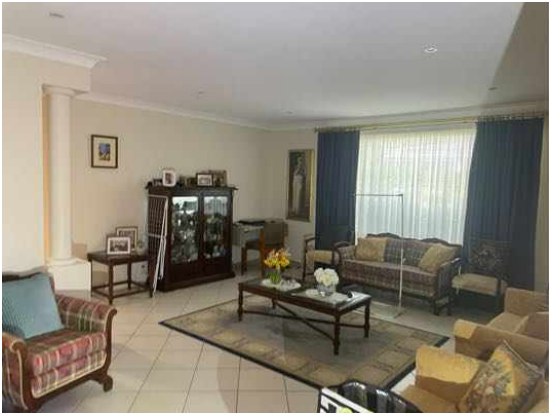
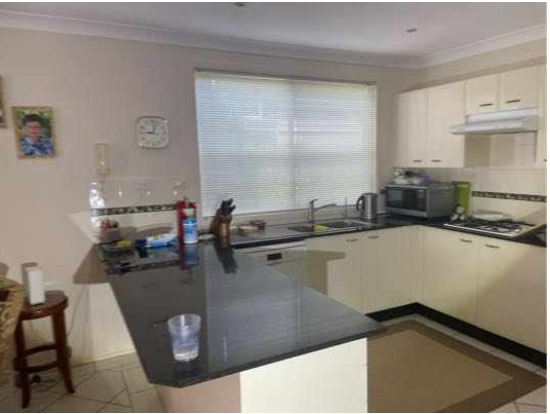
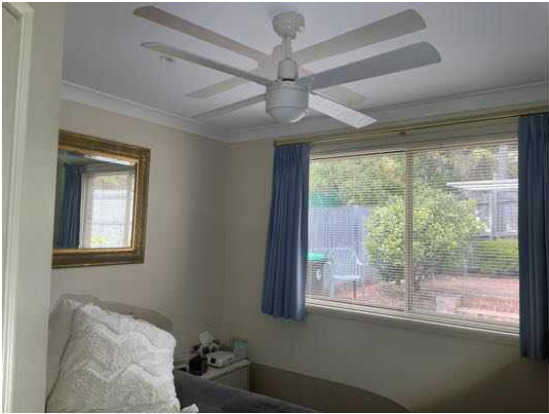
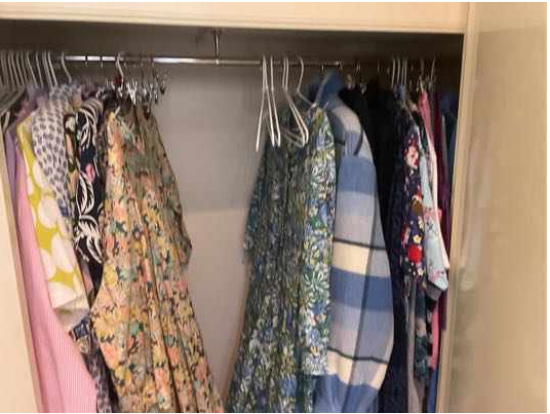
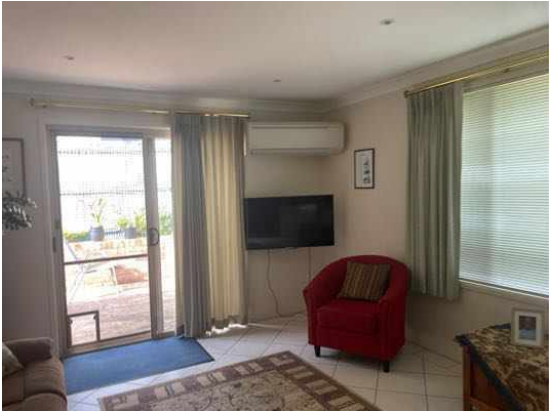
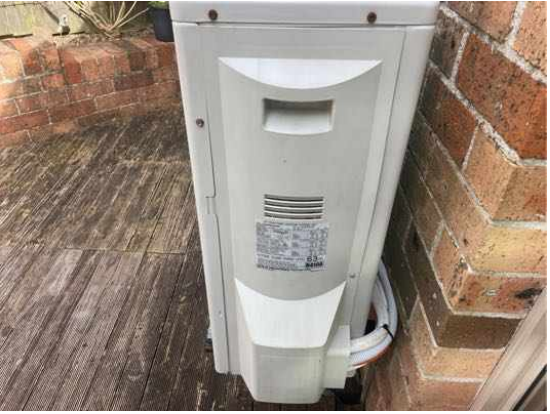
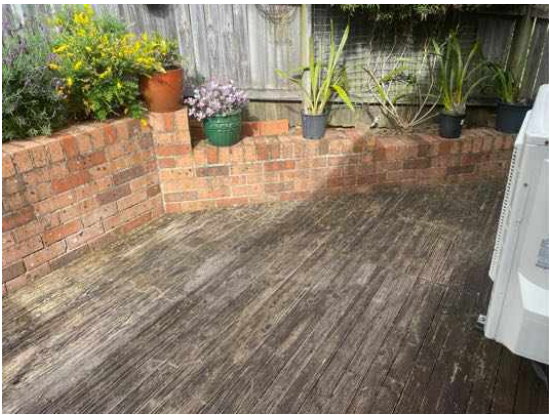
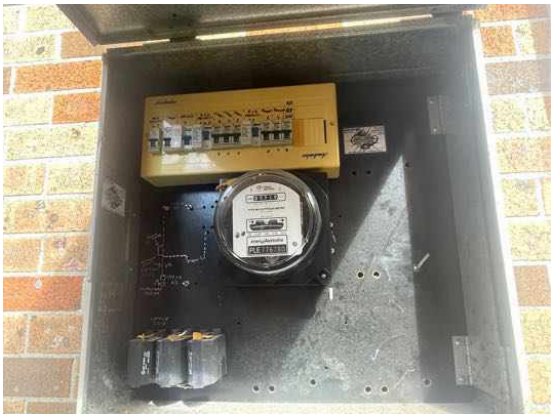
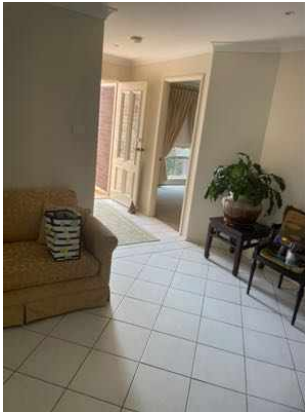
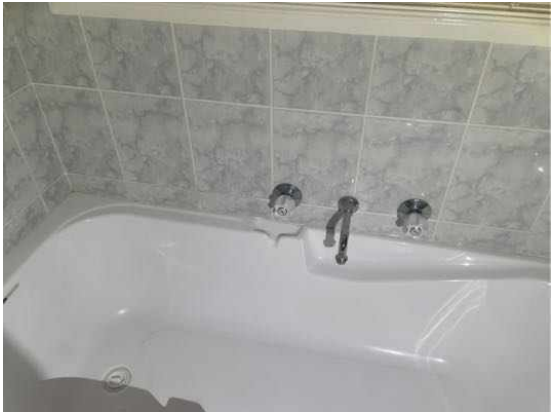
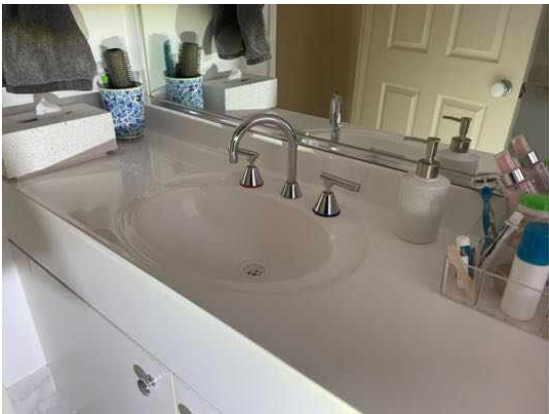
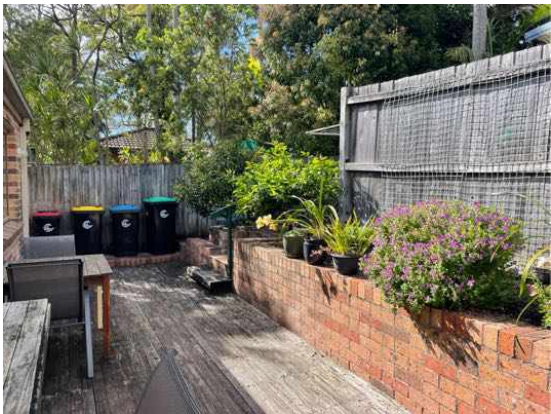
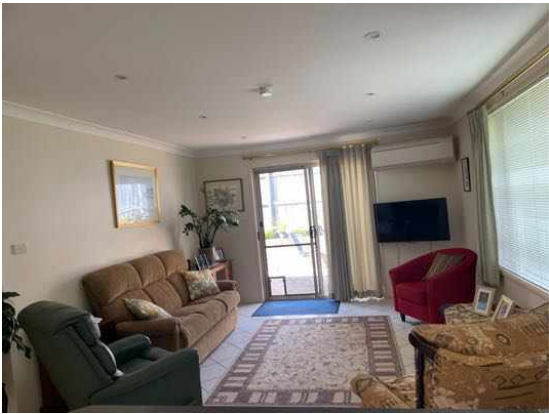
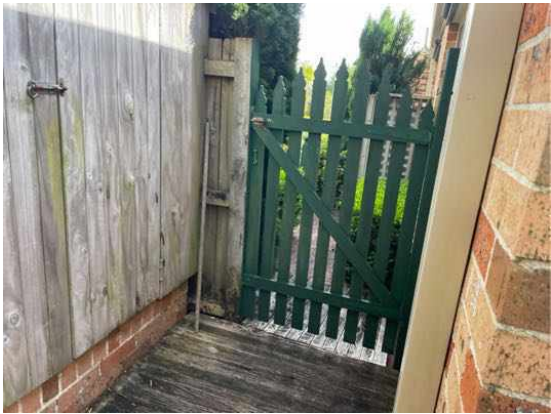
Building: Building 1
Location: All Areas
Finding: Additional Photos - Obstructions and Limitations
Information: These photographs are an indication of the obstructions and limitations which impeded full inspection of the property at the time of inspection. These obstructions can hide an array of defects and should be removed to allow full inspection to be carried out.

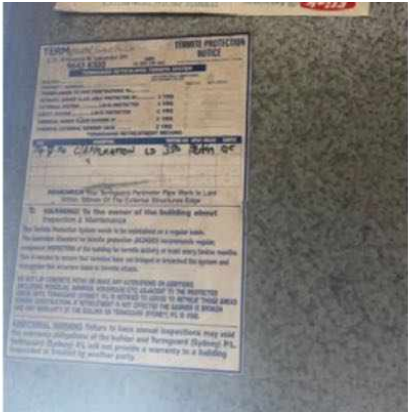
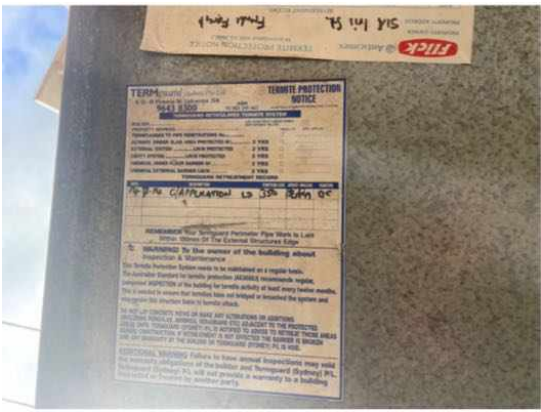
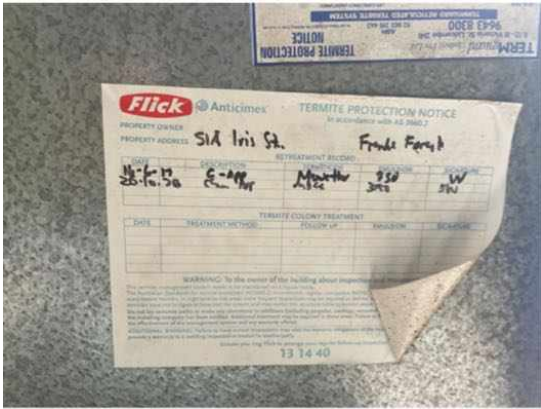
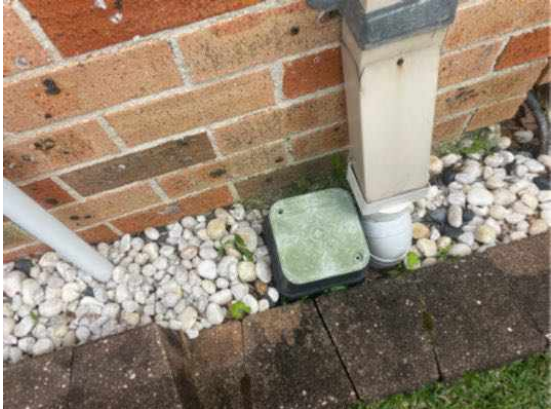
Building: Building 1
 Location: Yard - Side
 Finding: Termite durable notice present - inspection log appears out of date
 Information: The application of a post-construction chemical termite barrier is highly recommended for all properties. Such barriers are highly effective in preventing termite attack on any timber building elements throughout the property.

A durable notice has been placed in the switchboard unit to indicate current termite barriers. At the time of inspection, it appeared as though there is only a chemical termite management system has been installed and inspections appear to not be up to date.

The client may consider gaining further advice from a Timber Pest Specialist/ pest controller as to the costs and procedures involved with this application. It is recommended that obtaining such advice be a short-term priority.
