VISUAL VENDOR MAINTENANCE PEST INSPECTION REPORT **33108-2017**

Date Inspection carried out: Wednesday, 09th AUGUST 2017

10 Springvale Avenue, FRENCHS FOREST.

VISUAL TIMBER PEST INSPECTION REPORT

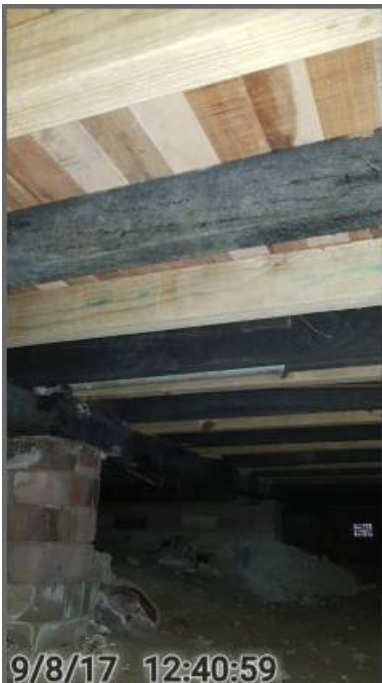
New Timbers**New or repaired timberwork**

Some timbers (listed below) appear to be new or not the original timbers. This replacement may have been due to timber pest attack or some other factor. We recommend if you are using this report to purchase this property, further enquiries should be made to determine the reason for timber replacement.
