VISUAL BUILDING AND PEST INSPECTION REPORT

Complies with Australian Standard 4349.1 & 4349.3

Inspected Property:

36 Nandi Avenue, Frenchs Forest

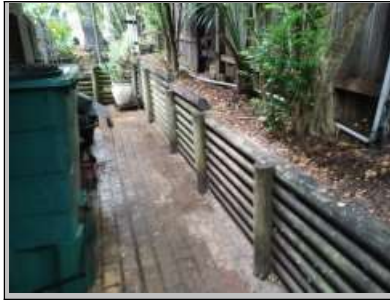
The timber retaining walls appear in acceptable condition.

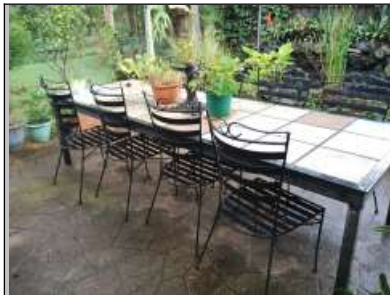
Rear elevation.

Constructed from concrete or masonry. The condition of the structure is generally acceptable.

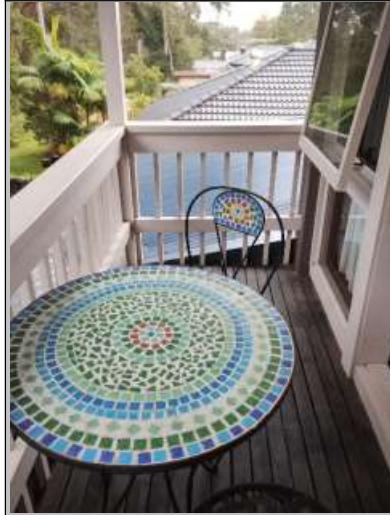
Rear elevation.

The general condition of this structure is fair.

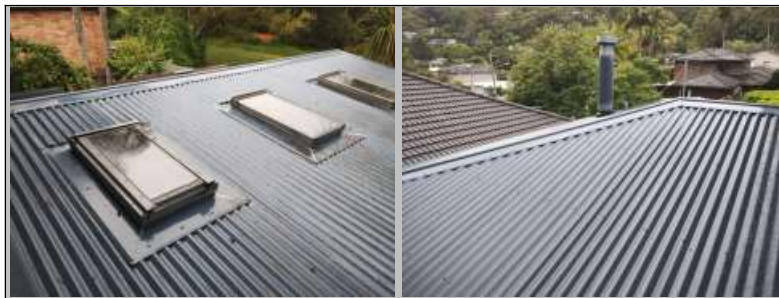
The roof is of pitched construction.

No access was possible to part of the external roof area due to the roof not being accessible from a 3.6 meter ladder.

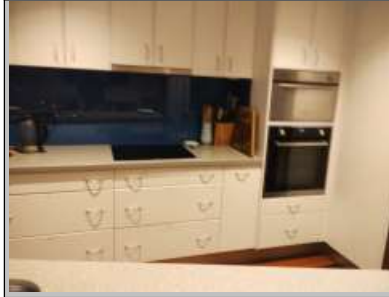
The condition of the fixtures is generally good, A glass splashback is located over the benchtop area. Glass appears to be in serviceable condition.

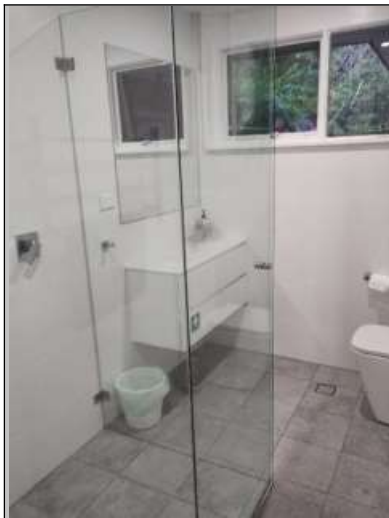
Ground floor.

The shower recess was tested and there was no visible water penetration to surrounding areas. IMPORTANT NOTE: This test may not reveal water leaks until the shower is put into constant use and surrounding areas monitored over a period of time.

The condition of the tiles is generally good.

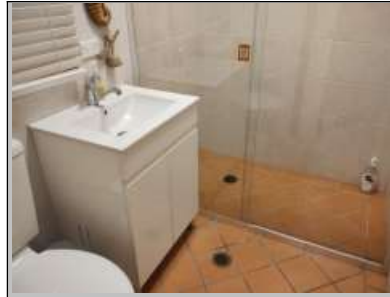
Ground floor. Rear.

The shower recess was tested and there was no visible water penetration to surrounding areas. IMPORTANT NOTE: This test may not reveal water leaks until the shower is put into constant use and surrounding areas monitored over a period of time.

The condition of the tiles is generally fair.

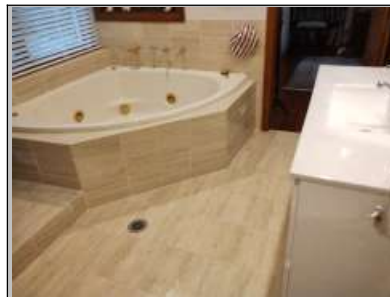
Level one.

The condition of the tiles is generally fair. Some cracked tiles were noted in this area. Consider repair or replacement of damaged tiles.

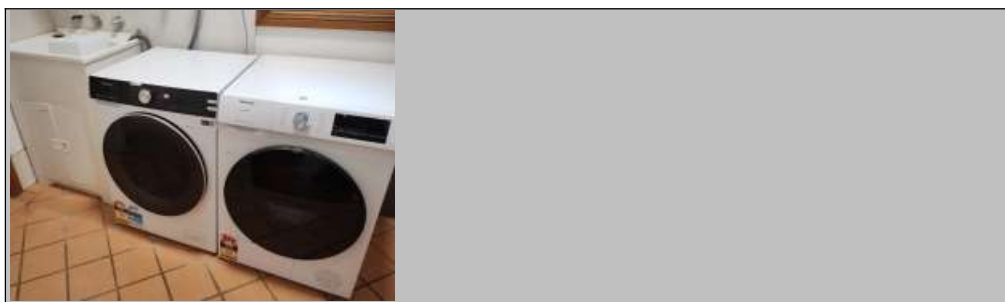
Ground floor. Rear.

The tub and taps appear serviceable. Drain appears serviceable.

The condition of the tiles is generally fair.

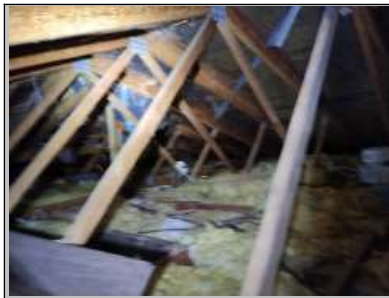
roof void at rear present but is not accessible as the entry point is currently inaccessible due to the position of the trap. Body access into the roof void was restricted and access was not gained to any areas beyond the roof access hole.

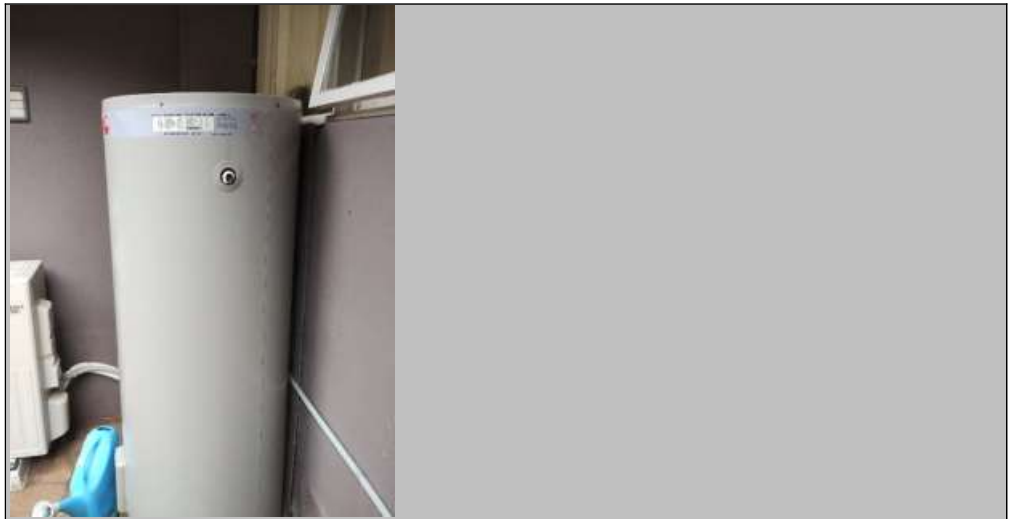
Mains electric hot water system: Mains pressure: Located externally: The hot water system appears to be in working condition. No specific tests other than running the hot water tap were carried out. No determination has been made as to the suitability or adequacy of the hot water system in relation to capacity or otherwise.

The unit was manufactured in 2015.

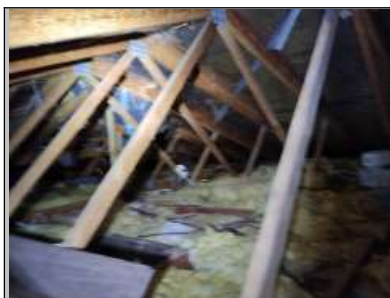
roof void at rear present but is not accessible as the entry point is currently inaccessible due to the position of the trap. Body access into the roof void was restricted and access was not gained to any areas beyond the roof access hole.
