122 Forest Way, Belrose, New South Wales

**Pre-Purchase Standard
Property & Timber Pest Report**

**Building and Pest Inspection - RBI Pre-Purchase Standard Property & Timber
Pest Report 2023 Version. 3.0 | Standard Report**

8th May 2025

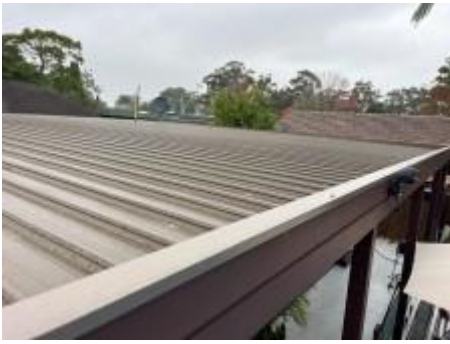
The roof space was not inspected due to the skillion roof design, which does not provide sufficient clearance or access for safe entry.

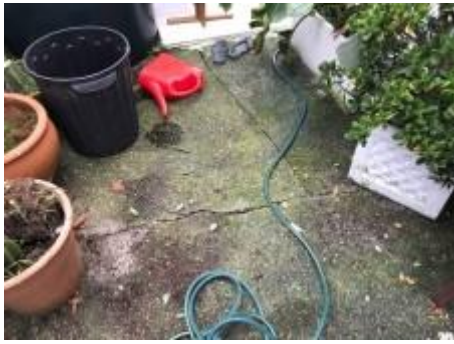
Some movement and/or cracking to parts of the concrete paths and landscape paving around the property. Recommend engaging a builder to conduct repairs required to reduce the risk of further deterioration.

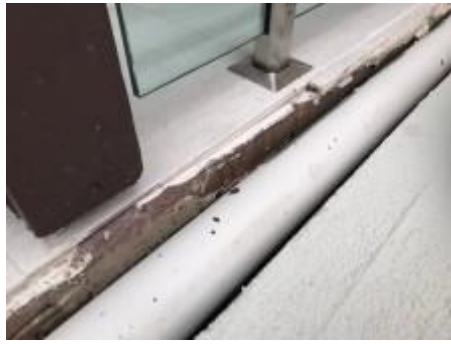
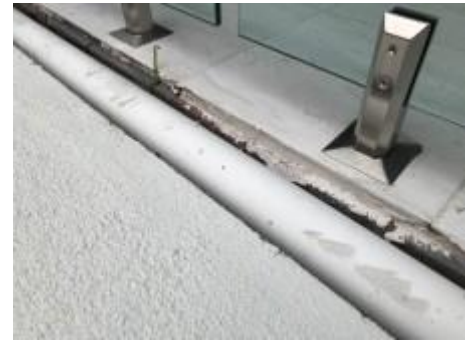
The perimeter of the patio tiles is not properly finished with drip edge flashing or protective trim, leaving the exposed edges vulnerable to water runoff. Without this protection, moisture can seep into the substrate beneath the tiles, potentially causing long-term damage such as delamination, staining, or structural deterioration. It is advisable to install suitable edge treatment to ensure effective water shedding and durability.

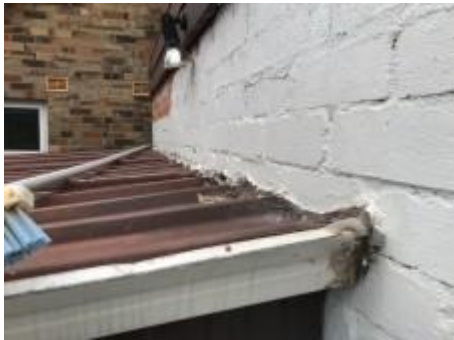
The flashing where the shed roof abuts the garage wall is insufficient, creating a risk of water ingress at the junction. Without adequate flashing, rainwater can penetrate the connection point, potentially leading to water damage, deterioration of building materials, and reduced weatherproofing. Installation of properly detailed flashing is recommended to ensure a watertight seal and long-term protection.

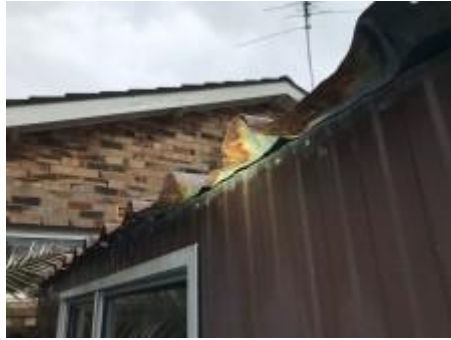
The shed roof has no gutters or downpipes installed, resulting in uncontrolled water runoff, which has contributed to visible rust and deterioration of the roofing material. This lack of proper drainage can accelerate roof damage and may also lead to water pooling around the base of the shed, potentially affecting the structure. It is recommended that appropriate guttering and downpipes be installed to manage stormwater effectively and prevent further deterioration.

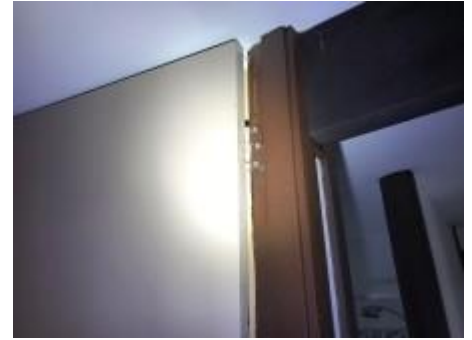
The laundry door jamb is split, with visible movement at the hinge point. This damage may compromise the door's alignment, functionality, and long-term stability. Repair or replacement of the affected section of the jamb is recommended to ensure the door operates correctly and remains securely fixed.

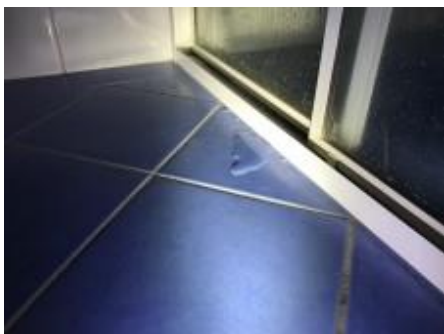
Water is leaking from the shower enclosure.

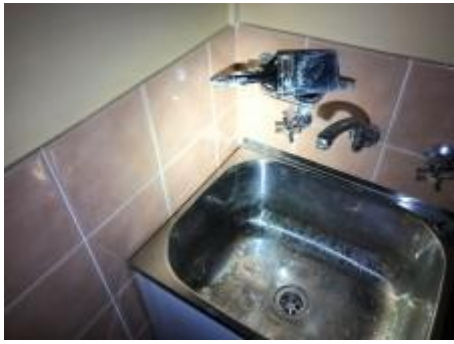
The laundry tub is not adequately sealed to the surrounding surface, creating a risk of water penetration that may lead to damage to cabinetry, walls, and flooring over time. Additionally, there is no splashback installed, leaving the area vulnerable to moisture exposure and potential deterioration. To prevent water ingress and maintain the integrity of surrounding materials, it is recommended to properly seal the tub junction and install a suitable splashback.

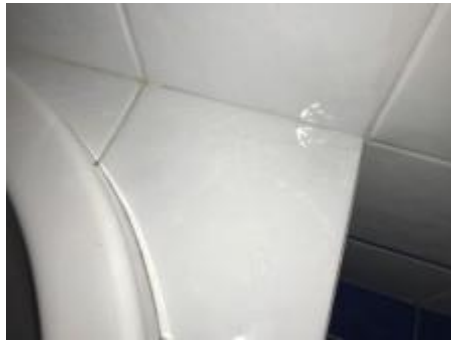
A cracked tile was observed on the bathtub surround, which may allow moisture to penetrate behind the tiling and potentially lead to water damage or deterioration of the substrate. It is recommended to replace the damaged tile and ensure proper sealing to maintain waterproofing integrity.

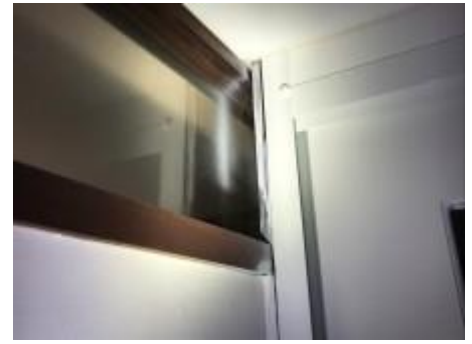
Showing examples of paint/finishing defects

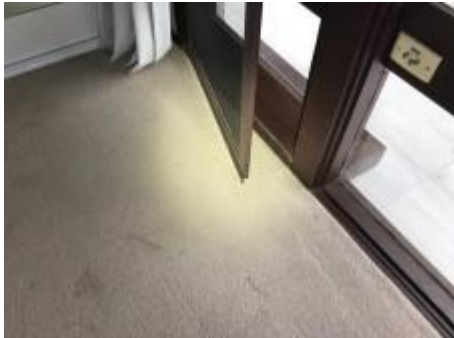
The patio door in the master bedroom is rubbing against the carpet due to the carpet floor being higher than the door clearance allows. This can hinder smooth operation of the door and may cause wear to both the carpet and door over time. Trimming the door or adjusting the flooring or threshold may be required to resolve the issue.

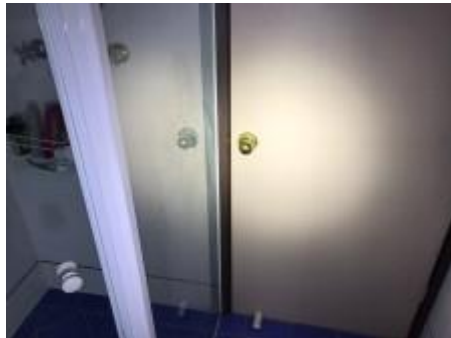
The bathroom door latch does not properly engage with the strike plate, causing the door to fail to remain securely closed.

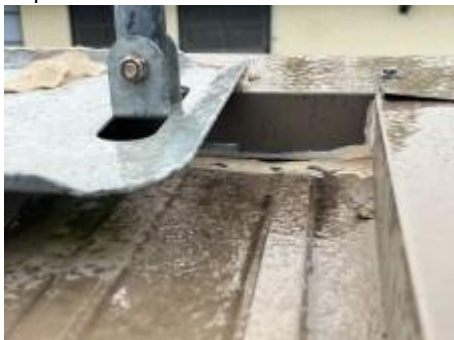
Sections of the sealant to the roof exterior, intended to provide a watertight seal, are deteriorated and loose. This may allow moisture ingress and should be rectified by a licensed roofing contractor.

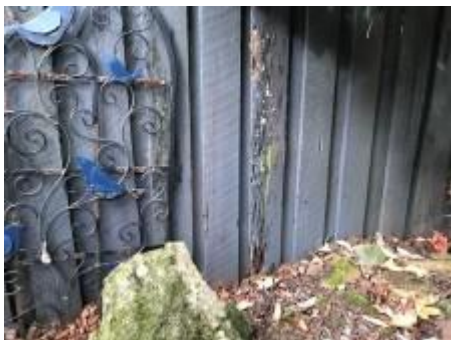
Wood rot to parts of the fences

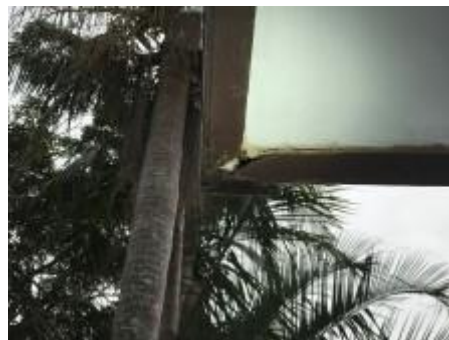
Wood rot to external mouldings

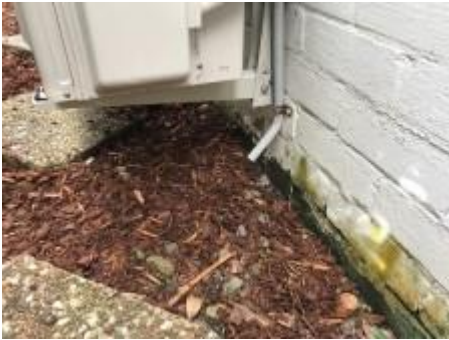
AC unit overflow/s, recommend diverting away from the building or to a suitable drain

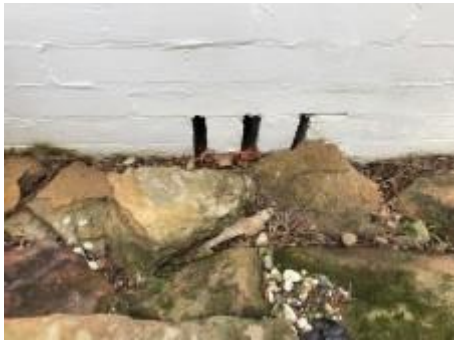
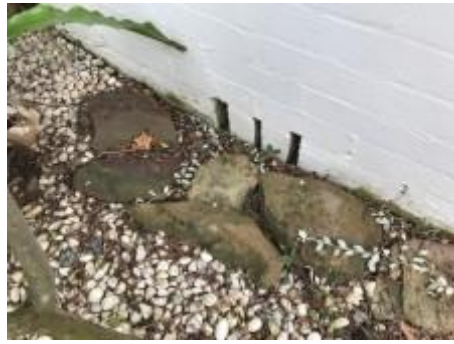
Subfloor air vents are in contact with the ground. Recommend exposing a minimum of 75mm underneath them to reduce the risk of termite attacks/water ingress to the building causing footing and moisture related issues.

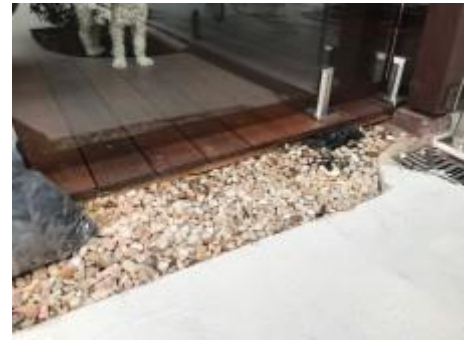
Timber/s in contact with ground - recommend exposing 75mm under timbers to allow for visual inspection zone and to prevent the risk of wood rot and termite attack.

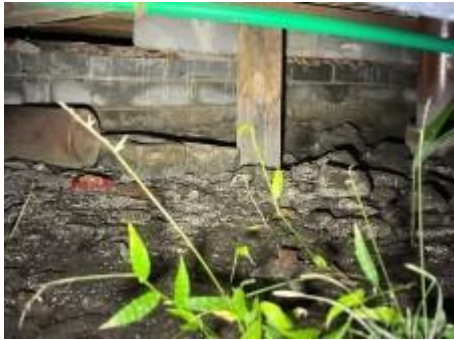
Leaving formwork timbers in direct contact with the ground under a subfloor can significantly increase the risk of termite infestation and structural damage. Termites are drawn to timber, particularly when it is untreated and in contact with soil, as it provides both a food source and a favorable environment for them to thrive. Additionally, the timber can serve as a pathway for termites to access the building. To reduce this risk, any leftover timber in the ground should be promptly removed to eliminate potential food sources for termites.

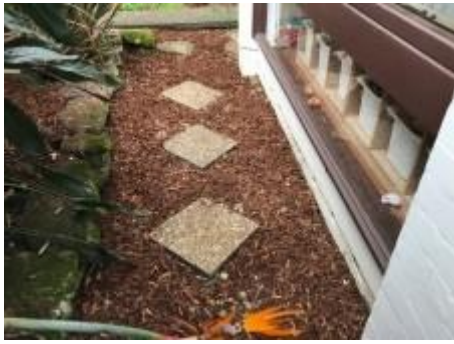
Mulch was observed in direct contact with the external walls of the structure. Organic mulch retains moisture and can create conditions conducive to subterranean termite activity by providing both a food source and a moist environment. Additionally, it can obscure visual inspection of the foundation and weep holes, making early detection of termite activity more difficult. It is recommended to maintain a clearance of at least 150 mm between mulch and the foundation or siding, and to avoid piling mulch directly against the structure.

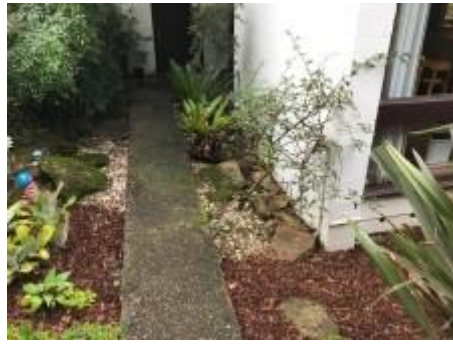
Garden beds and vegetation in direct contact with external walls create a moisture-rich environment and provide concealed access for termites. Recommend removing to reduce the risk of infestation.

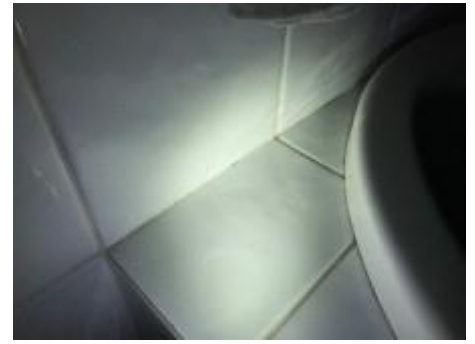
Sections of grout/sealant to the wet areas are missing/loose/cracked which could lead to water leaks and potential damage. It is advisable to consult a plumber and/or a waterproofing technician to address this issue promptly and effectively.
