# Timber Pest Inspection Report

Inspection Date: Sat, 11 Jul 2020

Property Address: 56 Epping Dr, Frenchs Forest NSW 2086, Australia

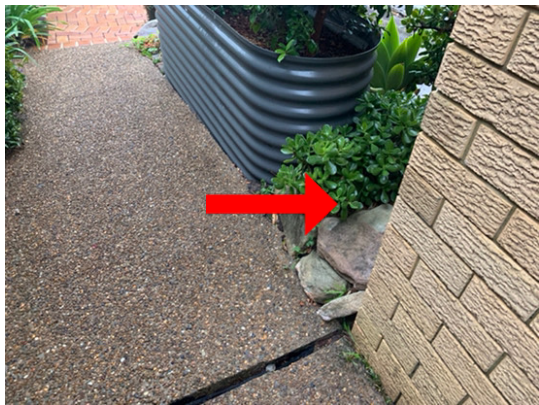
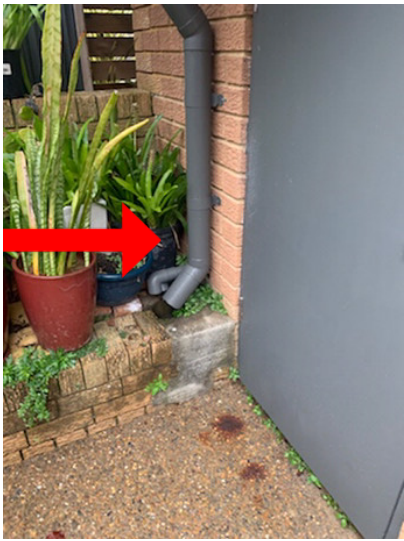
### Termite and Timber Pest

| Building: | Building 1 |
| Location: | All Areas |
| Finding: | In ground contact |
| Information: | Any timbers in direct ground contact provide opportunity for concealed termite entry and are likely to be subject to premature rot and decay as the soil retains moisture or damp conditions against the timbers. |

Remove untreated timber that is in direct contact with external grounds. Consider replacement with more durable materials i.e. treated timber or non timber elements. Frequent pest inspections are advised to readily identify any termite activity in these areas.

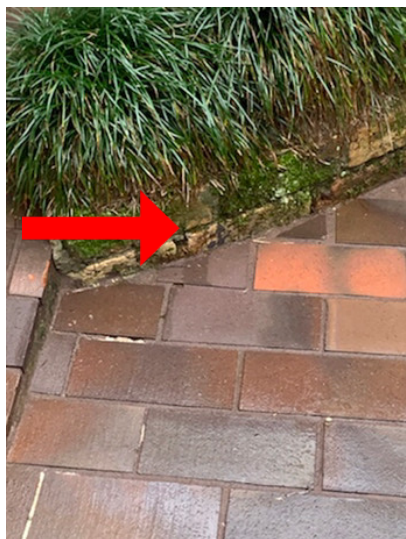
## Termite and Timber Pest

| Building: | Building 1 |
| Location: | All External Areas |
| Finding: | Excessive moisture - identified |
| Information: | Excessive moisture can attract termites and produce conditions that promote fungal growth and wood decay. |

Excessive moisture is generally caused by deteriorated inadequate or missing roof drainage leaking plumbing pipes or fixtures poorly plumbed HWS overflows or condenser units and poor site drainage.

If mould growth has been found there may be environmental biological or health issues involved. In these cases an appropriately qualified inspector should also be contacted.

Prior to any remedial works being performed a qualified plumber should be appointed to further inspect the property and to identify the cause of the excessive moisture. Works to remove affected building elements may then be necessary and should be performed by an appropriate tradesperson.

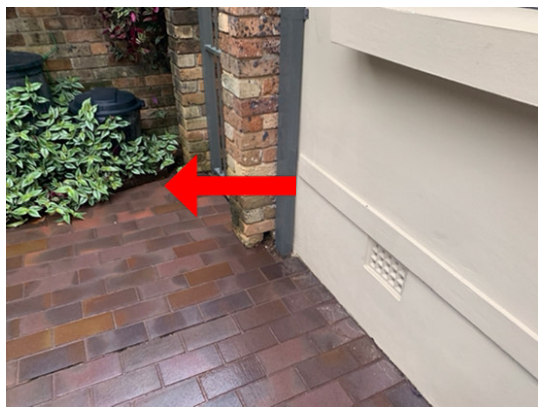
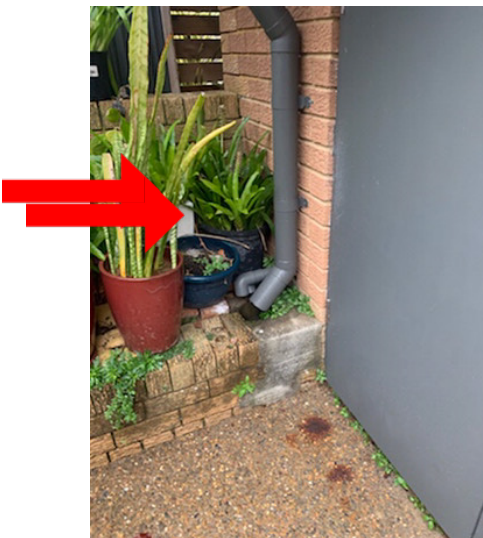
Building: Building 1  
Location: Yard - Back  
Finding: Garden Beds - Conditions Conducive to Termites  
Information: Garden beds were found to be evident in the garden area. These garden beds can include untreated timber, and with a combination of moisture from watering hosing can make conditions conducive to termite activity and termite ingress.

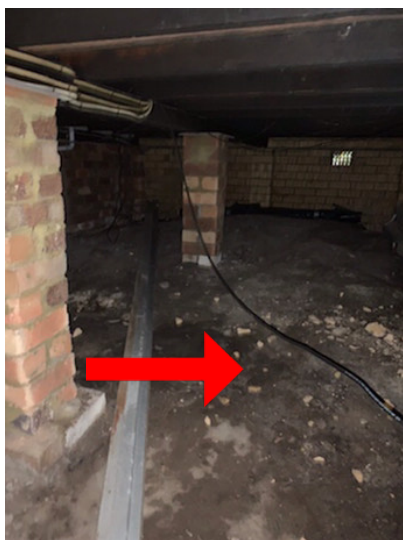
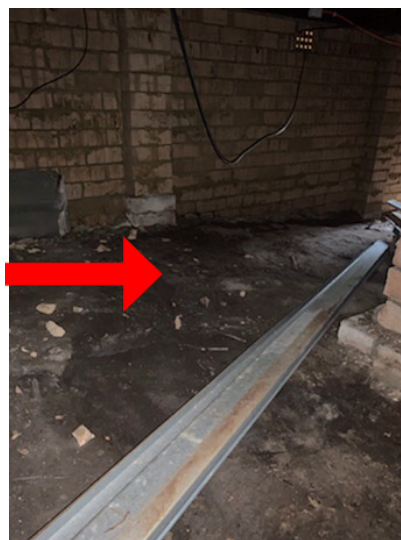
## Termite and Timber Pest

| Building: | Building 1 |
| Location: | Subfloor |
| Finding: | Evidence of excessive moisture was present at the time of inspection |
| Information: | Excessive moisture can attract termites and produce conditions that promote termite attack fungal growth and wood decay. |

Excessive moisture is generally caused by deteriorated inadequate or missing roof drainage leaking plumbing pipes or fixtures poorly plumbed HWS overflows or condenser units and poor site drainage.

It is highly recommended that all plumbing and drainage fixtures and fittings be maintained regularly in order to prevent excessive moisture being present in the external / internal property.

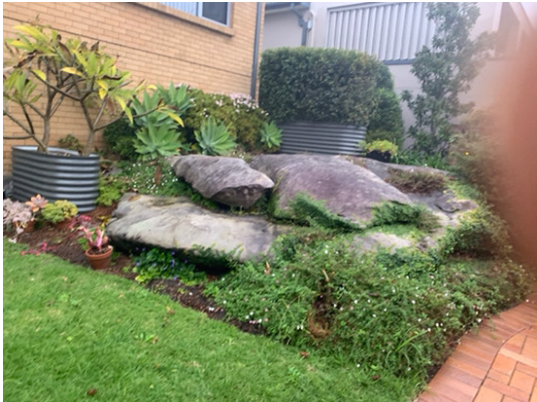
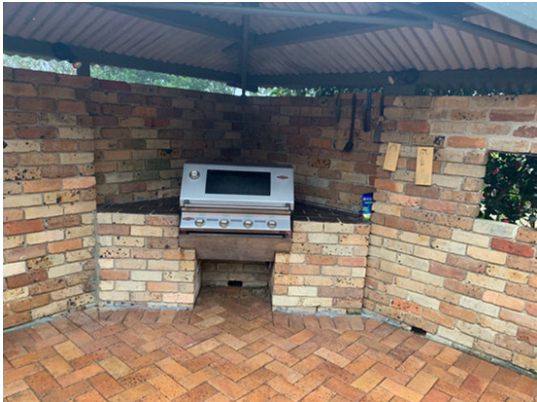
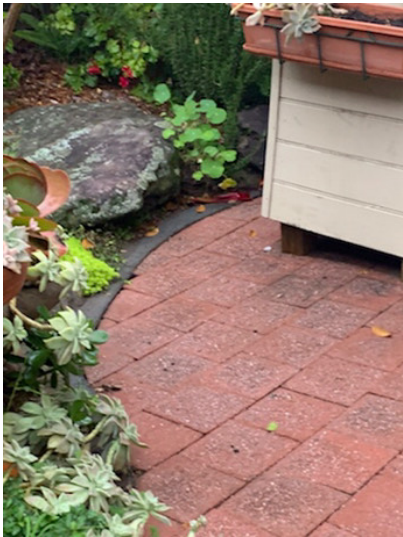
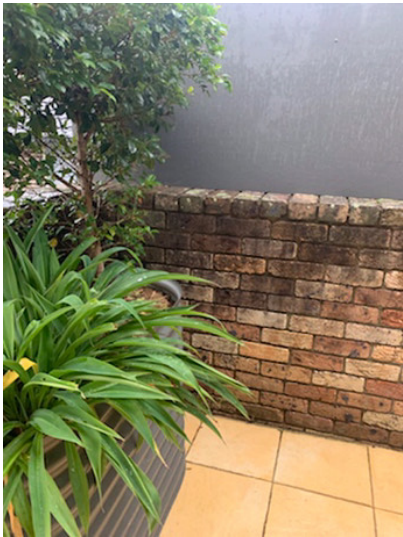
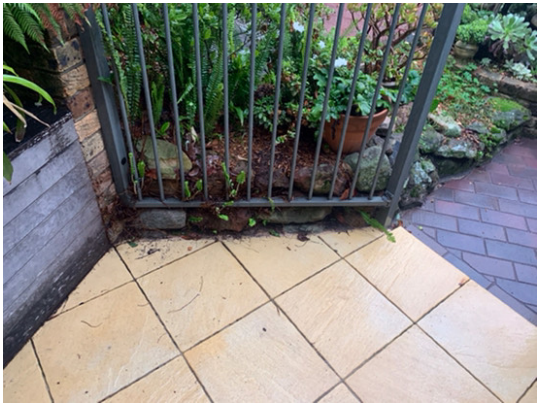
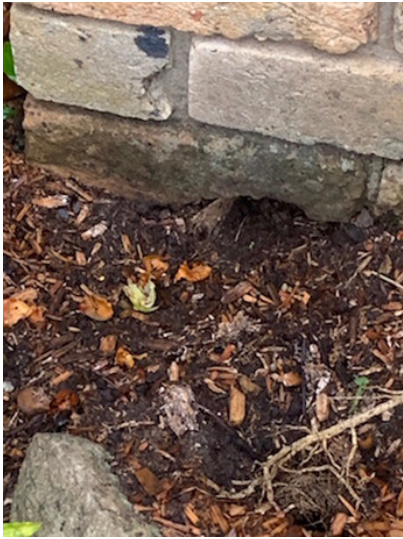
Additional Photos - Obstructions and Limitations

These photographs are an indication of the obstructions and limitations which impeded full inspection of the property at the time of inspection.

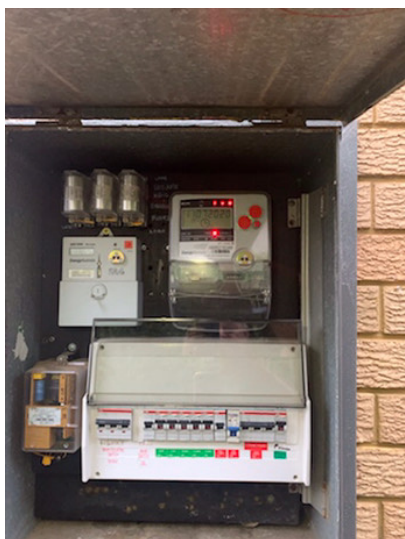
Building: Building 1  
Location: Yard - Side  
Finding: Termite Management System - no evidence of installation  
Information: The application of a post-construction chemical termite barrier is highly recommended for all properties, particularly if live termite activity has been found on the site previously. Such barriers are highly effective in preventing termite attack on any timber building elements throughout the property.

A durable notice should be placed in the switchboard unit to indicate current termite barriers. At the time of inspection, it appeared as though no termite management system has been installed, with no evidence to suggest preventative works taking place.

The client may consider gaining further advice from a pest controller as to the costs and procedures involved with this application. It is recommended that obtaining such advice be a short-term priority.
