Timber Pest Inspection Report

Inspection Date: Tue, 16 Jan 2024

Property Address: 7 Kurrajong Rd, Frenchs Forest NSW
2086

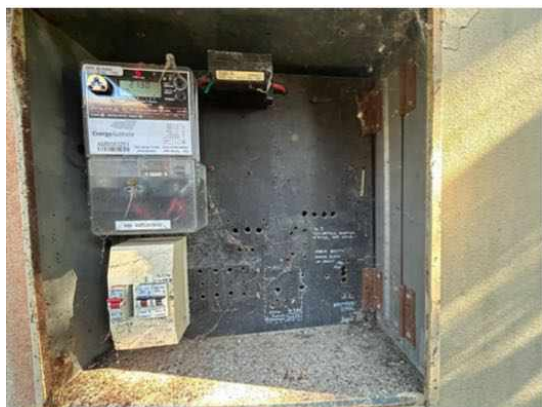
Termite and Timber Pest 1.01

Building:	Building 1
Location:	All Areas
Finding:	Termite Management System - durable notice not present
Information:	A durable notice has not been placed in the switchboard unit to indicate current termite barriers. At the time of inspection, it appeared as though there is no termite management system installed.

The client may consider gaining further advice from a pest controller/ installer as to the costs and procedures involved with this application. It is recommended that obtaining such advice be a short-term priority.

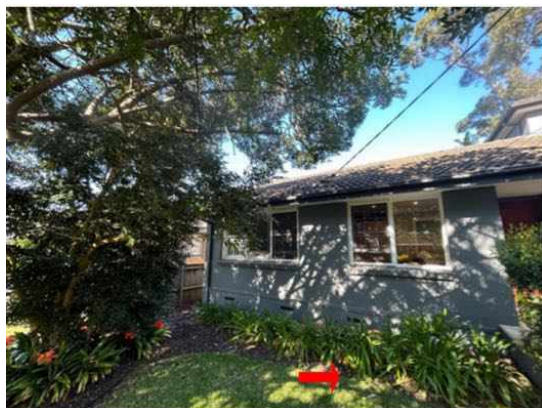
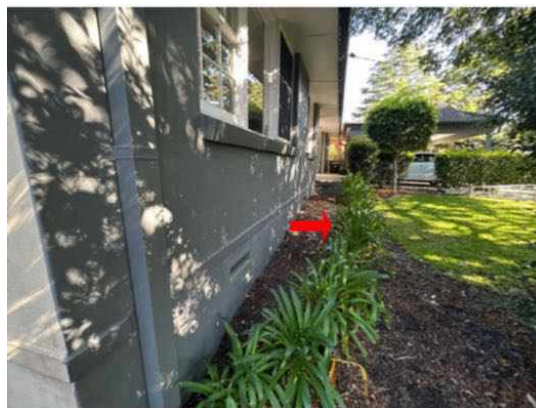
Termite and Timber Pest 1.02

Building:	Building 1
Location:	All Areas
Finding:	Garden Beds - Conditions Conducive to Termites
Information:	Garden beds were found to be evident in the garden area. These garden beds can include untreated timber, and with a combination of moisture from watering hosing can make conditions conducive to termite activity and termite ingress.

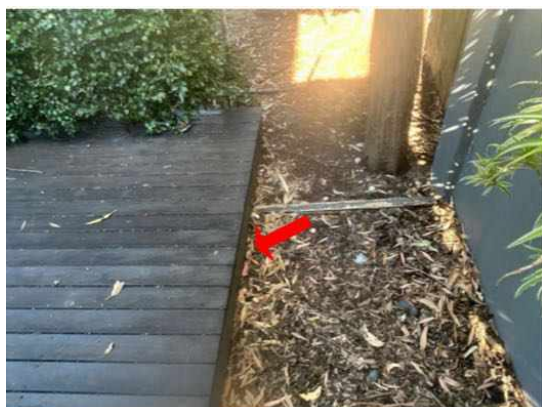
Termite and Timber Pest 1.03

Building:	Building 1
Location:	All Areas
Finding:	Building materials in direct ground contact - conducive to termites
Information:	Where timber elements are in direct contact with the ground and consequently moisture or dampness they become conducive to termite activity. Whether timber is used as a building element part of a fencing structure or stored as an unused item they can provide an environment that is attractive to termite infestation.

When met with excessive moisture timber begins to decay and develop wood rot. Any timbers that are in direct contact with external grounds especially if left untreated or non- durable also provide ingress for subterranean termites into that particular element.

The removal of any such materials that may be conducive to termite activity should be removed as soon as possible to minimise the risk of termite attack.

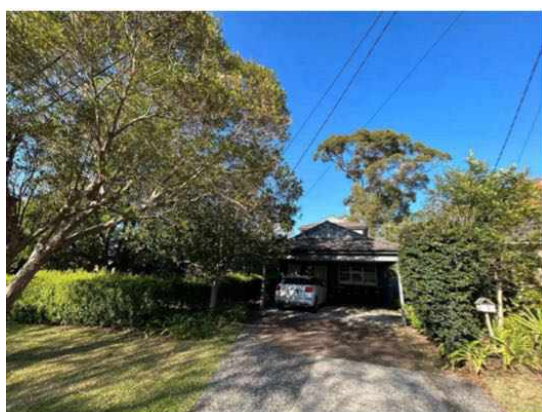
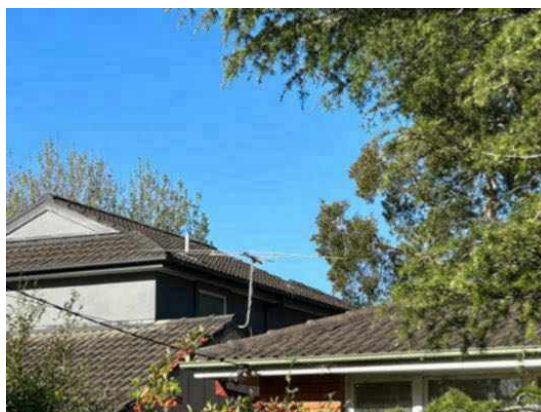
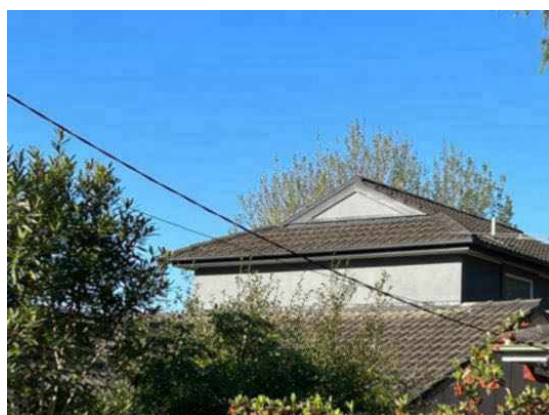
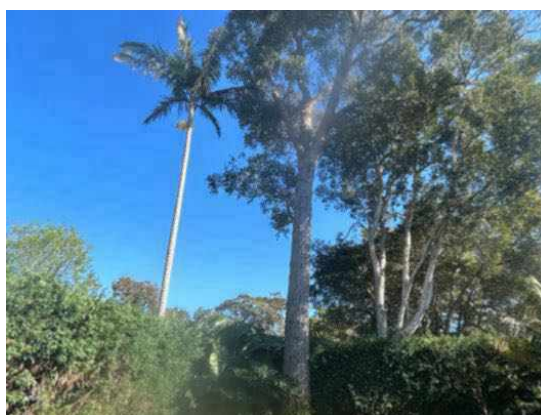
Termite and Timber Pest 1.04

Building:	Building 1
Location:	All External Areas
Finding:	Trees - Overhanging and filling gutters

Information: Overhanging trees often result in excessive amounts of leaf debris accumulating in gutters.

Gutters are a critical part of the building's management of storm water and rain. It is therefore important that they be kept clear to prevent secondary damage to associated building elements, including exterior and interior walls, ceiling linings and any adjoining building elements. Where gutters are blocked, pooling of rainwater is likely to occur, fast-tracking rust and corrosion of the roof plumbing elements.

It is highly advised that all overhanging tree branches be removed as soon as possible to prevent any further damage. Repair and/or replacement of sections of damaged guttering may also be required where the extent of the damage necessitates.

Such works should be performed by the homeowner; however, appointment of a landscape contractor or an arborist may be required.

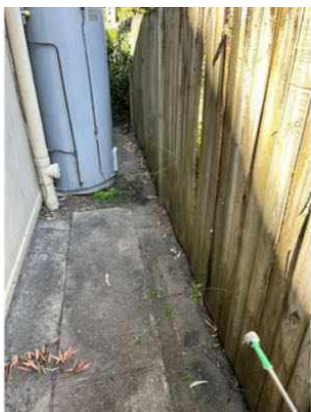
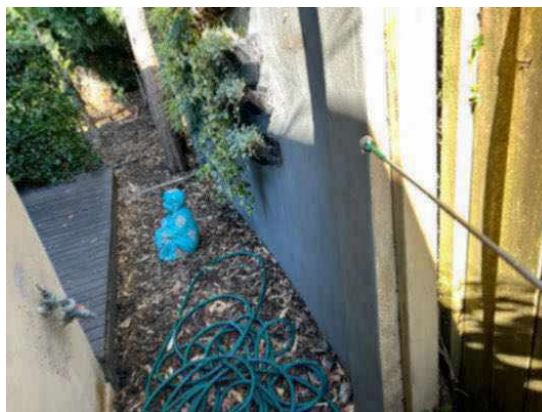
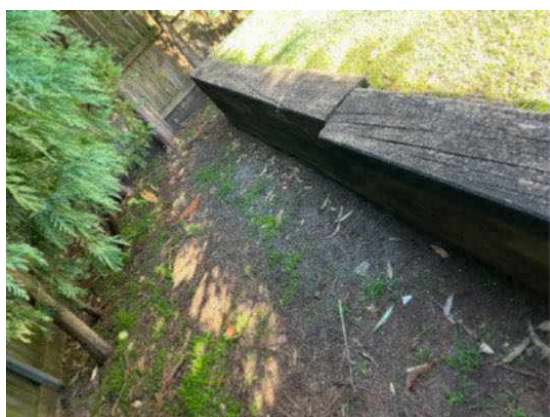
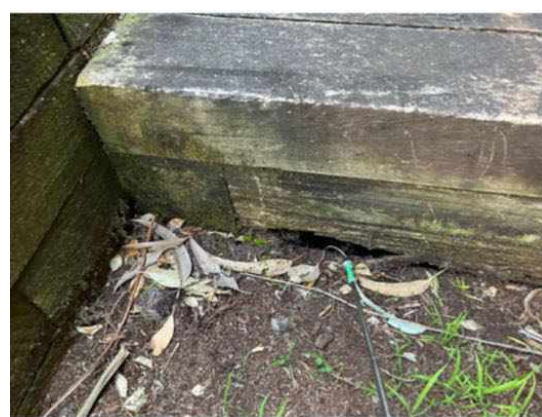
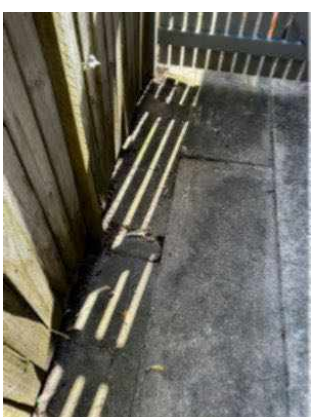
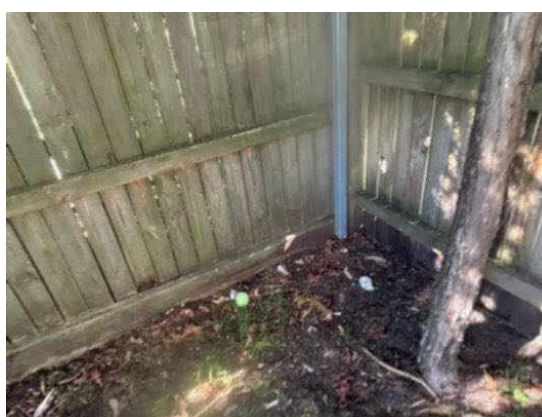
Termite and Timber Pest 1.05

Building: Building 1
 Location: All External Areas/ subfloor
 Finding: Evidence of excessive moisture was present at the time of inspection
 Information: Excessive moisture can attract termites and produce conditions that promote termite attack fungal growth and wood decay.

Excessive moisture is generally caused by deteriorated inadequate or missing roof drainage leaking plumbing pipes or fixtures poorly plumbed HWS overflows or condenser units and poor site drainage.

It is highly recommended that all plumbing and drainage fixtures and fittings be maintained regularly in order to prevent excessive moisture being present in the external / internal property.

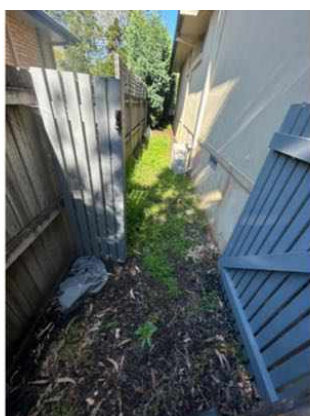
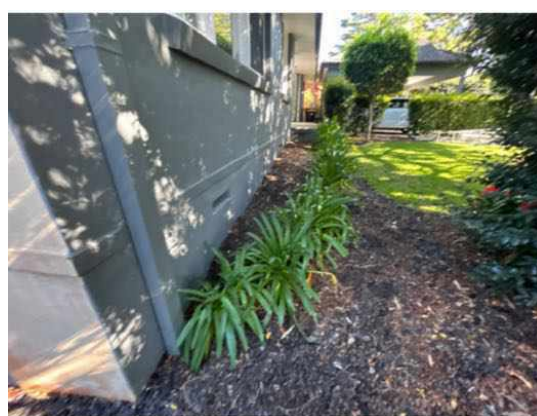
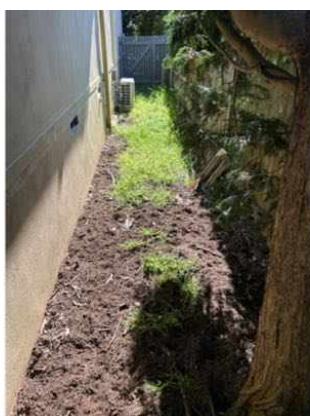
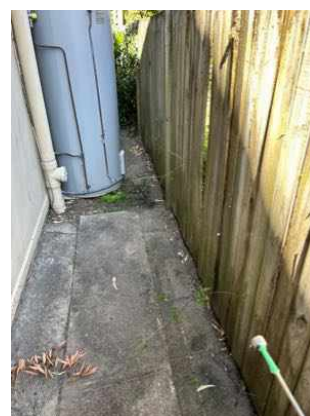
Termite and Timber Pest 1.06

Building: Building 1
Location: All External Areas

Finding: Site drainage - suspected Inadequate
 Information: The site drainage in this area was found to be inadequate at the time of inspection, creating potential for subsequent water damage to associated building elements.

It is important that water does not lie against the base of walls; surrounding paths and ground levels should be sloped to drain water away from walls. Downpipes should not discharge stormwater onto lower walls or plinths. Stormwater should be carried away by large, regularly cleaned drains. Ground levels may need to be lowered to expose a buried DPC.

Where site drainage is inadequate, installation of an Agricultural (Aggie) Drain may be required. A qualified plumber should be appointed to further inspect the property and perform any remedial works as necessary. Water damage and secondary defects are likely to occur if left unmanaged.

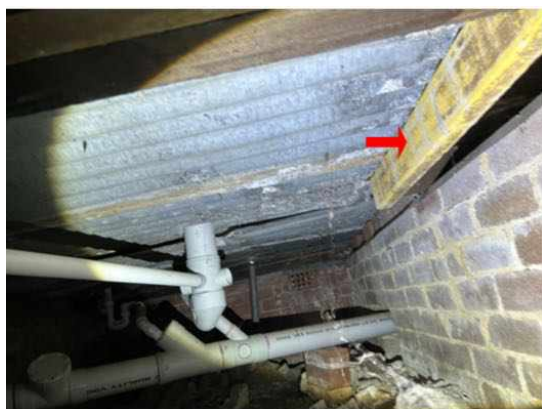
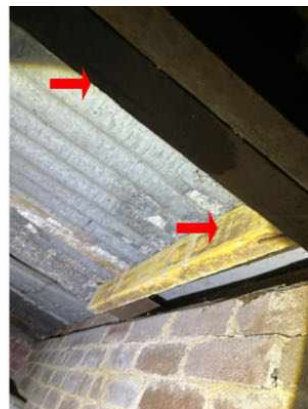
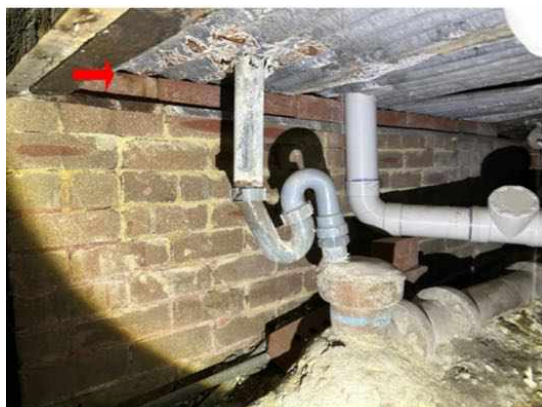
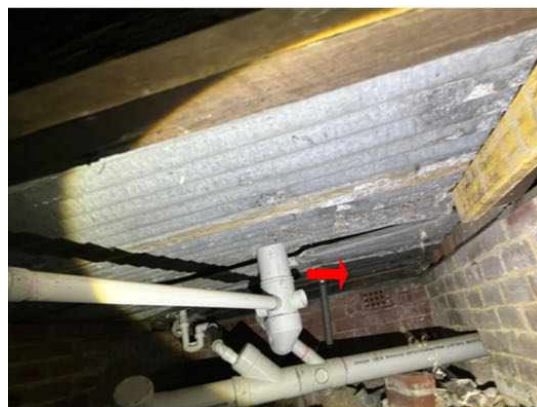
Termite and Timber Pest 1.07

Building: Building 1
 Location: Subfloor
 Finding: Formwork timbers - left in situ
 Information: Formwork timber appears to have been left on site and in situ after concrete construction.

Formwork timber is used to support and shape the concrete while pouring during the construction process. Leaving formwork timbers in the subfloor space or around the exterior of the property increases the risk of termite activity being present. As they are likely to come into contact with weather conditions or excessive moisture wood rot is likely to develop on timbers that are not treated.

It is highly recommended that any formwork timbers be immediately removed from areas in which they may attract any termite/timber pest attack. Minimisation of risk/prevention of termite attack is far more adequate than dealing with the presence of termite activity.

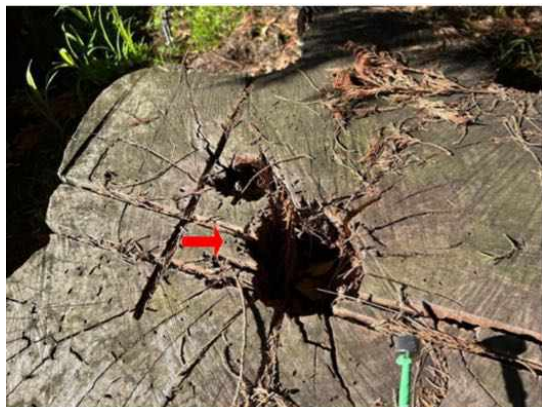
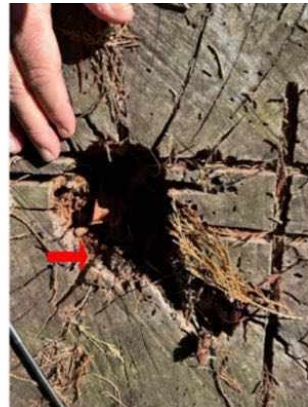
Termite and Timber Pest 3.01

Building:	Building 1
Location:	Yard - Back
Finding:	Evidence of termite damage - minor

Information: Despite no live termite or timber pest activity being indicated, previous termite damage was found to have affected this area. This damage is considered to be inactive and is minor in nature.

At the time of inspection, damage is not structural and is only considered to be superficial.

A Timber Pest Inspector may be appointed to provide a further invasive inspection if further damage is evident.

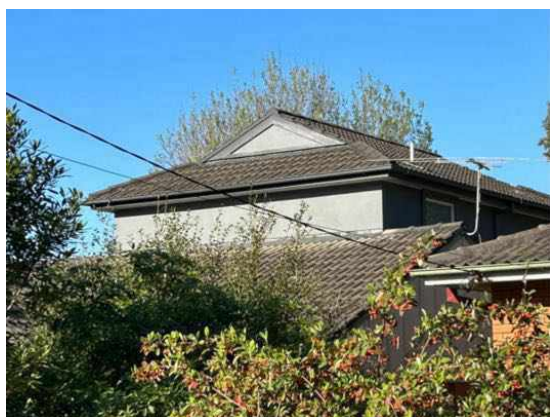
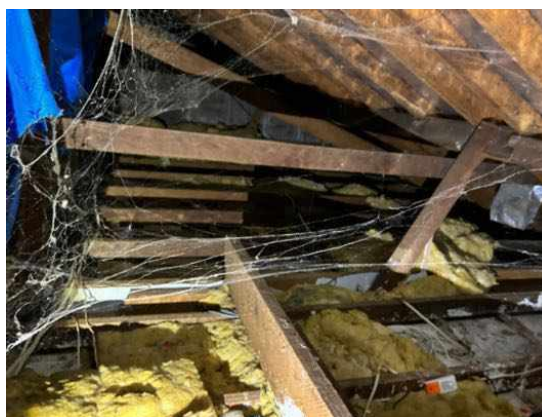
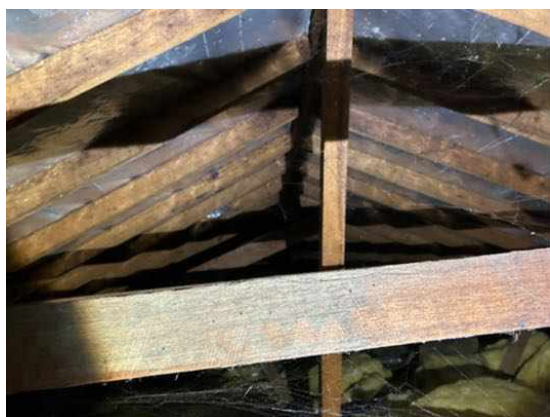
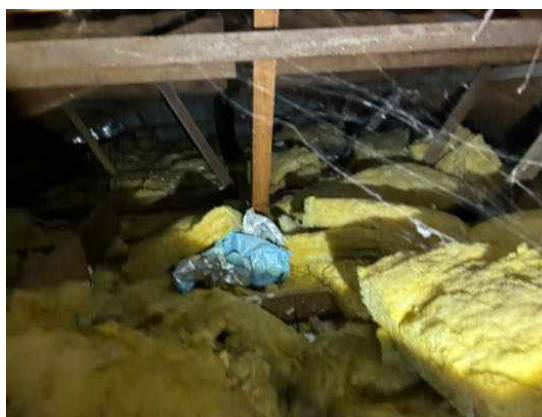
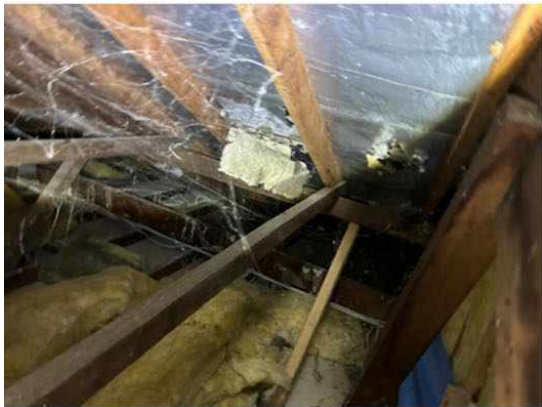
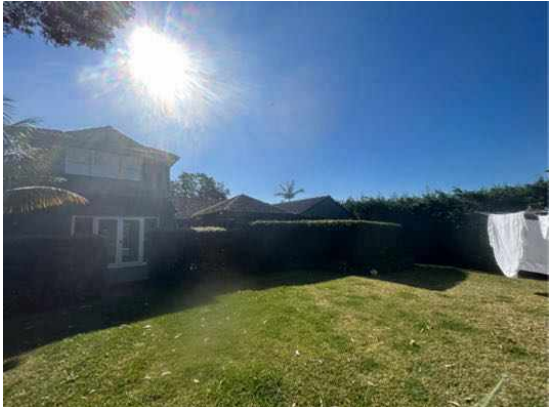
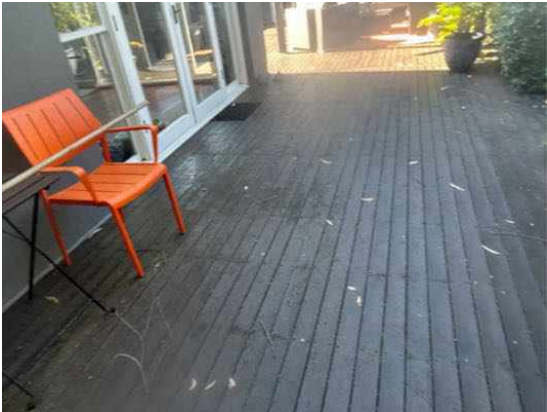
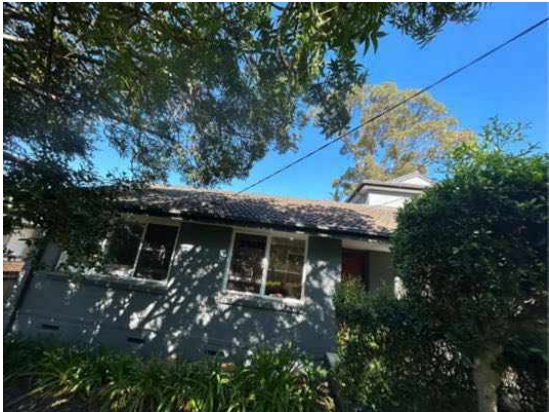
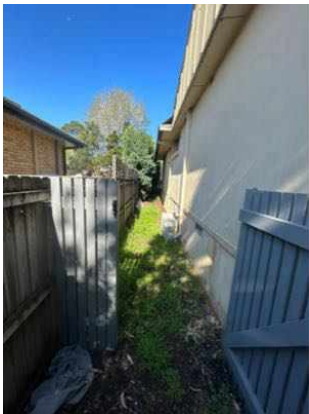
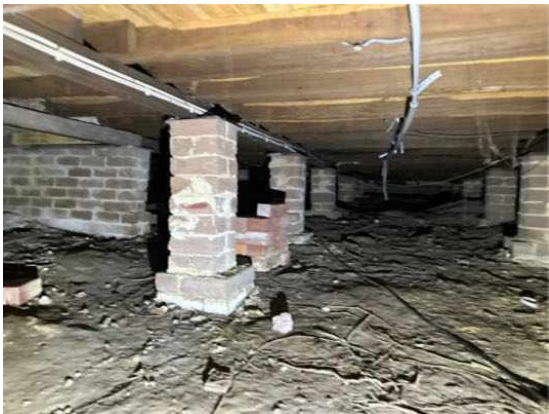
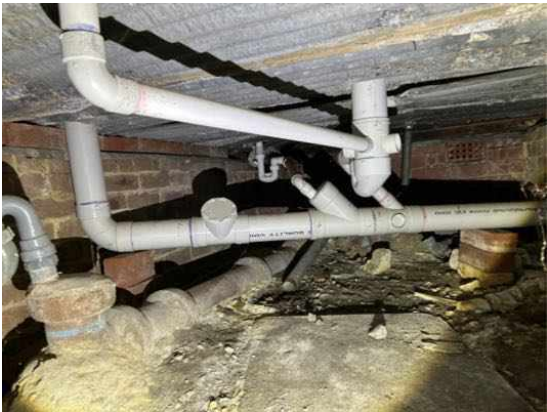
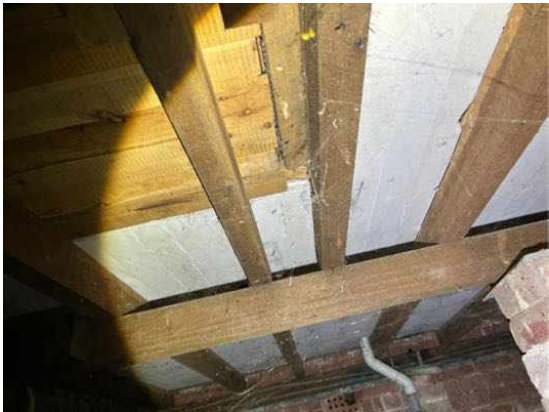
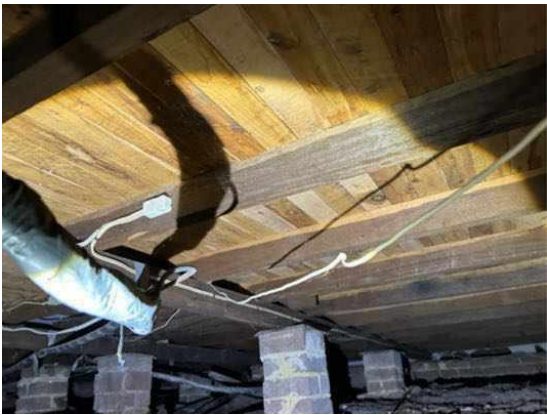
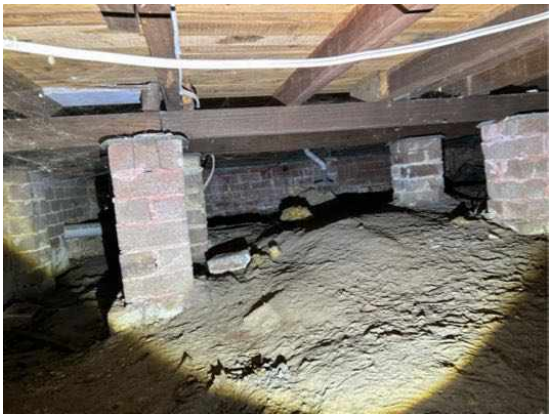
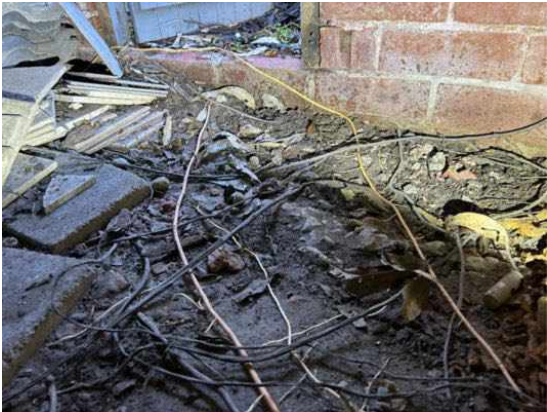
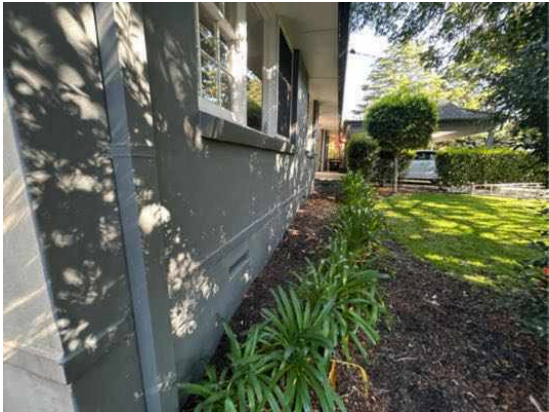
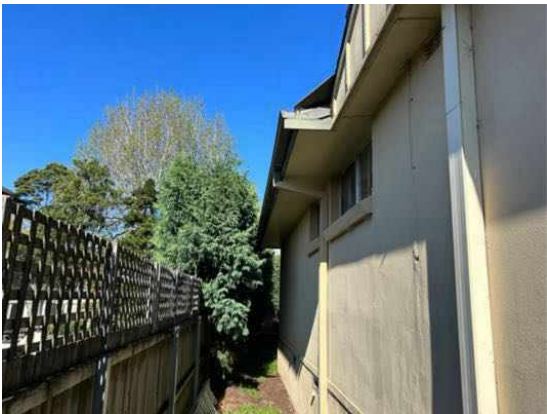
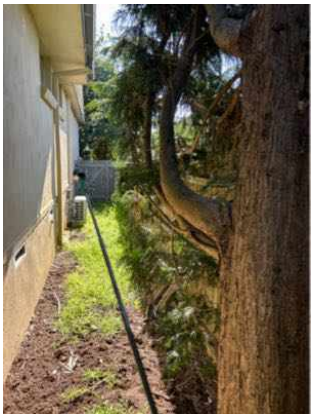
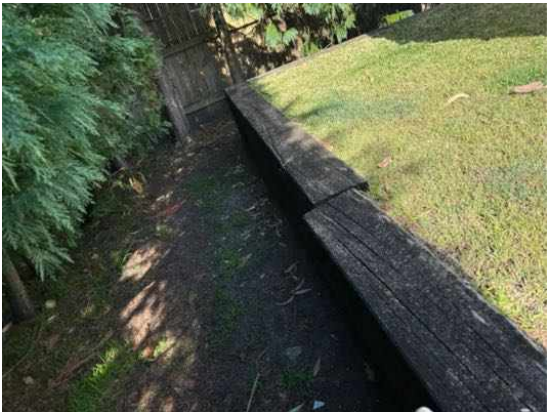
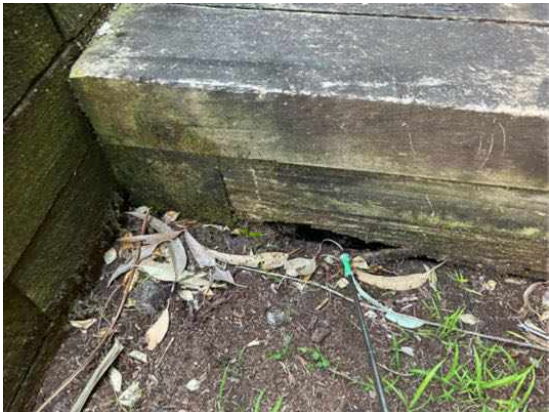
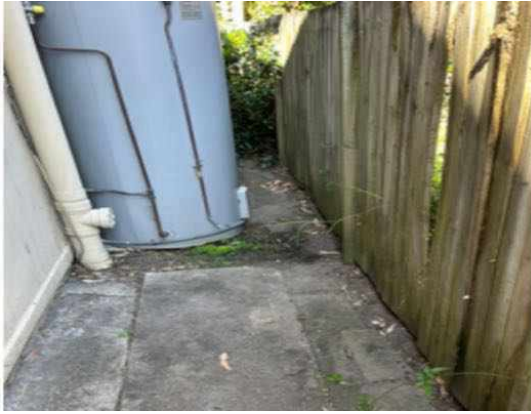
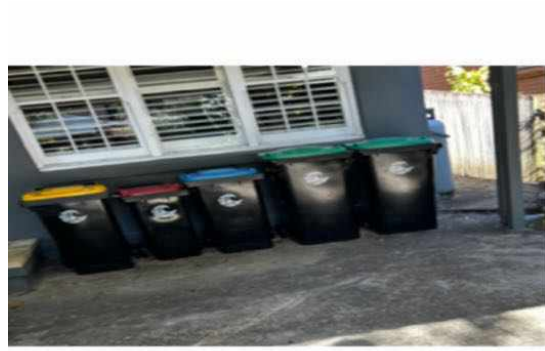
Noted Item

Building: Building 1
Location: All Areas
Finding: Additional Photos - Obstructions and Limitations
Information: These photographs are an indication of the obstructions and limitations which impeded full inspection of the property at the time of inspection. These obstructions can hide an array of defects and should be removed to allow full inspection to be carried out. A re-inspection is recommended once the areas are made accessible.
