# Timber Pest Inspection Report

Inspection Date: Tue, 01 Oct 2019

Property Address: 94 Bantry Bay Road, Frenchs Forest NSW, Australia

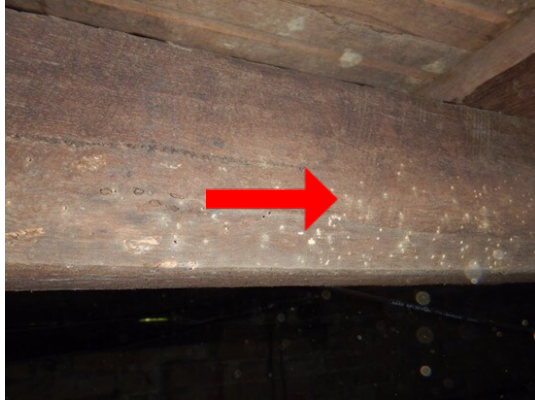
Building:	Main Building
Location:	Subfloor
Finding:	Evidence of termite damage - minor
Information:	Despite no live termite or timber pest activity being indicated, previous termite damage was found to have affected this area. This damage is considered to be inactive and is minor in nature.

It is advised that the area be visually inspected frequently to ensure that the condition of affected building materials does not worsen. At the time of inspection, damage is not structural and is only considered to be superficial.

A building contractor may be appointed to provide a further invasive inspection if further damage is evident.

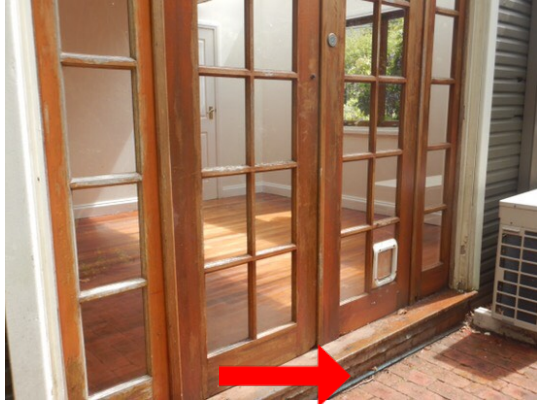
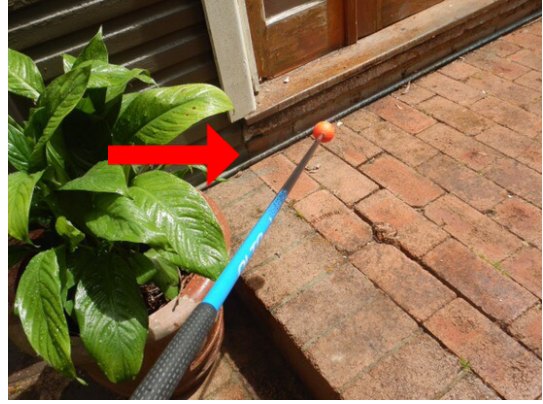
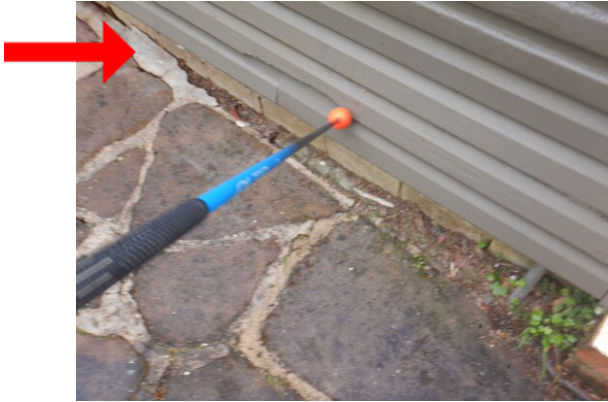
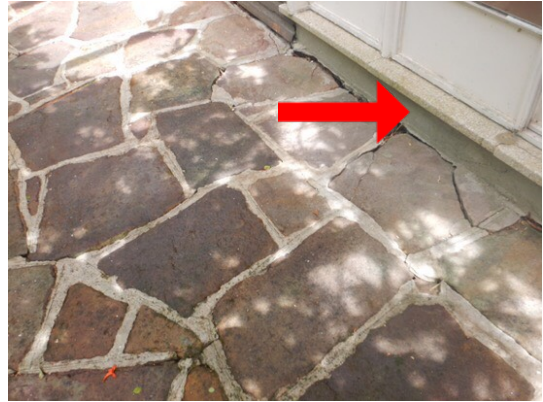
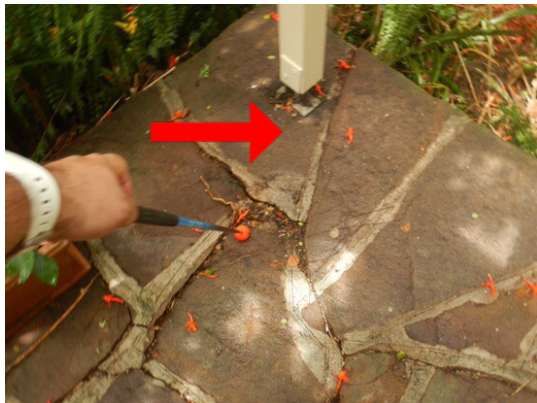
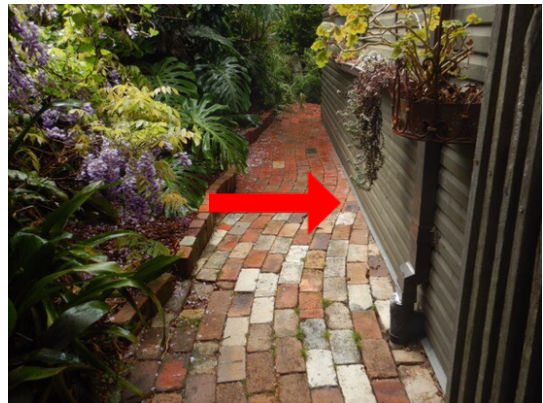
Finding: In ground contact

Information: Any timbers in direct ground contact provide opportunity for concealed termite entry and are likely to be subject to premature rot and decay as the soil retains moisture or damp conditions against the timbers.

Remove untreated timber that is in direct contact with external grounds. Consider replacement with more durable materials i.e. treated timber or non timber elements. Frequent pest inspections are advised to readily identify any termite activity in these areas.

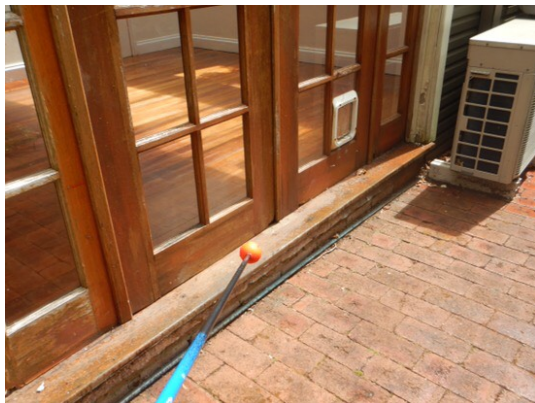
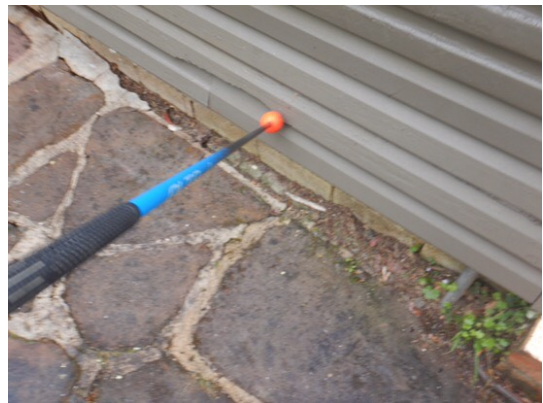
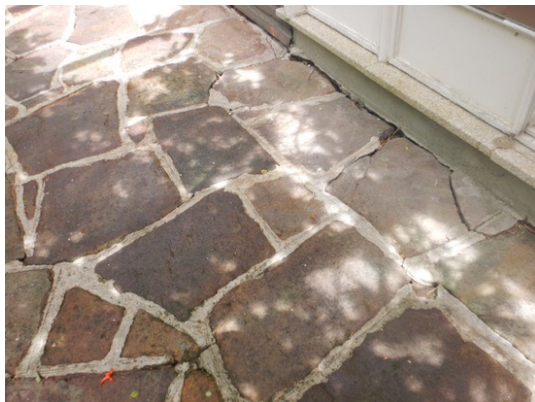
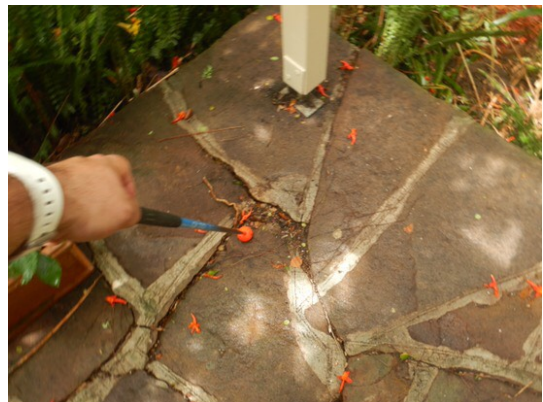
Building: Main Building  
Location: All Areas  
Finding: Evidence of excessive moisture was present at the time of inspection  
Information: Excessive moisture can attract termites and produce conditions that promote termite attack fungal growth and wood decay.

Excessive moisture is generally caused by deteriorated inadequate or missing roof drainage leaking plumbing pipes or fixtures poorly plumbed HWS overflows or condenser units and poor site drainage.

It is highly recommended that all plumbing and drainage fixtures and fittings be maintained regularly in order to prevent excessive moisture being present in the external / internal property.

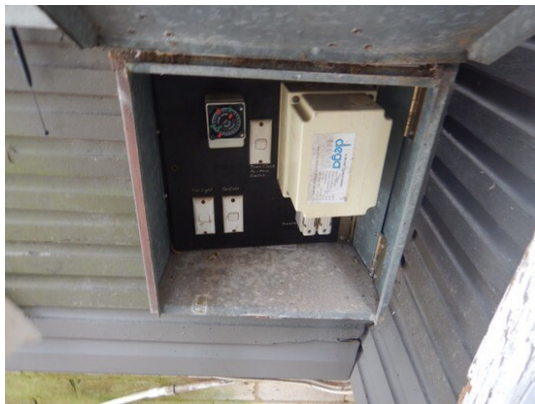
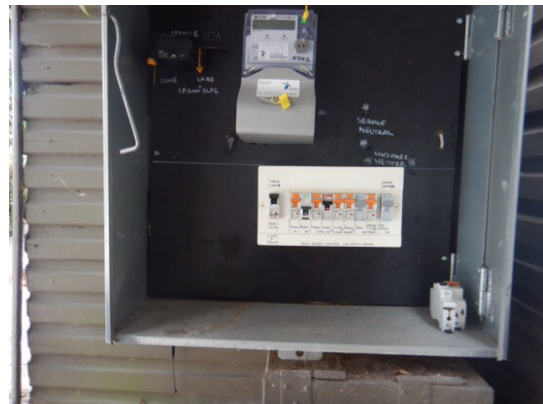
Building: Main Building  
Location: Yard - Side  
Finding: Termite Management System - no evidence of installation  
Information: The application of a post-construction chemical termite barrier is highly recommended for all properties, particularly if live termite activity has been found on the site previously. Such barriers are highly effective in preventing termite attack on any timber building elements throughout the property.

A durable notice should be placed in the switchboard unit to indicate current termite barriers. At the time of inspection, it appeared as though no termite management system has been installed, with no evidence to suggest preventative works taking place.

The client may consider gaining further advice from a pest controller as to the costs and procedures involved with this application. It is recommended that obtaining such advice be a short-term priority.

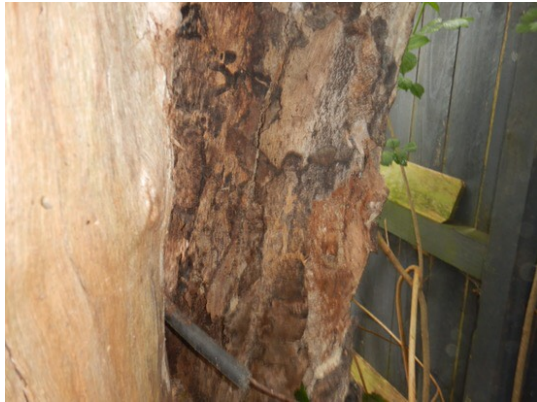
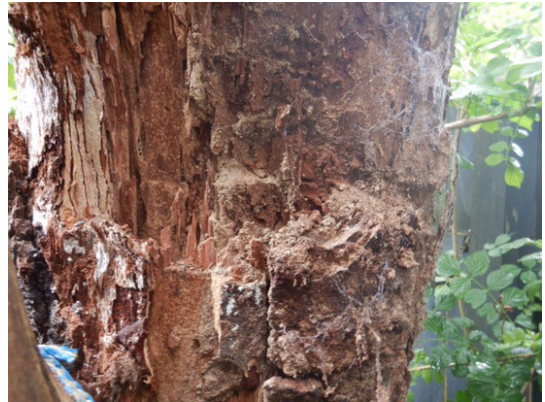
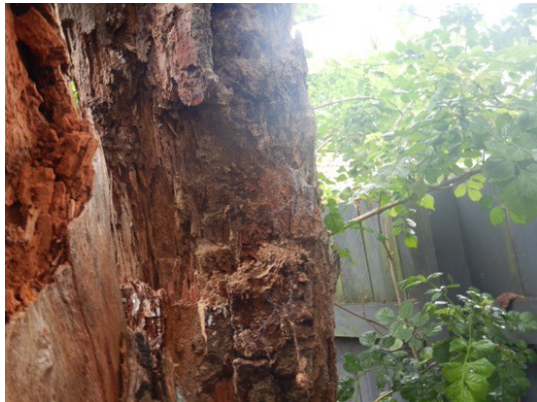
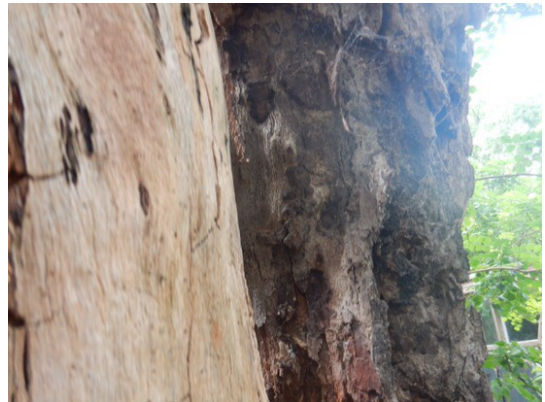
Finding: Termite - Past activity

Information: Past activity was found in tree stump located front left hand side of house. It is highly recommended regular inspections to be done by a pest controller or for the stump to be removed.
