Building and Timber Pest Inspection Report

Inspection Date: Tue, 15 Apr 2025

Property Address: 288 Bungarribee Rd, Blacktown NSW 2148,
Australia

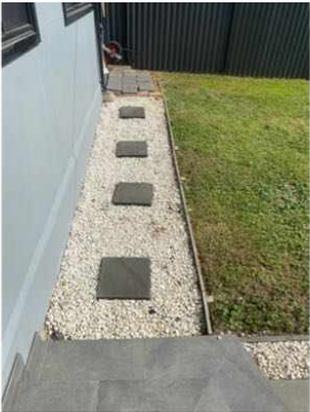
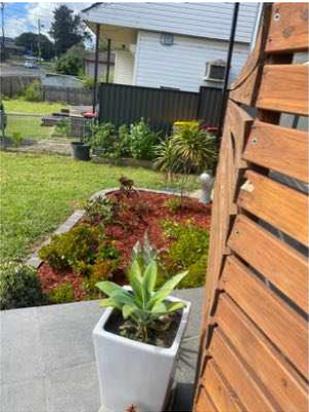
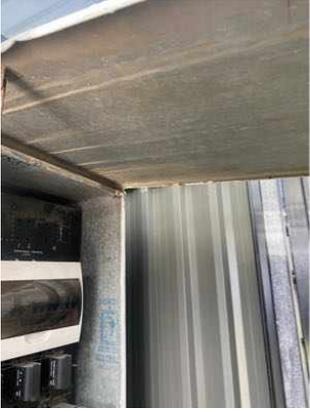
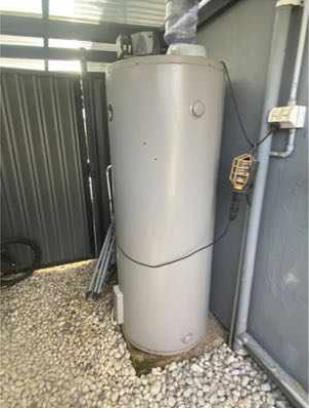
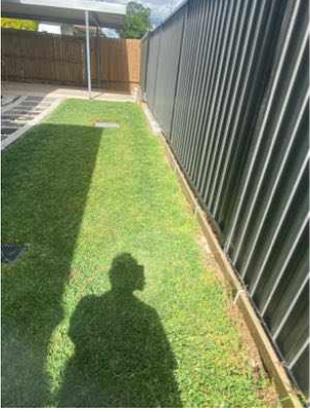
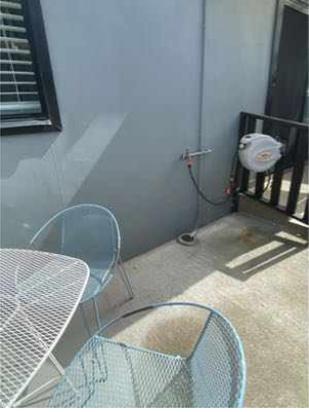
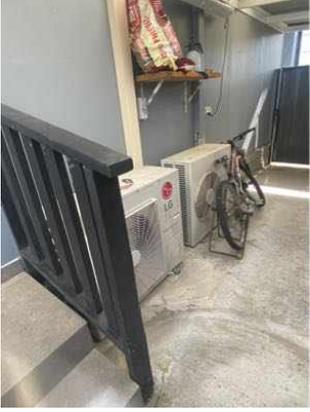
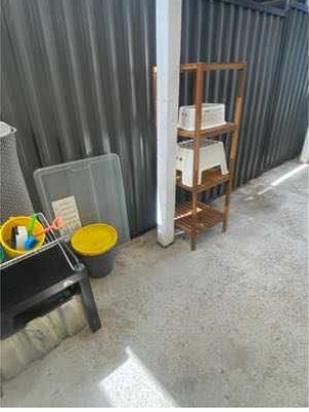
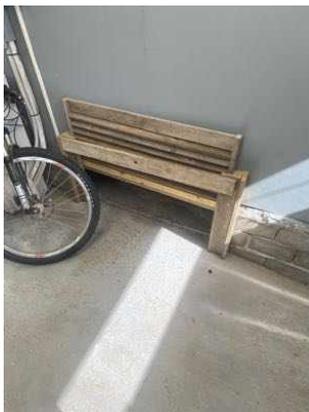
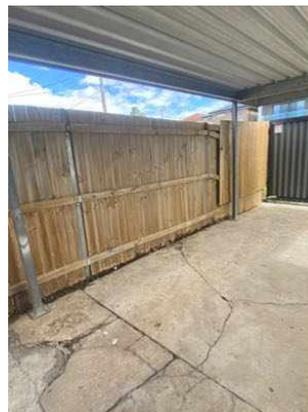
Building: Main Building
 Location: All Areas
 Finding: Conditions Conducive to Termites
 Information: Areas and conditions conducive to termites include the following and should be addressed through maintenance, repair, additional monitoring, or the installation of a termite management system:

No Evidence of Previous Termite Treatment: Absence of a termite management system increases vulnerability. Install a termite management system if none exists.

Inadequate Hot Water System (HWS) Overflow: This can create excess moisture, attracting termites. Ensure proper drainage systems are installed and maintained.

Inadequate Air Conditioner Overflow Drainage: Leaks or overflows can increase moisture. Ensure overflow drains are functioning properly.

No Drain to Tap: Leaking or dripping taps without proper drainage can create moisture issues. Install or repair drainage to direct water away from the structure.

Drains Not Connected to the Mains: Poor drainage systems can cause water pooling. Ensure all drains are properly connected to the mains.

Old Tree Stumps or Garden Beds: These provide a natural food source and habitat for termites. Remove old stumps and avoid garden beds close to structures.

Timber Directly In Contact to Ground - Where timber elements are in direct contact with the ground and consequently moisture or dampness they become conducive to termite activity.

Timber Fences, Decks, and Landscaping Timbers: Wood in contact with soil is highly attractive to termites. Use treated timber or ensure proper separation from the ground.

Recommendations:

Maintain and repair these areas to minimize conditions favorable to termites.

Schedule regular monitoring and inspections for termite activity.

Install a termite management system as a preventative measure.

Drill and test trees with a diameter greater than 100mm on the property for potential

termite activity.

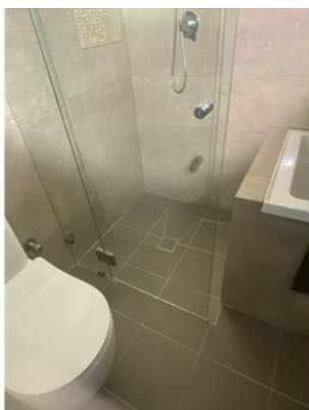
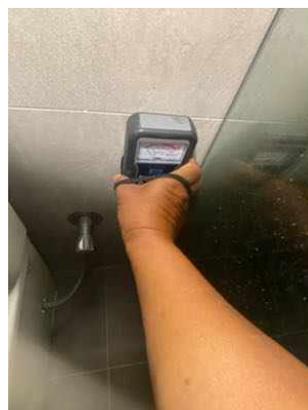
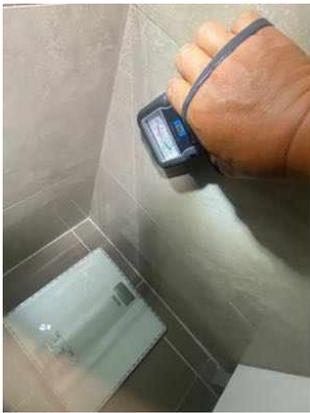
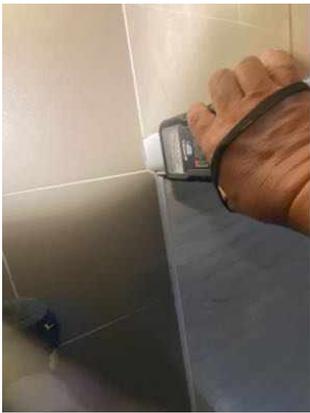
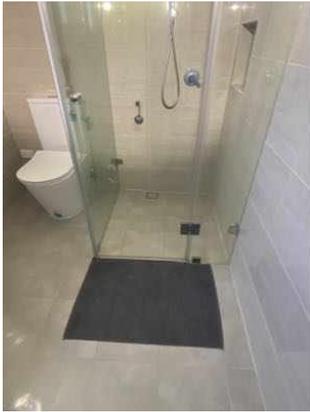
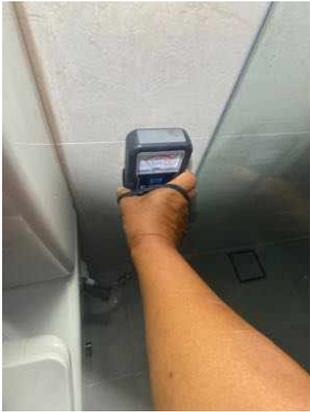
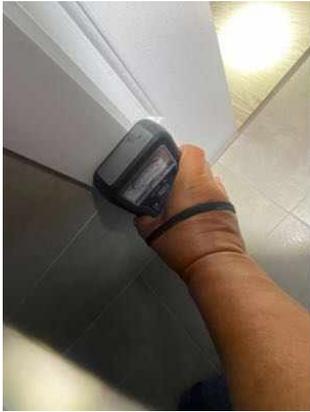
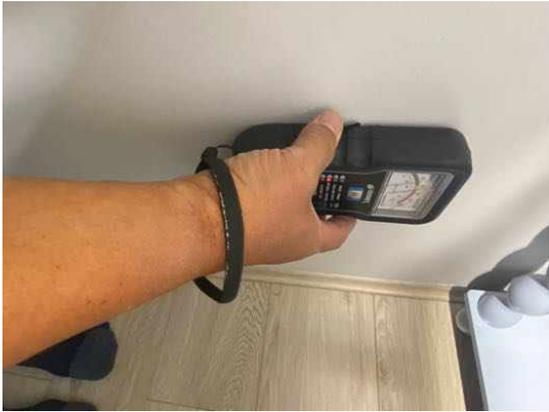
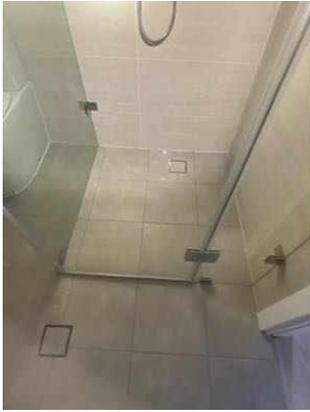
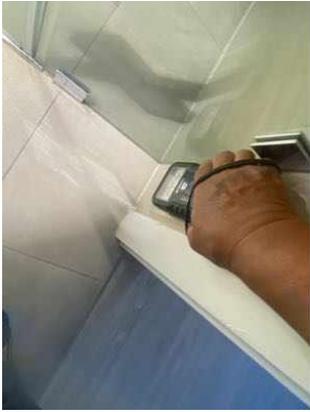
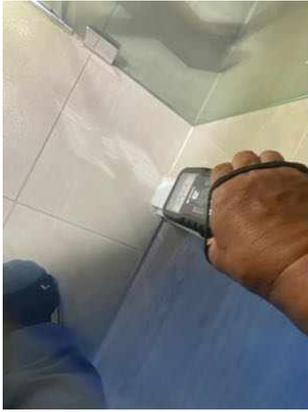
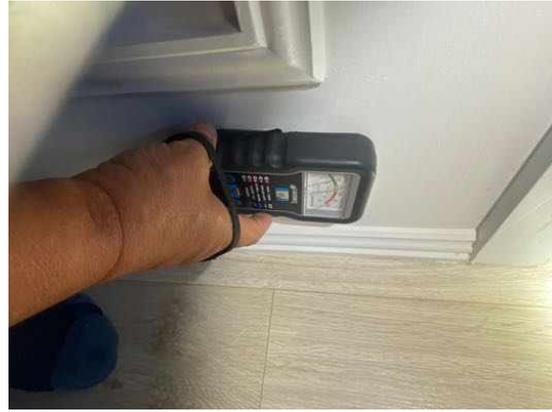
Building: Main Building
 Location: Bathrooms
 Finding: Minimal Moisture Metre Readings
 Information: After conducting an assessment of the shower recess, the moisture content of the walls in and around the shower was examined. The results indicated that there was no significant difference in moisture readings between the walls behind the wet area and other walls, and there were no visible signs of recent water damage on the surrounding walls that could be inspected.

Based on these observations, it can be assumed that the waterproofing of the shower is sound and there is currently no evidence of any leakage. However, it is important to note that if the shower has not been used recently, moisture readings may not be a reliable indicator of any leaks.

It should also be noted that the visual inspection carried out may not be able to detect leaks under all circumstances. Therefore, if a more accurate assessment is required, a special purpose inspection should be requested. Alternatively, it is recommended to continue with the assumption that the shower may leak until further confirmation can be obtained.

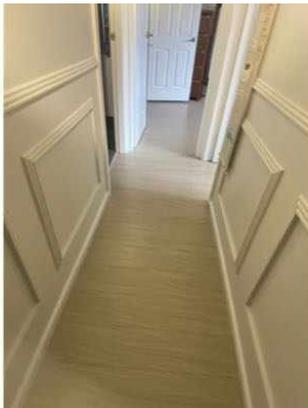
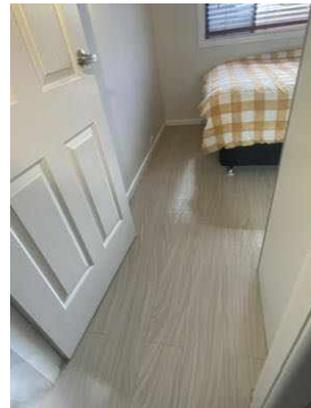
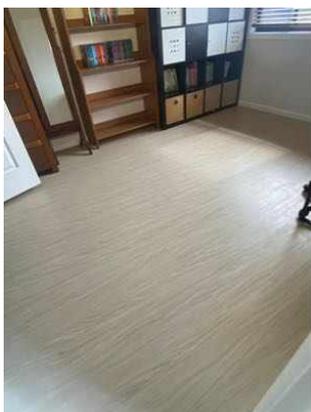
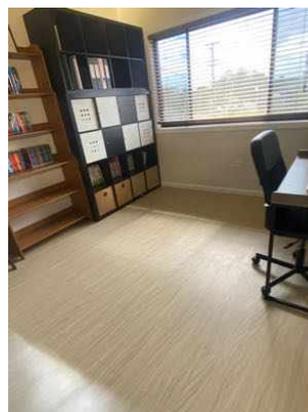
Building: Main Building
 Location: All Areas
 Finding: Flooring - Uneven
 Information: The internal flooring in this area is uneven, which may indicate minor defects such as normal foundation movement or, potentially, subsidence of the subfloor stumps. Uneven flooring is a common issue in homes with pier foundations.

It is recommended to monitor the flooring over time to detect any further movement. If the flooring remains relatively stable for several months, the issue is likely due to expected foundation movement.

However, if the unevenness worsens, a more detailed inspection of the subfloor structures, including the stumps, will be necessary. In this case, repairs may be required, which should be carried out by a registered builder specializing in re-stumping.

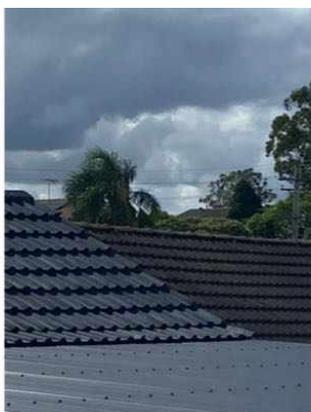
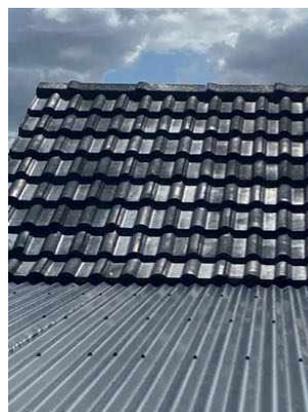
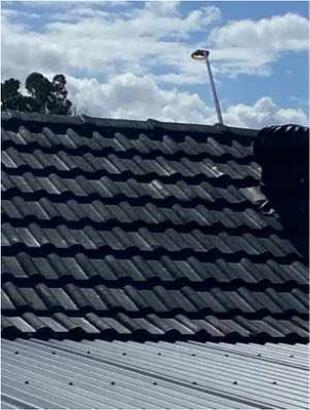
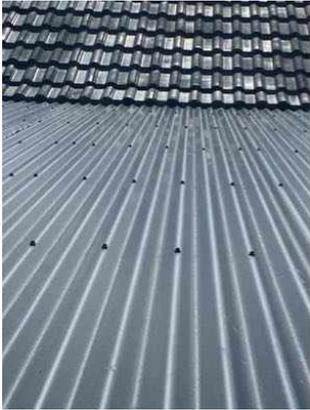
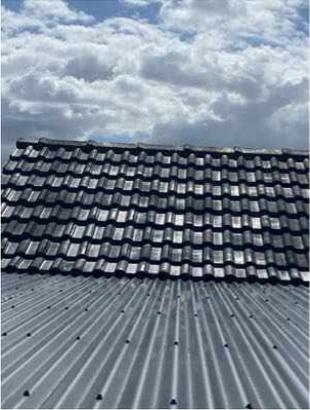
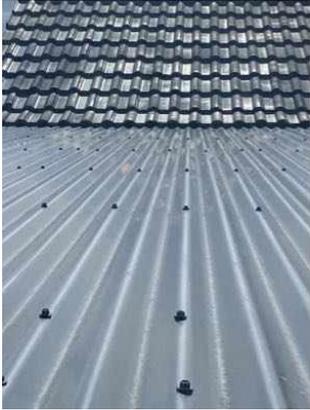
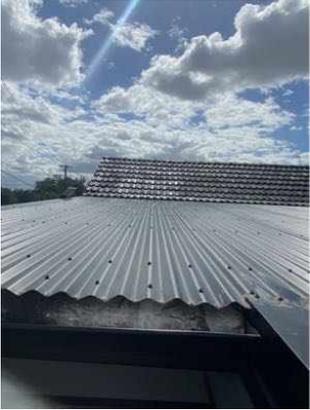
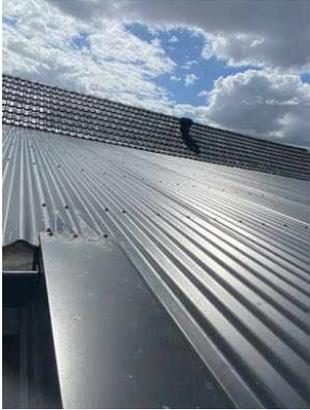
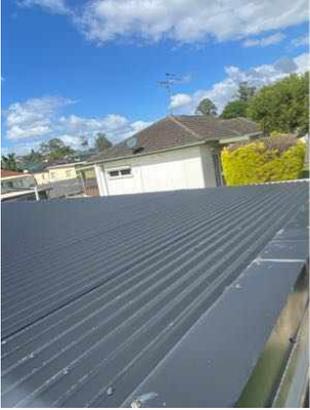
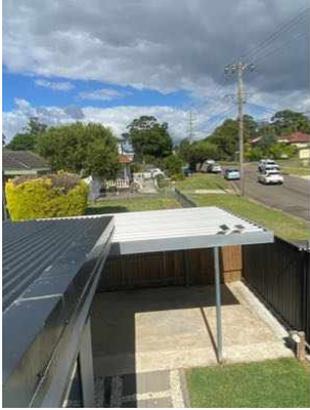
Building: Main Building
 Location: Roof Exterior
 Finding: Condition of the external roof
 Information: Overall Roof Condition: The roof tiles appear to have some wear and discoloration, likely due to weathering over time. Moss or dirt accumulation is visible in certain areas, which may require cleaning to prevent further degradation.

Structural Elements: No major cracks or visible damages to the tiles are evident, indicating that the roof structure is relatively intact. Edges and overlaps between tiles seem appropriately aligned, maintaining the roof's water resistance.

Gutters: Gutters along the edge of the roof appear functional, though they might benefit from a check for blockages (e.g., debris accumulation) to ensure proper drainage.

Repairs and Maintenance: Some sections of the roof show patched tiles, suggesting previous repair work. Inspection of these patches may be necessary to confirm their durability and effectiveness.

Additional Features: The whirlybird (roof ventilation) appears intact and functional. Other fixtures, such as satellite dishes or antennas, seem securely attached.

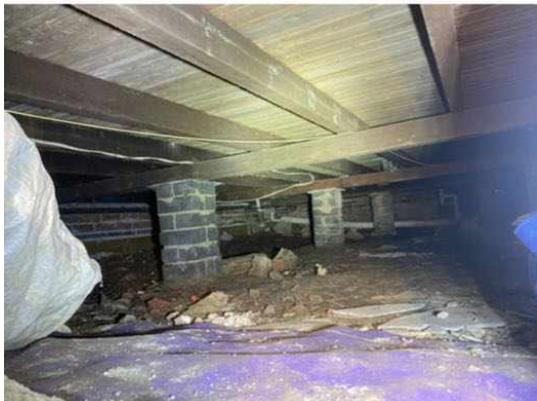
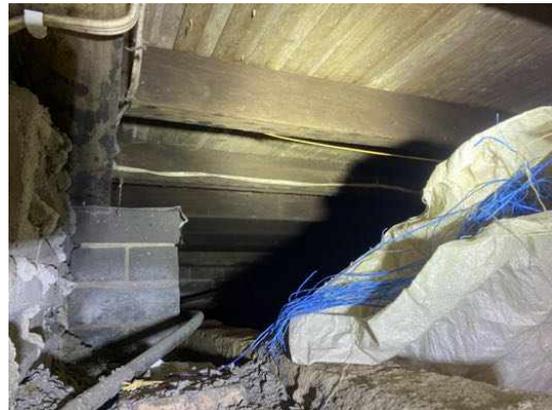
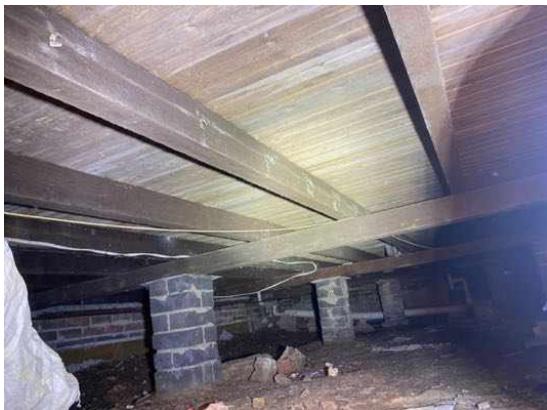
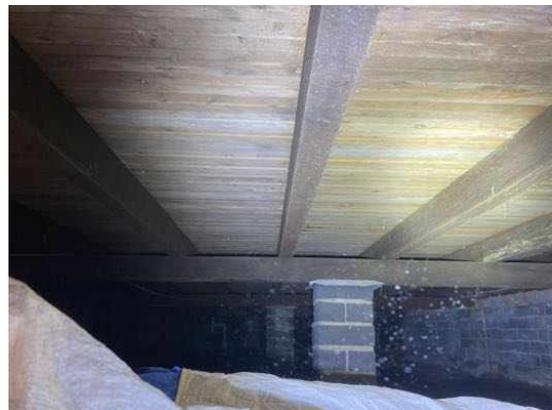
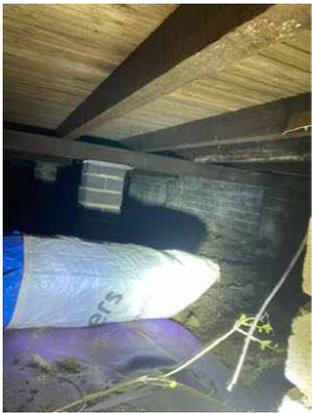
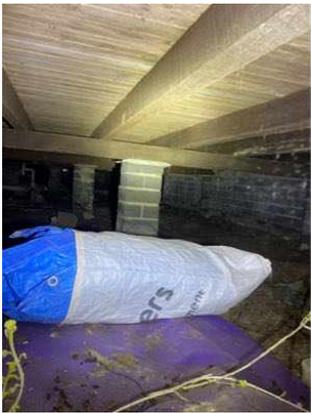
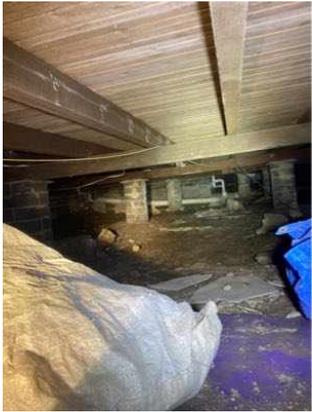
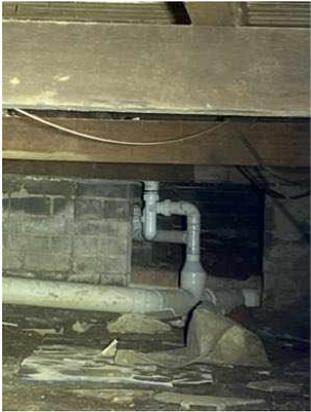
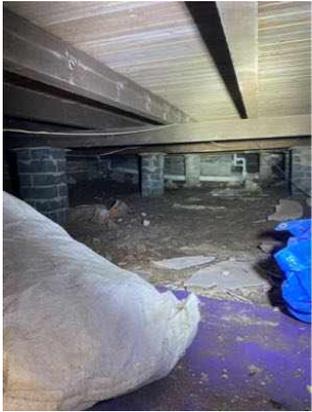
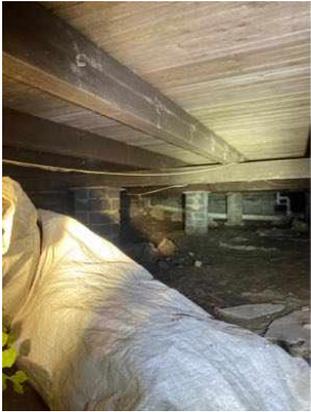
Building: Main Building
Location: Subfloor
Finding: Condition of Building Elements in the Subfloor
Information: The subfloor structure appears to be in serviceable condition, with timber bearers and joists presenting as generally straight and free from significant visible deterioration.

The brick piers appear to be evenly spaced and adequately supporting the timber framing, with no major signs of displacement or cracking noted from the vantage point of the inspection.

The underside of the flooring and subfloor ventilation appears intact, and no evidence of active moisture ingress, timber decay, or pest activity was visible from the external perimeter.

It is noted that the subfloor inspection was conducted from outside the subfloor area due to the restricted size of the manhole, which prevented internal access. As such, this assessment is limited to visual observations from the accessible perimeter.

No immediate structural concerns were evident from these views, and the condition of the subfloor appears consistent with age and expected use. Further internal assessment may be warranted if future access becomes available.
