## Building Inspection Report

Inspection Date: Sat, 11 Jul 2020

Property Address: 56 Epping Dr, Frenchs Forest NSW 2086, Australia

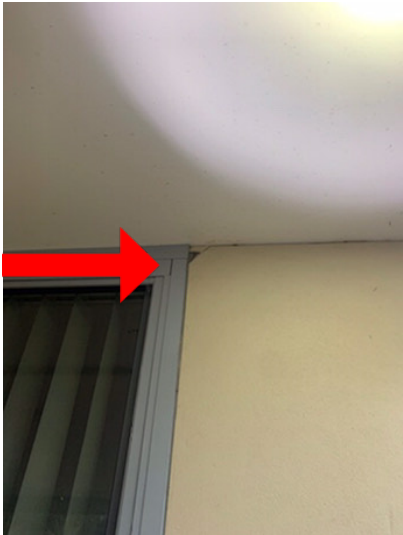
### Defects 3.01

Building: Building 1  
Location: Yard - Back  
Finding: Cracks to rendered surfaces  
Information: It has been observed that cracking to the rendered surfaces has occurred.

Always contact your builder should cracks widen, lengthen, or become more numerous.

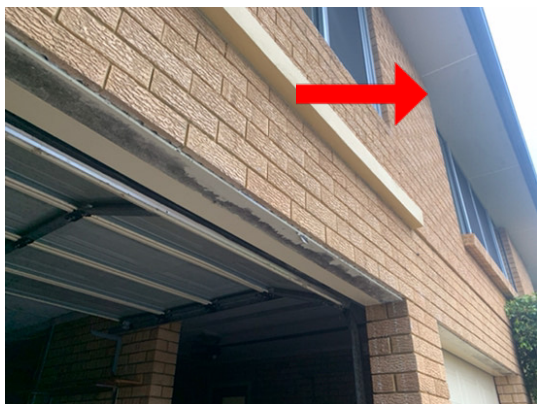
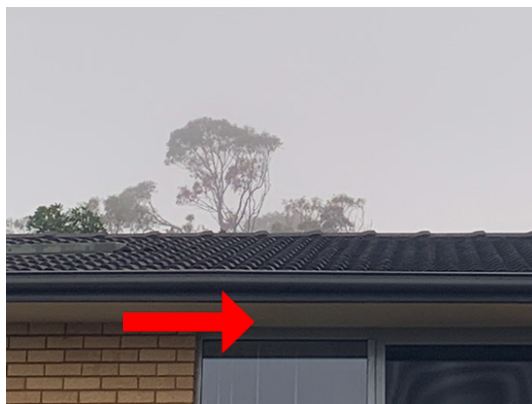
### Defects 3.02

Building: Building 1  
Location: Eaves  
Finding: Paint finish - Incomplete  
Information: The paint finish in this area was identified as being incomplete at the time of inspection.

A painting contractor should be appointed to perform necessary works to aid the appearance of the affected area and to ensure the area is protected against further deterioration. Alternatively, the homeowner following manufacturer instructions may perform these works.

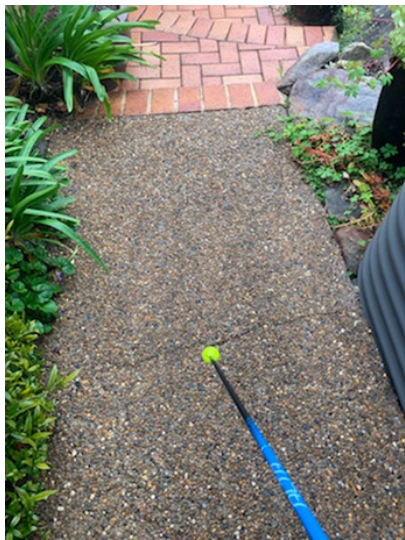
## Defects 3.03

| Finding: | Cracking - External Concrete Paving Damage Category 1 - Fine (less than 2mm) |
| Information: | Fine cracks were identified in external concrete paving. Although fine cracks are quite noticeable, they are often only considered to be an appearance defect, and usually do not indicate any structural damage. To be considered a Category 1 or fine crack, the crack is found to be <2mm in width. |

Generally the cause of a hairline crack in existing concrete paving such as driveways and pathways is indicative of the expansion and contraction of the concrete. Such causes are generally due to environmental factors, such as moisture levels, weather conditions, root systems of nearby trees or the soil types on which they are laid.

Fine cracks may also be due to poor original installation of the concrete. Factors such as poor compaction of the sub surface and/or inadequate reinforcing of the slab may create cracking and other secondary defects.

Monitoring of all cracking should be conducted frequently. Always contact a builder should cracks widen, lengthen, or become more numerous.

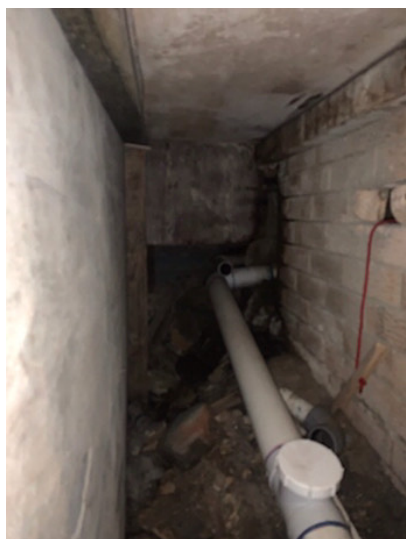
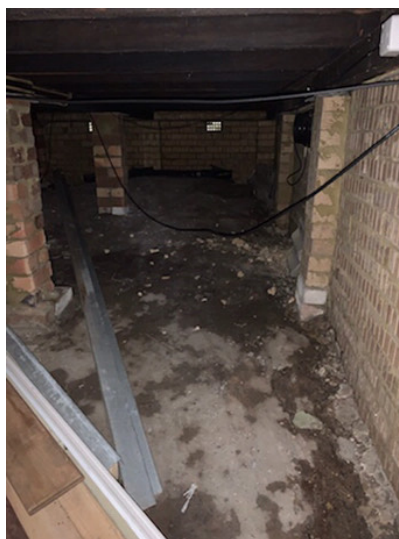
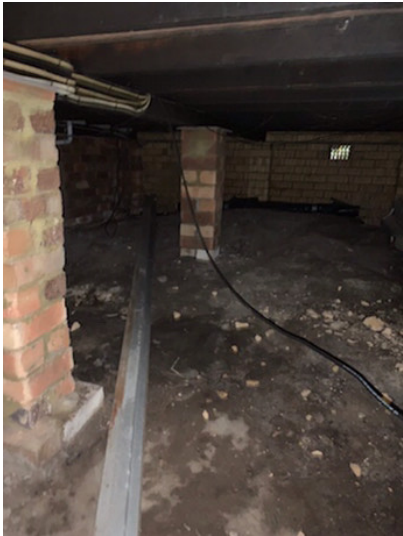
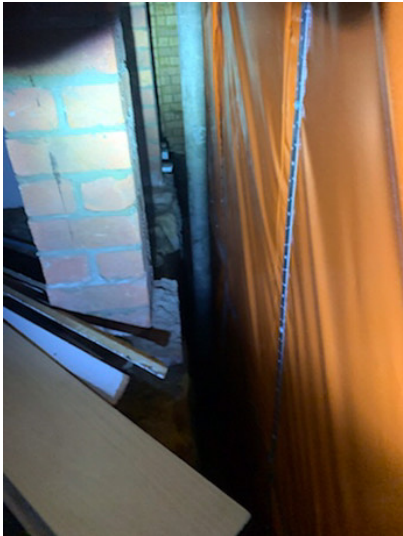
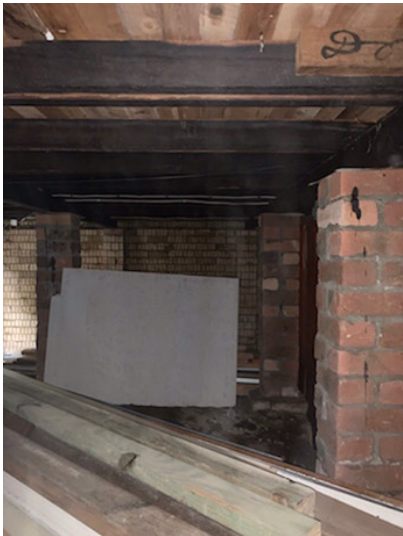
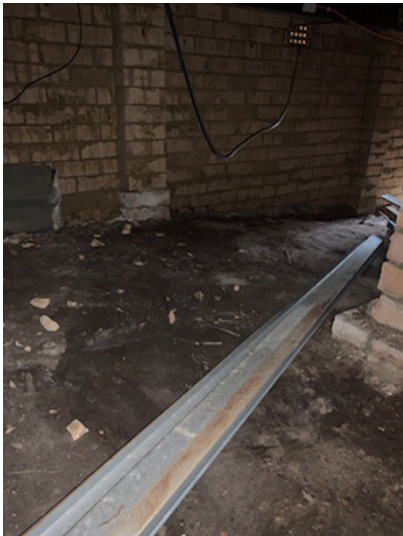
### Defects 3.04

Finding: Subfloor - Debris

Information: An array of debris was found in the subfloor area at the time of inspection. Debris in this area restricts subfloor ventilation and creates potential for concealed pest entry. Stored timbers and other materials may also make the area susceptible to termite activity and wood rot.

A clear and empty subfloor will be better ventilated and easier to maintain in a dry condition. The removal of any timber debris is vital in minimising the risk of termite or wood borer activity.

Debris in the subfloor should be removed as soon as possible. Depending on the location and amount of debris and stored items, the homeowner may elect to undertake this task. Alternatively there are a large number of rubbish removal subcontractors that could undertake these works.

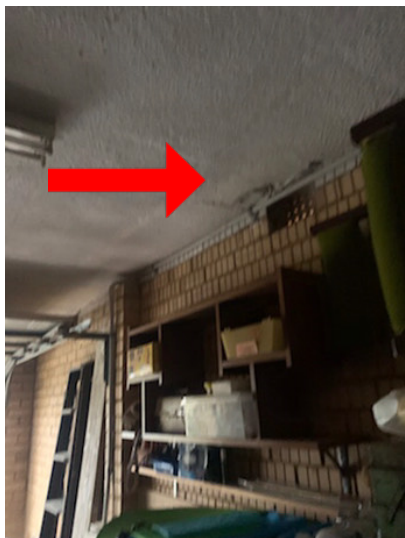
### Defects 3.05

Building: Building 1  
Location: Garage  
Finding: Painted surface - Bubbling  
Information: A section of paint in this area was found to have bubbled and deteriorated.

It is advised that the affected paint be cleaned to allow a further, more invasive inspection by a licensed plumber. Failure to act on this defect may necessitate major works in the future.

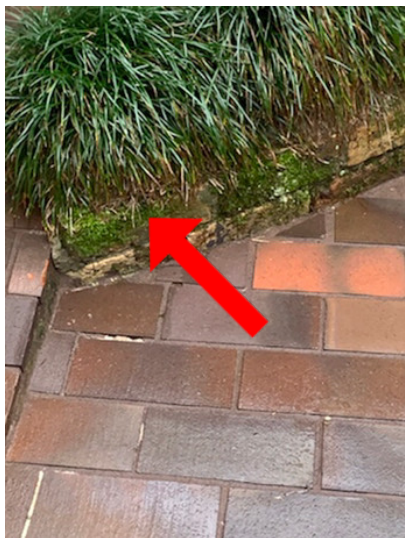
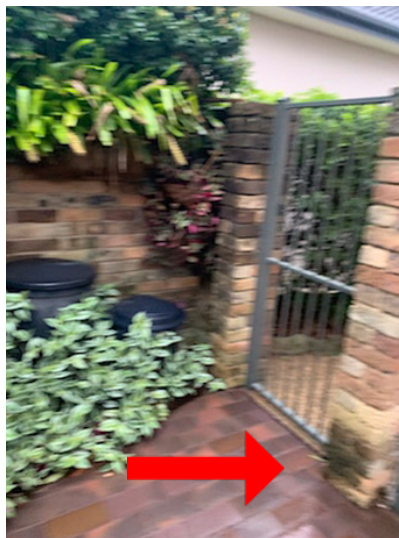
### Defects 3.06

| Finding: | Evidence of excessive moisture was present at the time of inspection |
| Information: | Excessive moisture can attract termites and produce conditions that promote termite attack fungal growth and wood decay. |

It is recommended that all plumbing and drainage fixtures and fittings be maintained regularly in order to prevent excessive moisture being present in the external / internal property.

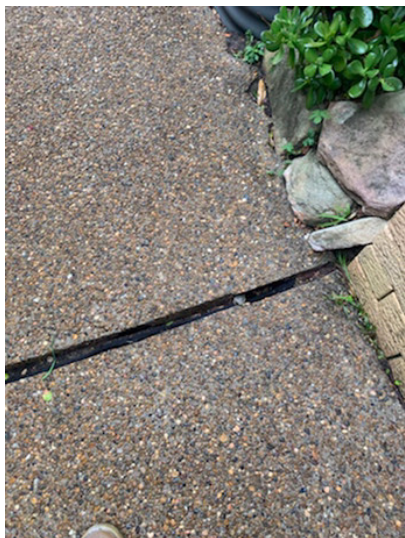
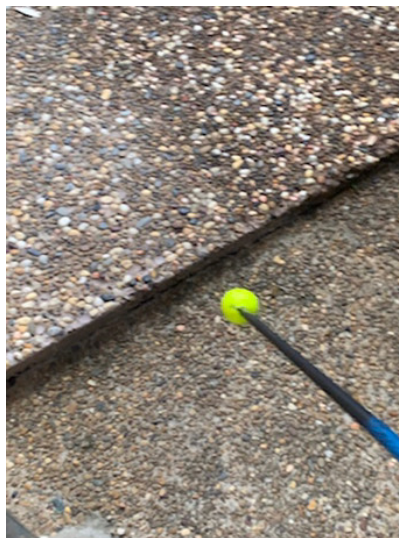
### Defects 3.07

| Finding: | Subsidence - Local trees and vegetation |
| Information: | Trees and other vegetation can have a significant local effect on drying of soils. Over a number of years, especially during drought conditions, adjacent trees and vegetation may draw excessive moisture from the soils. The opposite may also occur, where swelling of the soil results when the trees decline or are removed. |

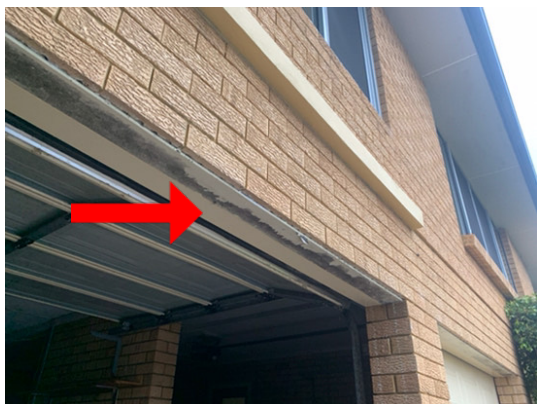
### Defects 3.08

| Finding: | Painting deteriorated |
| Information: | Degraded paint finishes should be sanded back and painted, as applicable. |

A painting contractor should be appointed to perform necessary works to aid the appearance of the affected area and to ensure the area is protected against further deterioration. Alternatively, the homeowner following manufacturer instructions may perform these works.

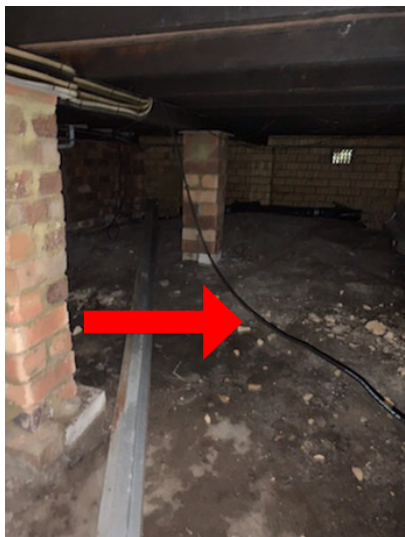
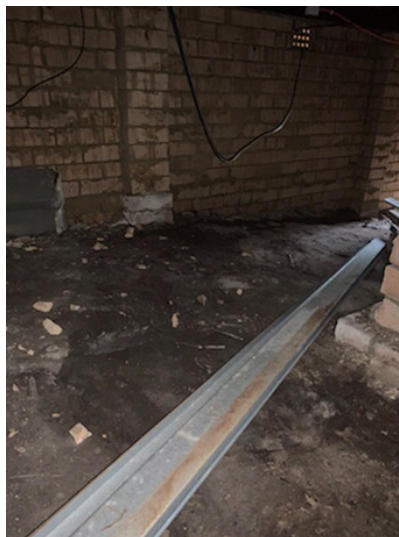
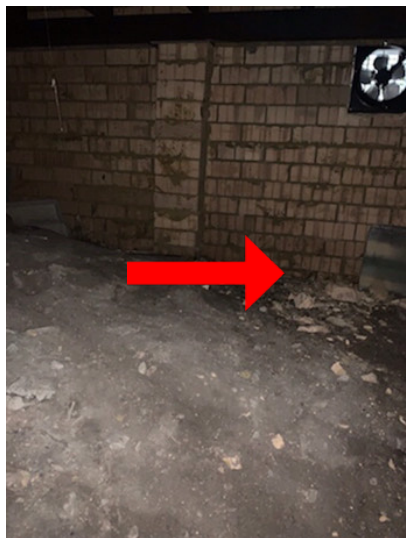
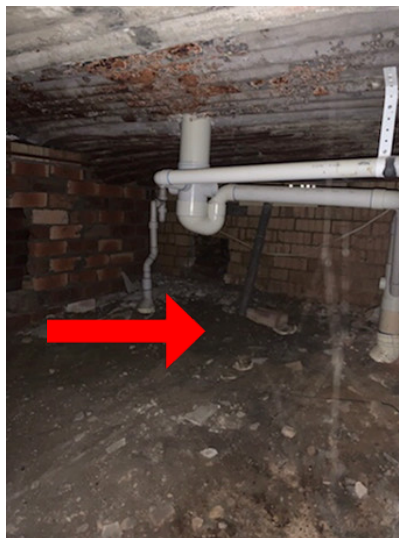
### Defects 3.09

Building: Building 1  
Location: Subfloor  
Finding: Evidence of excessive moisture was present at the time of inspection  
Information: Excessive moisture can attract termites and produce conditions that promote termite attack fungal growth and wood decay.

It is recommended that all plumbing and drainage fixtures and fittings be maintained regularly in order to prevent excessive moisture being present in the external / internal property.

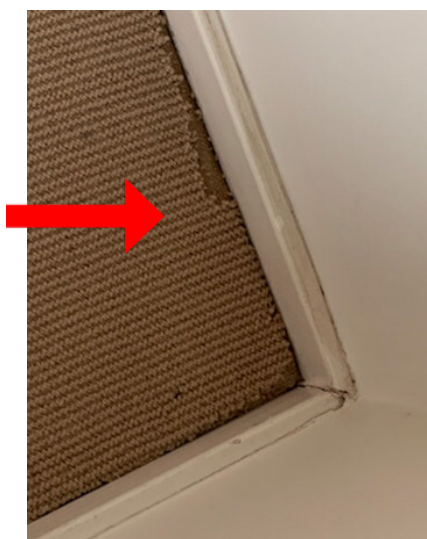
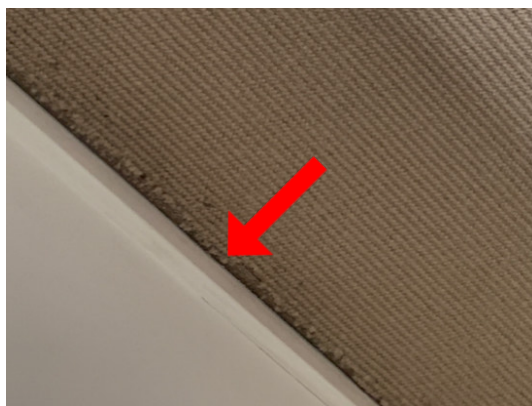
### Defects 3.1

| Finding: | Carpet - effect by carpet beetle |
| Information: | Some of the carpet floor covering in this area appeared to damage by carpet beetle. |

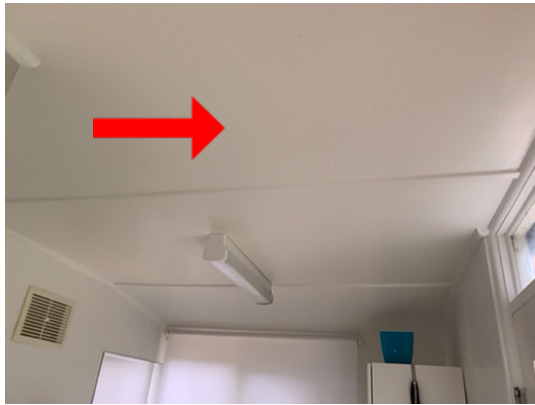
Building: Building 1  
Location: Laundry  
Finding: Asbestos - Suspected ACM Identified on Site  
Information: Reporting on Asbestos is outside the Scope of this Report. This suspected defect is highlighted as a caution only. We suspect, based on our experience in the building industry, that there is a higher risk of the identified building element containing asbestos.

As Asbestos Reporting is outside the scope of this report, we advise that you consider a separate Asbestos Inspection and Condition Audit, which can include the taking of samples for definitive confirmation of the presence of Asbestos.

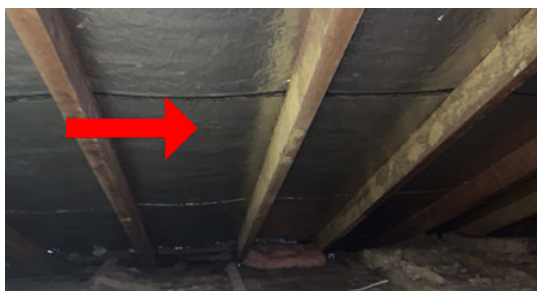
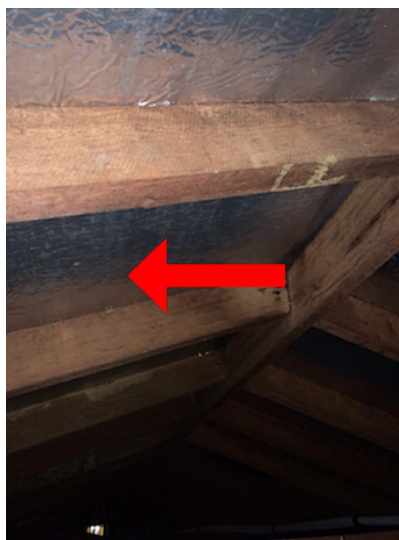
Building: Building 1  
Location: Roof Void  
Finding: Sarking - installed  
Information: Sarking, a laminated aluminium foil applied to the interior of the roof covering, assists in insulating the property and acting as a vapour-barrier to the roof void and, subsequently, to the household.

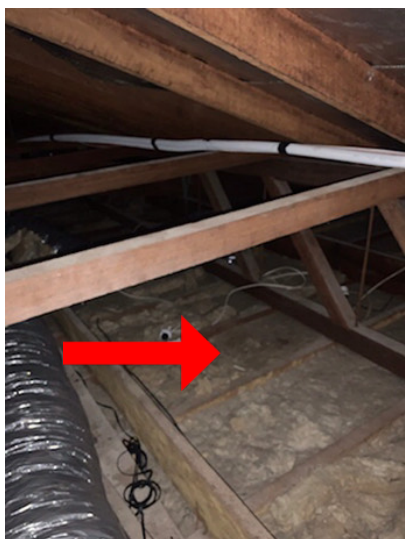
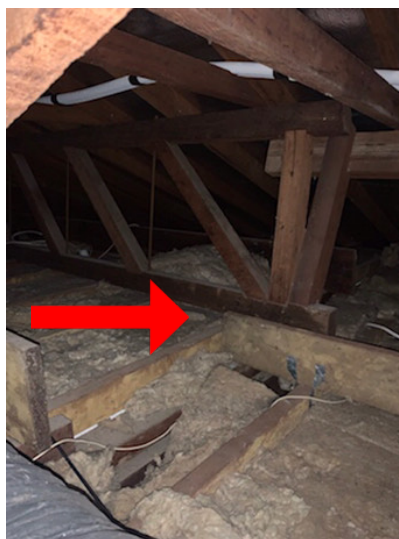
Building: Building 1  
Location: Roof Void  
Finding: Insulation - Missing  
Information: Upon inspection of the roof void it was noted that insulation is present.
