## **VISUAL BUILDING AND PEST INSPECTION REPORT**

Complies with Australian Standard 4349.1 & 4349.3

102 Bantry Bay Road, Frenchs Forest

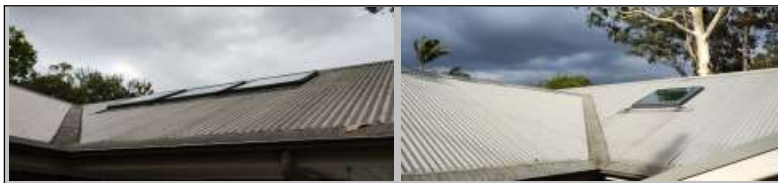
The overall condition of the roof coverings is good.

Flashing material is of sheet metal. Flashings appear to be in serviceable condition.

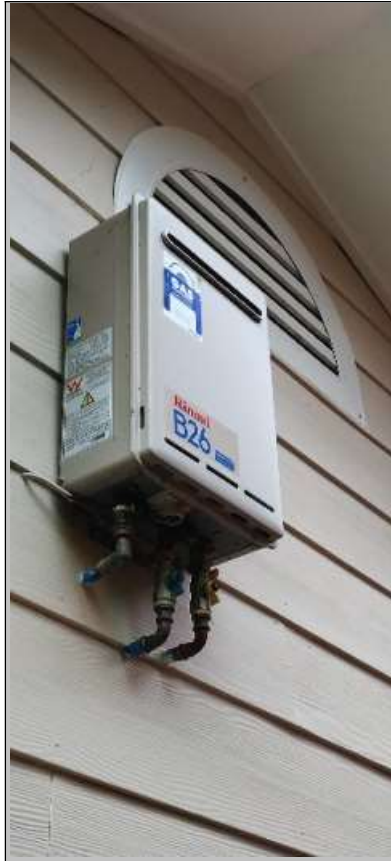
Gas hot water system: Mains pressure: Instantaneous: Located externally: The hot water system appears to be in working condition. No specific tests other than running the hot water tap were carried out. No determination has been made as to the suitability or adequacy of the hot water system in relation to capacity or otherwise.

We were unable to determine the age of the unit.

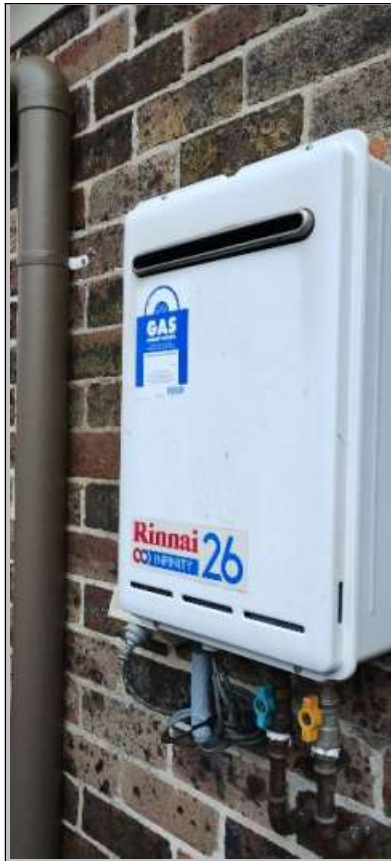
Gas hot water system: Mains pressure: Instantaneous: Located externally: The hot water system appears to be in working condition. No specific tests other than running the hot water tap were carried out. No determination has been made as to the suitability or adequacy of the hot water system in relation to capacity or otherwise.

We were unable to determine the age of the unit.

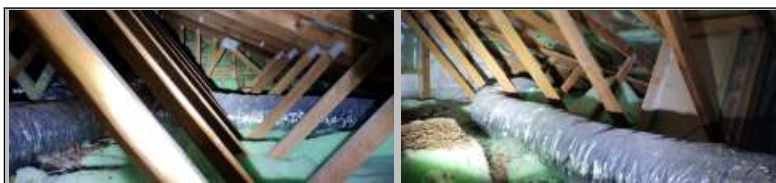
Insulation is present in the roof cavity. This restricted inspection to some roofing timbers. Removal of insulation is not within the scope of a standard visual inspection report, however as in accordance with "industry best standard" the inspector will lift insulation in 3 areas in roof void. Sarking membrane covered tile battens restricting inspection.

A section of the roof is of cathedral type construction where the ceilings follow the roof contour and no cavity is present for inspection.
