# Timber Pest Inspection Report

Inspection Date: Wed, 29 Jan 2020

Property Address: 45 Dareen St, Frenchs Forest NSW 2086, Australia

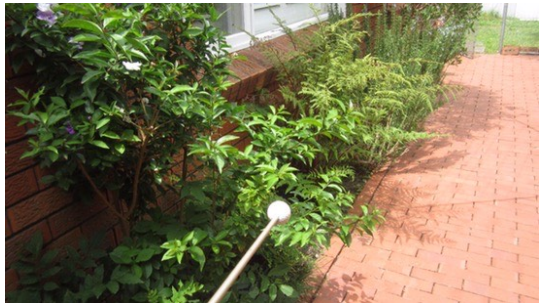
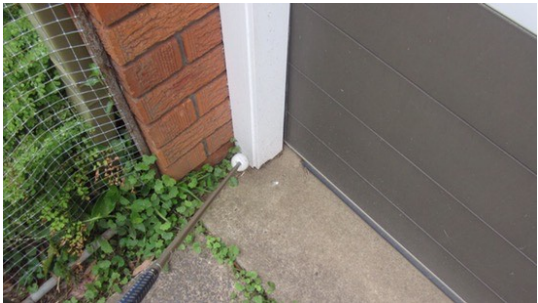
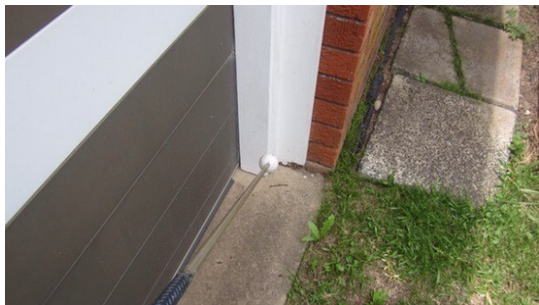
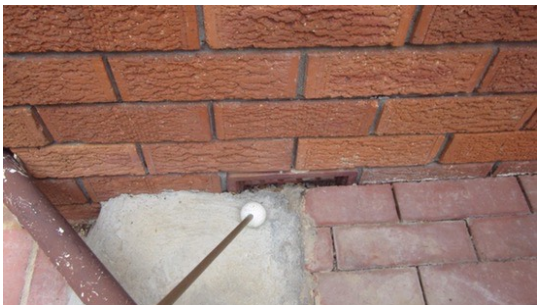
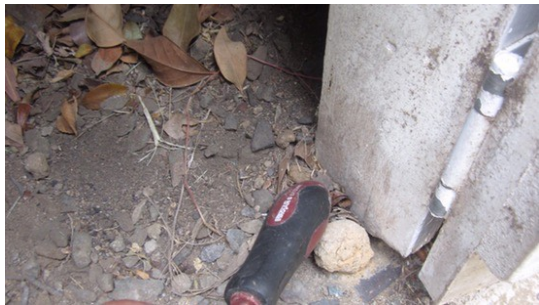
| Location: | All Areas |
| Finding: | In ground contact |
| Information: | <p>Any timbers in direct ground contact provide opportunity for concealed termite entry and are likely to be subject to premature rot and decay as the soil retains moisture or damp conditions against the timbers.</p> <p>Remove untreated timber that is in direct contact with external grounds. Consider replacement with more durable materials i.e. treated timber or non timber elements. Frequent pest inspections are advised to readily identify any termite activity in these areas.</p> |

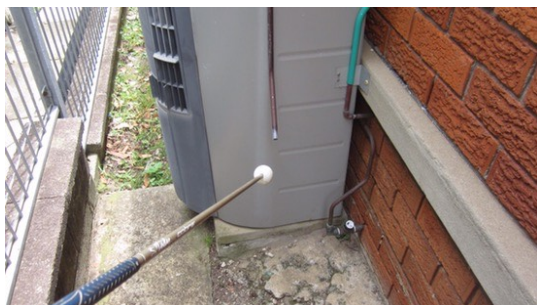
| Location: | Yard - Side |
| Finding: | Overflow - Not plumbed for drainage |
| Information: | The overflow is not plumbed or connected to suitable drainage, which has resulted in the surrounding area becoming excessively damp. |

These damp conditions can lead to secondary defects such as rot, rust or corrosion of associated building elements, the formation of fungal decay, or even the creation of potential slip hazards. When coupled with poor site drainage, pooling of water may also attract termite activity to this area.

It is highly recommended that a qualified plumber be appointed to install adequate drainage to the overflow. These works will ensure that the area remains dry and free of any secondary defects.

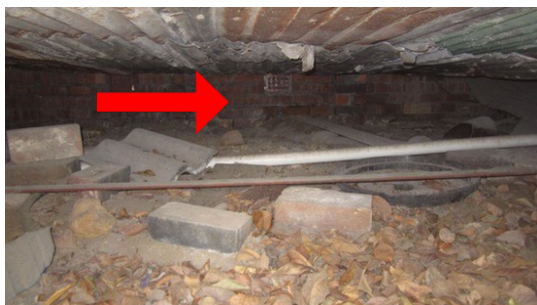
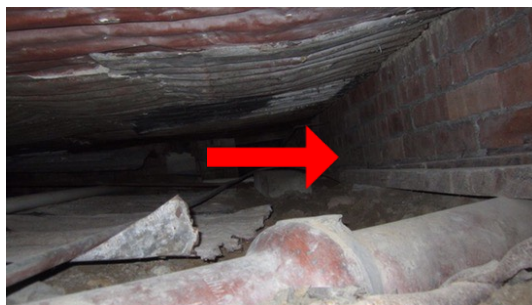
| Location: | Subfloor |
| Finding: | Evidence of excessive moisture was present at the time of inspection |
| Information: | Excessive moisture can attract termites and produce conditions that promote termite attack fungal growth and wood decay. |

Excessive moisture is generally caused by deteriorated inadequate or missing roof drainage leaking plumbing pipes or fixtures poorly plumbed HWS overflows or condenser units and poor site drainage.

It is highly recommended that all plumbing and drainage fixtures and fittings be maintained regularly in order to prevent excessive moisture being present in the external / internal property.

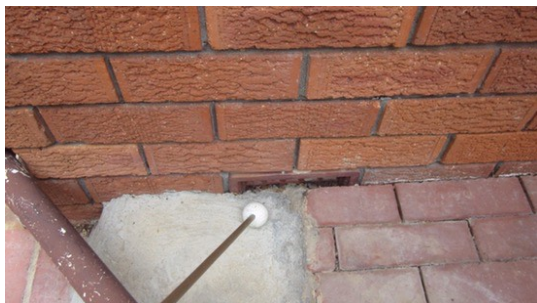
| Location: | All External Areas |
| Finding: | Subfloor ventilation - Inadequate |
| Information: | Adequate subfloor ventilation aids in preventing excessive moisture wood rot and termite activity by ensuring a dry subfloor environment. |

Where ventilation is substandard it is usually caused by factors such as failure to install adequate vents during construction subsequent building works or earth and vegetation covering over vents low subfloor clearance and items or debris in the subfloor restricting airflow.

Subfloor ventilation can be improved in most cases by addressing the causes such as exposing subfloor vents installing additional new vents installing mechanical (forced airflow) ventilation and removing debris from the subfloor.

A registered builder should be appointed as soon as possible to perform these works as necessary.

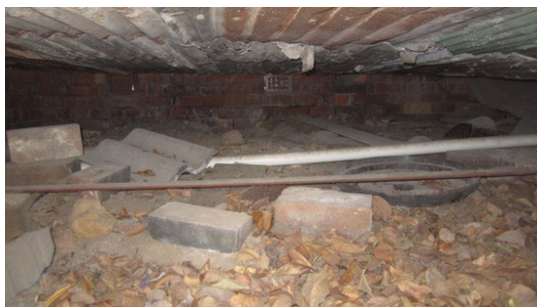
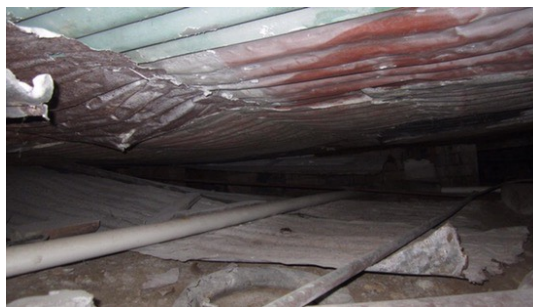
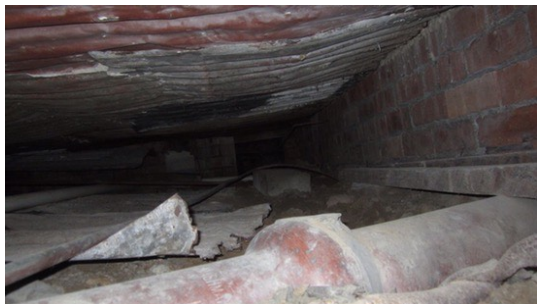
Location: Subfloor

Finding: Subfloor - Debris

Information: An array of debris was found in the subfloor area at the time of inspection. Debris in this area restricts subfloor ventilation and creates potential for concealed pest entry. Stored timbers and other materials may also make the area susceptible to termite activity and wood rot.

A clear and empty subfloor will be better ventilated and easier to maintain in a dry condition. The removal of any timber debris is vital in minimising the risk of termite or wood borer activity.

Debris in the subfloor should be removed as soon as possible. Depending on the location and amount of debris and stored items, the homeowner may elect to undertake this task. Alternatively there are a large number of rubbish removal subcontractors that could undertake these works.

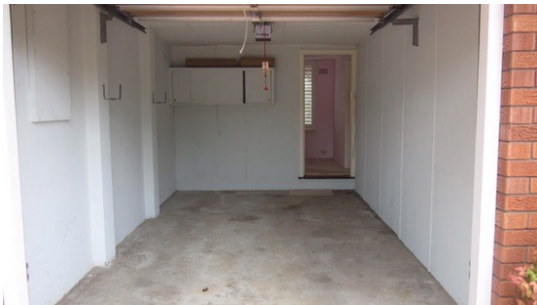
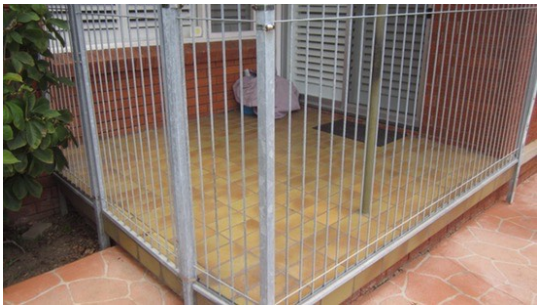
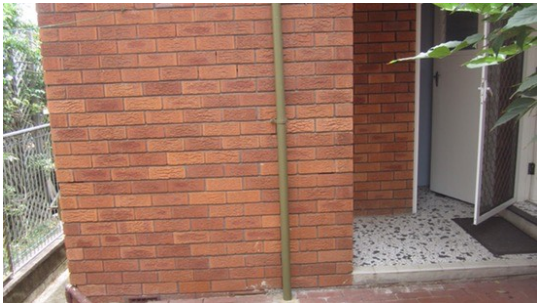
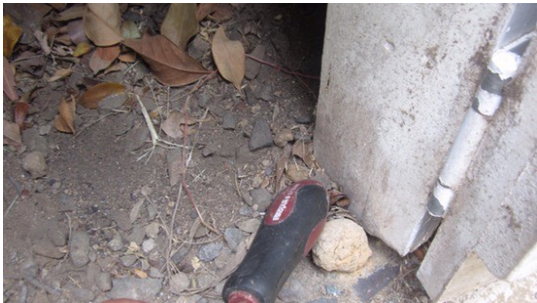
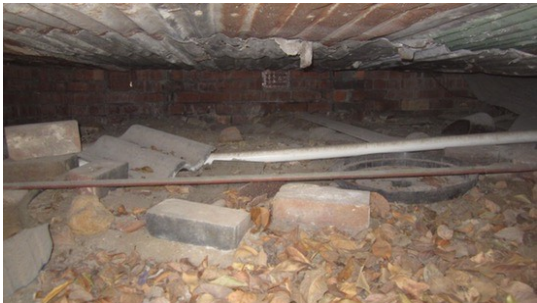
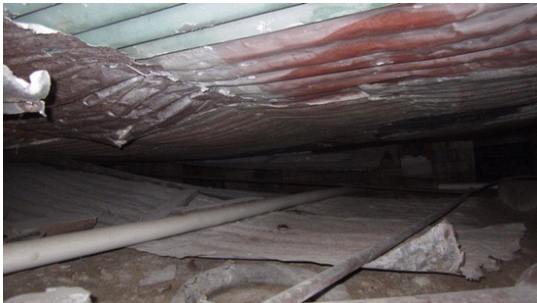
Building: Main Building  
Location: All Areas  
Finding: Additional Photos - Obstructions and Limitations  
Information: These photographs are an indication of the obstructions and limitations which impeded full inspection of the property at the time of inspection.

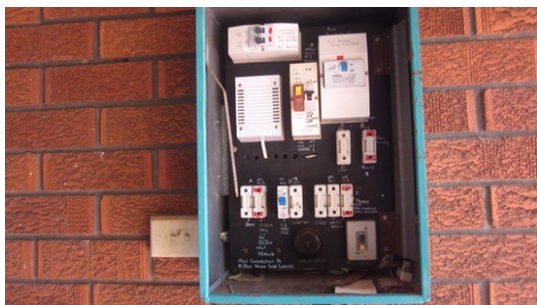
Location: Yard - Side

Finding: Termite Management System - No evidence of installation

Information: The application of a post-construction chemical termite barrier is highly recommended for all properties, particularly if live termite activity has been found on the site previously. Such barriers are highly effective in preventing termite attack on any timber building elements throughout the property.

A durable notice should be placed in the switchboard unit to indicate current termite barriers. At the time of inspection, it appeared as though no termite management system has been installed, with no evidence to suggest preventative works taking place.

The client may consider gaining further advice from a pest controller as to the costs and procedures involved with this application. It is recommended that obtaining such advice be a short-term priority.

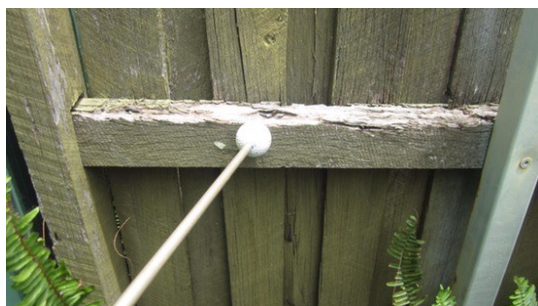
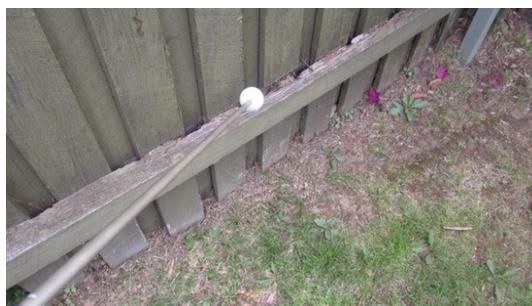
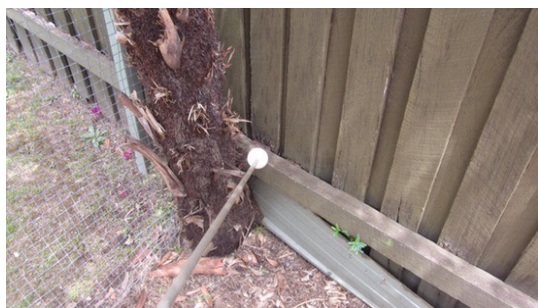
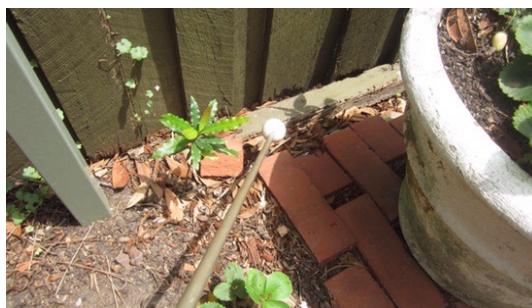
| Location: | All External Areas |
| Finding: | Wood rot |
| Information: | This building element shows evidence of wood rot. Wood rot, also known as Fungal Decay, occurs when timbers and other cellulose building materials are exposed to damp conditions on an ongoing basis. This could be the result of exposure to weathering over a prolonged period of time, or the attraction of excessive moisture from other abutting building materials. Contributing factors also include poor air ventilation in the area. |

Wood rot is often associated with general damp problems and is evidenced by a 'musty' smell or mould and mildew occurring on surfaces. If left unmanaged, damp conditions can lead to further health problems and the decay of timbers will continue.

Early intervention and regular maintenance, particularly of exterior timbers, will prolong the useful life of these building elements. Prior to any works being performed, the cause of the moisture that has created the visible wood rot should be identified and addressed in a suitable manner. Replacement of affected timbers may then be a necessary step in protecting surrounding building elements from such deterioration.

A qualified plumber may be appointed to assess the cause of excessive moisture and to provide advice on any remedial works as required. A qualified carpenter or registered builder may also be required to replace affected building materials.
