**ACCURATE PROPERTY INSPECTIONS
BUILDING INSPECTION REPORT**

Domestic, two storey, brick veneer and weatherboard, brick piers, timber floors with concrete areas and a tiled roof.

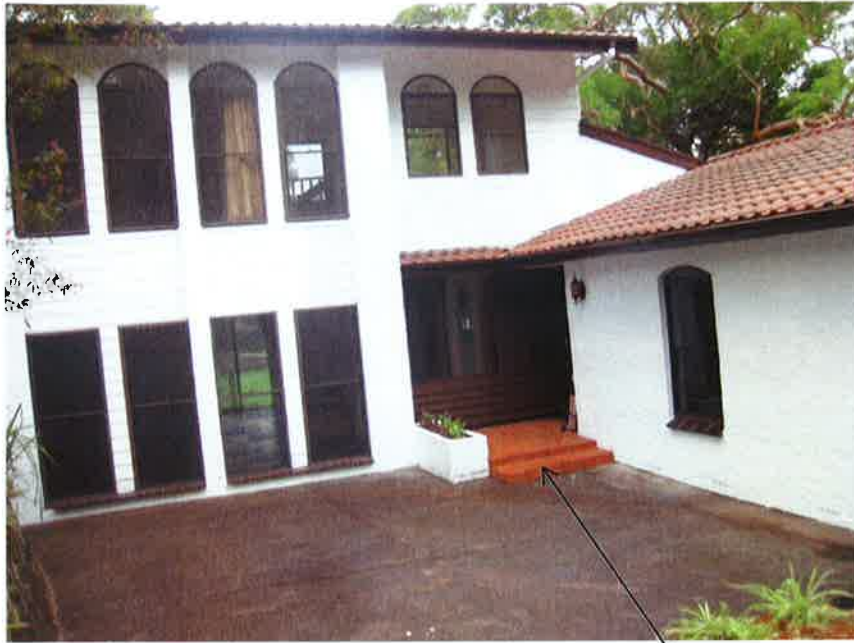
Front View

The cracked tiles will need to be replaced for aesthetic reasons.

Replace the cracked tiles for aesthetic reasons

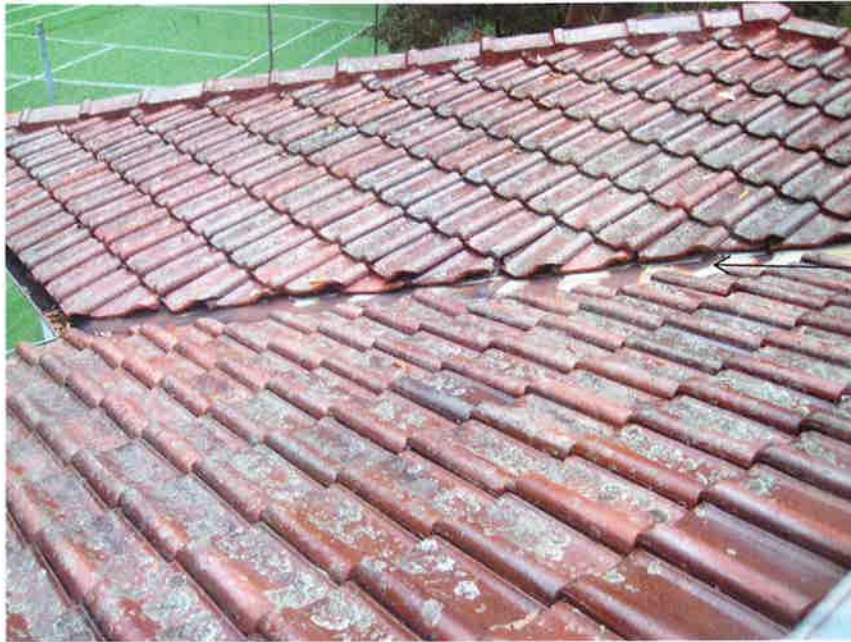
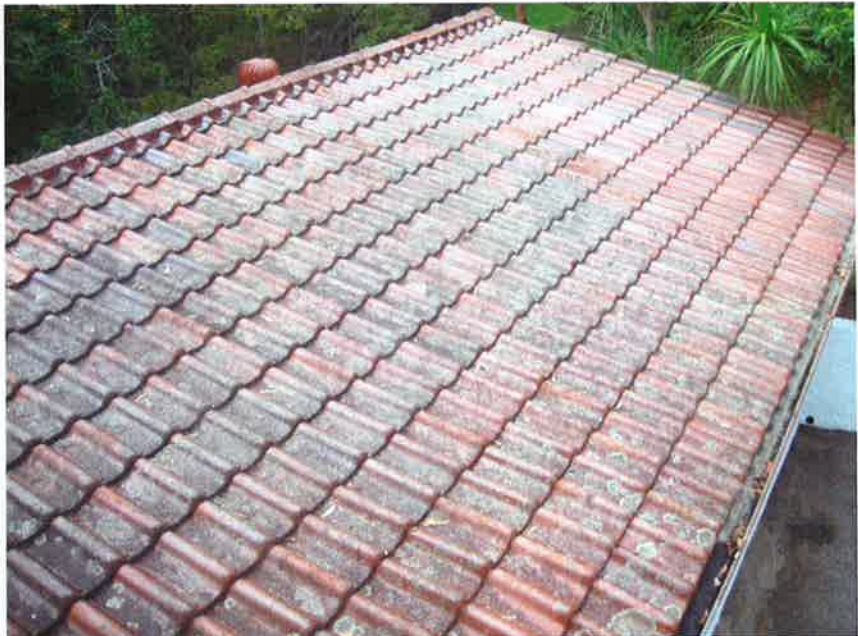
Roof Covering

The valley gutters will need to be cleaned and maintained against corrosion to prevent possible water penetration inside the building.

Maintain the valley gutters against corrosion.

It is recommended that a licensed roof plumber inspect and detail the requirements to ensure that the roof cappings and flashings are functional and adequate for the situation.

Maintain the gutters to prevent possible leakage inside the roof area.

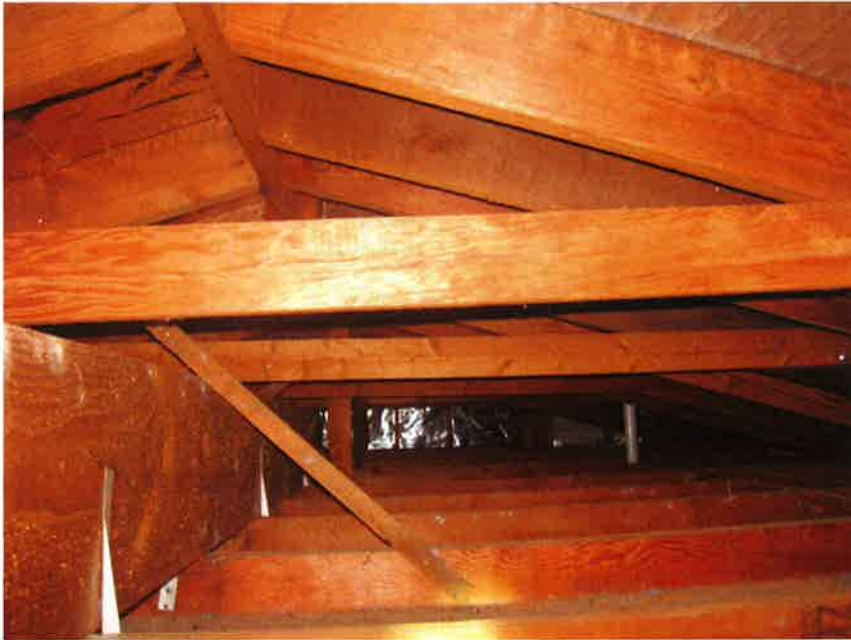
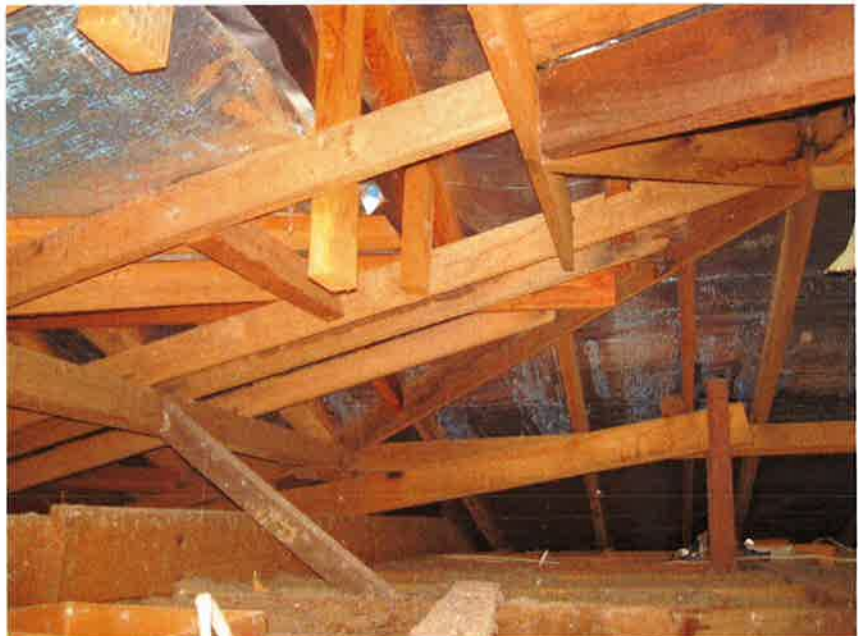
Roof Structure

There is some insulation fitted. It is recommended that the roof area covered with insulation be inspected by a licensed electrician to ensure that the insulation has been installed correctly and does not pose a fire hazard to the property.

It is recommended that the roof area covered with insulation be inspected by a licensed electrician to ensure that the insulation has been installed correctly and does not pose a fire hazard to the property.
