VISUAL BUILDING & PEST INSPECTION REPORT

Complies with Australian Standard 4349.1 & 4349.6

19 Sir Thomas Mitchell Drive Davidson

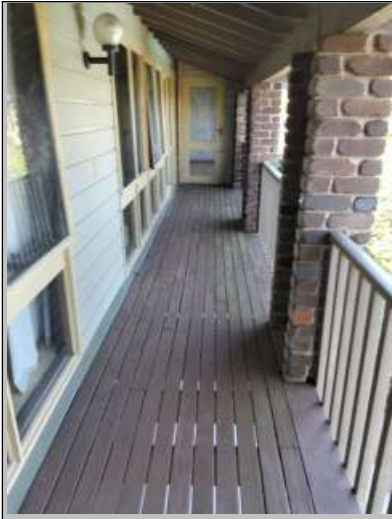
Rear elevation.

The general condition of this structure is fair.

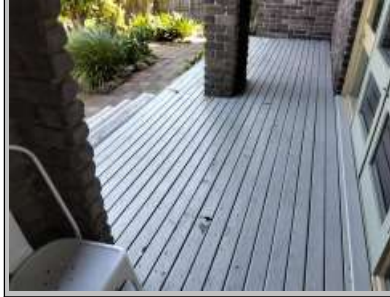
Rear elevation.

The general condition of this structure is fair.

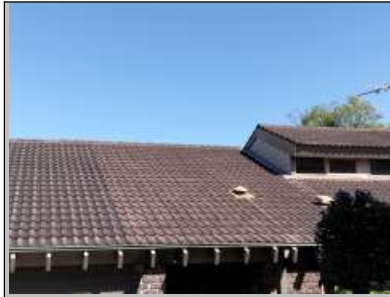
The roof is of pitched construction.

The overall condition of the roof coverings is fair.

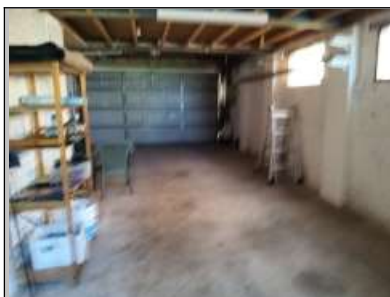
Garage.

The structure is generally in fair condition.

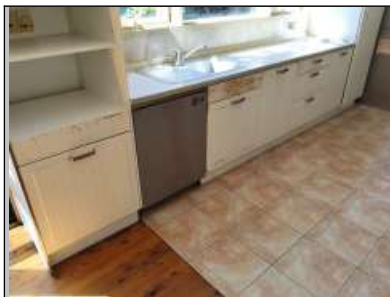
Wear and tear is noted to cabinets and some maintenance or repairs will be required.

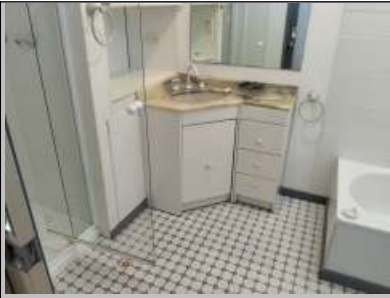
Level one.

The shower recess was tested and there was no visible water penetration to surrounding areas. IMPORTANT NOTE: This test may not reveal water leaks until the shower is put into constant use and surrounding areas monitored over a period of time.

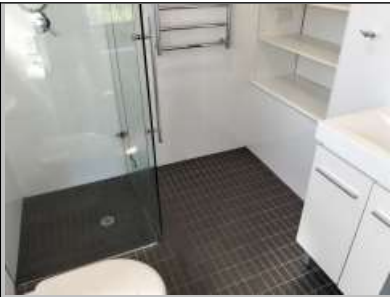
Level one.

The shower recess was tested and there was no visible water penetration to surrounding areas. IMPORTANT NOTE: This test may not reveal water leaks until the shower is put into constant use and surrounding areas monitored over a period of time.

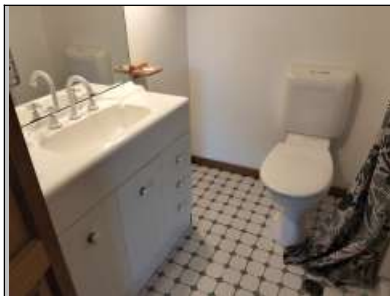
Level one.

The shower recess was tested and there was no visible water penetration to surrounding areas. IMPORTANT NOTE: This test may not reveal water leaks until the shower is put into constant use and surrounding areas monitored over a period of time.

Some drummy, loose tiles were noted and these areas will require repair and or replacement.

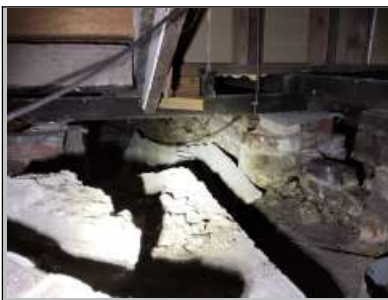
Crawl space was limited due to the method of construction resulting in a limited visual inspection from a distance being carried out. Inspection was restricted in or below the following locations and or areas: Lower level.

The subfloor ventilation appears to be inadequate. Additional vents and/or fan forced ventilation should be installed.

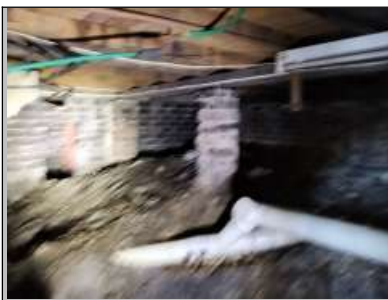
The building is constructed on a combination of strip footings and piers. The footings appear to be generally sound.

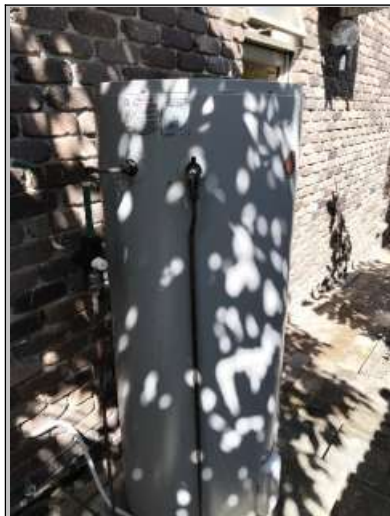
Mains electric hot water system: Mains pressure: Located externally: The hot water system appears to be in working condition. No specific tests other than running the hot water tap were carried out. No determination has been made as to the suitability or adequacy of the hot water system in relation to capacity or otherwise.

The unit was manufactured in 2019.

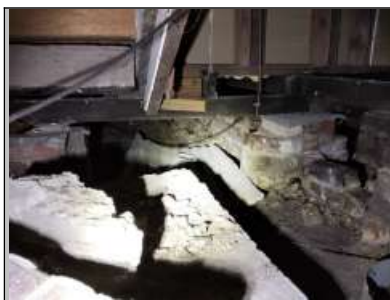
Crawl space was limited due to the method of construction resulting in a limited visual inspection from a distance being carried out. Inspection was restricted in or below the following locations and or areas: Lower level.

Underfloor ventilation is inadequate. Improvement in ventilation is required. Due to the method of construction, we recommend forced fan ventilation be installed.
