Property Inspection Report

32 Greygum Avenue, Rouse Hill, NSW 2155
Inspection prepared for: Wen Yuan Rui
Real Estate Agent: Mandeep Singh - Urban Land Housing - Box Hill

Date of Inspection: 15/8/2023 Time: 10:00AM
Weather: Sunny, 13C

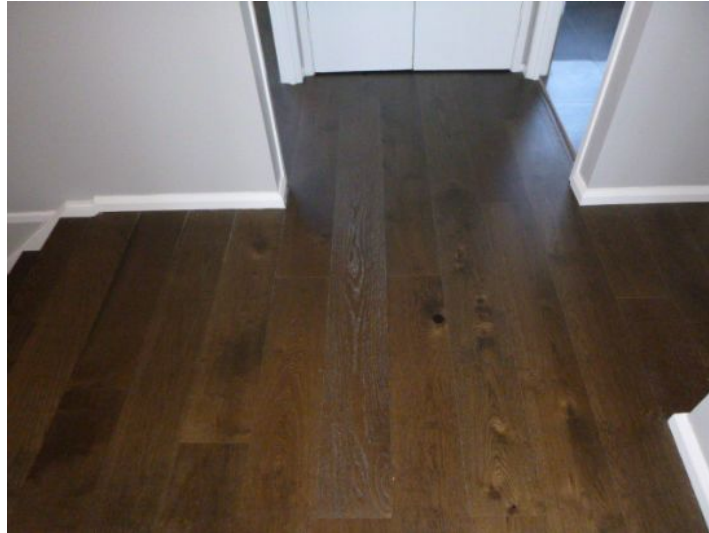
- The timber suspended floor appear to be performing satisfactorily. However, there are some minor bouncy floorboards in some locations. These movements do not appear to have detrimentally affected the overall structural integrity of the house. Monitor for changes in condition over the time.

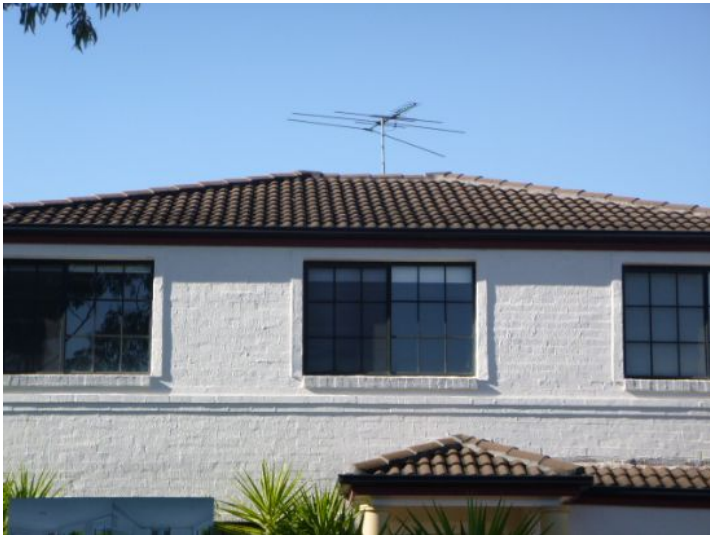
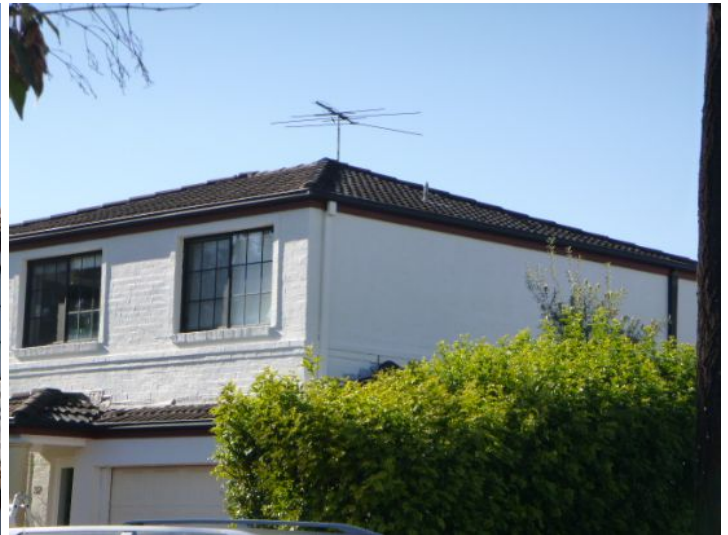
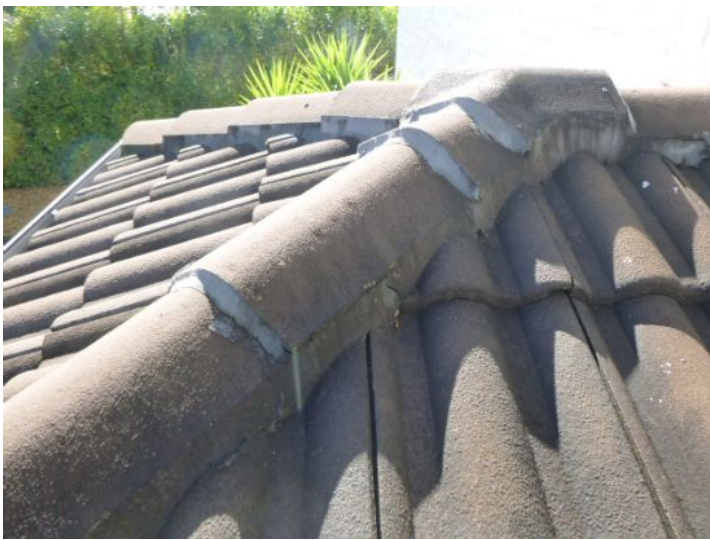
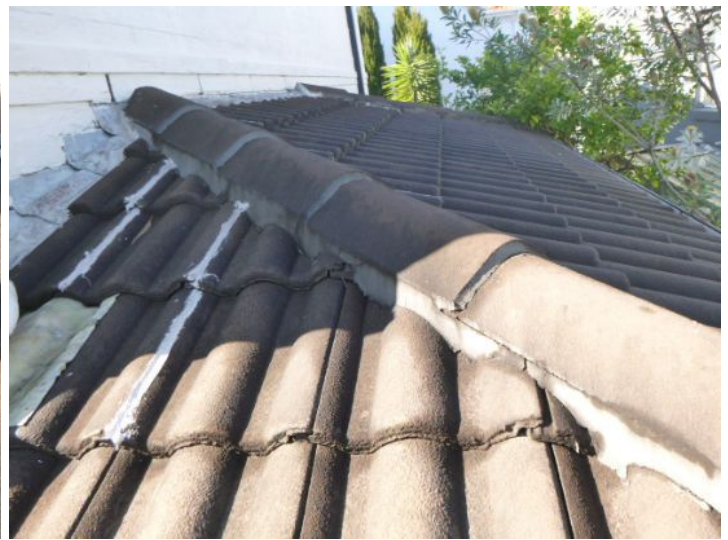
- The concrete tile roofing material appeared to be in satisfactory condition where visible.
- TV Antennae noted on the roof.
- TV satellite dish noted on the roof.
- There are previous silicone repairs noted on the garage roof coverings. These tiles should be monitored as silicone can deteriorate over time.
- There are minor cracks in the bedding cement. This is not unusual for a tiled roof, and is often caused by normal movements in the roof frame. Monitor for changes and rectify as needed.

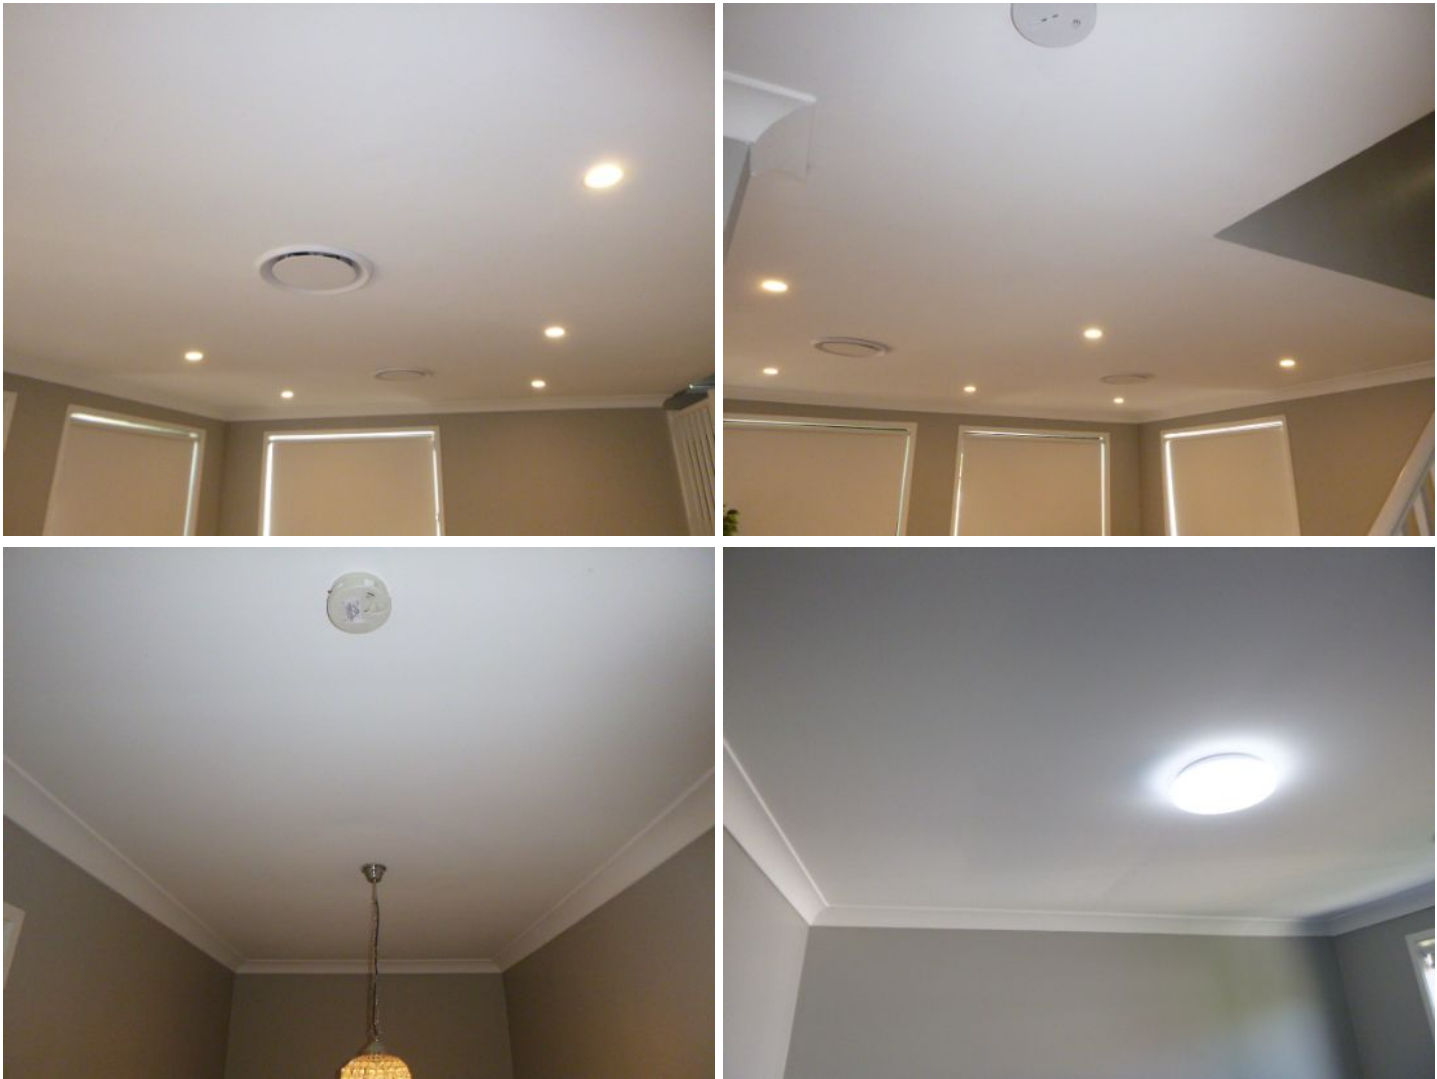
- Some minor deflections noted along the ceiling coverings. This does not appear to have affected the structural integrity of the ceilings. Monitor for any change in condition.

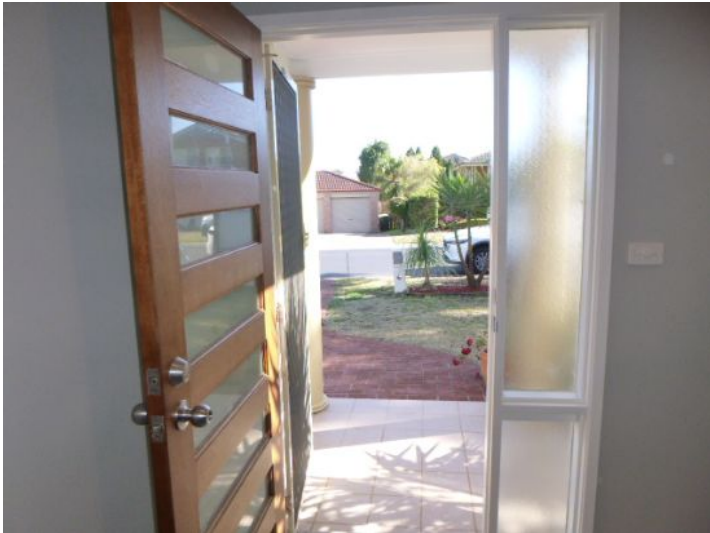
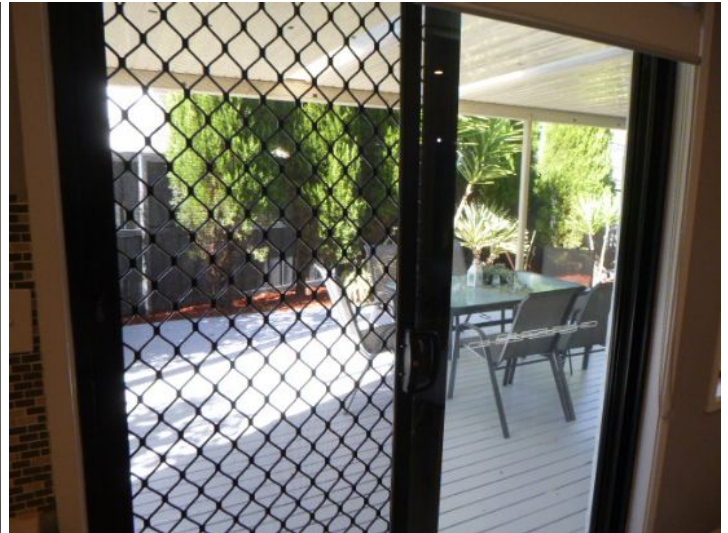
- The exterior doors function satisfactorily.
- The interior doors function satisfactorily.
- Only a representative number of doors were tested/operated during the inspection.
- One or more doors were locked and could not be tested at the time of the inspection. These should be checked at the final inspection.
- Two bedroom doors are not latching when closed. Minor maintenance is required.

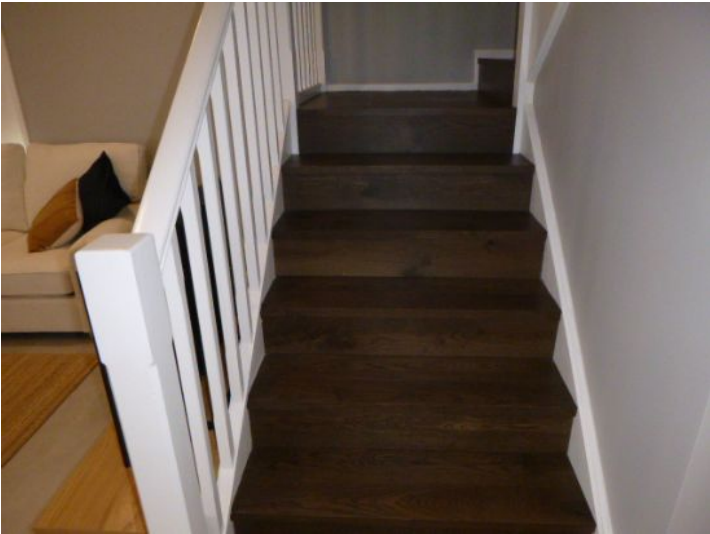
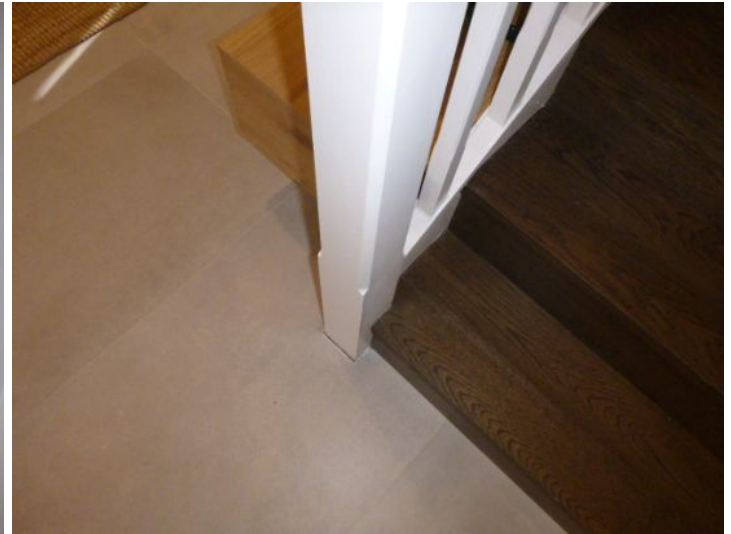
- Stairs and hand rails are in good condition at the time of inspection.
- Downstairs handrail post is loose slightly/not fully secured. Monitor for changes and rectify as needed.

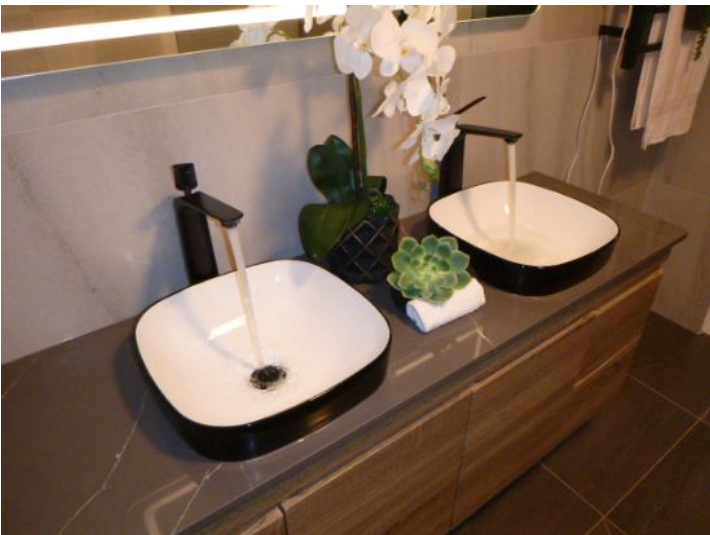
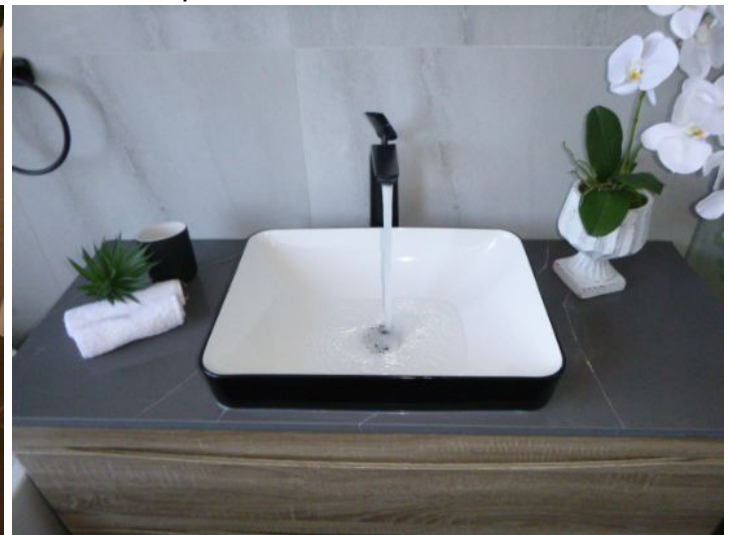
- The sinks and related components functioned normally when tested.
- We recommend all braided flexible water hoses in the property be checked regularly and replaced as required to prevent water damage.
- Slow drainage was noted at one of ensuite sinks which may indicate that the drain line needs to be cleaned. Maintenance is required.

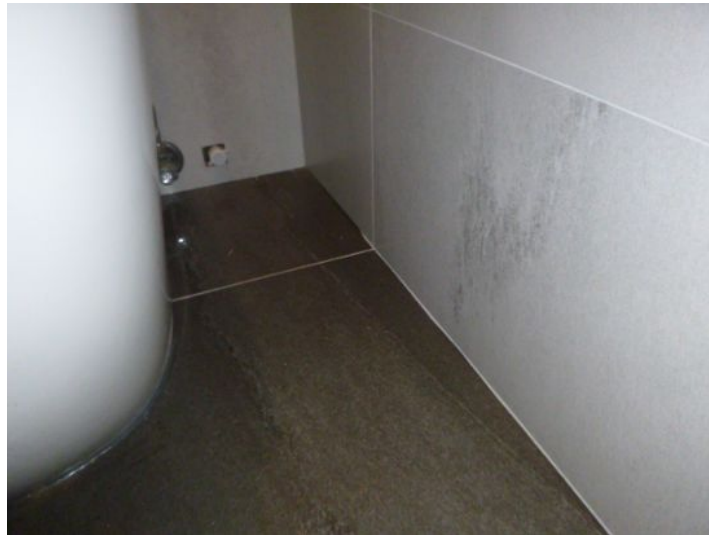
- Missing grout observed, suggest regrouting as necessary.

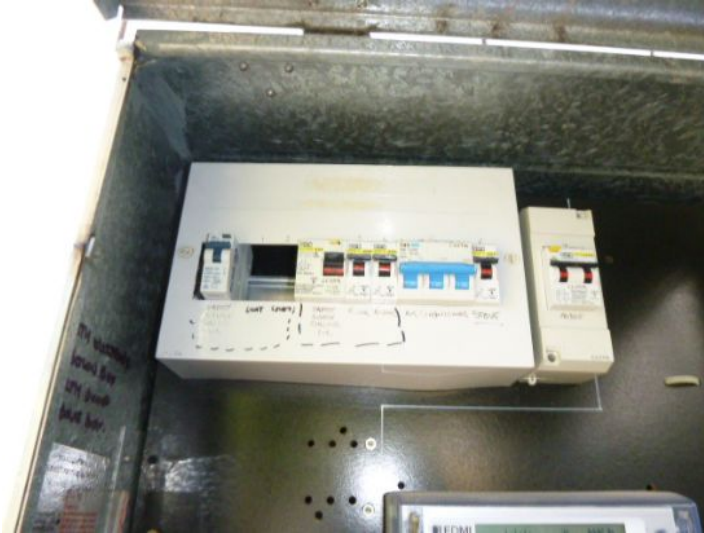
- At least one RCD (Safety Switch) has been installed.
- Missing components/outlets were observed along the main electrical panel. A qualified specialist should be consulted to provide further evaluation and rectification work where required.

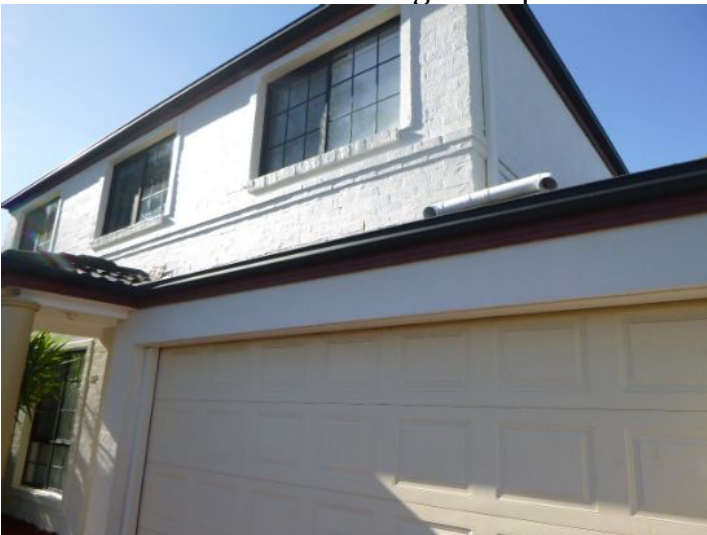
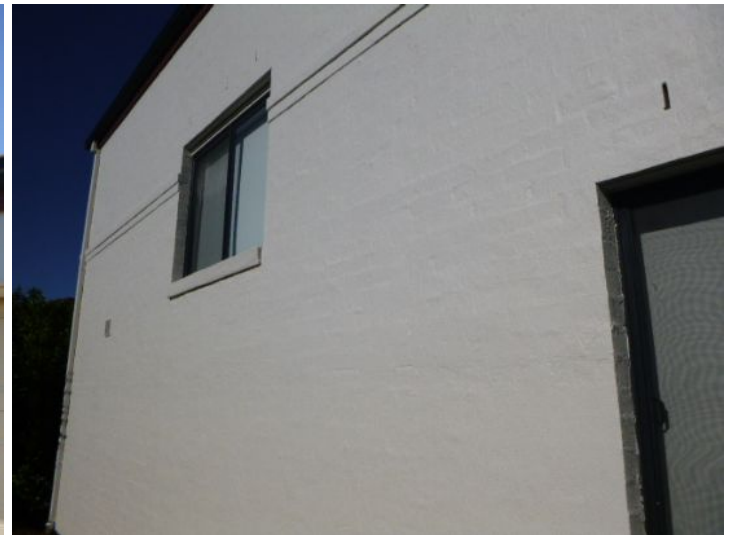
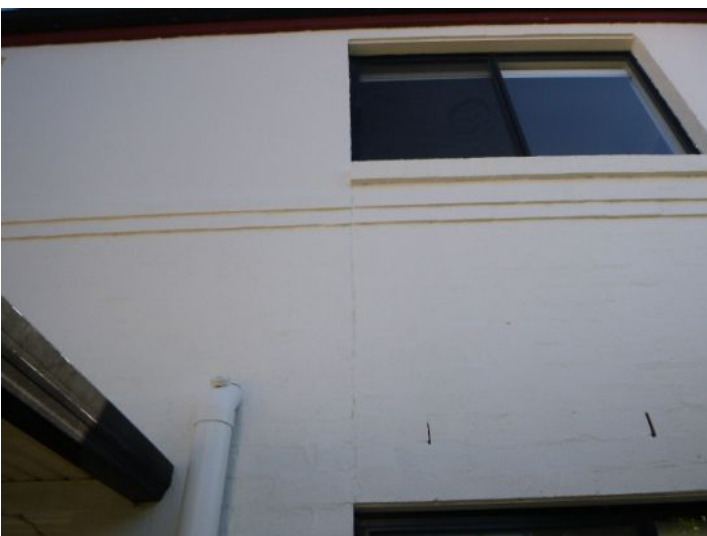
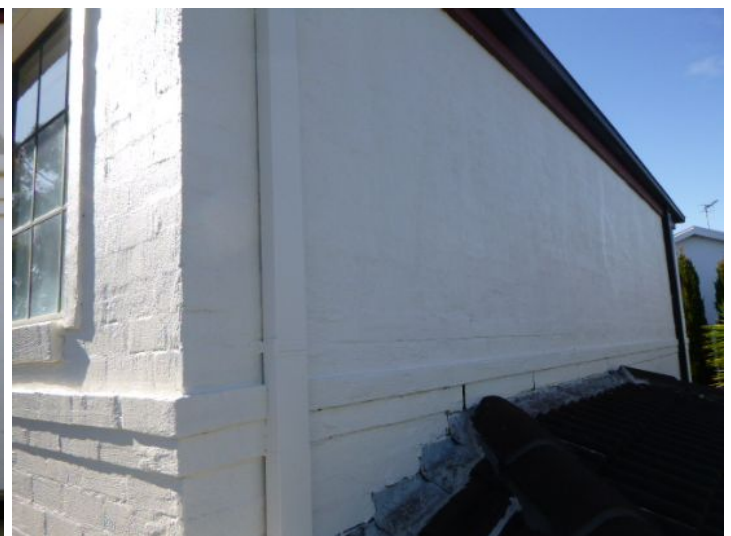
- Due to differential movement within the structure, minor movements have appeared around the property. These movements do not appear to have affected the overall structural integrity of the home. Monitor for changes in condition over the time.
- There are garden beds which are abutting external walls. This can result in water moisture affecting the structure over time. It is recommended that either the beds be removed or a water barrier be placed between the flower bed and the external walls. If these beds are retained it is important that any watering is directed away from the building and kept to an absolute minimum and is controlled.

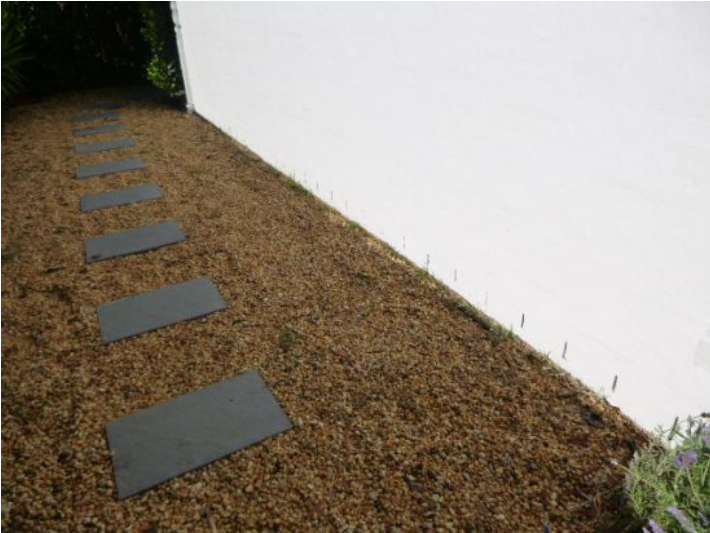
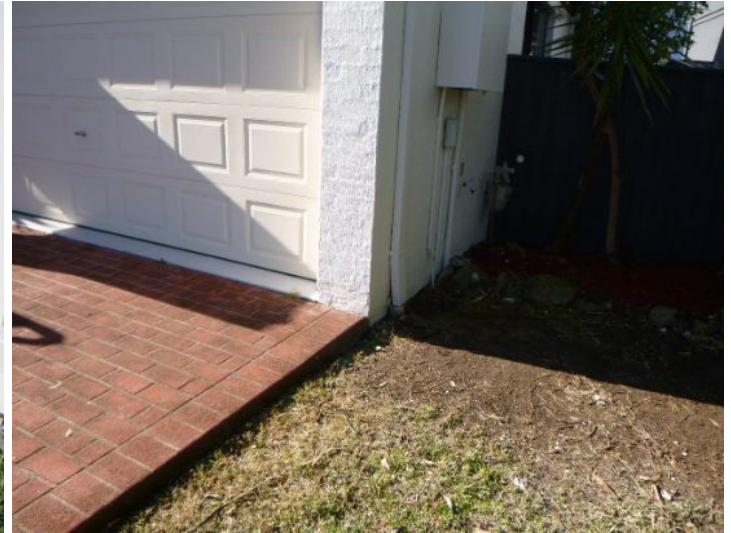
- There appears to be a small opening in the downpipe joints along the side of the property. Maintenance is required.
- The hot water system overflow pipe discharges on the foundations. This should ideally be directed into a stormwater drain or at least 3 metres away from the building.

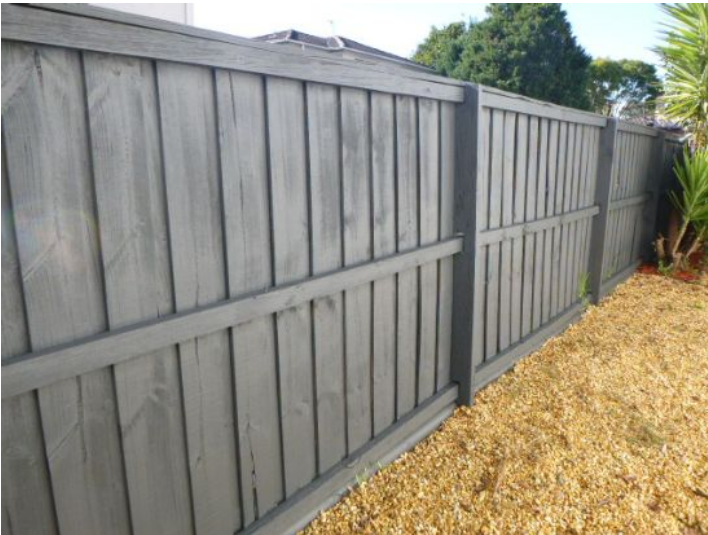
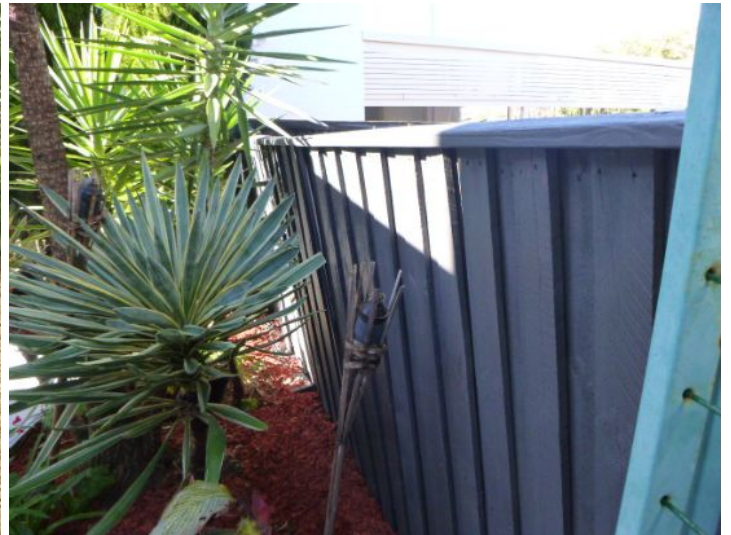
- The boundary fence is leaning slightly in areas. Monitor for changes and rectify as needed.
- Minor wood deterioration observed. Suggest repairs as needed at some point.
