VISUAL VENDOR MAINTENANCE PEST INSPECTION REPORT 35011-2015

7 Scarborough Place, BEACON HILL.

VISUAL TIMBER PEST INSPECTION REPORT

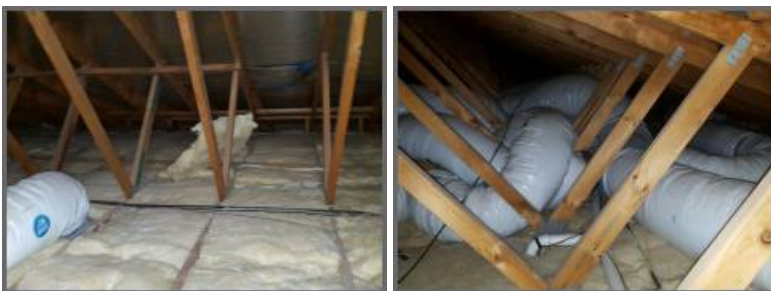
Inspection over the eaves was restricted due to the low pitch and construction allowing only a limited visual inspection from a distance to be carried out.

Insulation is present in the roof cavity. This restricted inspection to some roofing timbers. Removal of insulation is not within the scope of a standard visual timber pest inspection report however, this would be necessary for a more complete report to be submitted.

Sarking paper covered tile battens restricting inspection.

Ducting associated with air-conditioning or heating restricted inspection.

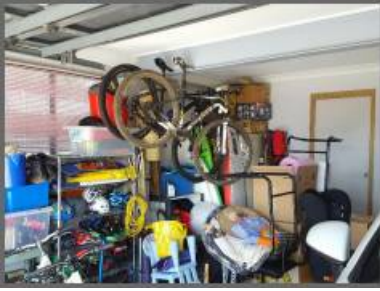
Stored items restricted inspection to the interior of the garage. The garage is partially lined preventing inspection to some framing timbers.
