## **VISUAL BUILDING AND PEST INSPECTION REPORT**

12 Peppercorn Drive, Frenchs Forest

8.11.23.

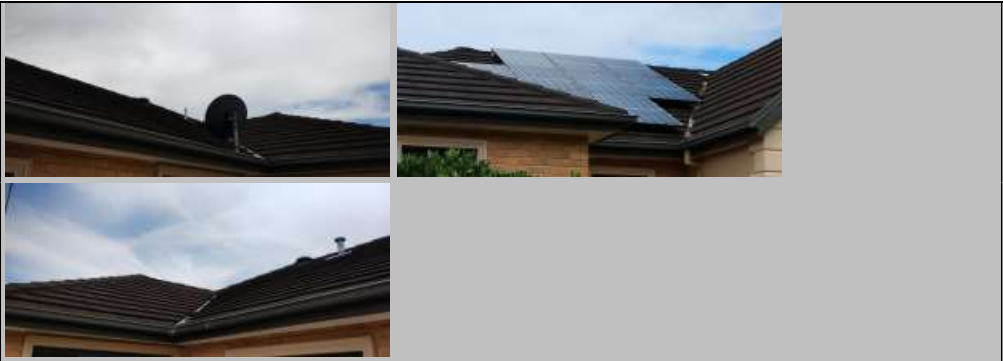
The overall condition of the roof coverings is fair.

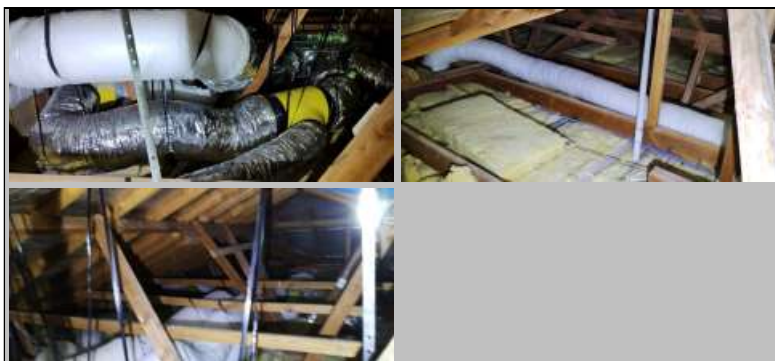
Insulation is present in the roof cavity. This restricted inspection to some roofing timbers. Removal of insulation is not within the scope of a standard visual inspection report, however as in accordance with "industry best standard" the inspector will lift insulation in 3 areas in roof void. Ducting associated with air-conditioning or heating restricted inspection.

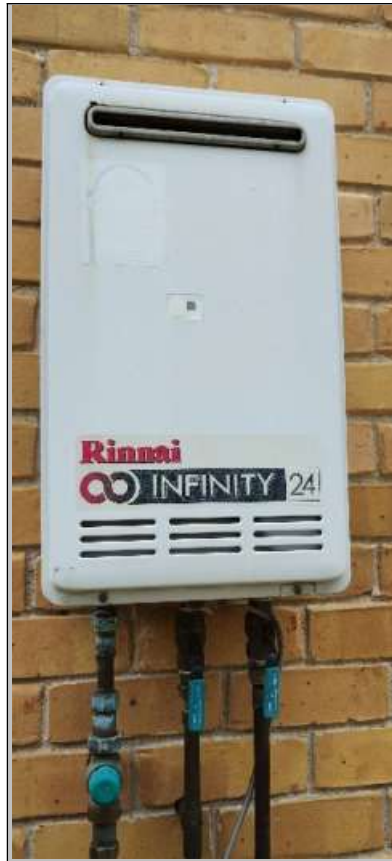
Gas hot water system: Mains pressure: Instantaneous: Located externally: The hot water system appears to be in working condition. No specific tests other than running the hot water tap were carried out. No determination has been made as to the suitability or adequacy of the hot water system in relation to capacity or otherwise.

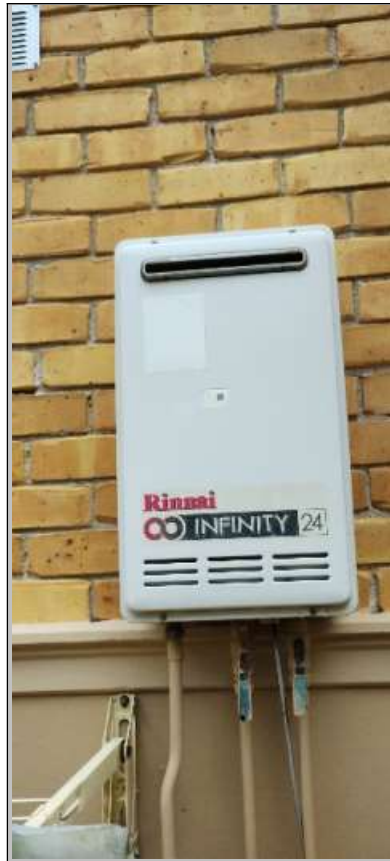
Gas hot water system: Mains pressure: Instantaneous: Located externally: The hot water system appears to be in working condition. No specific tests other than running the hot water tap were carried out. No determination has been made as to the suitability or adequacy of the hot water system in relation to capacity or otherwise.

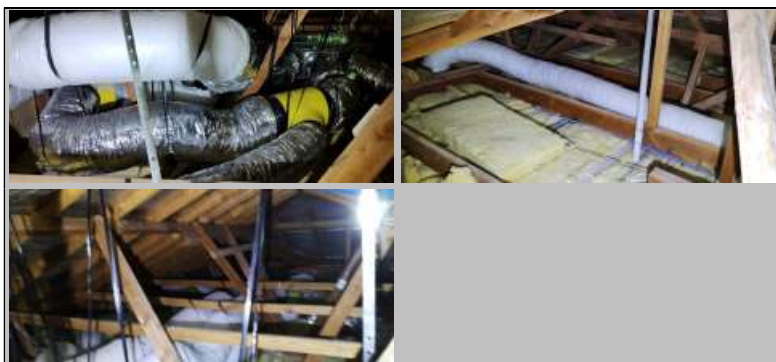
Insulation is present in the roof cavity. This restricted inspection to some roofing timbers. Removal of insulation is not within the scope of a standard visual inspection report, however as in accordance with "industry best standard" the inspector will lift insulation in 3 areas in roof void. Ducting associated with air-conditioning or heating restricted inspection.
