## **Timber Pest Inspection Report**

**AS4349.3-2014**

<b>Report Date</b>	17 May 2024
<b>Structure At</b>	92 Wolger St, Como NSW 2226, Australia
<b>Document Prepared By</b>	Anthony Lee
<b>Licence Number</b>	5073847 pest management technician

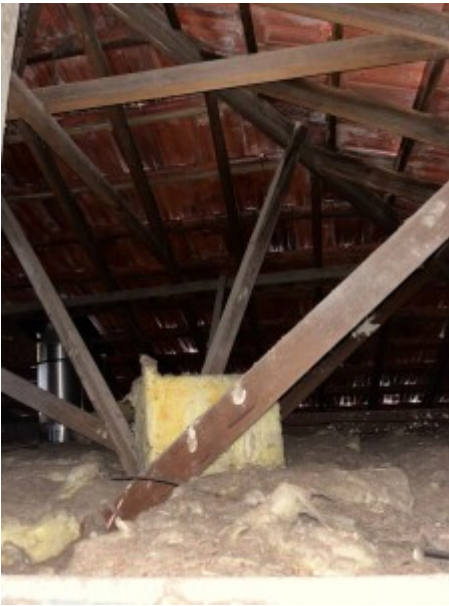
**Roof void**  
Insulated

Where insulation is present in the roof void it is recommended it be moved or removed and an inspection be carried out to the wall top plate timbers and other roofing timbers covered by the insulation. This invasive inspection will not be performed unless a separate contract is entered into.

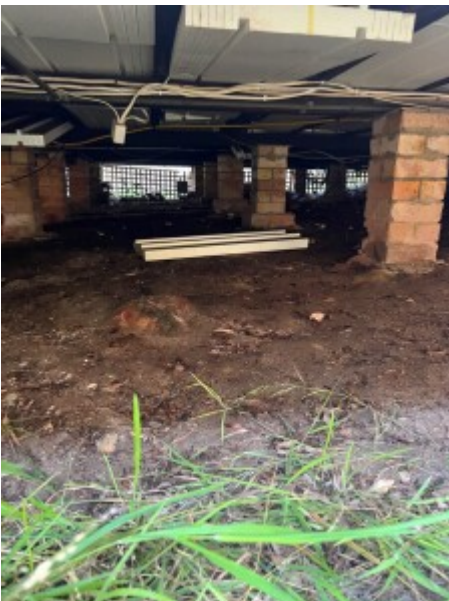
**Sub floor**  
Insulated

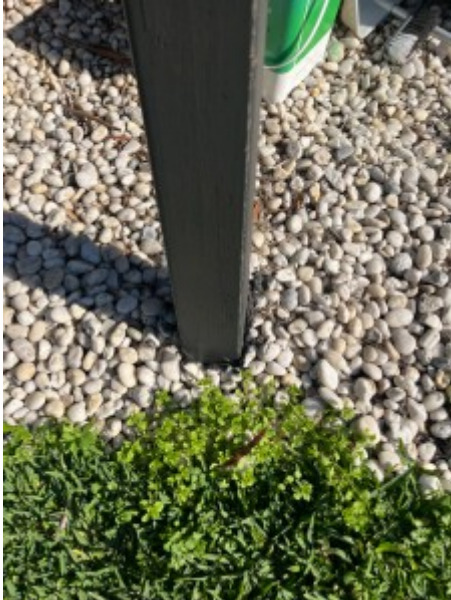
**Veranda subfloor**

Timber in contact with soil

- Timber in the subfloor (Remove)
- Timber structures in contact with the soil and are attached to the building/s (Either Remove or fit termite proof stirrups between soil and the timber)

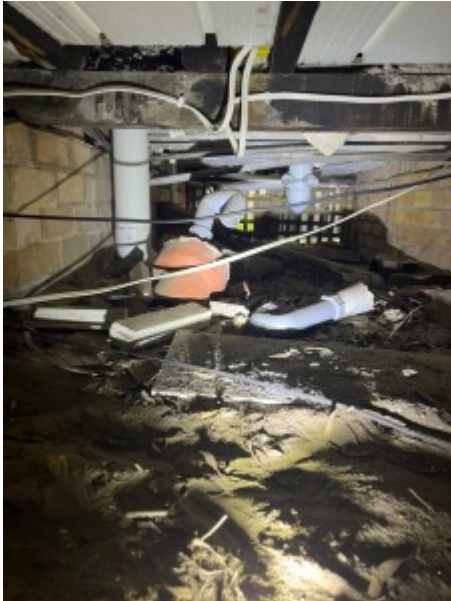
Debris in subfloor
