VISUAL BUILDING AND PEST INSPECTION REPORT

Complies with Australian Standard 4349.1 & 4349.3

19 Brooker Avenue, Beacon Hill

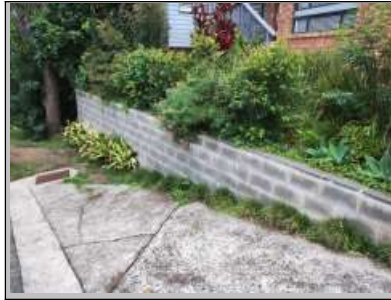
The masonry retaining walls appear in acceptable condition.

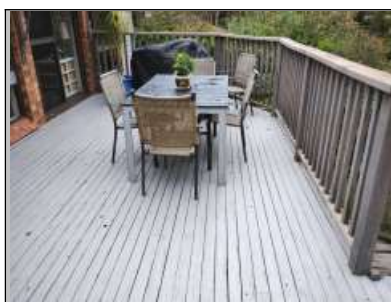
Rear elevation.

Where an external structure is constructed from timber or has significant timber components, and exposed to the elements, a suitably qualified engineer should inspect the structure to determine if it is structurally sound. We cannot determine or advise what weight the structure can hold, The general condition of this structure is fair.

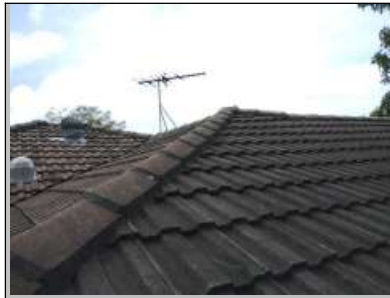
The roof is of pitched and skillion construction.

The overall condition of the roof coverings is fair.

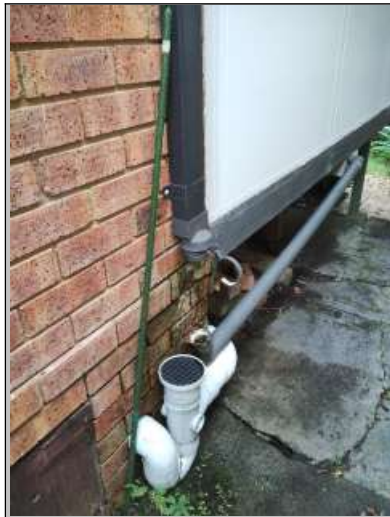
Appear to be in serviceable condition. PVC stormwater connection to downpipes is damaged and will require repair.

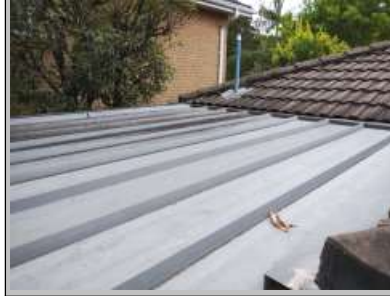
Rear elevation.

The overall condition of the roof coverings is fair.

Flashing material is of sheet metal. Flashings appear to be in serviceable condition.
Q.

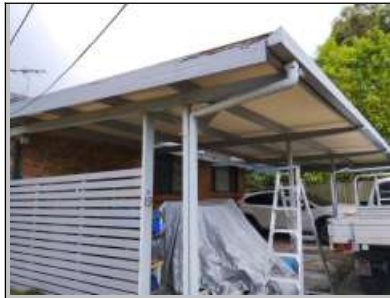
Carport.

The structure is generally in fair condition.

Moderate wet rot decay is present to some sections of the timber fascias/bargeboards. Maintenance and or replacement of damaged timber will be required.

The concrete floor is generally in fair condition. The concrete floor shows signs of cracking.

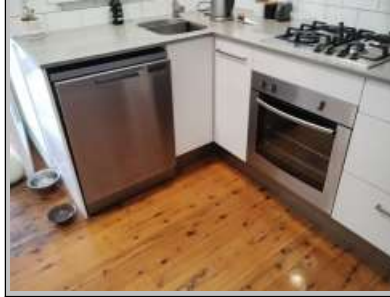
The condition of the fixtures is generally fair.

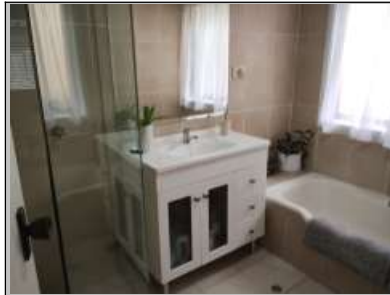
Rear.

The shower recess was tested and there was no visible water penetration to surrounding areas. IMPORTANT NOTE: This test may not reveal water leaks until the shower is put into constant use and surrounding areas monitored over a period of time.

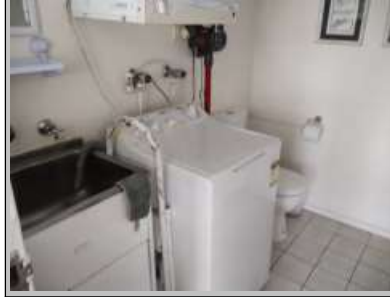
Rear.

The tub and taps appear serviceable. Drain appears serviceable.

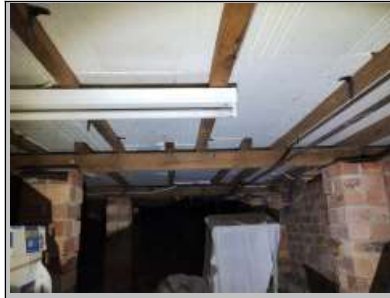
insulation has been installed to underside of floor.

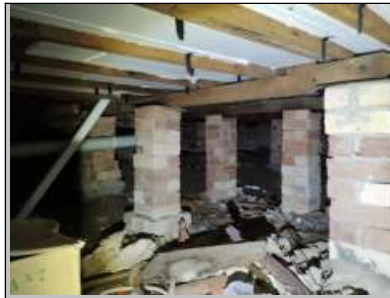
The building is constructed on a combination of strip footings and piers. The footings appear to be generally sound.

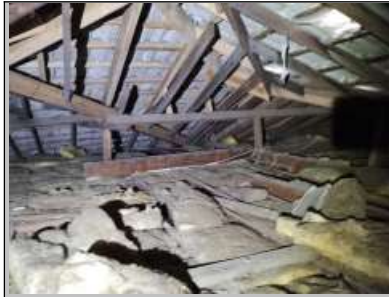
Insulation is present in the roof cavity. This restricted inspection to some roofing timbers. Removal of insulation is not within the scope of a standard visual inspection report, however as in accordance with "industry best standard" the inspector will lift insulation in 3 areas in roof void.

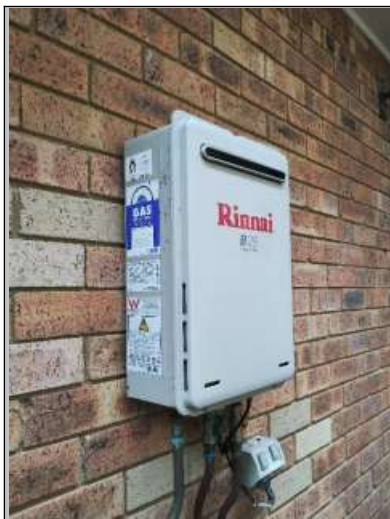
Gas hot water system: Mains pressure: Instantaneous: Located externally: The hot water system appears to be in working condition. No specific tests other than running the hot water tap were carried out. No determination has been made as to the suitability or adequacy of the hot water system in relation to capacity or otherwise.

The hot water service has no date but appears to be new.

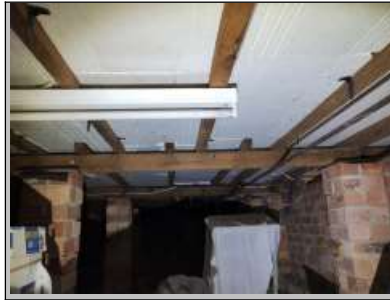
insulation has been installed to underside of floor.

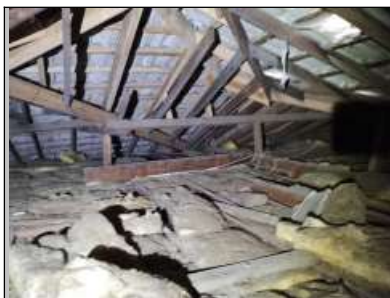
Insulation is present in the roof cavity. This restricted inspection to some roofing timbers. Removal of insulation is not within the scope of a standard visual inspection report, however as in accordance with "industry best standard" the inspector will lift insulation in 3 areas in roof void.
