# Building and Timber Pest Inspection Report VR

Inspection Date: Wed, 19 Jun 2024

Property Address: 22 Agnew Cl, Kellyville NSW 2155, Australia

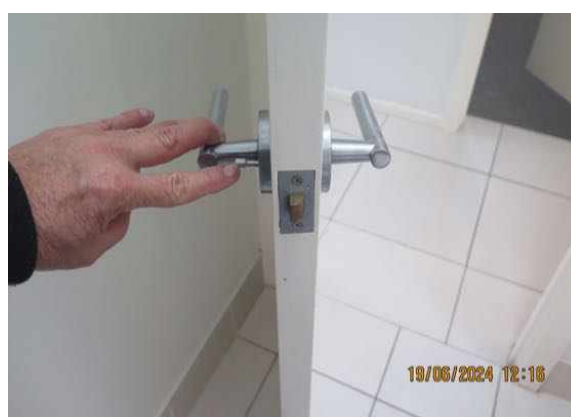
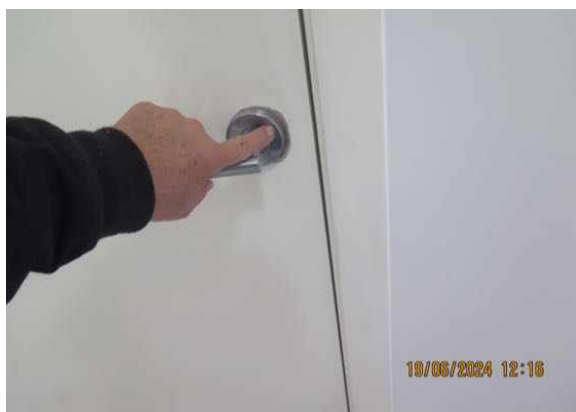
### Finding 3.02

Building: Main Building  
 Location: Bathroom  
 Finding: Lock - Not working  
 Information: The lock in this area was not operational at the time of inspection. Where locks have deteriorated to a point where they are no longer usable, the security of the property is immediately compromised.

Repair or replacement of the lock is highly recommended. Consultation with a locksmith or general handyman is required to gain further advice on any added security that may be available for the area.

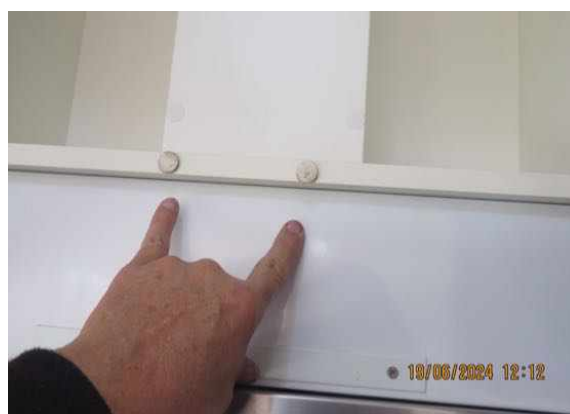
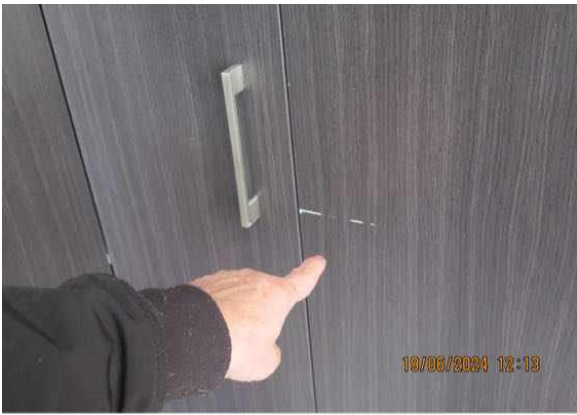
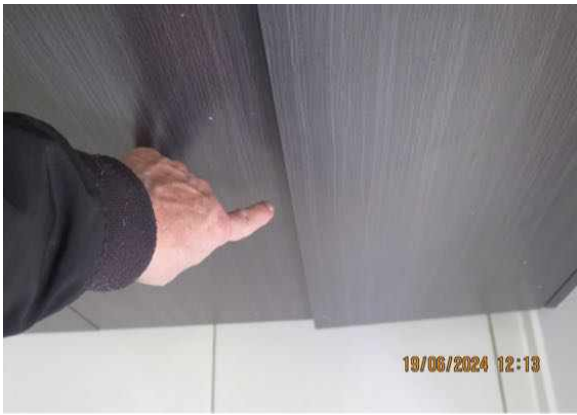
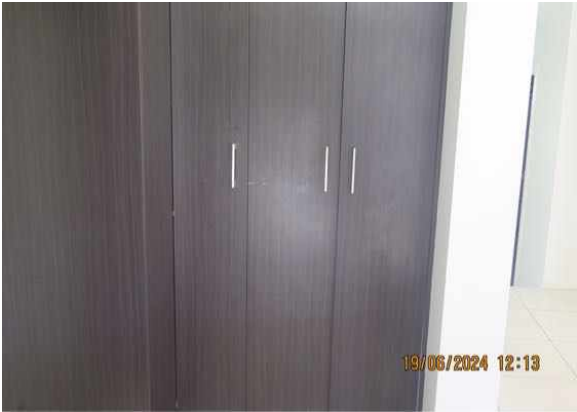
### Finding 3.04

Building:	Main Building
Location:	Kitchen
Finding:	Push to open mechanisms - Not operating - Damaged door - Door binding
Information:	Non-operational items should be addressed to ensure that the full function of the building structure is available. Where some building elements are not operating as intended, it is possible that secondary building defects could arise due to their non-operation.

Repair and/or replacement of the faulty building element is recommended. It is highly recommended that the relevant tradesperson be engaged to perform any necessary works.

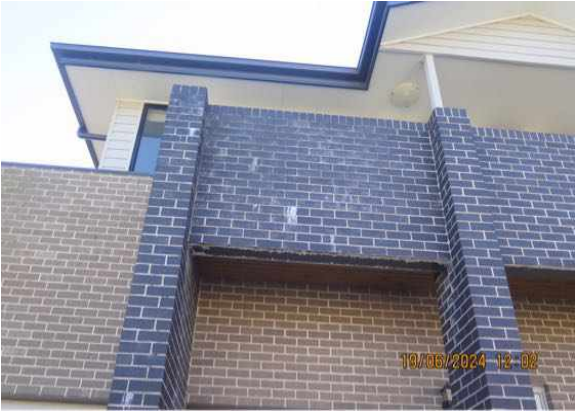
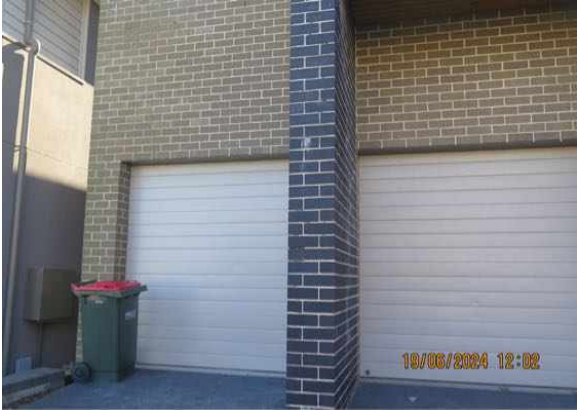
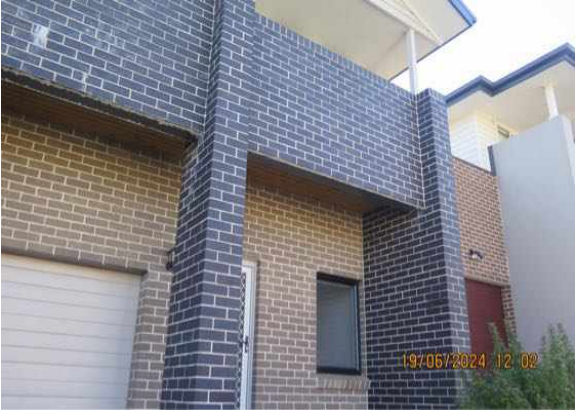
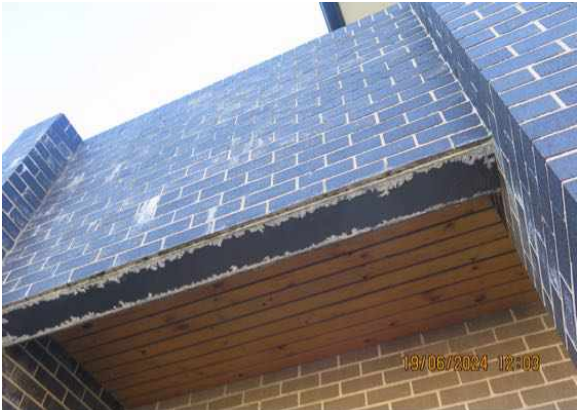
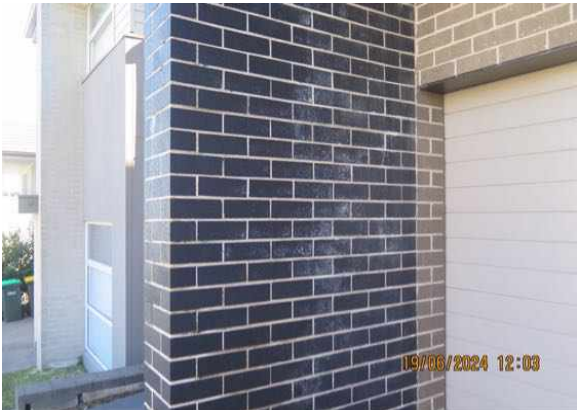
Finding 3.05

Building: Main Building  
Location: Yard - Front  
Finding: Brickwork - Efflorescence  
Information: Efflorescence appears to be affecting the brickwork, concrete or tiles in this area. Efflorescence typically occurs when excess salts within the concrete or cement mortar is leached to the surface due to water transfer.

It is typically seen as white salt deposits on the surfaces of concrete pavement or mortar between bricks or tiles. While detracting from the overall appearance of the affected area, efflorescence is not likely to develop into secondary damage if left unmanaged.

Generally, soluble salt deposits can be removed by dry brushing with a stiff-bristled brush. Repeated dry brushing is an ideal treatment for eliminating this forming of efflorescence. A cleaning contractor or general handyperson may be appointed to perform these works at the discretion of the client.
