## Timber Pest Inspection Report

Inspection Date: Thu, 25 May 2023

Property Address: 8 Dresden Ave, Beacon Hill NSW 2100,  
Australia

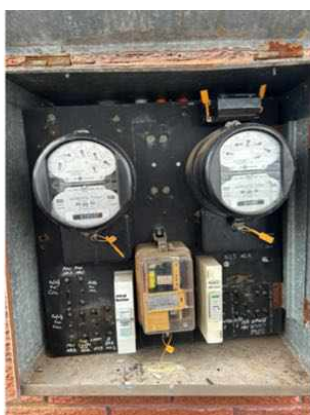
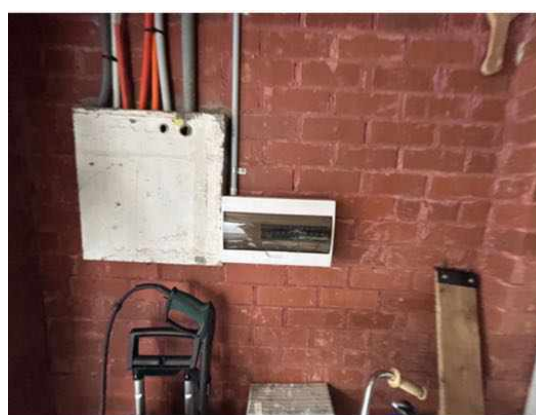
#### Termite and Timber Pest 1.01

Building:	Building 1
Location:	Yard - Side
Finding:	Termite Management System - durable notice not present
Information:	A durable notice has not been placed in the switchboard unit to indicate current termite barriers. At the time of inspection, it appeared as though there is only a physical termite management system has been installed.

The client may consider gaining further advice from a pest controller/ installer as to the costs and procedures involved with this application. It is recommended that obtaining such advice be a short-term priority.

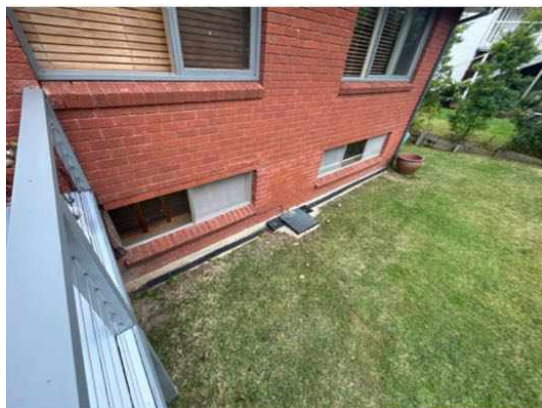
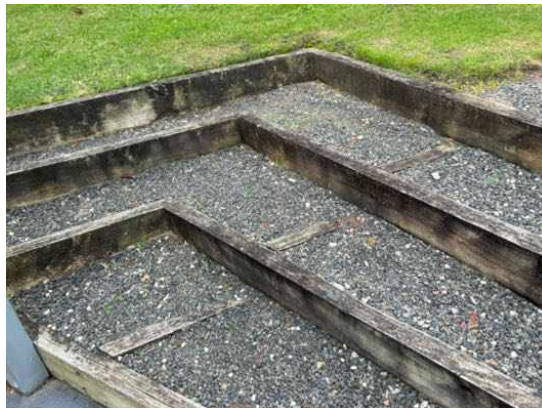
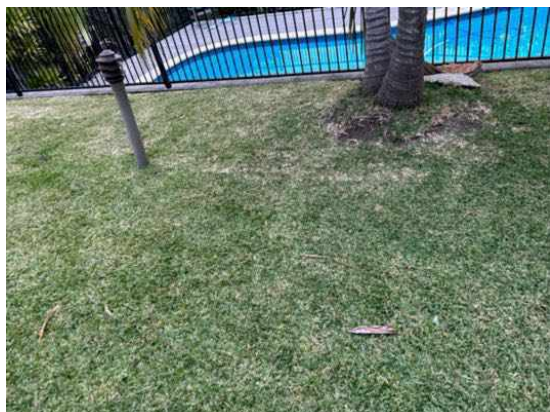
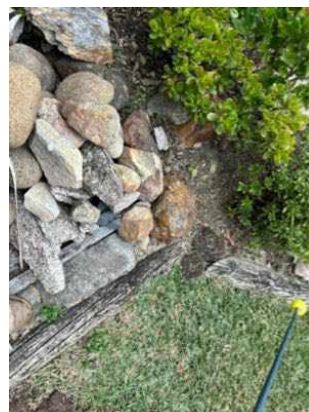
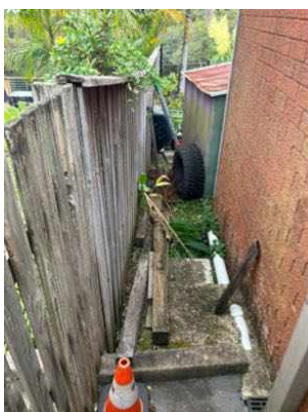
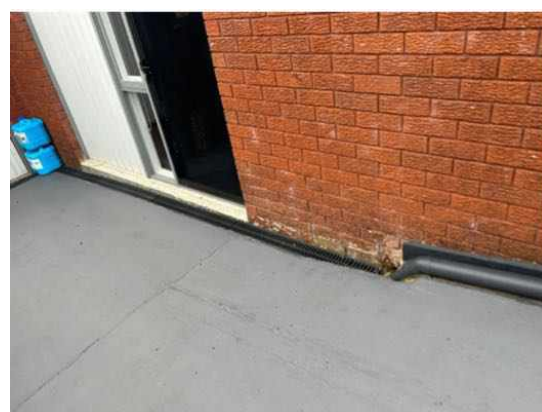
#### Termite and Timber Pest 1.02

Building:	Building 1
Location:	All Areas
Finding:	Evidence of excessive moisture was present at the time of inspection
Information:	Excessive moisture can attract termites and produce conditions that promote termite attack fungal growth and wood decay.

Excessive moisture is generally caused by deteriorated inadequate or missing roof drainage leaking plumbing pipes or fixtures poorly plumbed HWS overflows or condenser units and poor site drainage.

It is highly recommended that all plumbing and drainage fixtures and fittings be maintained regularly in order to prevent excessive moisture being present in the external / internal property.

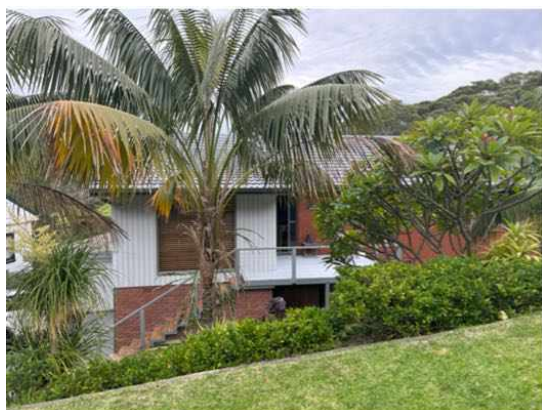
### Termite and Timber Pest 1.03

Building:	Building 1
Location:	All External Areas
Finding:	Garden Beds - Conditions Conducive to Termites
Information:	Garden beds were found to be evident in the garden area. These garden beds can include untreated timber, and with a combination of moisture from watering hosing can make conditions conducive to termite activity and termite ingress.

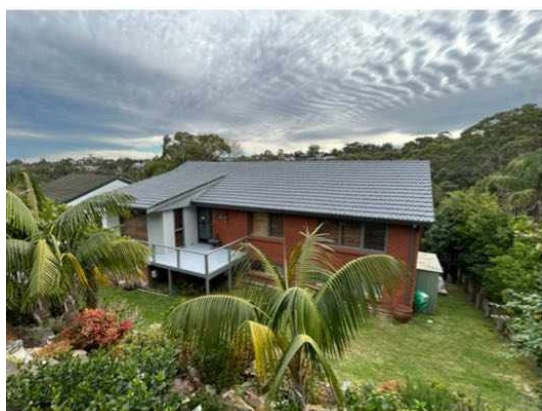
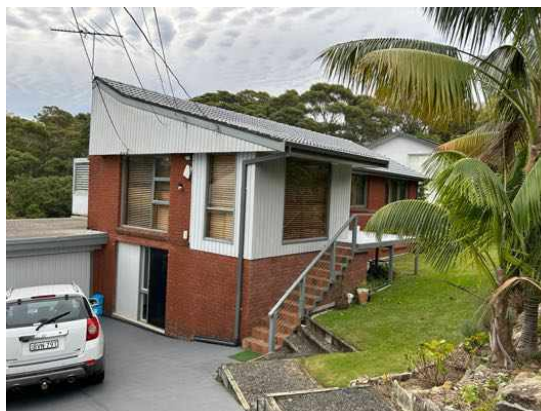
### Termite and Timber Pest 1.04

Building:	Building 1
Location:	Roof Exterior
Finding:	Trees - Overhanging and filling gutters
Information:	Overhanging trees often result in excessive amounts of leaf debris accumulating in gutters.

Gutters are a critical part of the building's management of storm water and rain. It is therefore important that they be kept clear to prevent secondary damage to associated building elements, including exterior and interior walls, ceiling linings and any adjoining building elements. Where gutters are blocked, pooling of rainwater is likely to occur, fast-tracking rust and corrosion of the roof plumbing elements.

It is highly advised that all overhanging tree branches be removed as soon as possible to prevent any further damage. Repair and/or replacement of sections of damaged guttering may also be required where the extent of the damage necessitates.

Such works should be performed by the homeowner; however, appointment of a landscape contractor or an arborist may be required. Consultation with a licensed roof plumber is required where guttering has been damaged.

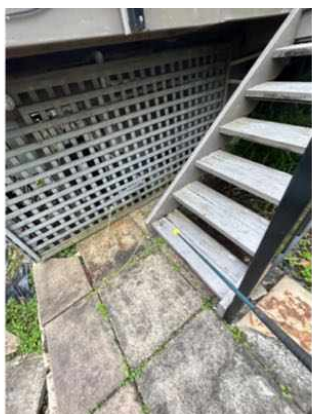
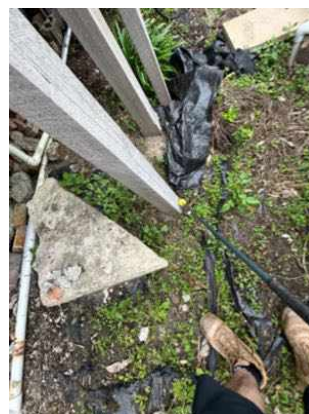
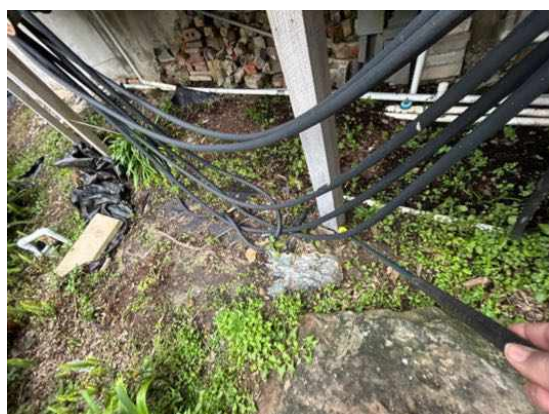
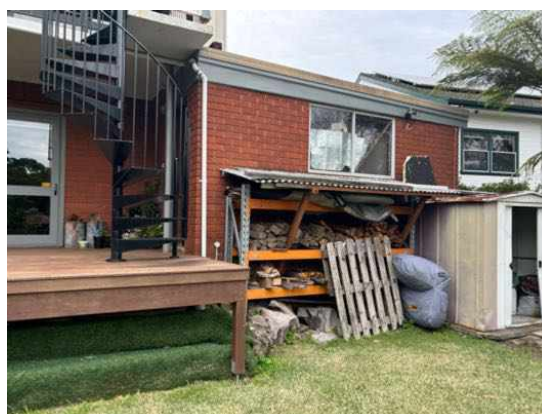
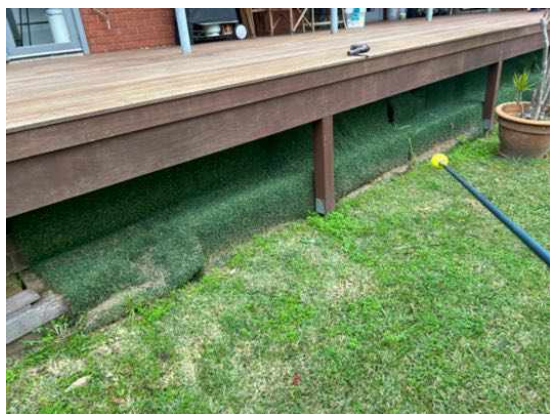
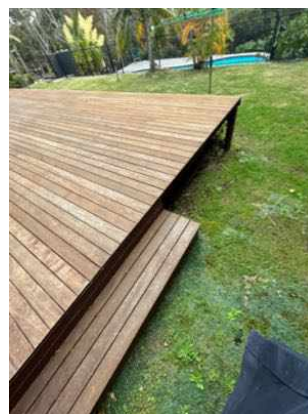
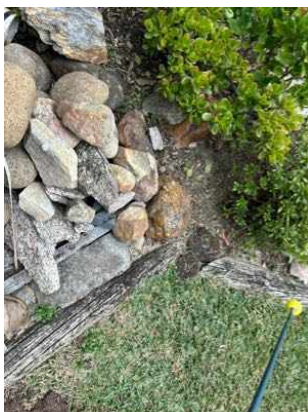
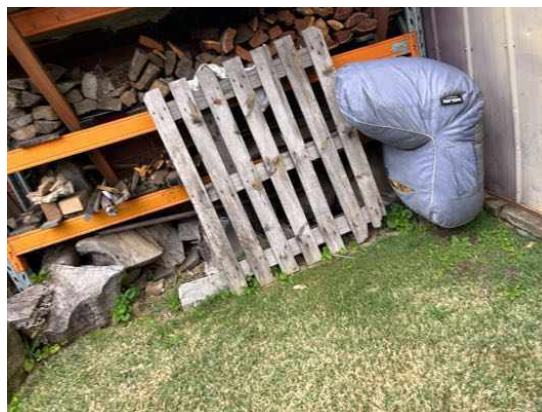
### Termite and Timber Pest 1.05

Building:	Building 1
Location:	All External Areas
Finding:	Building materials in direct ground contact - conducive to termites
Information:	Where timber elements are in direct contact with the ground and consequently moisture or dampness they become conducive to termite activity.

Whether timber is used as a building element part of a fencing structure or stored as an unused item they can provide an environment that is attractive to termite infestation.

When met with excessive moisture timber begins to decay and develop wood rot. Any timbers that are in direct contact with external grounds especially if left untreated or non- durable also provide ingress for subterranean termites into that particular element.

The removal of any such materials that may be conducive to termite activity should be removed as soon as possible to minimise the risk of termite attack.

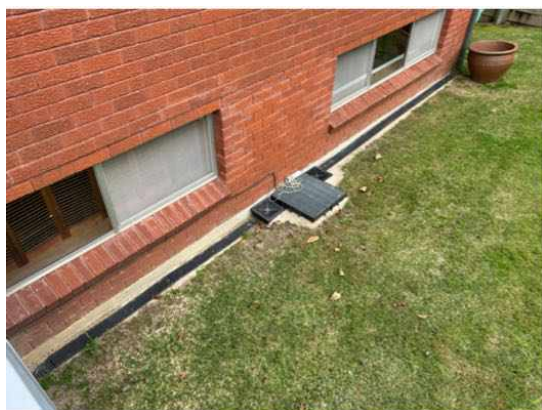
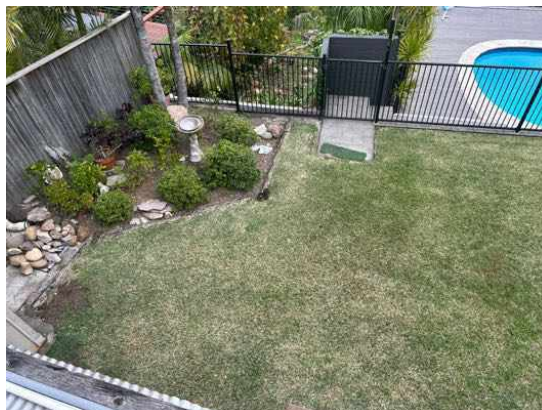
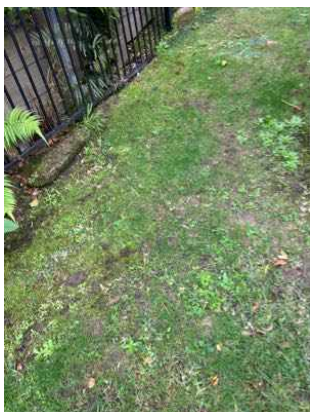
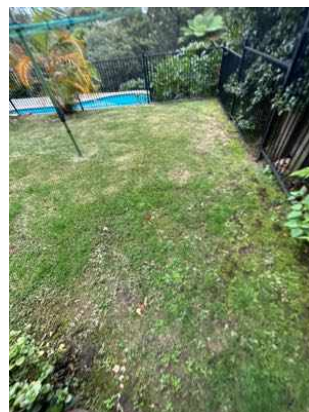
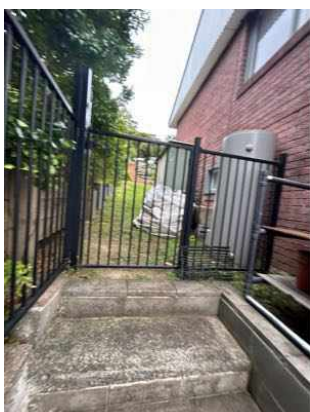
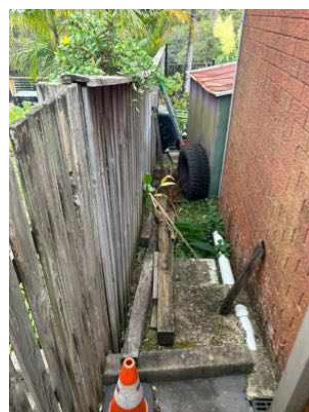
## Termite and Timber Pest 1.06

Building:	Building 1
Location:	All External Areas
Finding:	Site drainage - suspected Inadequate
Information:	The site drainage in this area was found to be inadequate at the time of inspection, creating potential for subsequent water damage to associated building elements.

It is important that water does not lie against the base of walls; surrounding paths and ground levels should be sloped to drain water away from walls. Downpipes should not disgorge stormwater onto lower walls or plinths. Stormwater should be carried away by large, regularly cleaned drains. Ground levels may need to be lowered to expose a buried DPC.

Where site drainage is inadequate, installation of an Agricultural (Aggie) Drain may be required. A qualified plumber should be appointed to further inspect the property and perform any remedial works as necessary. Water damage and secondary defects are likely to occur if left unmanaged.

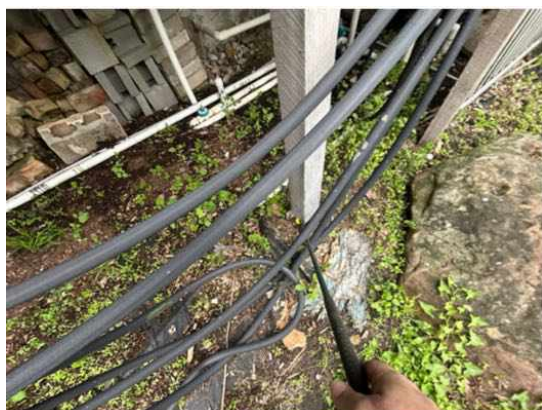
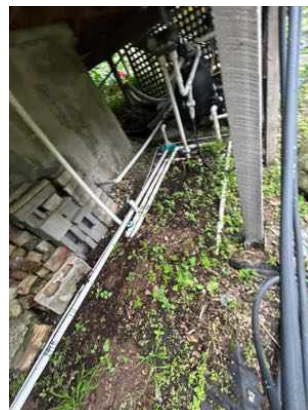
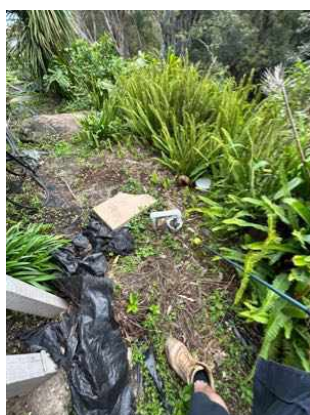
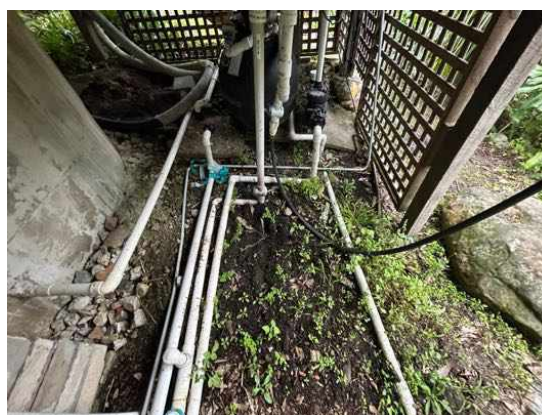
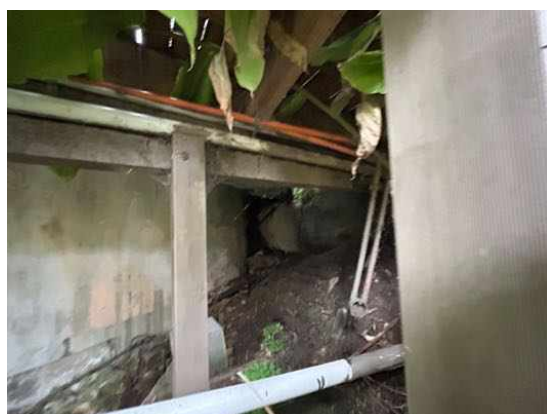
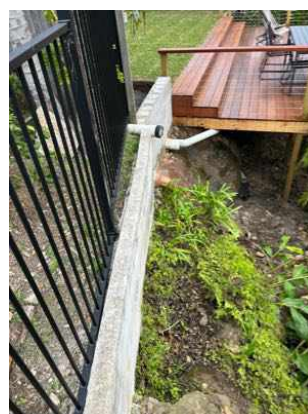
## Termite and Timber Pest 1.07

Building:	Building 1
Location:	Pool Area
Finding:	Evidence of excessive moisture was present at the time of inspection
Information:	Excessive moisture can attract termites and produce conditions that promote termite attack fungal growth and wood decay.

Excessive moisture is generally caused by deteriorated inadequate or missing roof drainage leaking plumbing pipes or fixtures poorly plumbed HWS overflows or condenser units and poor site drainage.

It is highly recommended that all plumbing and drainage fixtures and fittings be

maintained regularly in order to prevent excessive moisture being present in the external / internal property.

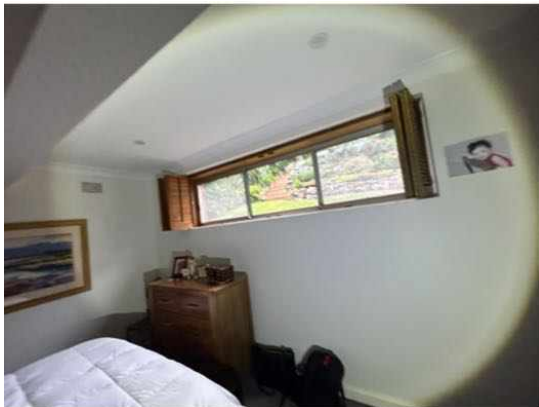
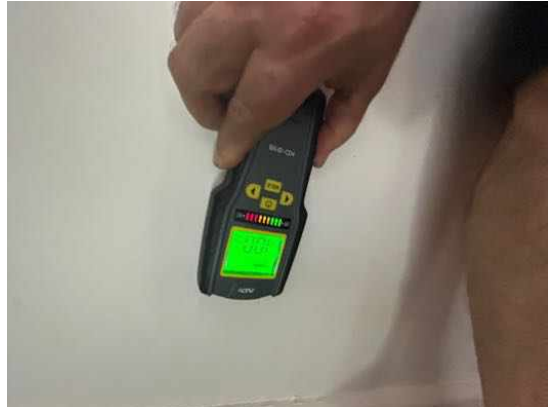
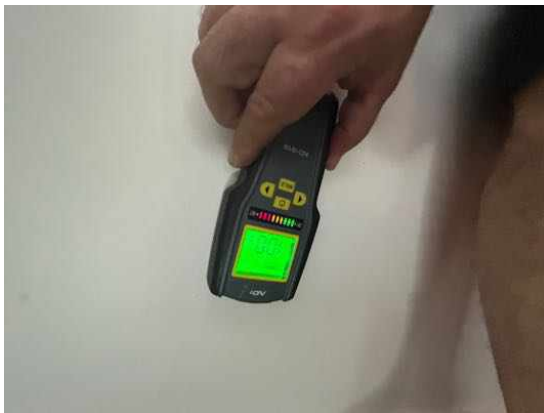
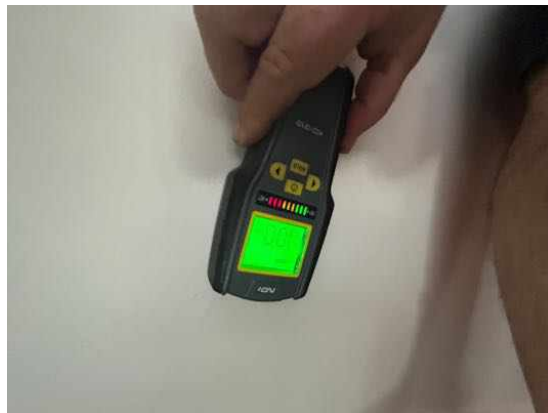
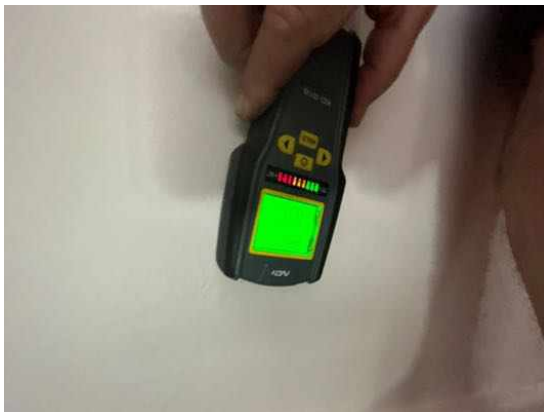
### Termite and Timber Pest 1.08

Building: Building 1  
 Location: Bedroom > Ground Level  
 Finding: Moisture meter readings - high  
 Information: The moisture meter result for the areas inspected.

The moisture reading of 0-15% is quite normal and gives no cause for concern. However, moisture readings in excess of 15% indicate the need for further inspection.

Levels between 25-30% indicate that there may be water ingress, meaning that remedial work could be required.

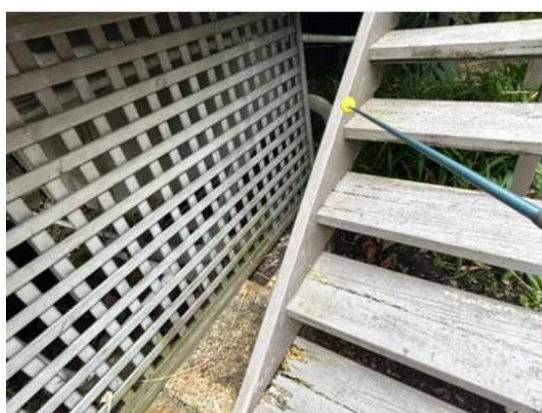
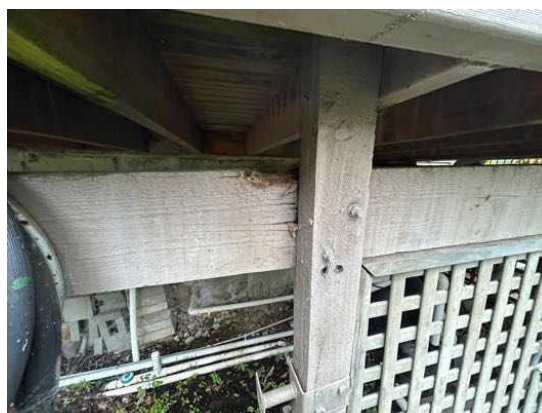
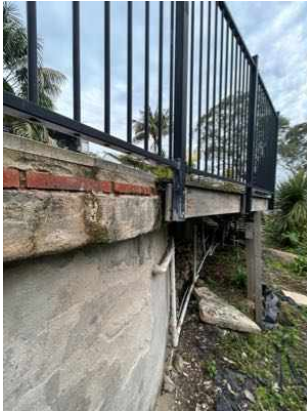
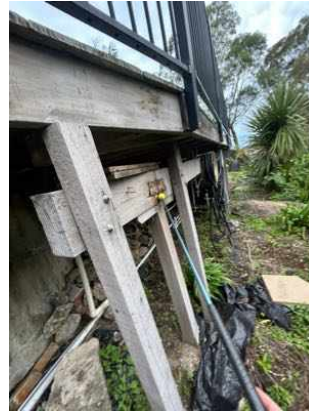
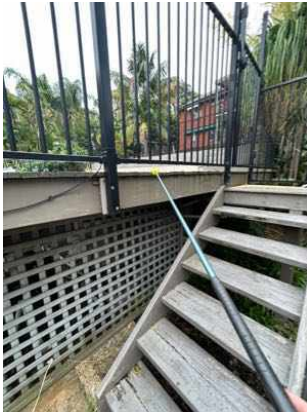
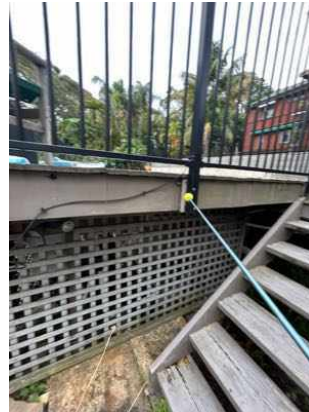
### Termite and Timber Pest 8.01

Building:	Building 1
Location:	Pool Area
Finding:	Wood rot
Information:	This building element shows evidence of wood rot. Wood rot, also known as Fungal Decay, occurs when timbers and other cellulose building materials are exposed to damp conditions on an ongoing basis. This could be the result of exposure to weathering over a prolonged period of time, or the attraction of excessive moisture from other abutting building materials. Contributing factors also include poor air ventilation in the area.

Wood rot is often associated with general damp problems and is evidenced by a 'musty' smell or mould and mildew occurring on surfaces. If left unmanaged, damp conditions can lead to further health problems and the decay of timbers will continue.

Early intervention and regular maintenance, particularly of exterior timbers, will prolong the useful life of these building elements. Prior to any works being performed, the cause of the moisture that has created the visible wood rot should be identified and addressed in a suitable manner. Replacement of affected timbers may then be a necessary step in protecting surrounding building elements from such deterioration.

A qualified plumber may be appointed to assess the cause of excessive moisture and to provide advice on any remedial works as required. A qualified carpenter or registered builder may also be required to replace affected building materials.

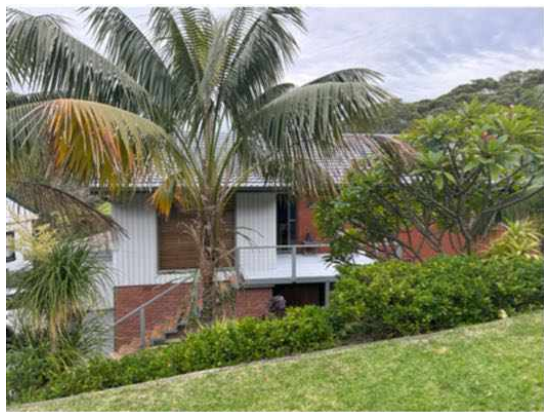
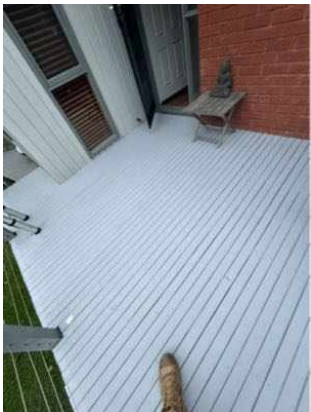
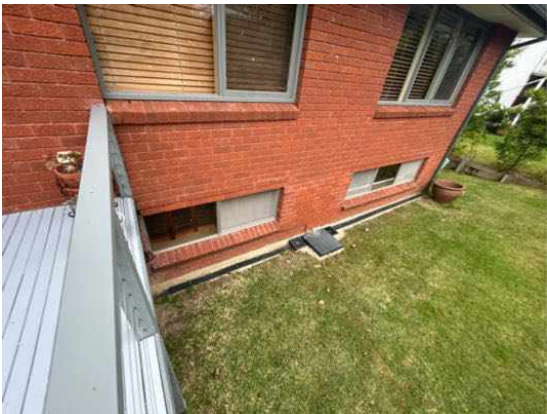
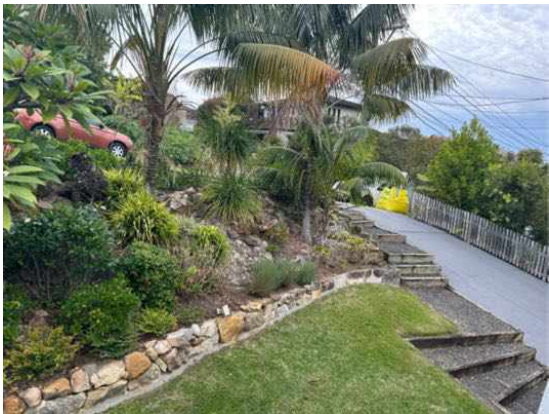
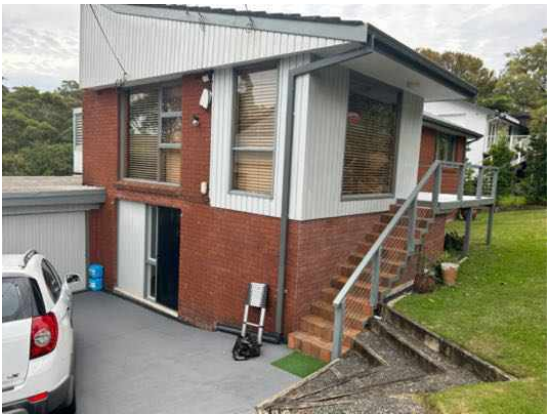
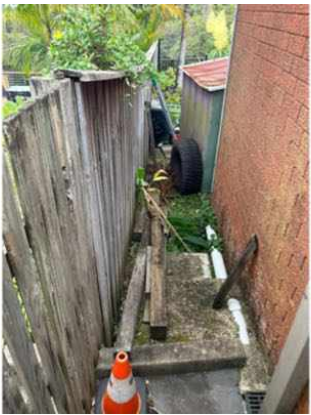
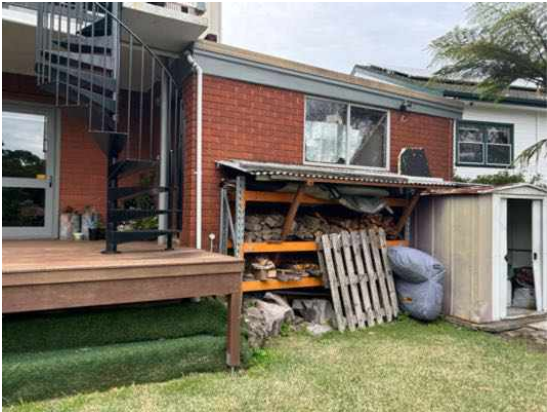
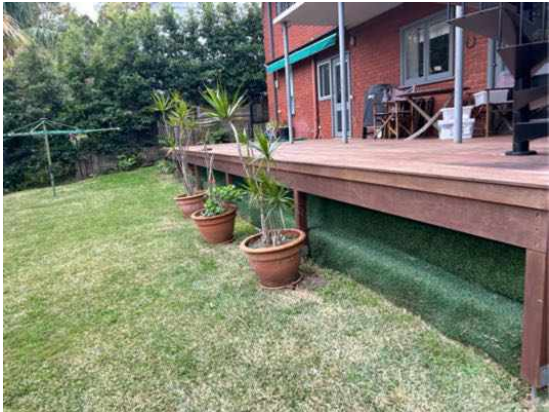
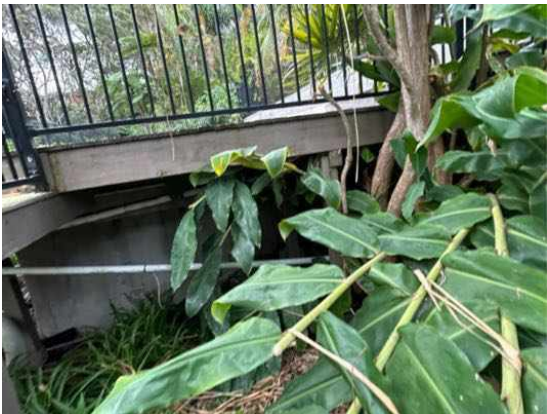
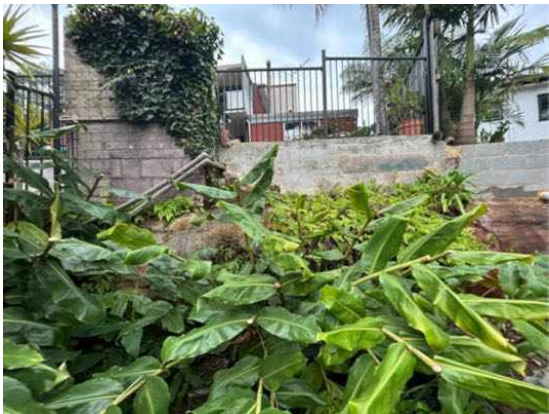
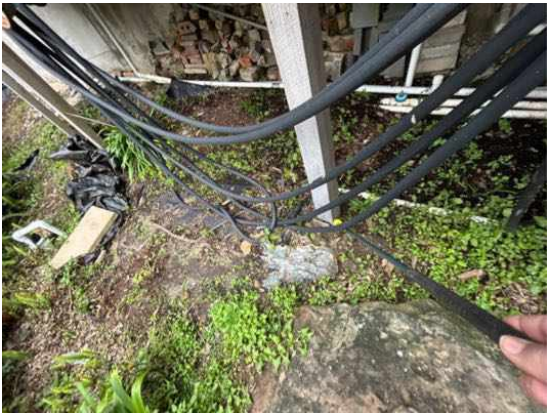
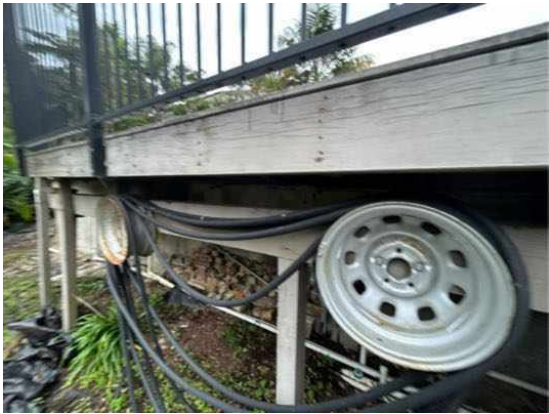
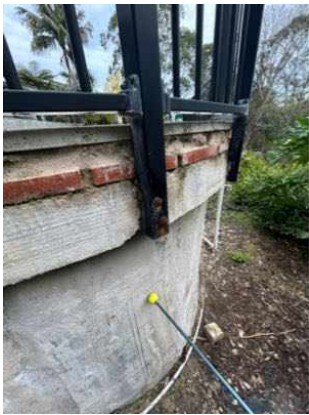
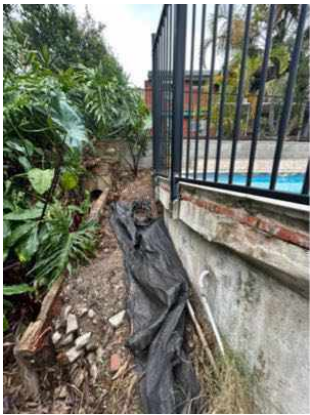
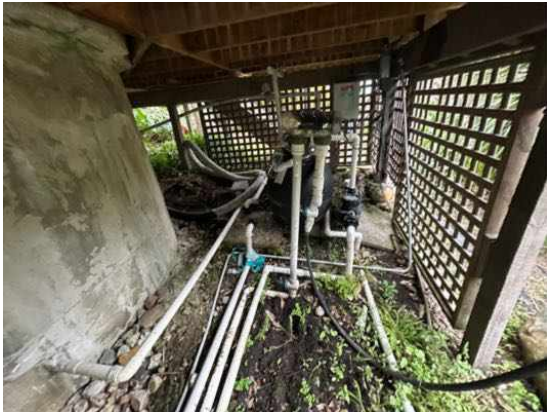
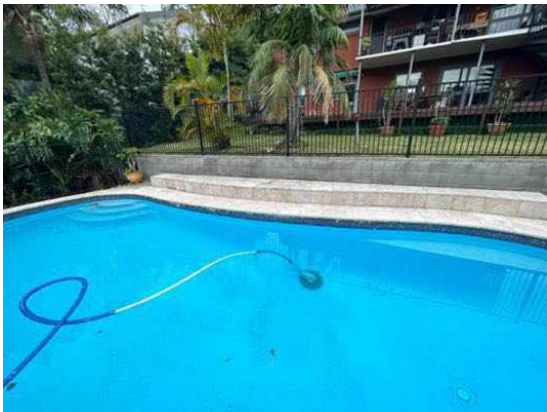
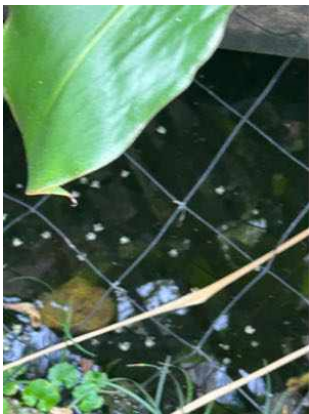
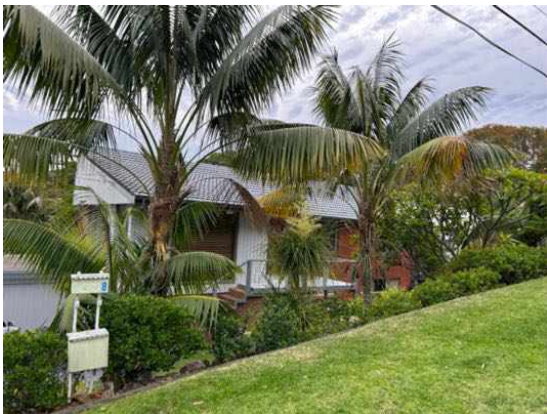
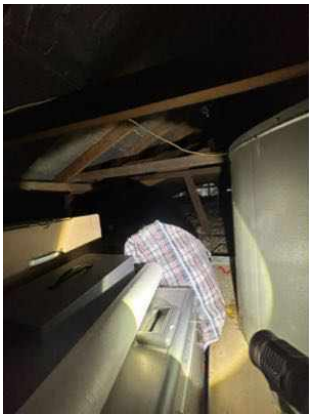
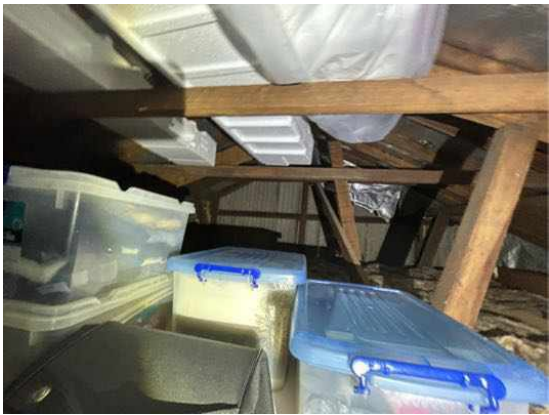
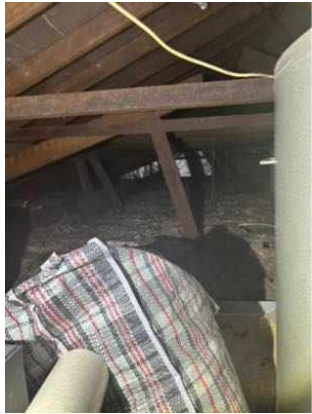
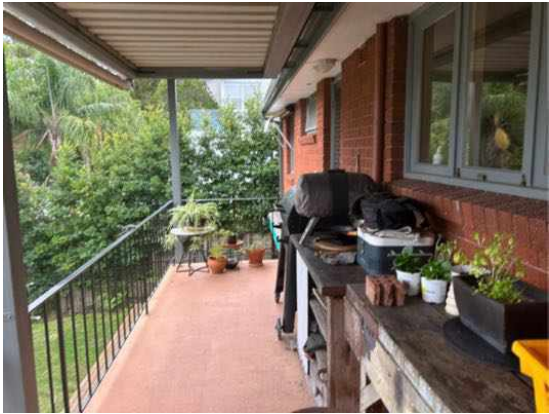
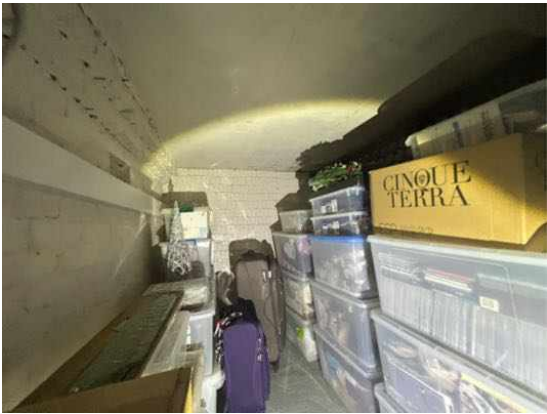
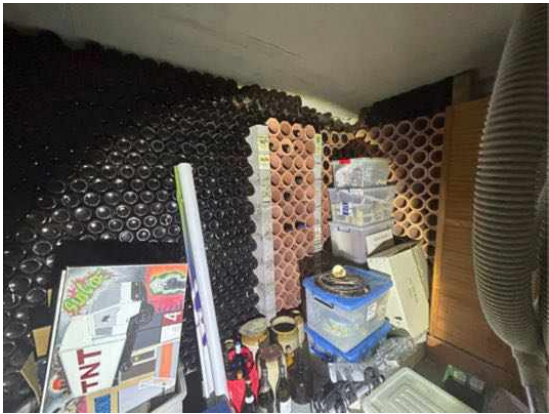
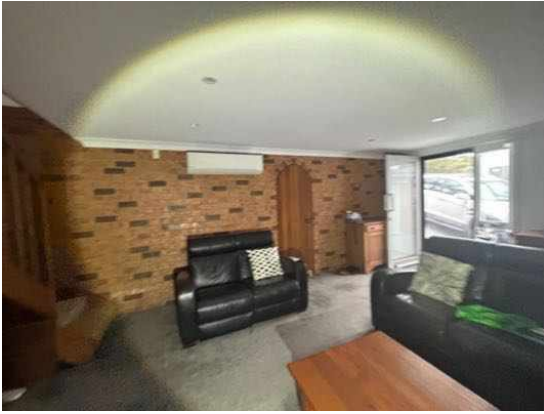
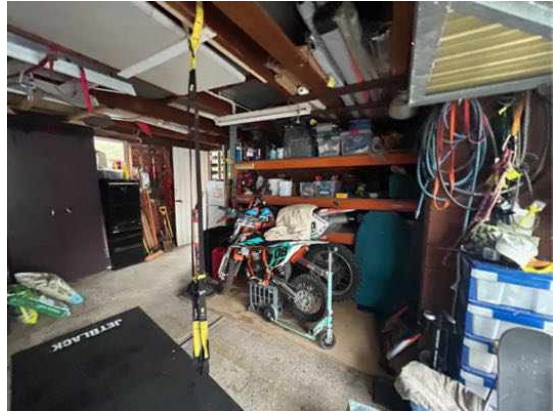
Noted Item

Building: Building 1  
Location: All Areas  
Finding: Additional Photos - Obstructions and Limitations  
Information: These photographs are an indication of the obstructions and limitations which impeded full inspection of the property at the time of inspection. These obstructions can hide an array of defects and should be removed to allow full inspection to be carried out. A re-inspection is recommended once the areas are made accessible.
