Building and Timber Pest Inspection Report

Inspection Date: Wed, 28 Apr 2021

Property Address: 34 Rangers Retreat Rd, Frenchs Forest
NSW 2086, Australia

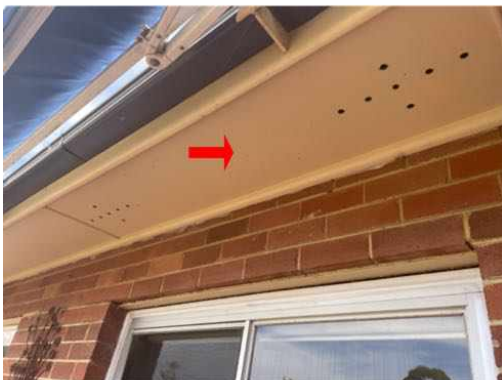
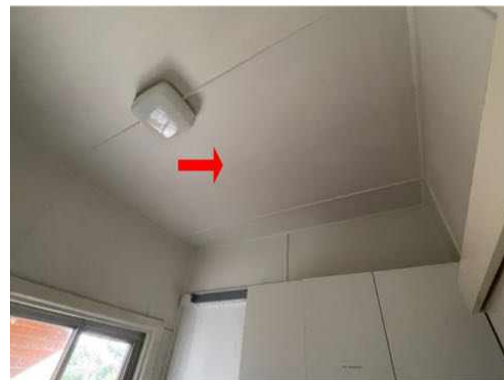
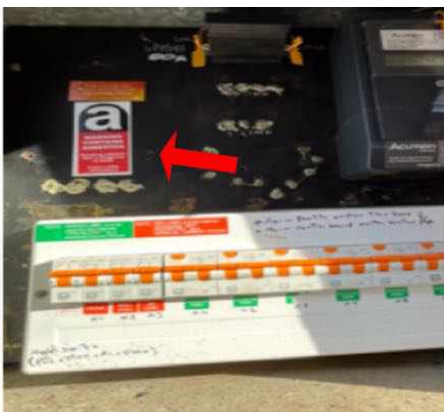
Defects 1.01

Building:	Building 1
Location:	All Areas
Finding:	Asbestos - Suspected ACM Identified on Site
Information:	Reporting on Asbestos is outside the Scope of this Report. This suspected defect is highlighted as a caution only. We suspect, based on our experience in the building industry, that there is a higher risk of the identified building element containing asbestos.

As Asbestos Reporting is outside the scope of this report, we advise that you consider a separate Asbestos Inspection and Condition Audit, which can include the taking of samples for definitive confirmation of the presence of Asbestos.

In the interim, the client is advised to act with caution, especially when considering any damage to building materials general wear and tear renovations extensions demolition and general maintenance activities due to the suspected presence of Asbestos.

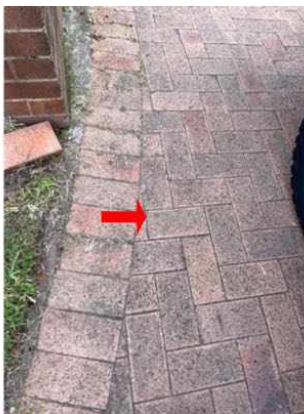
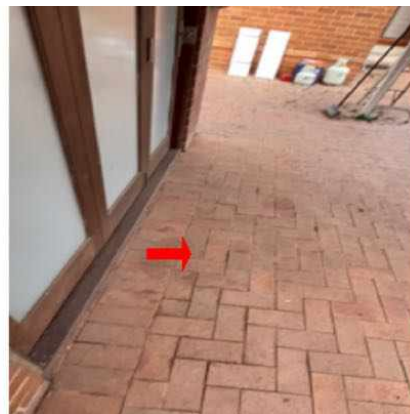
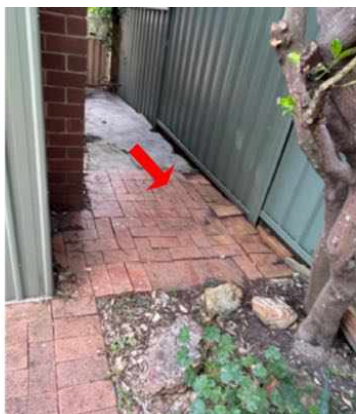
Defects 3.01

Building: Building 1
Location: Yard - Back
Finding: Paving - Uneven
Information: Sections of the external paved area are uneven, creating a potential trip hazard. It appears as though the area has been subject to rough installation, or that paving sections have lifted due to movements in the foundation of the property.

Where paving creates a trip hazard, personal injury may ensue if due caution is not taken by all persons within this area.

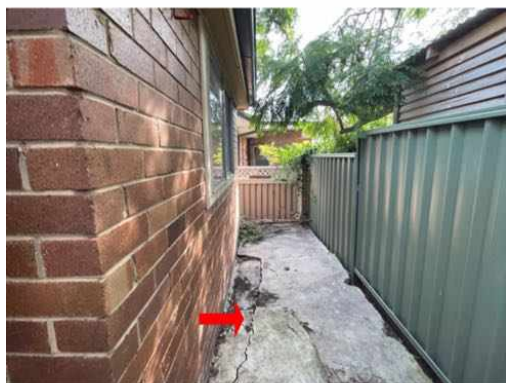
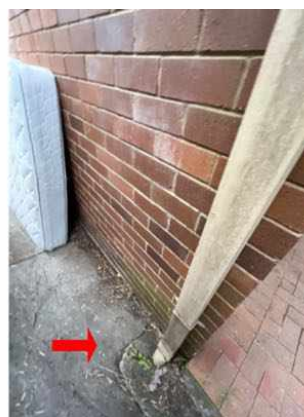
Defects 3.02

Location: All External Areas
 Finding: Crack in concrete slab - Category 3
 Information: A crack coded as Category 3 was identified in the slab. A Category 3 crack is described as a wide crack with obvious curvature or change in level, affecting the slab.

The approximate width of the crack to be considered Category 3 is greater than 2.0mm, or a change in offset of 15-25mm when a 3m straight edge is placed over the defect.

Category 3 cracks to slabs exceed allowable Standards and Tolerances, and are considered defects requiring rectification.

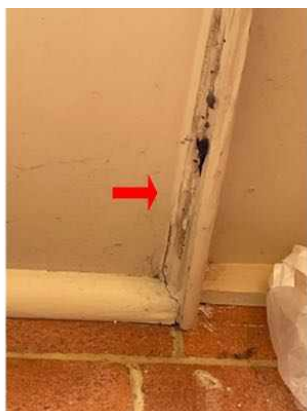
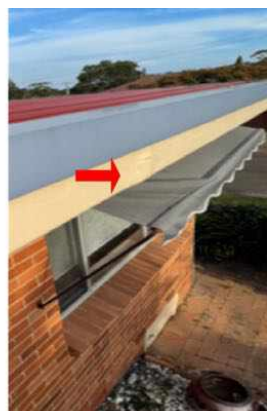
Defects 3.03

Building: Building 1
 Location: All Areas
 Finding: Fascias - Wood rot
 Information: Wood rot was found to be affecting fascias and barges in this area, evidenced by the presence of mould on the surface in some areas. Wood rot, also known as Fungal Decay, occurs when timbers and other cellulose building materials are exposed to damp conditions on an ongoing basis.

It is likely that this wood rot has developed as a result of faults in the roof plumbing, creating excessive moisture in this areas. Frequent exposure to rain and other weather conditions also make fascias and barges susceptible to accelerated deterioration.

Early intervention and regular maintenance will prolong the useful life of these building elements. Prior to any works being performed, the cause of the moisture that has created the visible wood rot should be identified and addressed in a suitable manner.

It is advised that a roof plumber be appointed to inspect all roof plumbing and subsequently identify the cause of the wood rot. Replacement of affected fascias and barges may then be a necessary step in protecting surrounding building elements from such deterioration.

A qualified plumber may be appointed to assess the cause of excessive moisture and to provide advice on any remedial works as required. A qualified carpenter or registered builder may also be required to replace affected building materials.

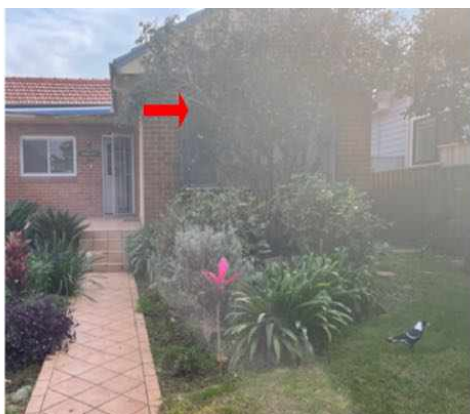
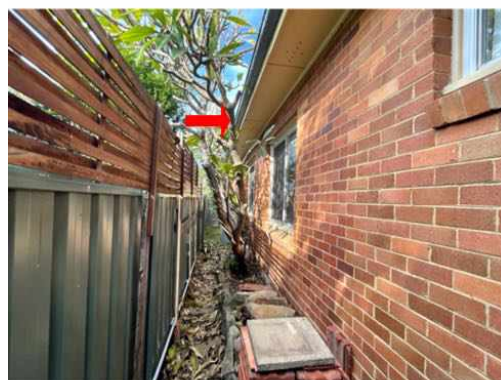
Defects 3.04

Building:	Building 1
Location:	All External Areas
Finding:	Trees - Overhanging and filling gutters
Information:	Overhanging trees often result in excessive amounts of leaf debris accumulating in gutters.

Gutters are a critical part of the building's management of storm water and rain. It is therefore important that they be kept clear to prevent secondary damage to associated building elements, including exterior and interior walls, ceiling linings and any adjoining building elements. Where gutters are blocked, pooling of rainwater is likely to occur, fast-tracking rust and corrosion of the roof plumbing elements.

It is advised that all overhanging tree branches be removed as soon as possible to prevent any further damage. Repair and/or replacement of sections of damaged guttering may also be required where the extent of the damage necessitates.

Such works should be performed by the homeowner; however, appointment of a landscape contractor or an arborist may be required. Consultation with a licensed roof plumber is required where guttering has been damaged.

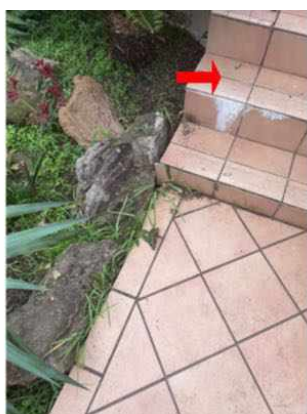
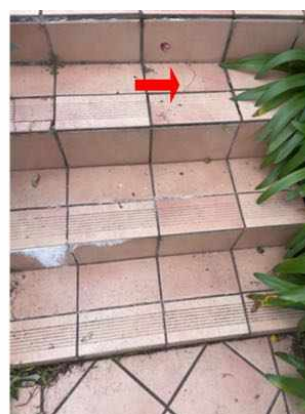
Defects 3.05

Finding: Tiles - Cracked or damaged

Information: Cracking was evident to the tiling in this area at the time of inspection. While the cracking appears to be minor, this area is frequently exposed to water, allowing potential for water penetration into adjoining sections of walls or flooring.

If left unmanaged, water penetration to these areas may lead to subsequent water damage, which is likely necessitate repair work to affected building elements.

A tiling contractor should be appointed to ensure that no further water damage occurs. The re-application of silicone and grouting throughout remaining tile work is also advised, to further protect the area against water penetration.

Where water penetration has led to water damage, appointment of a relevant tradesperson may be required to repair damaged building elements.

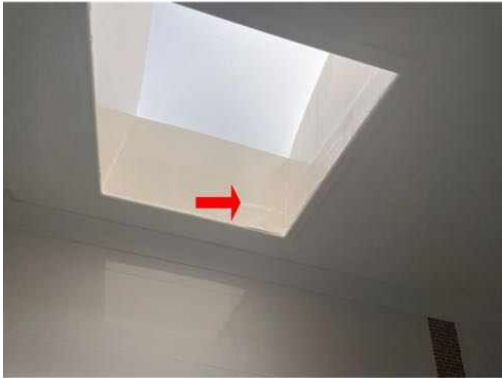
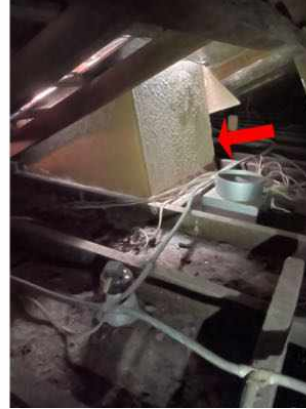
Defects 3.06

Finding: Skylight - Water damaged

Information: Water damage to the skyline get lining is generally an indication of excessive moisture being present in the roof void, usually via a leak to the roof covering.

Where water damage is evident to the ceiling, the primary requirement is to identify and rectify the source of the leak.

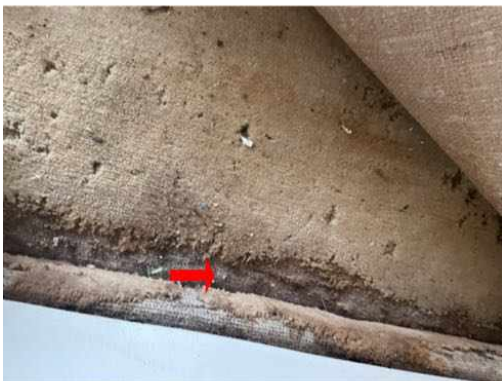
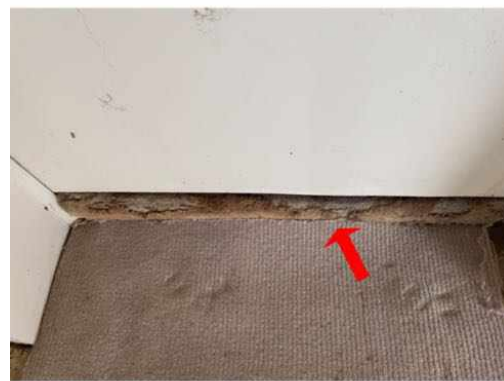
Defects 3.07

Finding: Carpet - Deteriorated

Information: Sections of the carpet floor covering in this area appeared to be mouldy. It is suspected that the presence of excessive moisture, possibly due to an internal water leak, has created an environment conducive to mould/fungi growth.

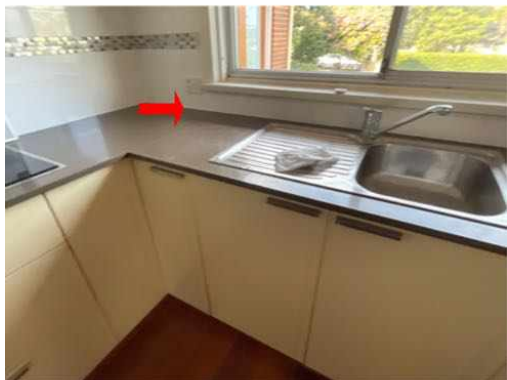
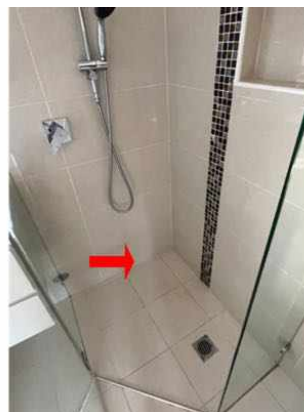
Defects 3.08

Finding: Sealant and grouting - Missing or damaged

Information: Flexible and mould resistant materials should be applied to affected areas to prevent any subsequent water damage that is likely to occur. Regular maintenance and

replacement of damage or missing or damaged sealant and grout is highly recommended to the wet areas, as this is a regular wear and tear defect. Sealant and grouting in areas that come into regular contact with water should be maintained for the long term care of your property.

A sealant specialist or tiling contractor should be appointed to complete these works as soon as possible

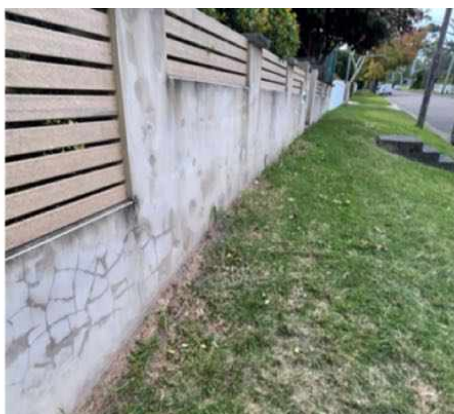
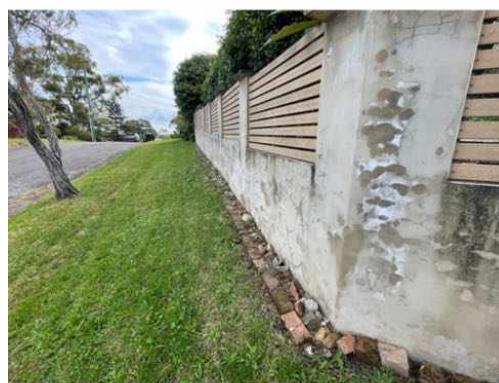
Defects 3.09

Building:	Building 1
Location:	All External Areas
Finding:	Paint finish - Substandard
Information:	The paint finish in this area was found to have been completed to a substandard level. Substandard painting is generally classified as an appearance defect. However, the substandard appearance may also be indicative of poor surface preparation and substandard workmanship.

If this applies, further areas of poor and incomplete finishes could develop over time. Furthermore, substandard paint finishes in areas exposed to moisture, e.g. external areas or wet areas, could lead to deterioration of underlying building materials.

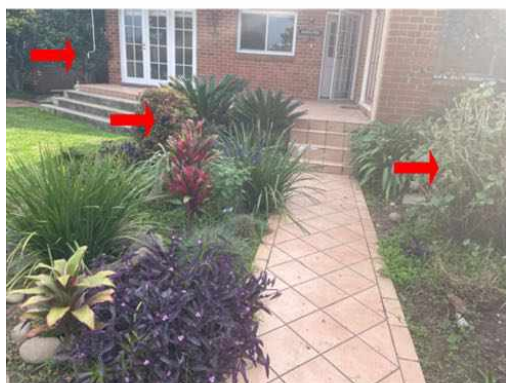
Building: Building 1
 Location: All External Areas
 Finding: Garden Beds - Conditions Conducive to Termites
 Information:

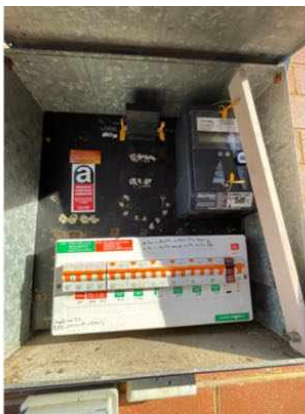
Building: Building 1
 Location: Yard - Side
 Finding: Termite Management System - no evidence of installation
 Information: The application of a post-construction chemical termite barrier is highly recommended for all properties, particularly if live termite activity has been found on the site previously. Such barriers are highly effective in preventing termite attack on any timber building elements throughout the property.

A durable notice should be placed in the switchboard unit to indicate current termite barriers. At the time of inspection, it appeared as though no termite management system has been installed, with no evidence to suggest preventative works taking place.

The client may consider gaining further advice from a pest controller as to the costs and procedures involved with this application. It is recommended that obtaining such advice be a short-term priority.

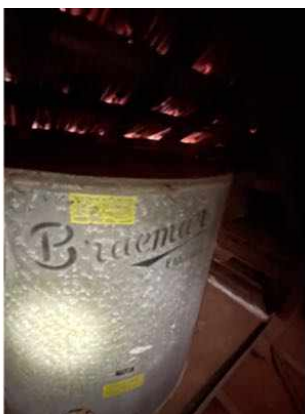
Building:	Building 1
Location:	Roof Void
Finding:	Gravity-Fed HWS - Disconnected
Information:	It was noted at the time of inspection that a disconnected gravity-fed hot water system (HWS) remains in this area.

Despite this plumbing structure being unused, it is likely to be storing residual water, and is therefore susceptible to rust and corrosion. If allowed to continue, rust and corrosion is likely to lead to damage to adjoining building elements, and may also make the area susceptible to termite or timber pest activity.

While it is a costly exercise to remove the disused gravity-fed HWS, it is advisable in the short-term future to prevent any further damage to the area. Further consultation with a licensed plumber is required to gain further advice on removal of the structure.

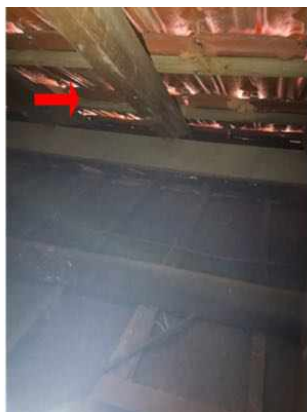
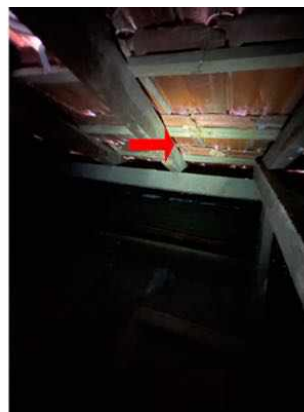
Building:	Building 1
Location:	Roof Void
Finding:	Sarking - Missing
Information:	Sarking is missing under the roof sheeting. Sarking acts as an insulator that helps with

noise reduction and protects against water penetration. Sarking plays a key role in the operation and function of the overall roofing structure and its performance.

Although not a requirement at the time of construction, replacement of any missing building element is advisable (although this can be quite expensive to do after the time of construction). Where sarking is missing, regular inspections of the roof tiles for cracking and potential moisture penetration is required.

Sarking may be retrospectively fitted by a registered builder at the discretion of the client.

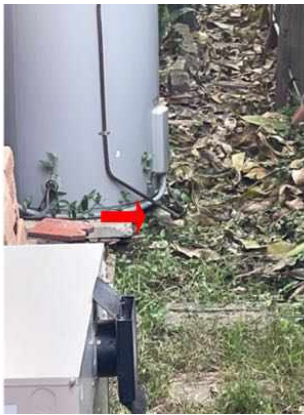
Building:	Building 1
Location:	Yard - Side
Finding:	Overflow - Not plumbed for drainage
Information:	The overflow is not plumbed or connected to suitable drainage, which has resulted in the surrounding area becoming excessively damp.

These damp conditions can lead to secondary defects such as rot, rust or corrosion of associated building elements, the formation of fungal decay, or even the creation of potential slip hazards. When coupled with poor site drainage, pooling of water may also attract termite activity to this area.

It is highly recommended that a qualified plumber be appointed to install adequate drainage to the overflow. These works will ensure that the area remains dry and free of any secondary defects.
