## **VISUAL BUILDING AND PEST INSPECTION REPORT**

Complies with Australian Standard 4349.1 & 4349.3

Vendor Report

18 Harmston Avenue, Frenchs Forest

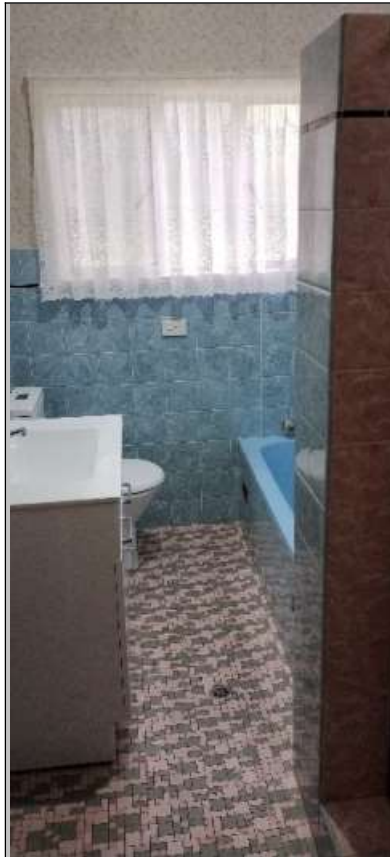
Adjacent to hall.

The shower recess was tested and there was no visible water penetration to surrounding areas. IMPORTANT NOTE: This test may not reveal water leaks until the shower is put into constant use and surrounding areas monitored over a period of time.

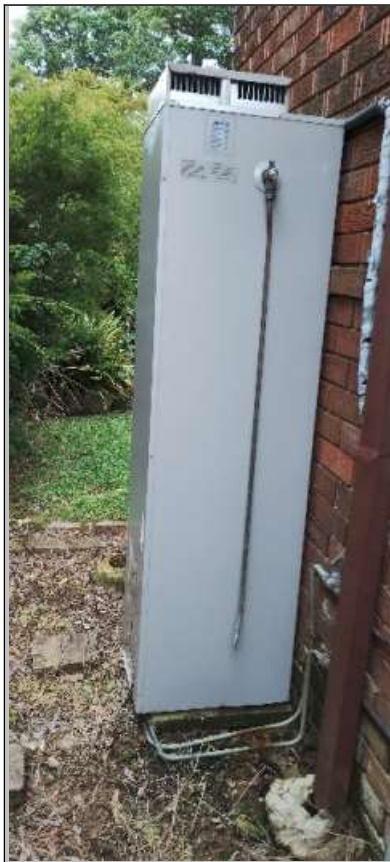
Gas hot water system: Mains pressure: Located externally: The hot water system appears to be in working condition. No specific tests other than running the hot water tap were carried out. No determination has been made as to the suitability or adequacy of the hot water system in relation to capacity or otherwise.

The unit was manufactured in 2017.
